Re: C/007/030 Wildcat Load Out 2015 Annual Report

Wild West Equipment & Hauling, LLC, on behalf of Intermountain Power Agency, respectfully submits the 2015 Annual Report for the Wildcat Load Out Permit C/007/030 on the enclosed CD.

Annual Report

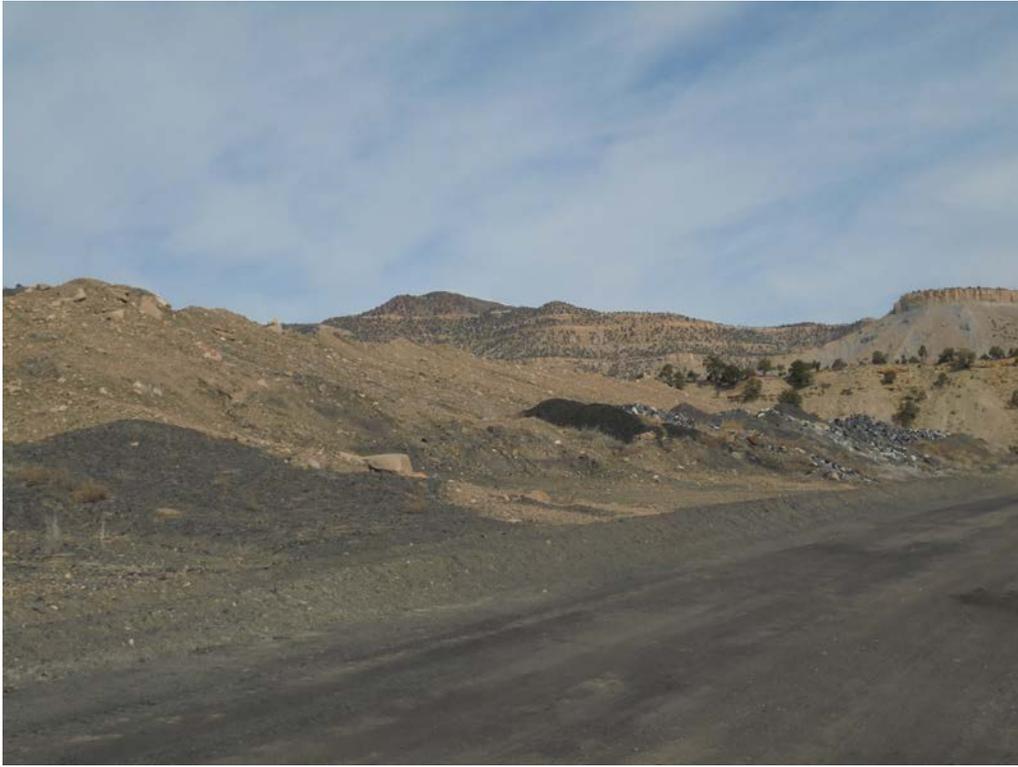
EAST SIDE OF REFUSE PILE

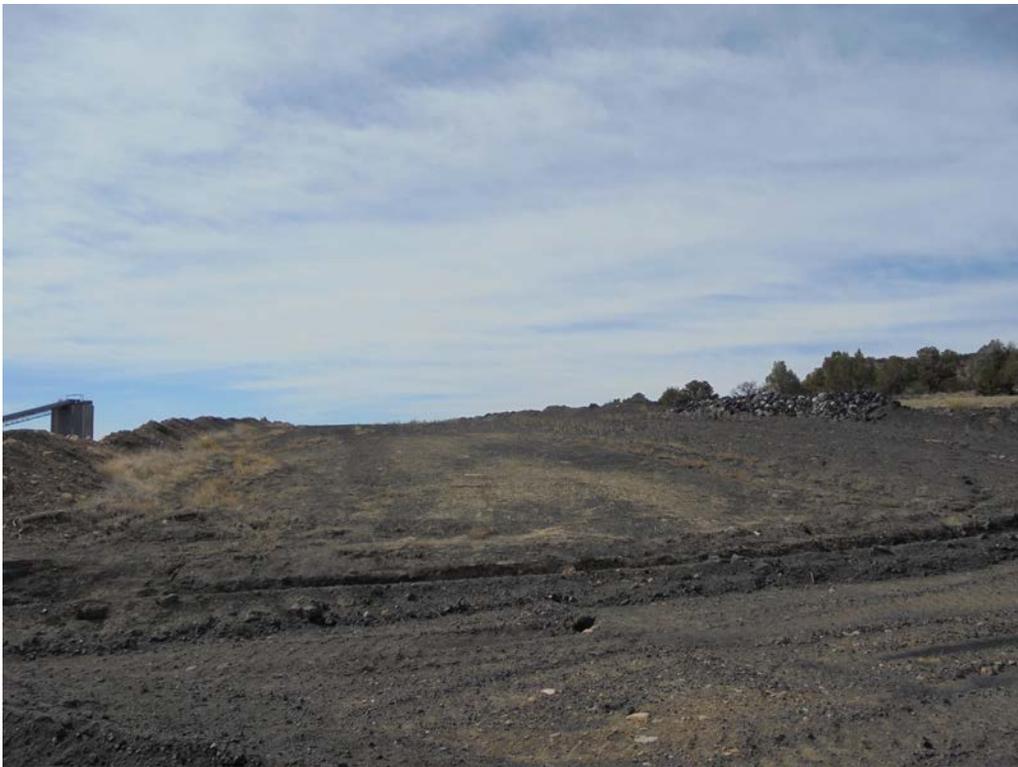
LOOKING SOUTH AT TOP OF REFUSE PILE

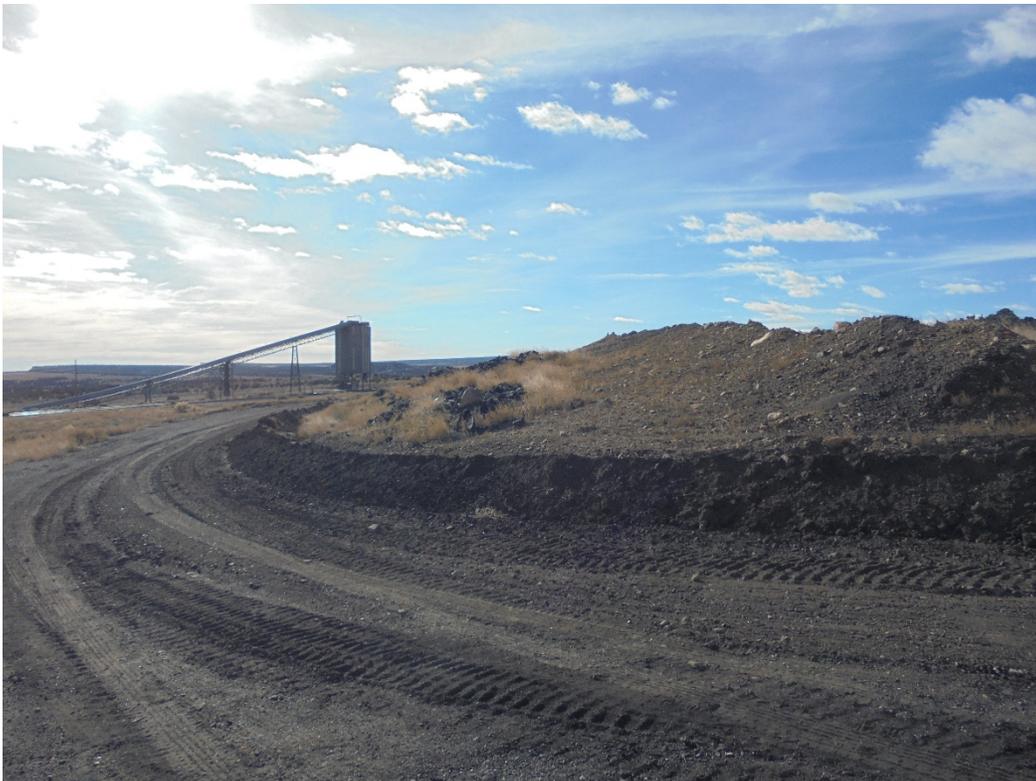
DRAINAGE DITCH CLEANED

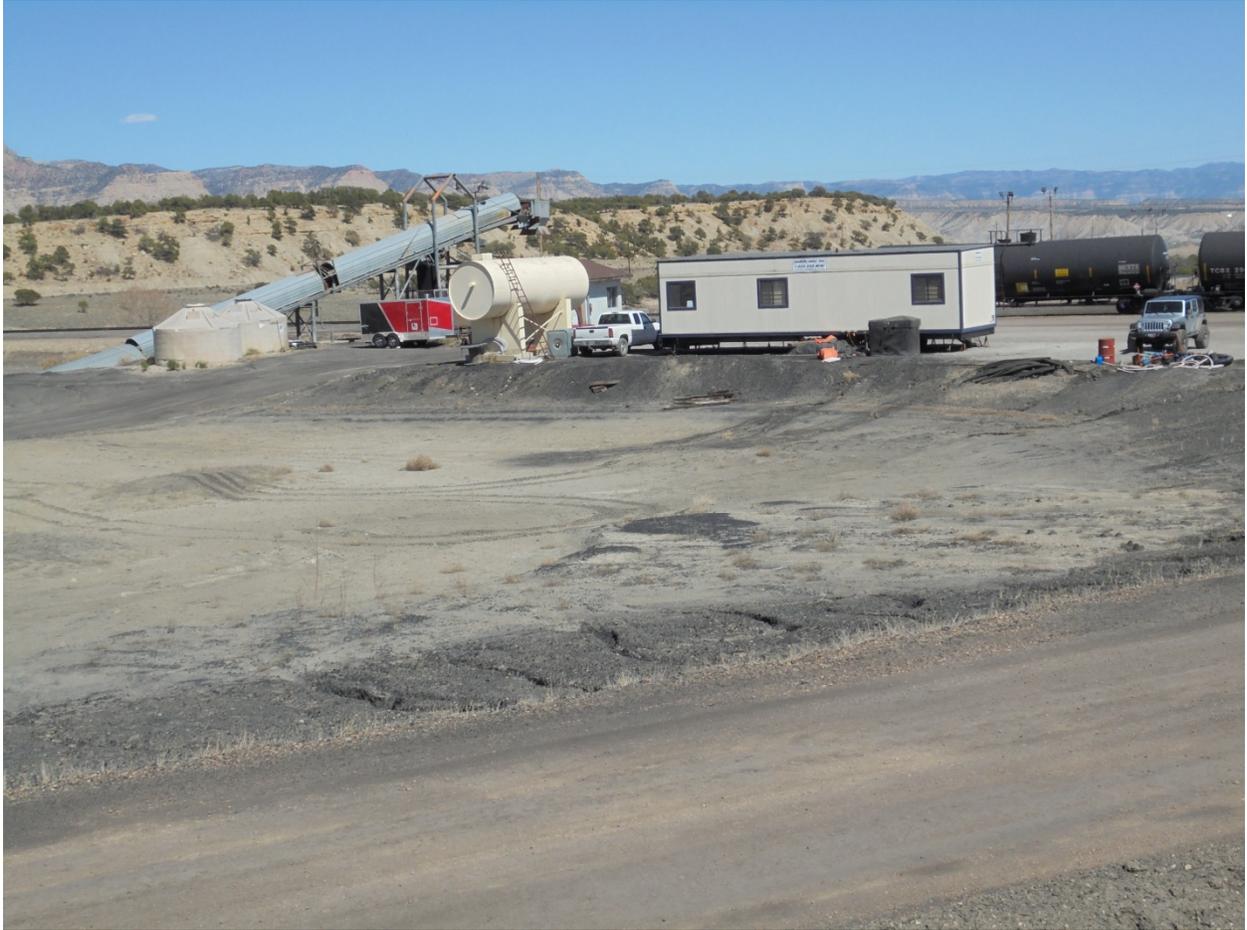
DEPRESSION AREA

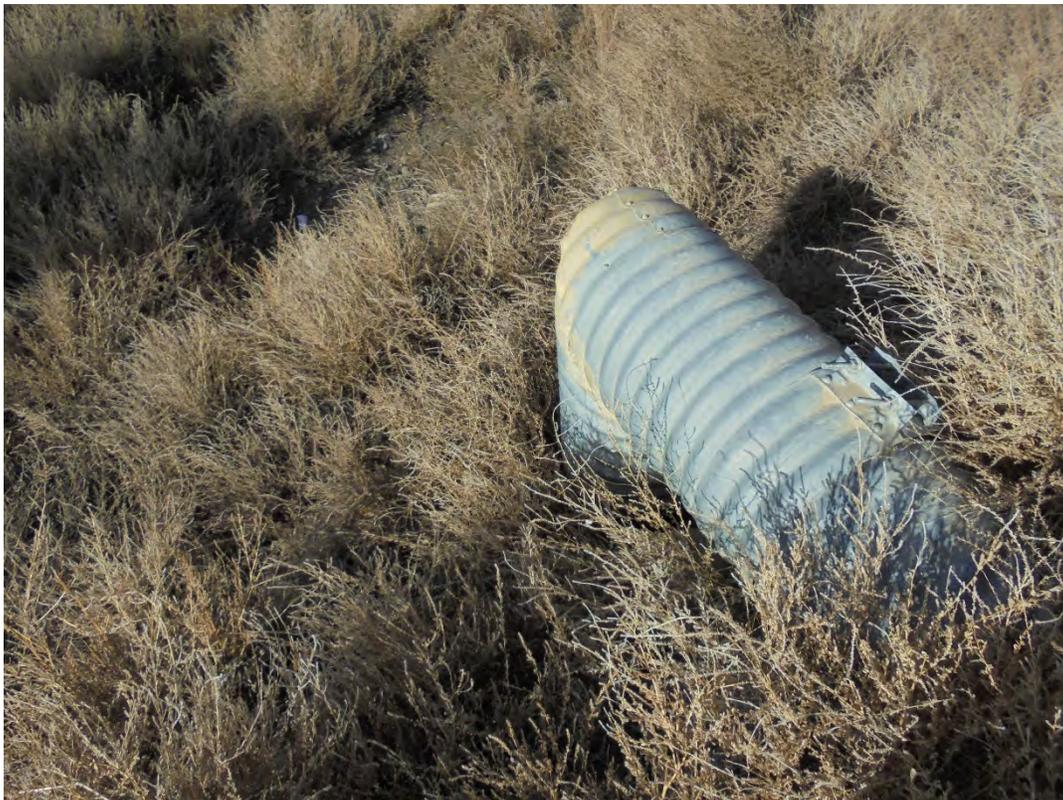
4. Field Information: Provide current water elevation, whether pond is discharging, type and number of samples taken, monitoring/instrumentation information, inlet/outlet conditions or other related activities associated with the pond including but not limited to sediment cleanout, pond decanting, embankment erosion/repairs, monitoring information, vegetation on out slopes of embankment erosion/repairs, monitoring information, vegetation on out slopes of embankments, etc.			
During the annual inspection December 8, 2015, the vegetative cover looked good with no signs of erosion. Weeds need to be removed from inlet of principle spillway. See attached photograph.

UPPER CELL PRINCIPLE SPILLWAY INLET WEEDS

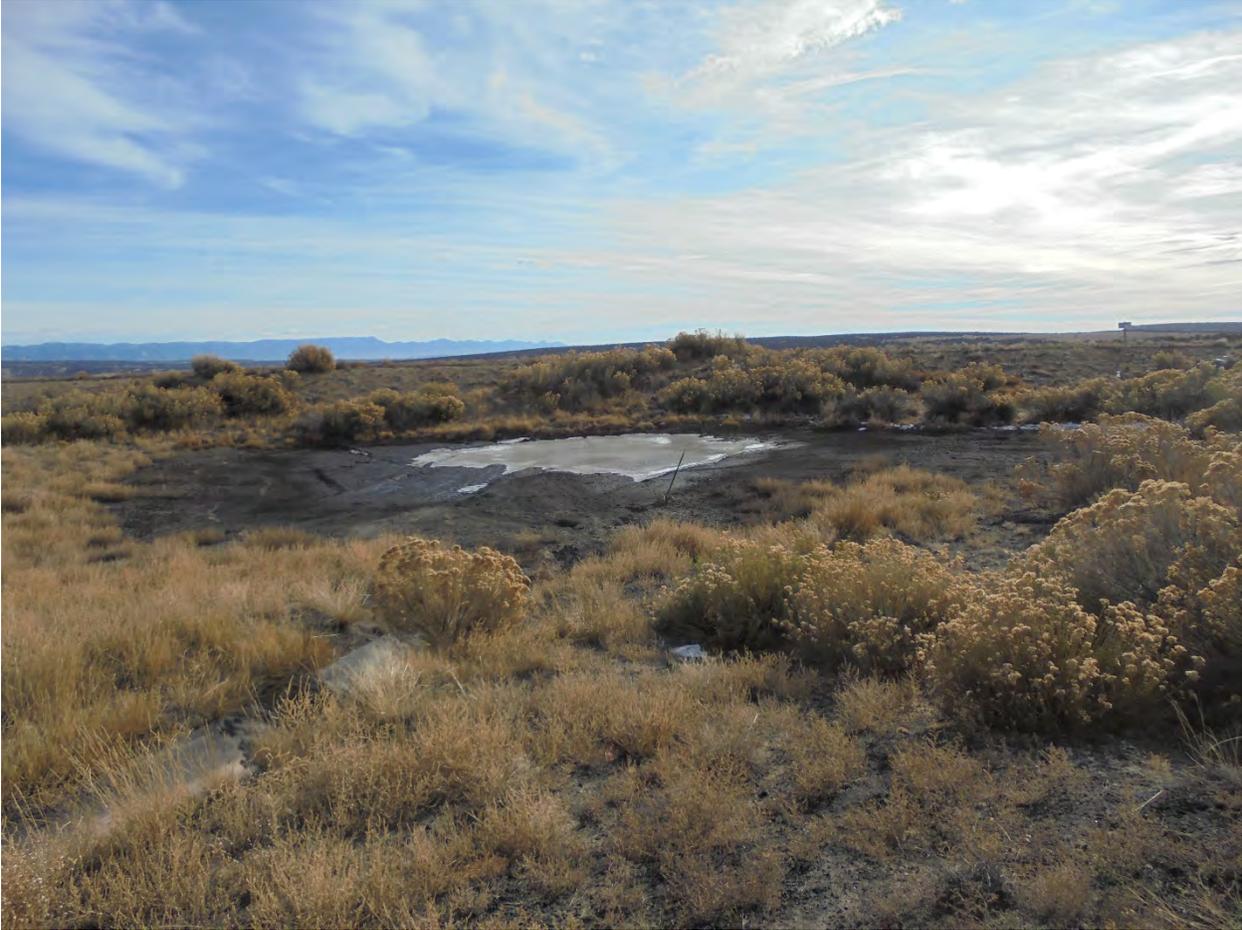
POND A

3. Principle and emergency spillway elevations		
	Principle spillway elevation: 6,149.0'		
	Emergency spillway elevation: 6,150.0'		
4. Field Information: Provide current water elevation, whether pond is discharging, type and number of samples taken, monitoring/instrumentation information, inlet/outlet conditions or other related activities associated with the pond including but not limited to sediment cleanout, pond decanting, embankment erosion/repairs, monitoring information, vegetation on outslopes of embankment erosion/repairs, monitoring information, vegetation on outslopes of embankments, etc.			
During the annual inspection, December 8, 2015, the vegetative cover looked good with no signs of erosion. Both spillways look good with no signs of stability problems.

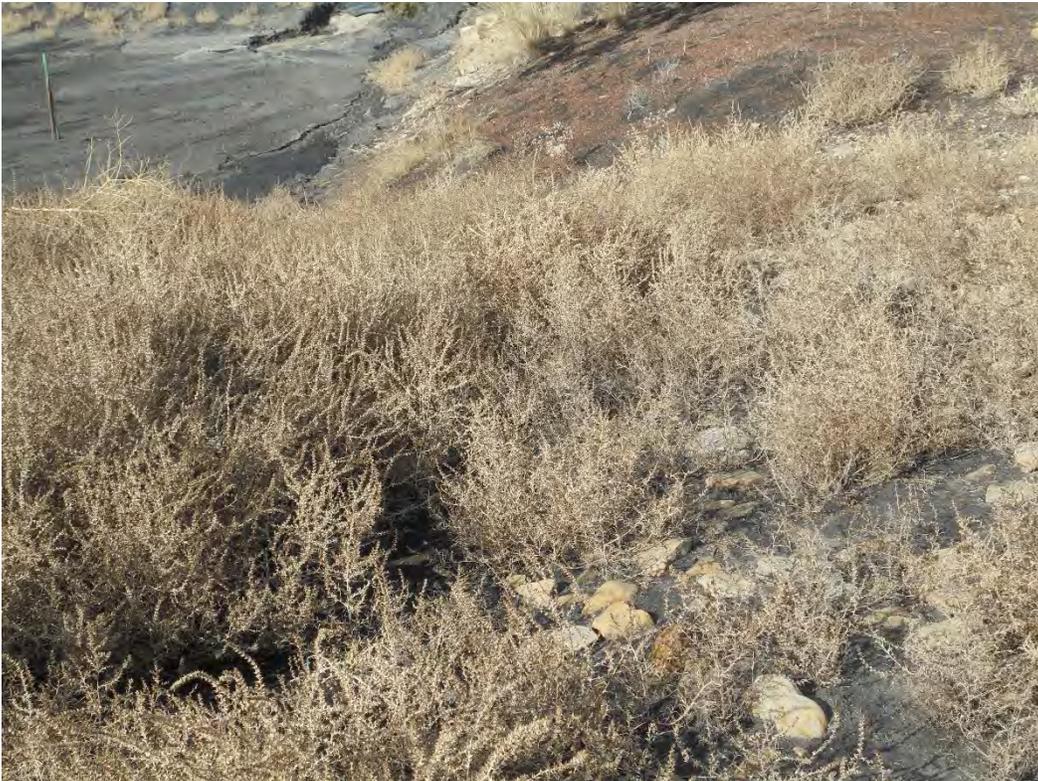
3. Principle and emergency spillway elevations		
	Principle spillway elevation: 6,138.0'		
	Emergency spillway elevation: 6,139.0'		
4. Field Information: Provide current water elevation, whether pond is discharging, type and number of samples taken, monitoring/instrumentation information, inlet/outlet conditions or other related activities associated with the pond including but not limited to sediment cleanout, pond decanting, embankment erosion/repairs, monitoring information, vegetation on out slopes of embankment erosion/repairs, monitoring information, vegetation on out slopes of embankments, etc.			
During the annual inspection, December 8, 2015, the vegetative cover looked good with no signs of erosion. Weeds in the emergency spillway need to be clean out. Refer to the attached photograph.

EMERGENCY SPILLWAY WEEDS

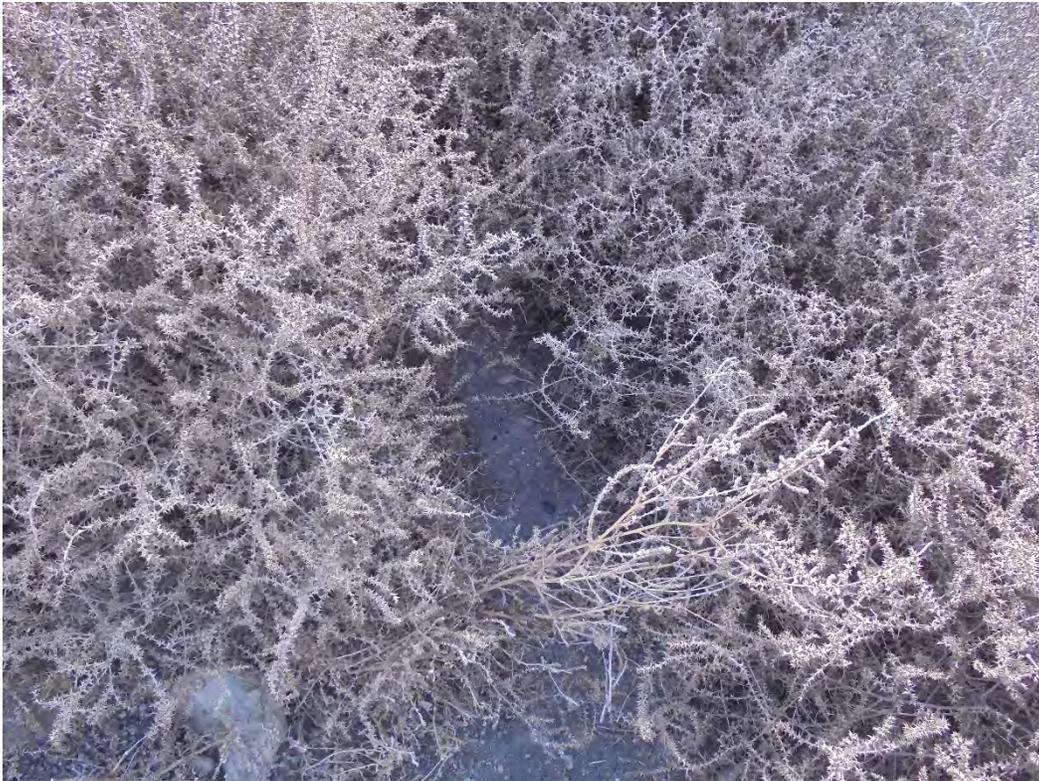
3. Principle and emergency spillway elevations		
	Principle spillway elevation: 6,137.0'		
	Emergency spillway elevation: 6,138.0'		
4. Field Information: Provide current water elevation, whether pond is discharging, type and number of samples taken, monitoring/instrumentation information, inlet/outlet conditions or other related activities associated with the pond including but not limited to sediment cleanout, pond decanting, embankment erosion/repairs, monitoring information, vegetation on out slopes of embankment erosion/repairs, monitoring information, vegetation on out slopes of embankments, etc.			
During the annual inspection, December 8, 2015, the vegetative cover looked good with no signs of erosion. Weeds at inlet and outlet of emergency spillway need to be removed. See the attached photograph.

EMERGENCY SPILLWAY INLET WEEDS

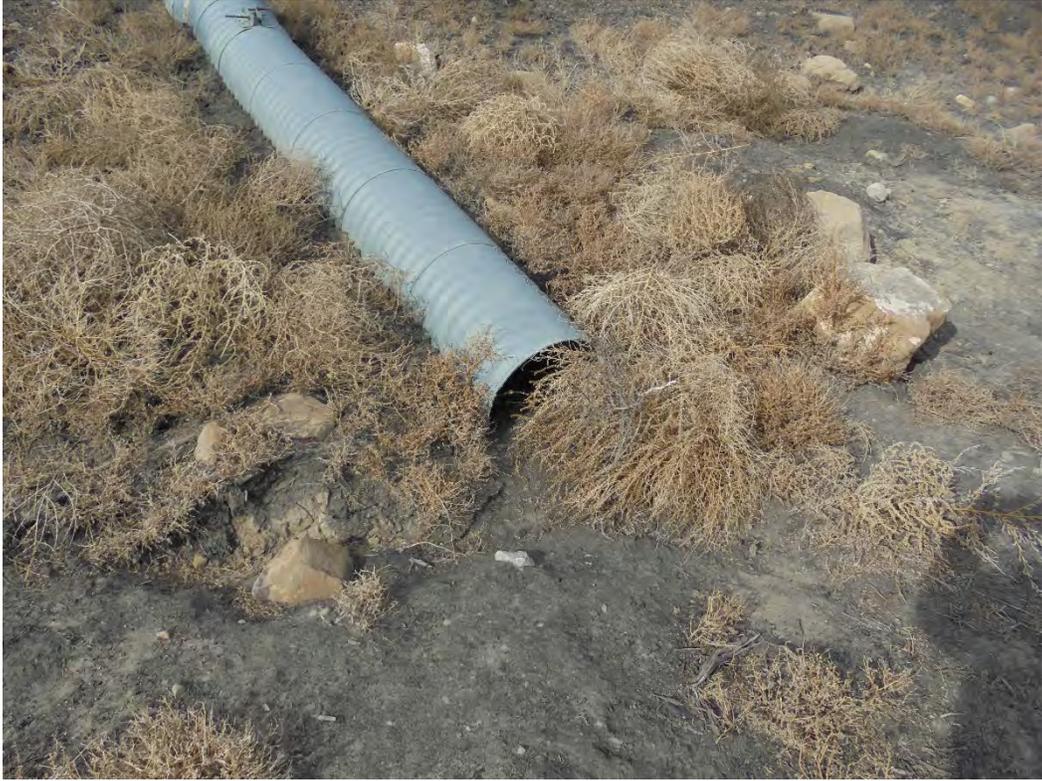
EMERGENCY SPILLWAY OUTLET WEEDS

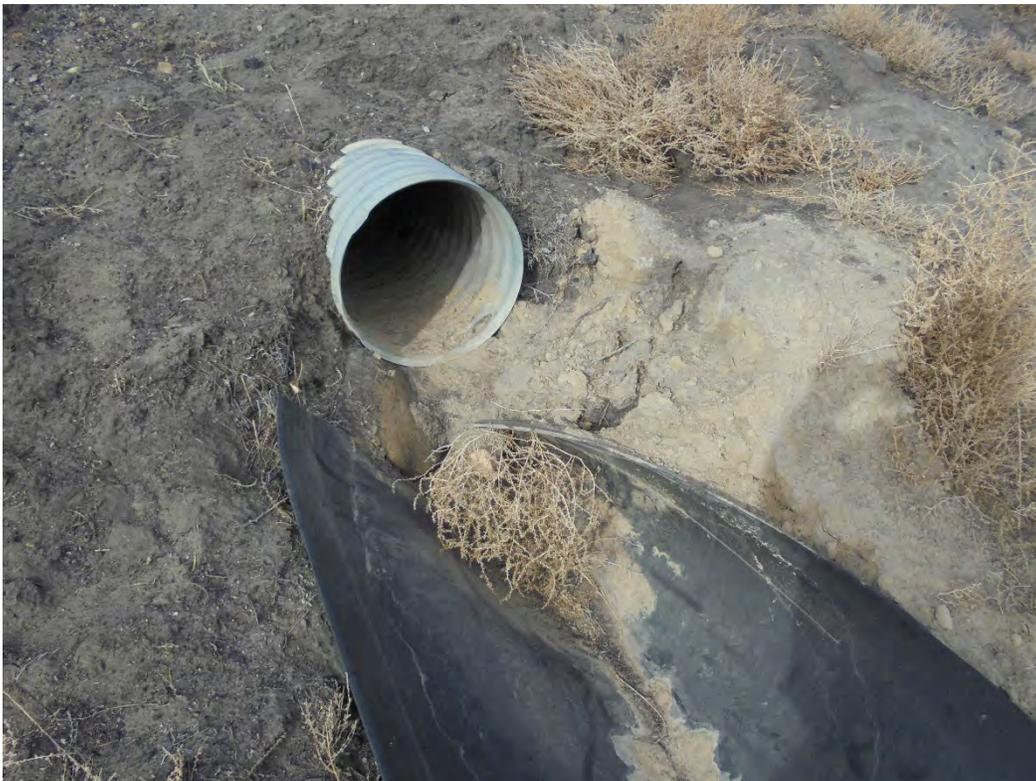
3. Principle and emergency spillway elevations		
	Principle spillway elevation: 6,139.0'		
	Emergency spillway elevation: 6,140.0'		
4. Field Information: Provide current water elevation, whether pond is discharging, type and number of samples taken, monitoring/instrumentation information, inlet/outlet conditions or other related activities associated with the pond including but not limited to sediment cleanout, pond decanting, embankment erosion/repairs, monitoring information, vegetation on outslopes of embankment erosion/repairs, monitoring information, vegetation on outslopes of embankments, etc.			
During the annual inspection, December 8, 2015, the vegetative cover looked good with no signs of erosion. Erosion belt on discharge of principle spillway needs to be straightened out. See attached photograph.

PRINCIPAL SPILLWAY OUTLET BELT

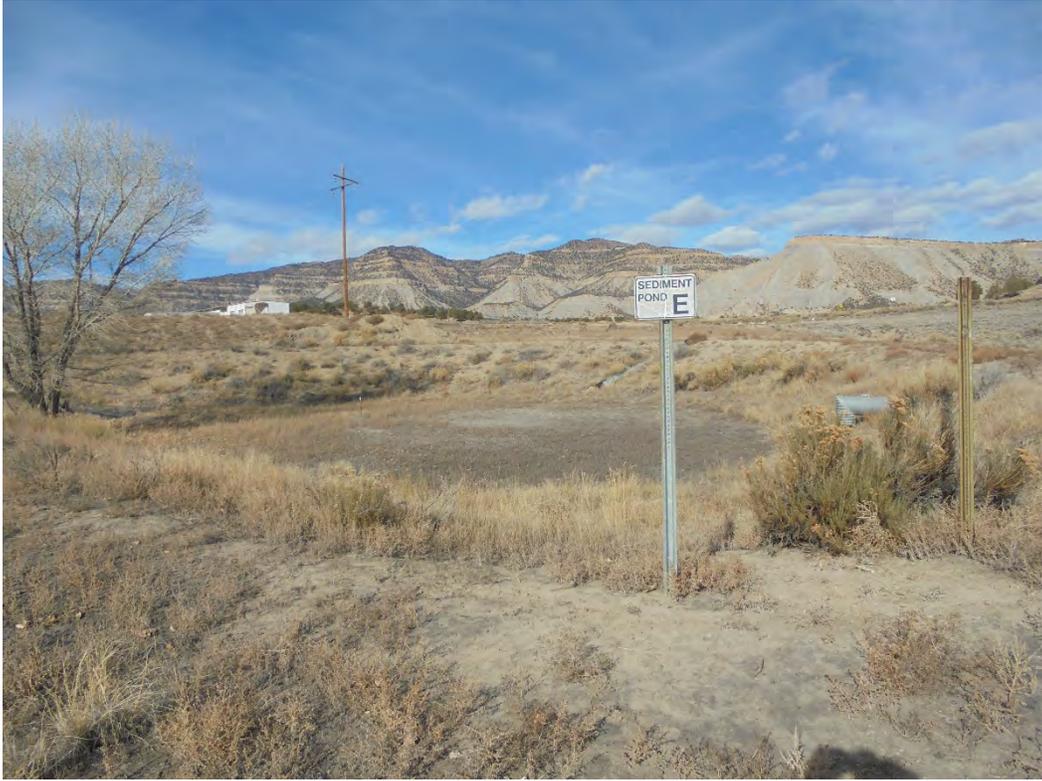
POND E

3. Principle and emergency spillway elevations		
	Principle spillway elevation: 6,145.0'		
	Emergency spillway elevation: 6,146.0'		
4. Field Information: Provide current water elevation, whether pond is discharging, type and number of samples taken, monitoring/instrumentation information, inlet/outlet conditions or other related activities associated with the pond including but not limited to sediment cleanout, pond decanting, embankment erosion/repairs, monitoring information, vegetation on out slopes of embankment erosion/repairs, monitoring information, vegetation on out slopes of embankments, etc.			
During the annual inspection, December 8, 2015, the vegetative cover looked good with no signs of erosion.

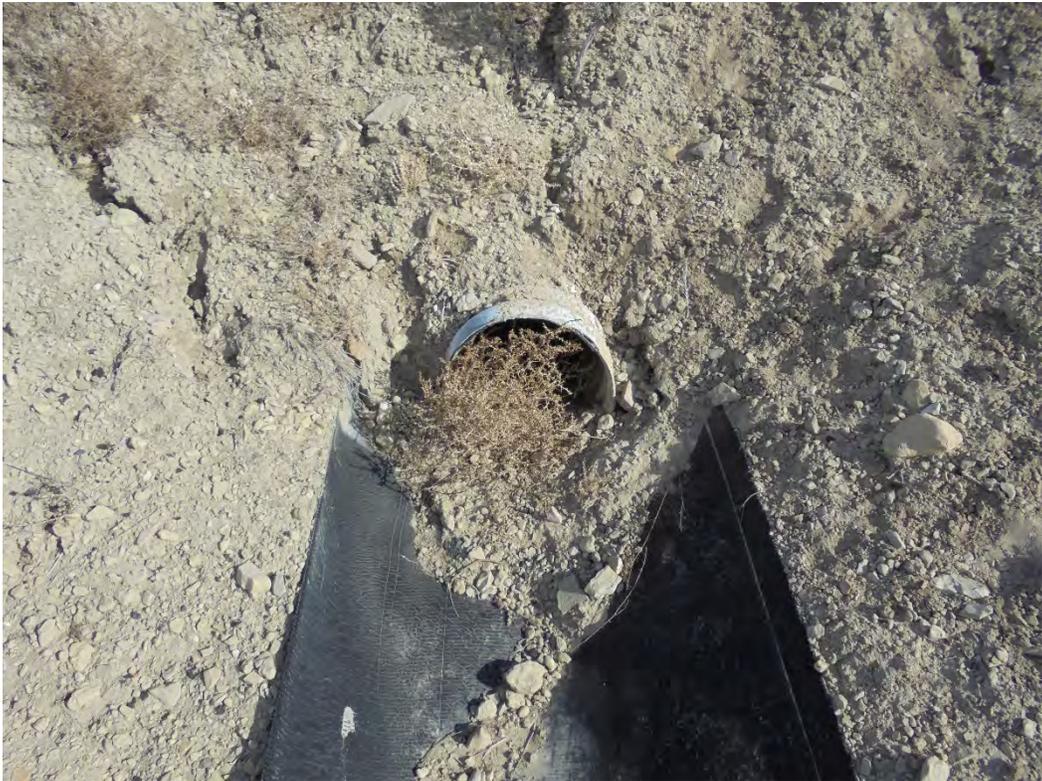
3. Principle and emergency spillway elevations		
	Principle spillway elevation: 6,173.0'		
	Emergency spillway elevation: 6,174.0'		
4. Field Information: Provide current water elevation, whether pond is discharging, type and number of samples taken, monitoring/instrumentation information, inlet/outlet conditions or other related activities associated with the pond including but not limited to sediment cleanout, pond decanting, embankment erosion/repairs, monitoring information, vegetation on out slopes of embankment erosion/repairs, monitoring information, vegetation on out slopes of embankments, etc.			
During the annual inspection, December 8, 2015, the vegetative cover looked good with no signs of erosion. Principle spillway outlet and east inlet need to be cleaned. See attached photograph.

PRINCIPLE SPILLWAY OUTLET WEEDS & DIRT

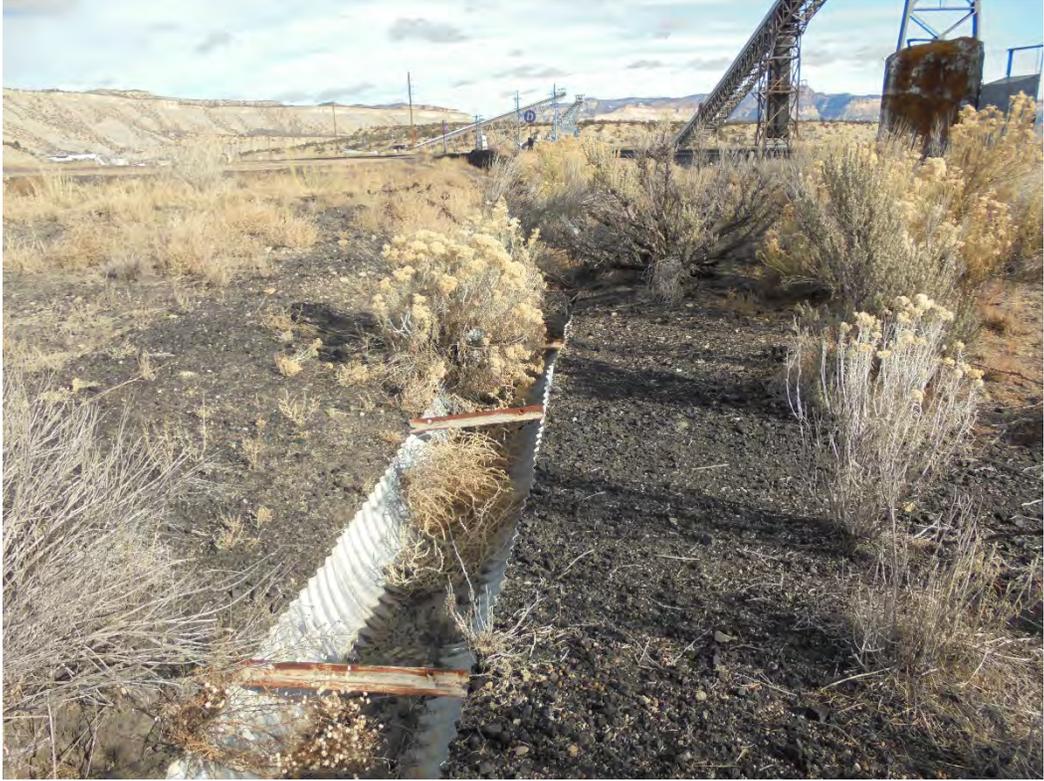
EAST INLET WEEDS
