Re: C/007/030 Wildcat Load Out 2015 Annual Report

Wild West Equipment & Hauling, LLC, on behalf of Intermountain Power Agency, respectfully submits the 2015 Annual Report for the Wildcat Load Out Permit C/007/030.

<b>1. IMPOUNDMENT INSPECTION AND CERTIFIED REPORT</b>		Page 1 of 2	
Permit Number:	ACT/015/025	Report Date: December 6, 2016	
Mine Name:	Wildcat Loadout		
Company Name	Wild West Equipment & Haulage, LLC		
Impoundment Identification:	Impoundment Name	Permanent Impoundment	
	Impoundment Number:	Permanent Impoundment	
	UPDES Permit Number:	UTG040007	
	MSHA ID Number:	42-01864	
<b>IMPOUNDMENT INSPECTION</b>			
Inspection Date:	October 29, 2016		
Inspected By:	J.T. Paluso		
Reason for Inspection:	Annual Inspection		
(Annual, Quarterly or other Periodic Inspection, Critical Installation or Completion of Construction)			
<b>1. Describe any appearances of any instability, structural weakness, or any other hazardous condition.</b>			
The pond's dam shows no signs of structural instability or other hazardous conditions.			
Required for an impoundment which functions as a SEDIMENTATION POND	<b>2. Sediment storage capacity and storage volumes.</b>

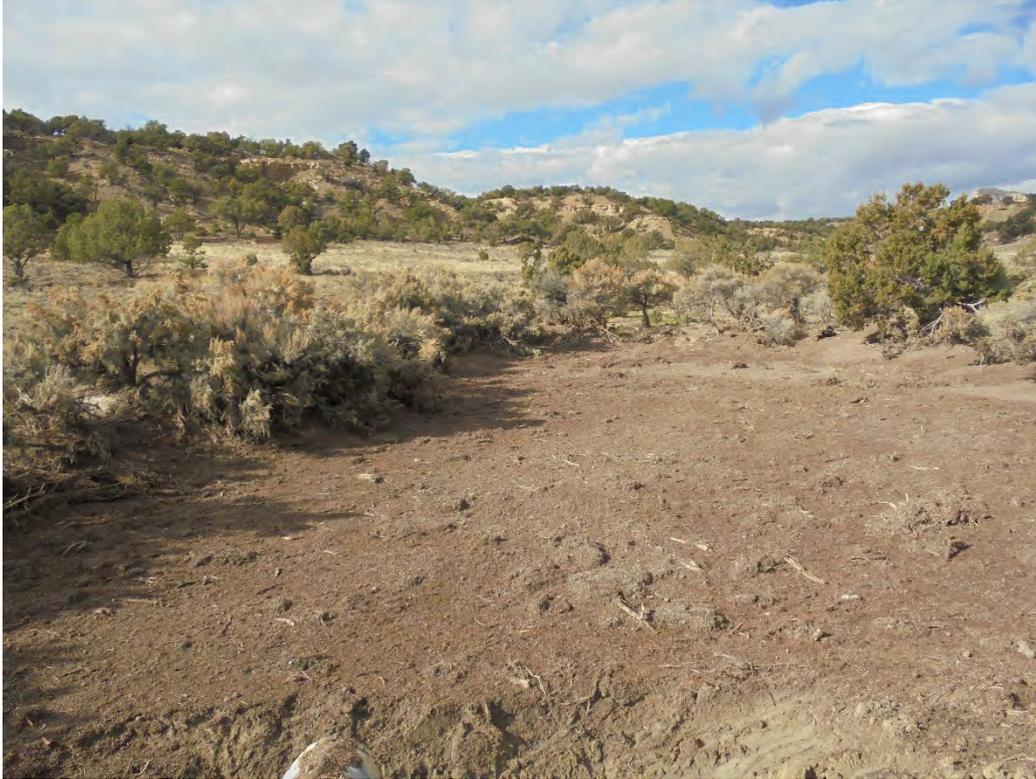
Existing Storage Capacity: 0.437 ac-ft (Upper) and 1.114 ac-ft (Lower)		
	Existing Sediment Storage Capacity (To Cleanout): NA		
	<b>3. Principle and emergency spillway elevations</b>		
	Principle spillway elevation: 6195.8 Upper Cell, 6185.8 Lower Cell		
	Emergency spillway elevation: 6196.3 Upper Cell, NA Lower Cell		
<b>4. Field Information:</b> Provide current water elevation, whether pond is discharging, type and number of samples taken, monitoring/instrumentation information, inlet/outlet conditions or other related activities associated with the pond including but not limited to sediment cleanout, pond decanting, embankment erosion/repairs, monitoring information, vegetation on out slopes of embankment erosion/repairs, monitoring information, vegetation on out slopes of embankments, etc.			
During the annual inspection October 29, 2016, the vegetative cover looked good with no signs of erosion. Due to past storms, work had been performed on inlet and outlet sides of the upper cell. See attached photograph.

**PERMANENT IMPOUNDMENT UPPER CELL**

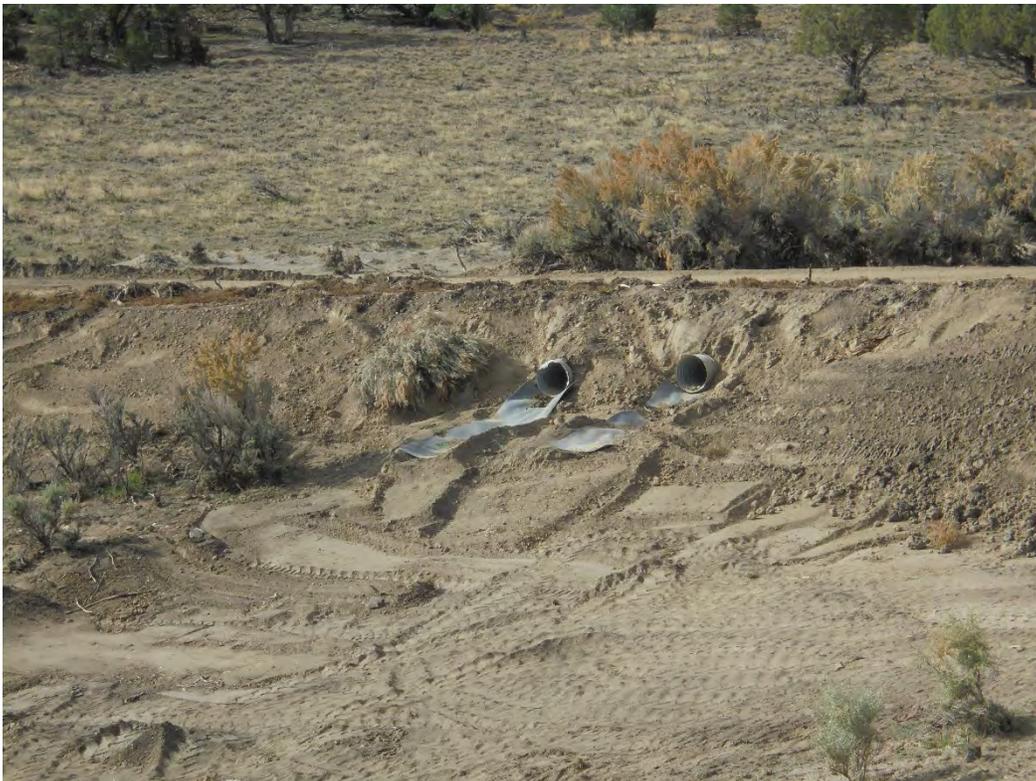
**UPPER CELL DISCHARGE SIDE WORK**

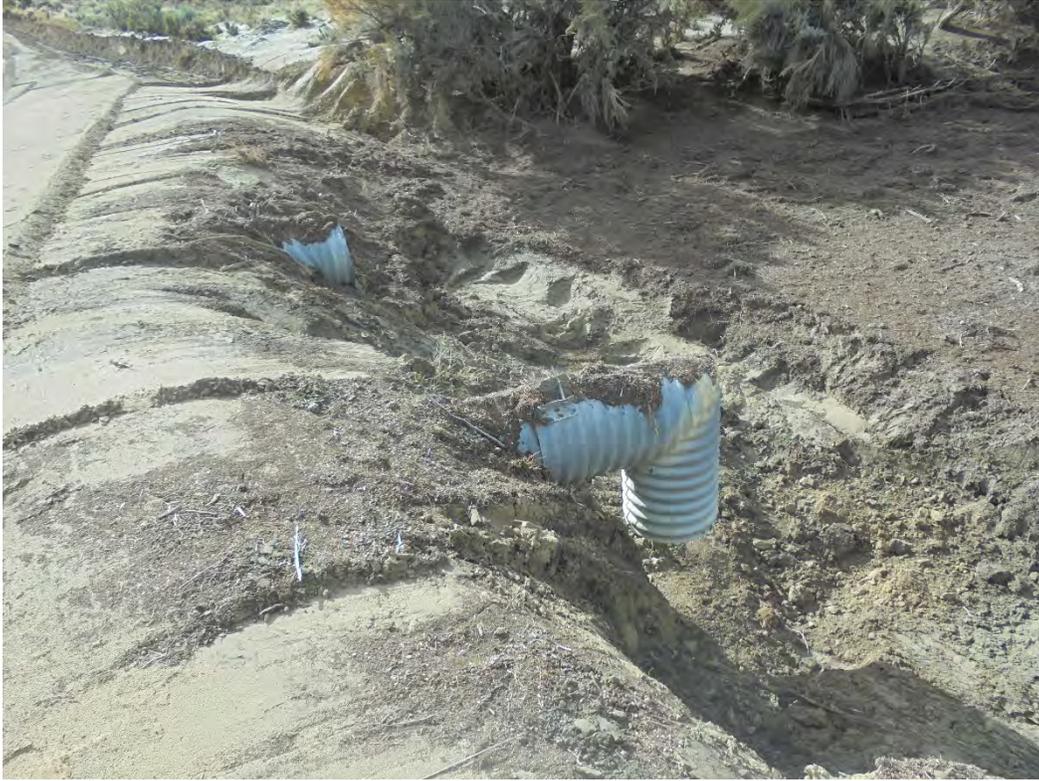
**UPPER CELL INTAKE SIDE WORK**

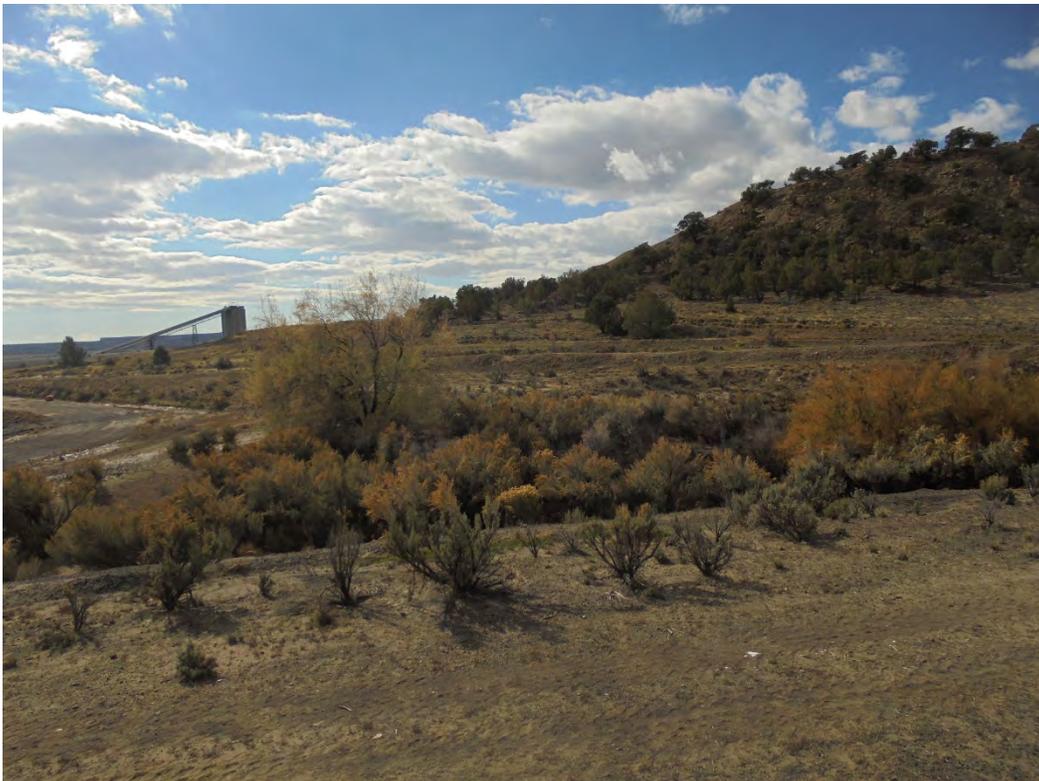
**PERMANENT IMPOUNDMENT LOWER CELL**

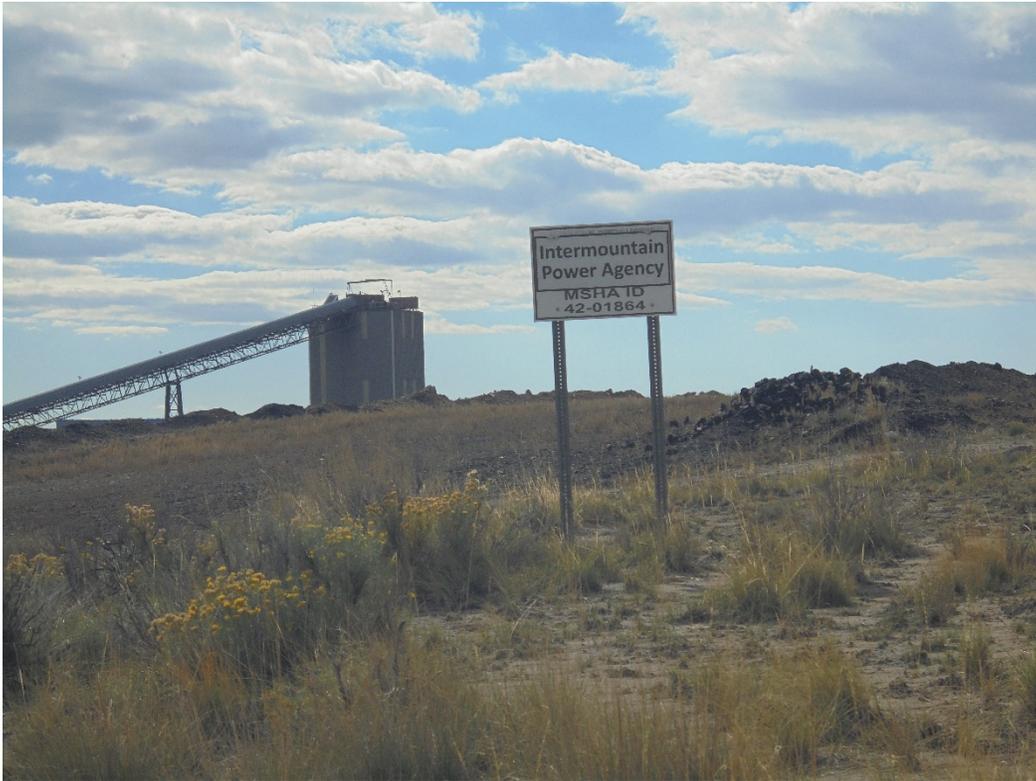
**REFUSE PILE SIGN**

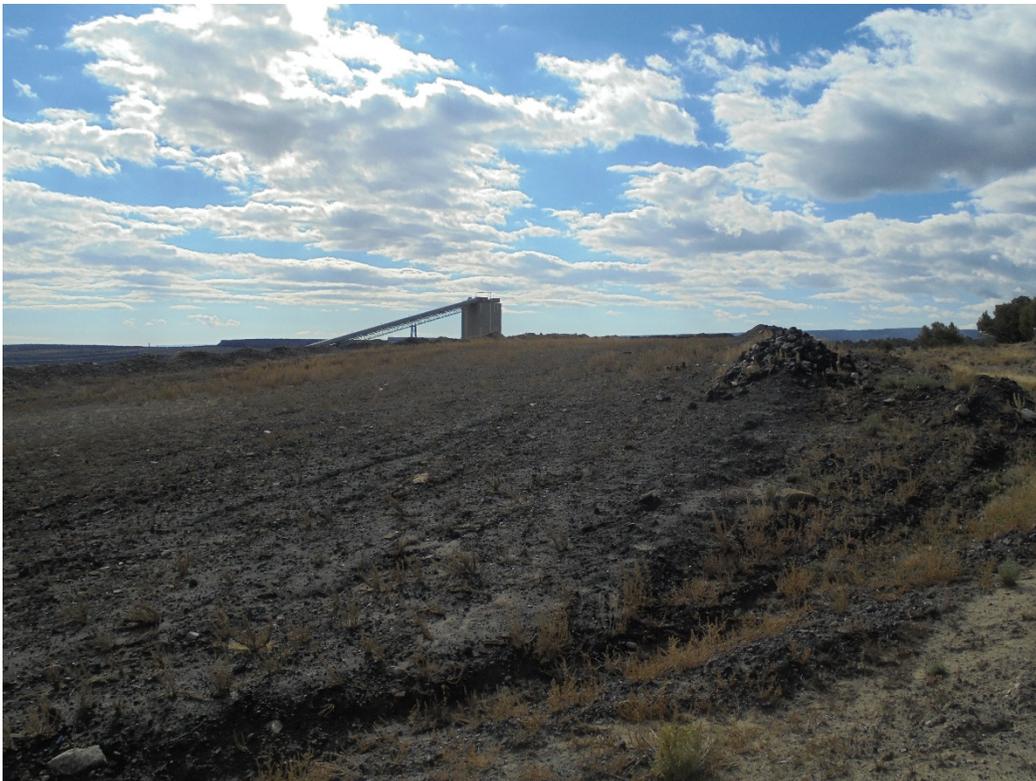
**LOOKING SOUTH**

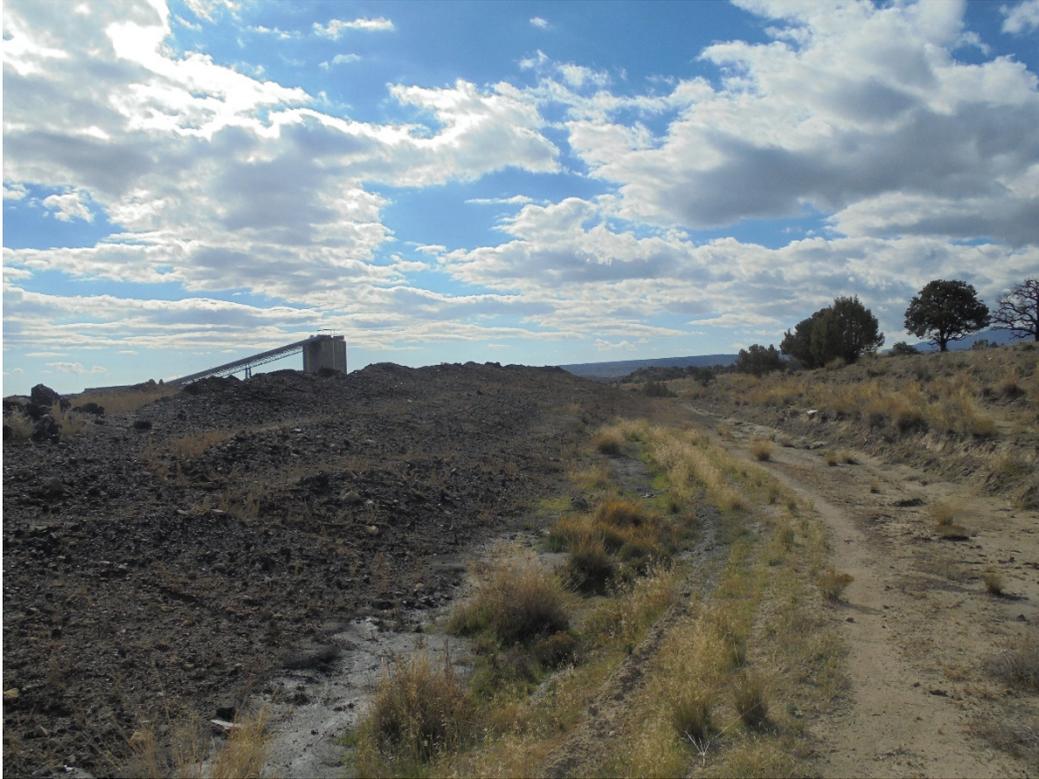
8. Describe placement of under drains, protective filter systems, and final surface drainage systems (report any seepage, including location, color, flow) :  
None known. Drainage ditch recently cleaned

**WEST DRAINAGE DITCH LOOKING SOUTH**

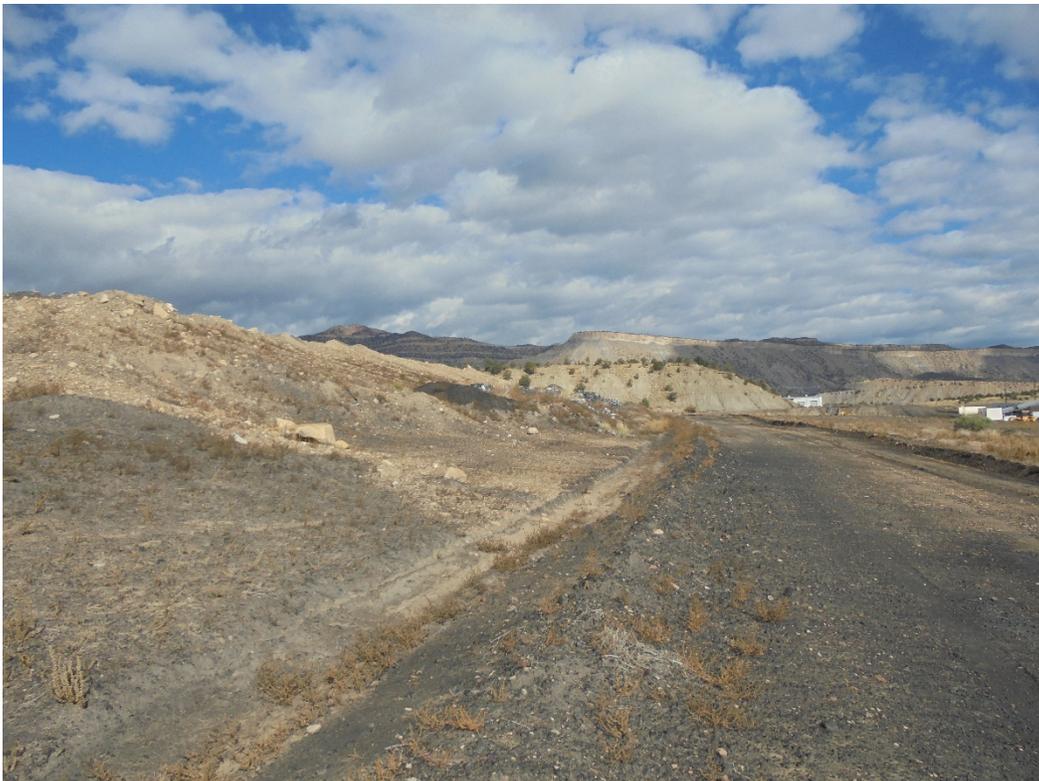
**EAST DRAINAGE DITCH LOOKING NORTH**

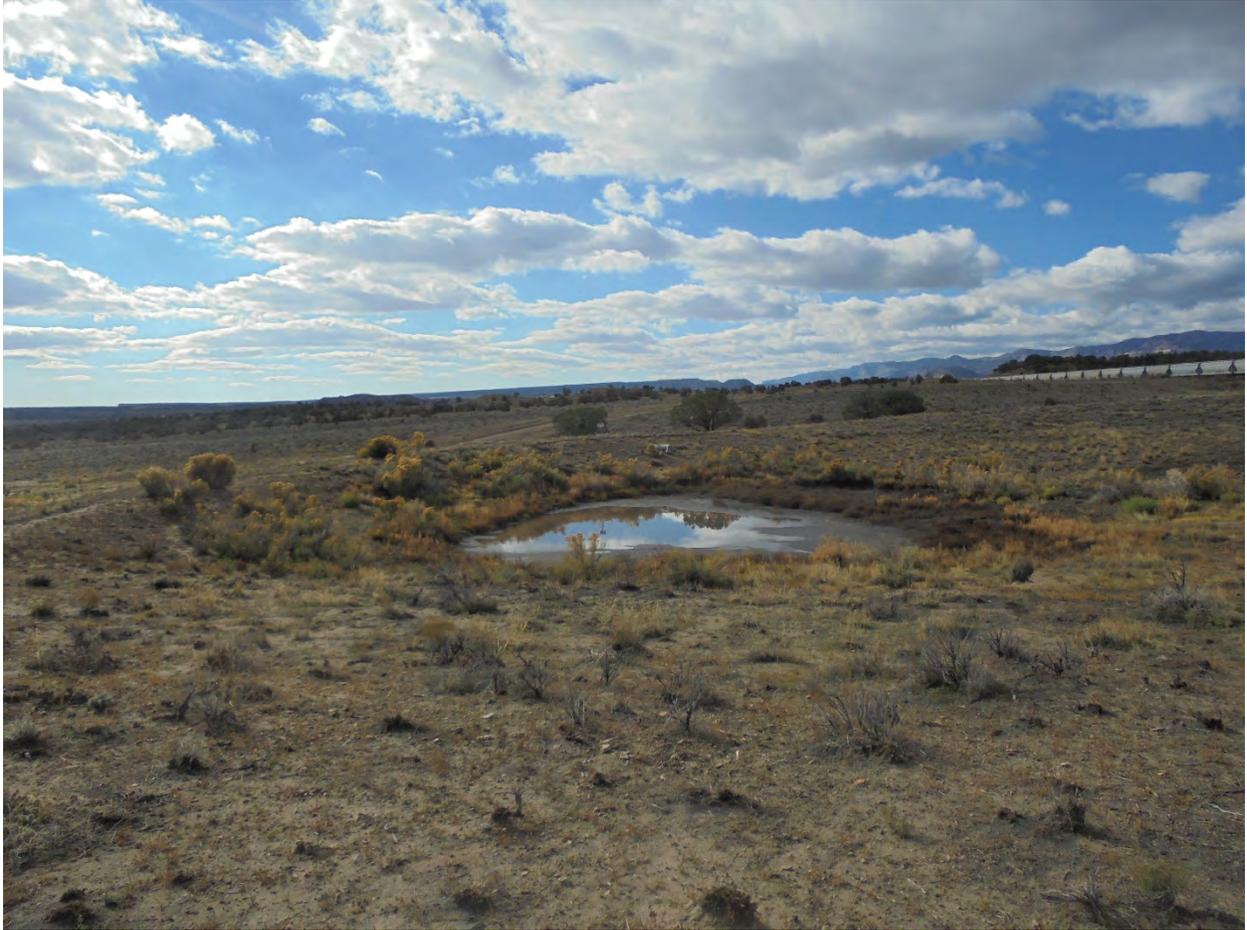
There was approximately 12" of water in the sediment pond, see the attached photograph. Sediment is 32" below cleanout level.			
<b>Qualified Statement</b>	I hereby certify that I am experienced in the construction of impoundments; I am qualified and authorized under the direction of a Registered Professional Engineer to inspect the condition and appearance of impoundments in accordance with the certified and approved designs for this structure, that the impoundment has been maintained in accordance with approved design and meet or exceed the minimum design requirements under all applicable federal, state and local regulations; and, that inspections and inspection reports are made by myself and include any appearances of instability, structural weakness or other hazardous conditions of the structure affecting stability.

**SEDIMENT POND A**

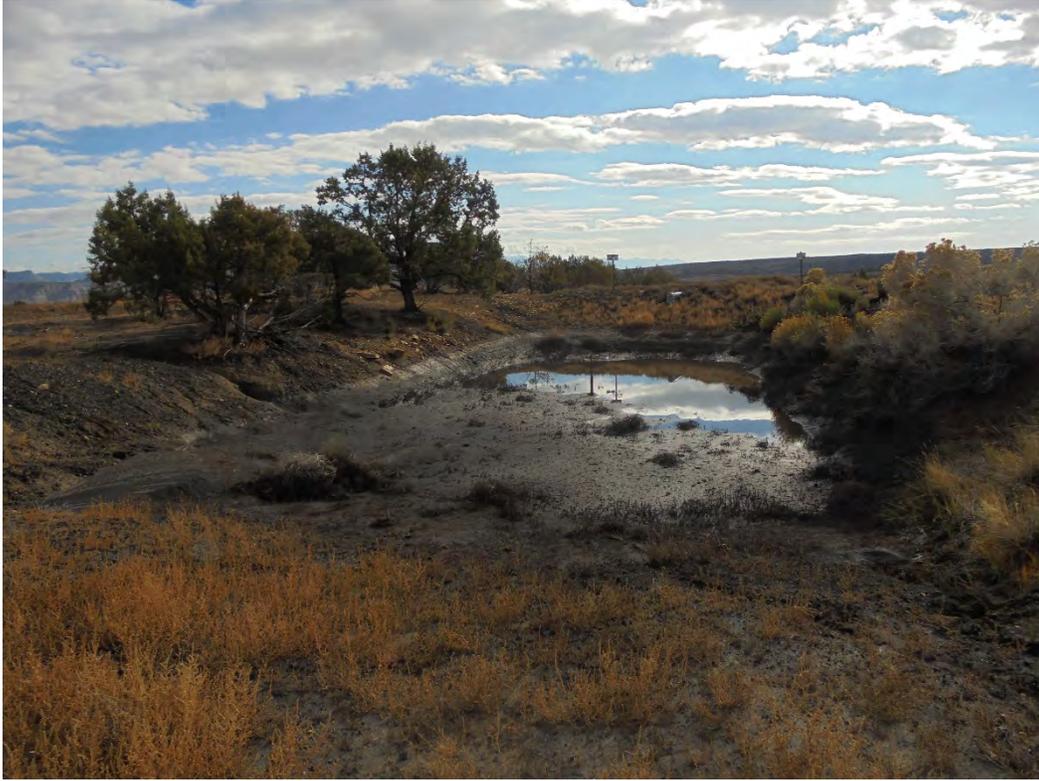
**SEDIMENT POND B**

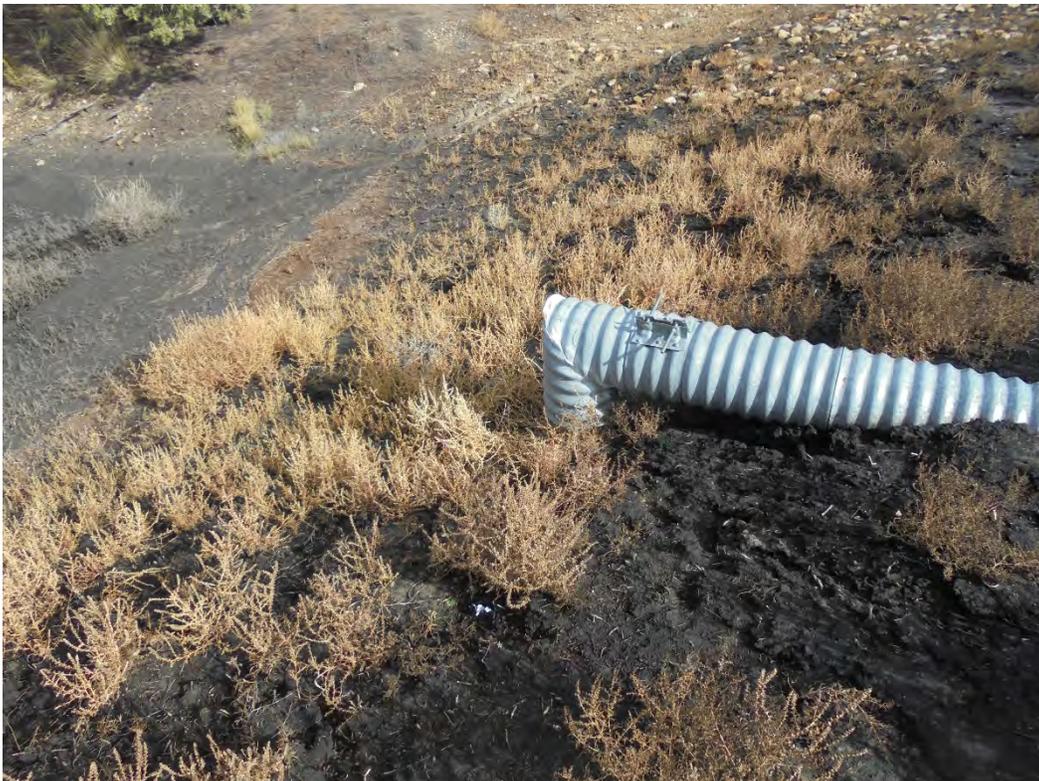
The sediment pond had approximately 1' of water, see the attached photograph. Sediment is 26" below cleanout level. Weeds need to be removed from inlet of principle spillway.			
<b>Qualified Statement</b>		I hereby certify that I am experienced in the construction of impoundments; I am qualified and authorized under the direction of a Registered Professional Engineer to inspect the condition and appearance of impoundments in accordance with the certified and approved designs for this structure, that the impoundment has been maintained in accordance with approved design and meet or exceed the minimum design requirements under all applicable federal, state and local regulations; and, that inspections and inspection reports are made by myself and include any appearances of instability, structural weakness or other hazardous conditions of the structure affecting stability.

**WEEDS AT PRINCIPLE SPILLWAY INTAKE**

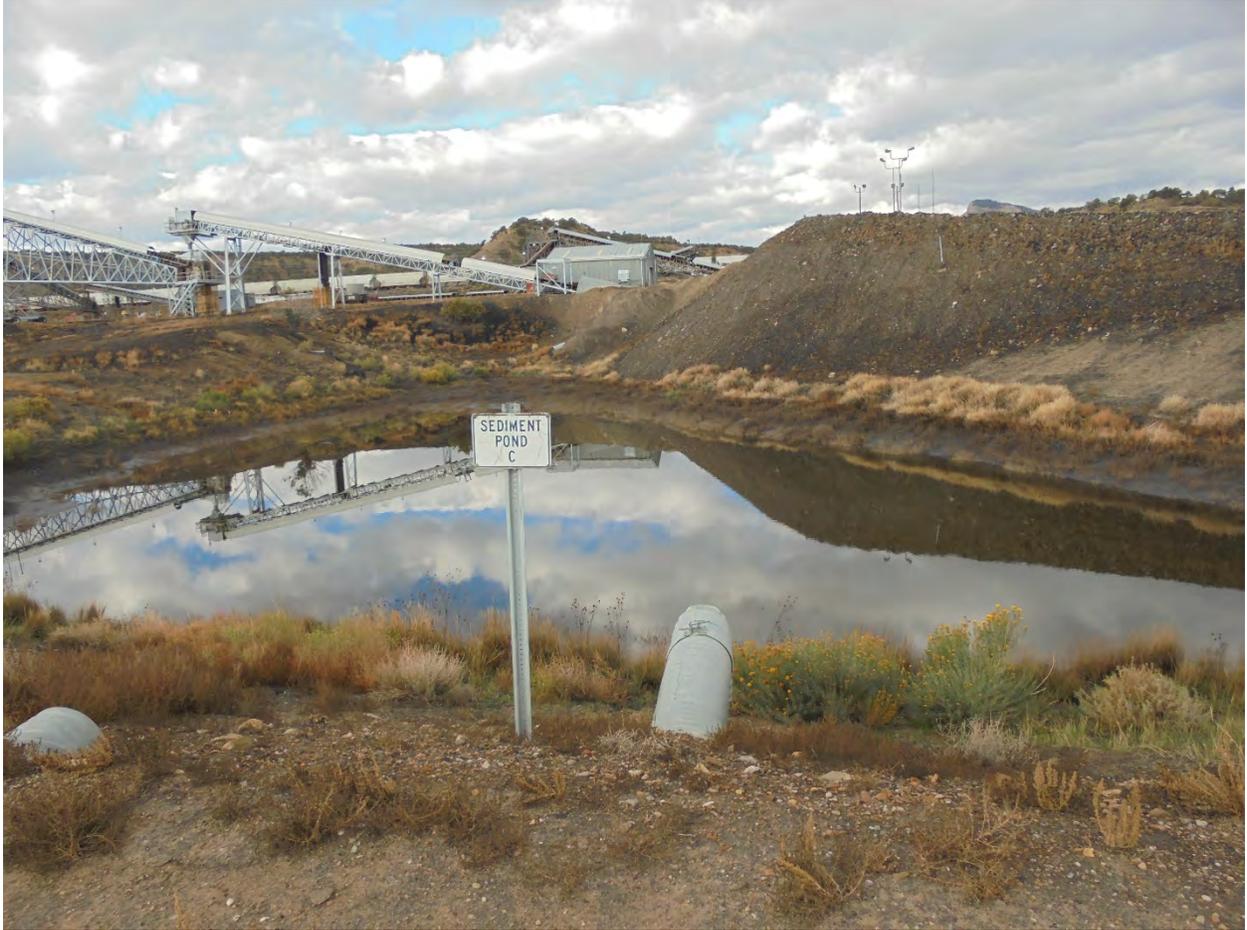
Existing Storage Capacity: 4.174 ac-ft		
	Existing Sediment Storage Capacity (To Cleanout): 0.88 ac-ft (See Section 4)		
	<b>3. Principle and emergency spillway elevations</b>		
	Principle spillway elevation: 6,137.0'		
	Emergency spillway elevation: 6,138.0'		
<b>4. Field Information:</b> Provide current water elevation, whether pond is discharging, type and number of samples taken, monitoring/instrumentation information, inlet/outlet conditions or other related activities associated with the pond including but not limited to sediment cleanout, pond decanting, embankment erosion/repairs, monitoring information, vegetation on out slopes of embankment erosion/repairs, monitoring information, vegetation on out slopes of embankments, etc.			
During the annual inspection, October 29, 2016, the vegetative cover looked good with no signs of erosion. Animal hole under inlet of principle spillway needs to be filled. Due to approximately 3' of water, it was not possible to determine the existing sediment storage capacity (to Cleanout). See the attached photograph.

**SEDIMENT POND C**

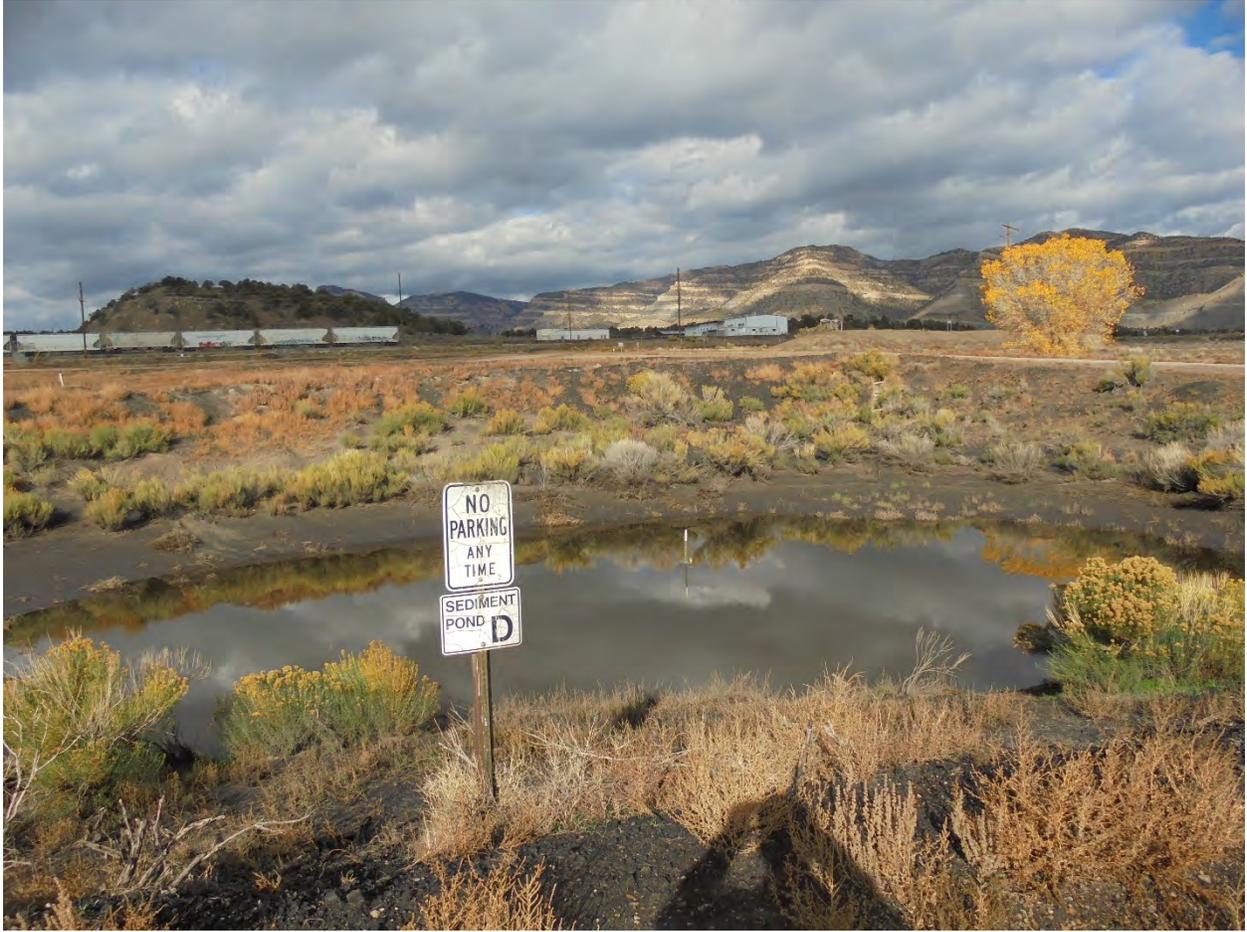
Existing Storage Capacity: 1.131 ac-ft		
	Existing Sediment Storage Capacity (To Cleanout): 0.40 ac-ft (See Section 4)		
	<b>3. Principle and emergency spillway elevations</b>		
	Principle spillway elevation: 6,139.0'		
	Emergency spillway elevation: 6,140.0'		
<b>4. Field Information:</b> Provide current water elevation, whether pond is discharging, type and number of samples taken, monitoring/instrumentation information, inlet/outlet conditions or other related activities associated with the pond including but not limited to sediment cleanout, pond decanting, embankment erosion/repairs, monitoring information, vegetation on outslopes of embankment erosion/repairs, monitoring information, vegetation on outslopes of embankments, etc.			
During the annual inspection, October 29, 2016, the vegetative cover looked good with no signs of erosion. Due to water level, it was not possible to determine the existing sediment storage capacity (to Cleanout). See attached photograph.

**SEDIMENT POND D**

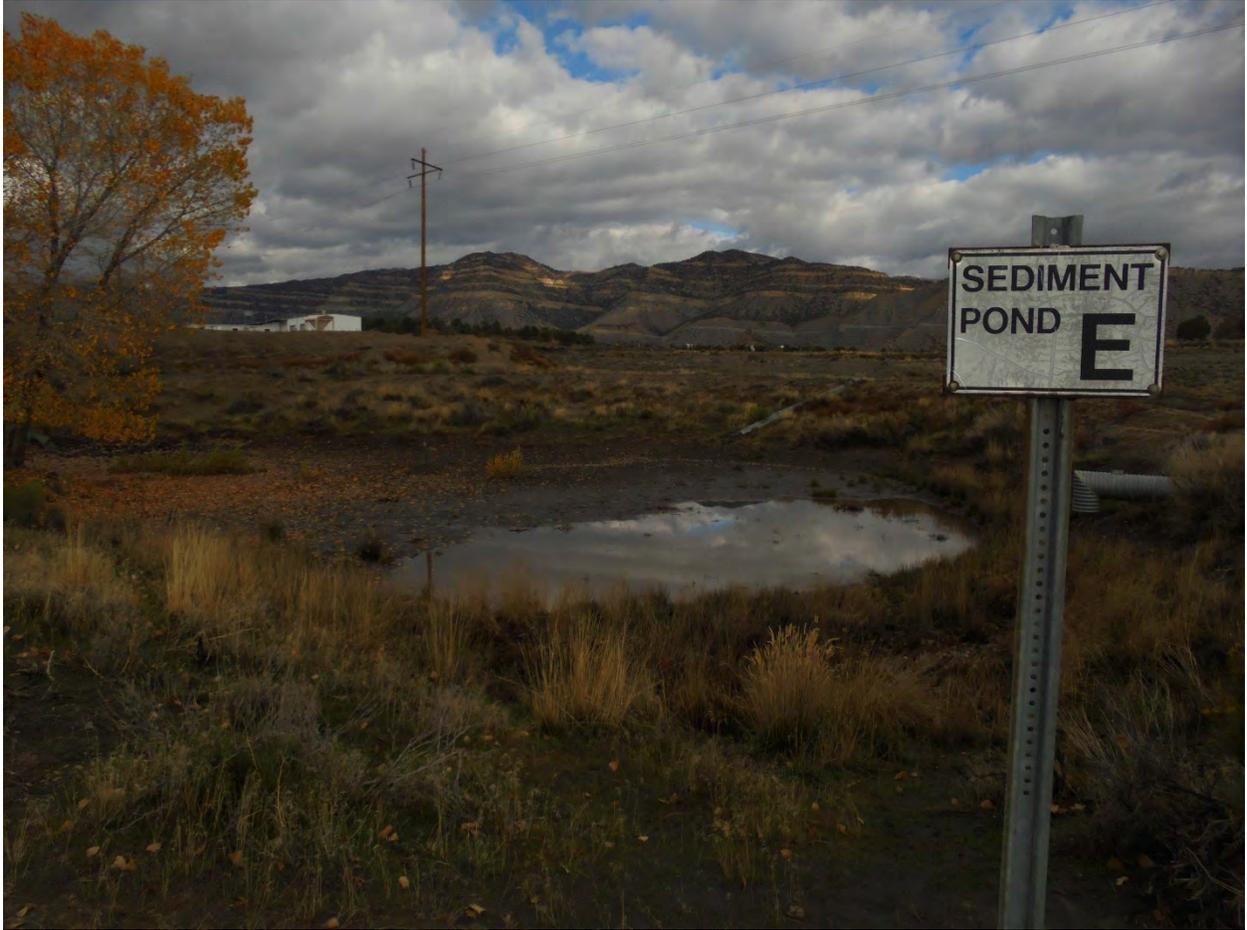
The sediment pond had approximately 6" of water. See the attached photograph. Sediment is 26" below cleanout level.			
<b>Qualified Statement</b>	I hereby certify that I am experienced in the construction of impoundments; I am qualified and authorized under the direction of a Registered Professional Engineer to inspect the condition and appearance of impoundments in accordance with the certified and approved designs for this structure, that the impoundment has been maintained in accordance with approved design and meet or exceed the minimum design requirements under all applicable federal, state and local regulations; and, that inspections and inspection reports are made by myself and include any appearances of instability, structural weakness or other hazardous conditions of the structure affecting stability.

**Sediment Pond E**

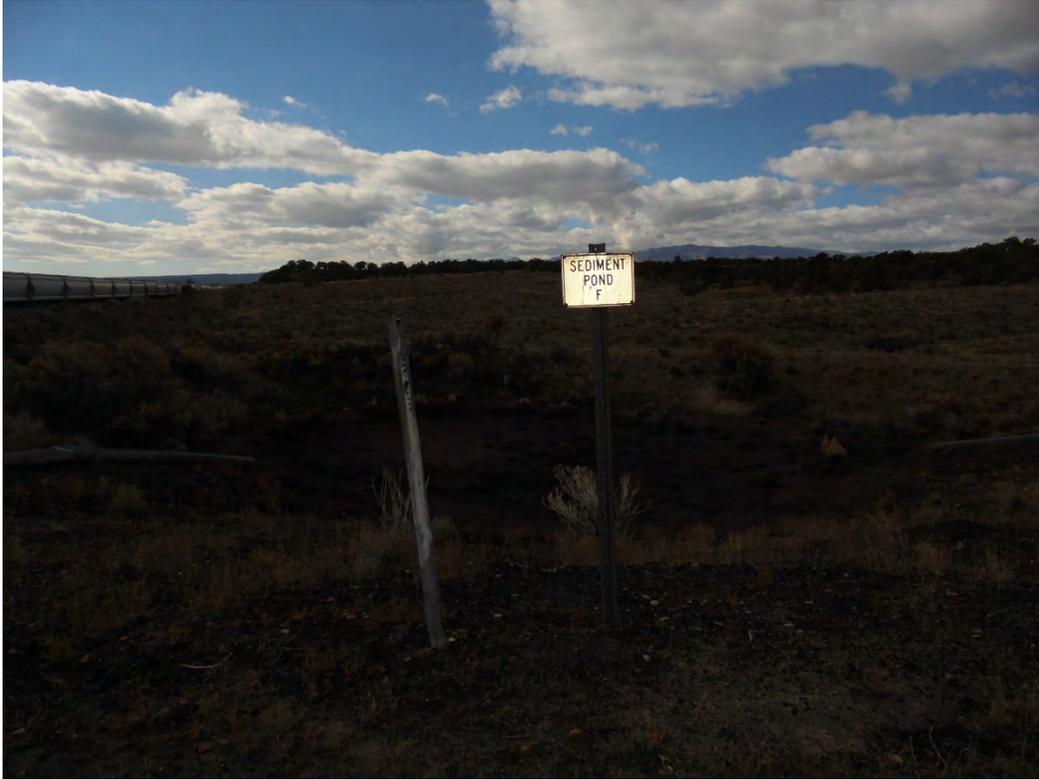
The sediment pond was dry. See the attached photograph. Sediment is approximately 13.5" below cleanout level.

**SEDIMENT POND F**

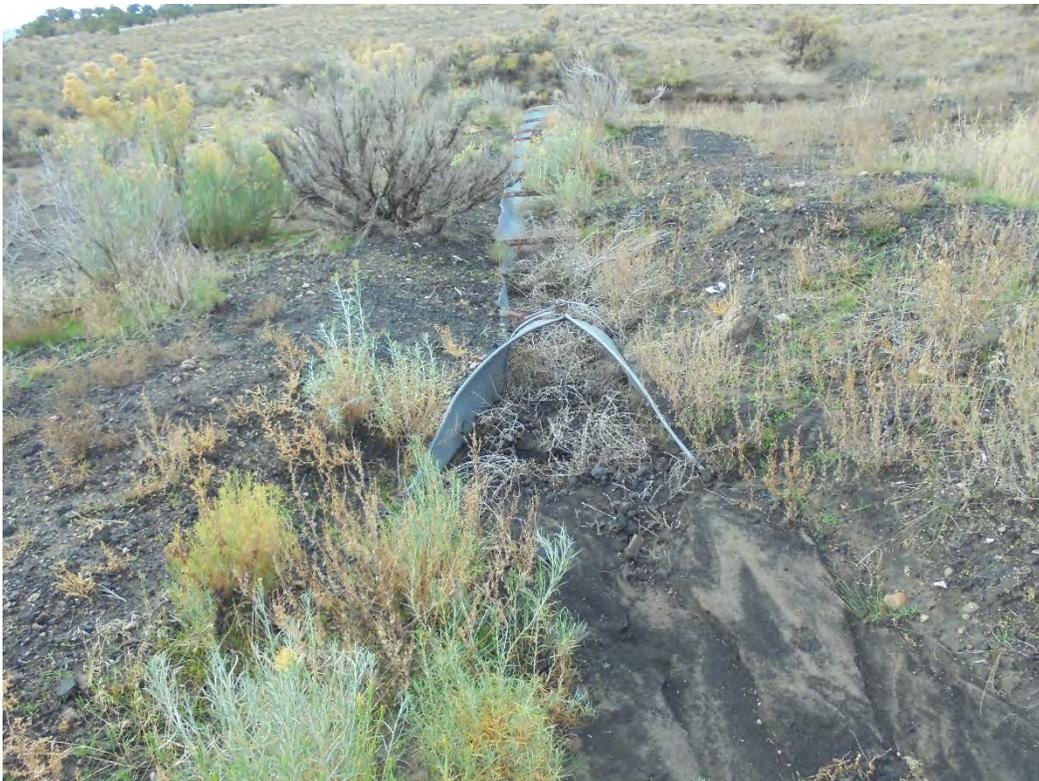
During the annual inspection, October 29, 2016, the vegetative cover looked good with no signs of erosion. There are weeds in the east inlet and the principle spillway outlet has a small amount of dirt in the culvert. See attached photograph.

**EAST INLET WEEDS**
