ANNUAL REPORT

Company Name	Intermountain Power Agency	Mine Name	Wildcat Loadout
Permit Number	C/007/0033	Permit expiration Date	May 5, 2019
Operator Name	Wild West Equipment & Hauling, LLC	Phone Number	+1 (435) 650-7339
Mailing Address	P.O. Box 1	Email	kit@emerytelcom.net
City	Price		
State	Utah	Zip Code	84501

Quarterly Inspection Form - Refuse Disposal Areas
 (please provide to DOGM promptly after inspection is complete)

**WILDCAT COAL FINES ISSUE
DIVISION ORDER-04 (WIND BLOWN FINES)
SECOND QUARTER 2017**

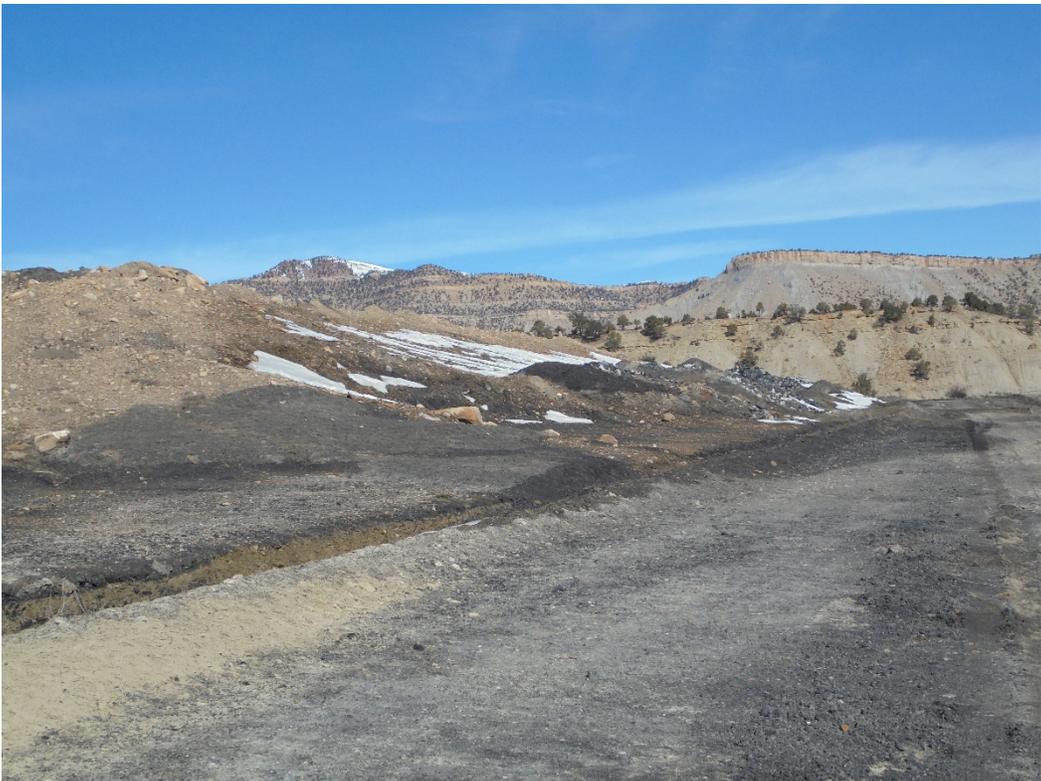
EAST SLOPE OF REFUSE PILE

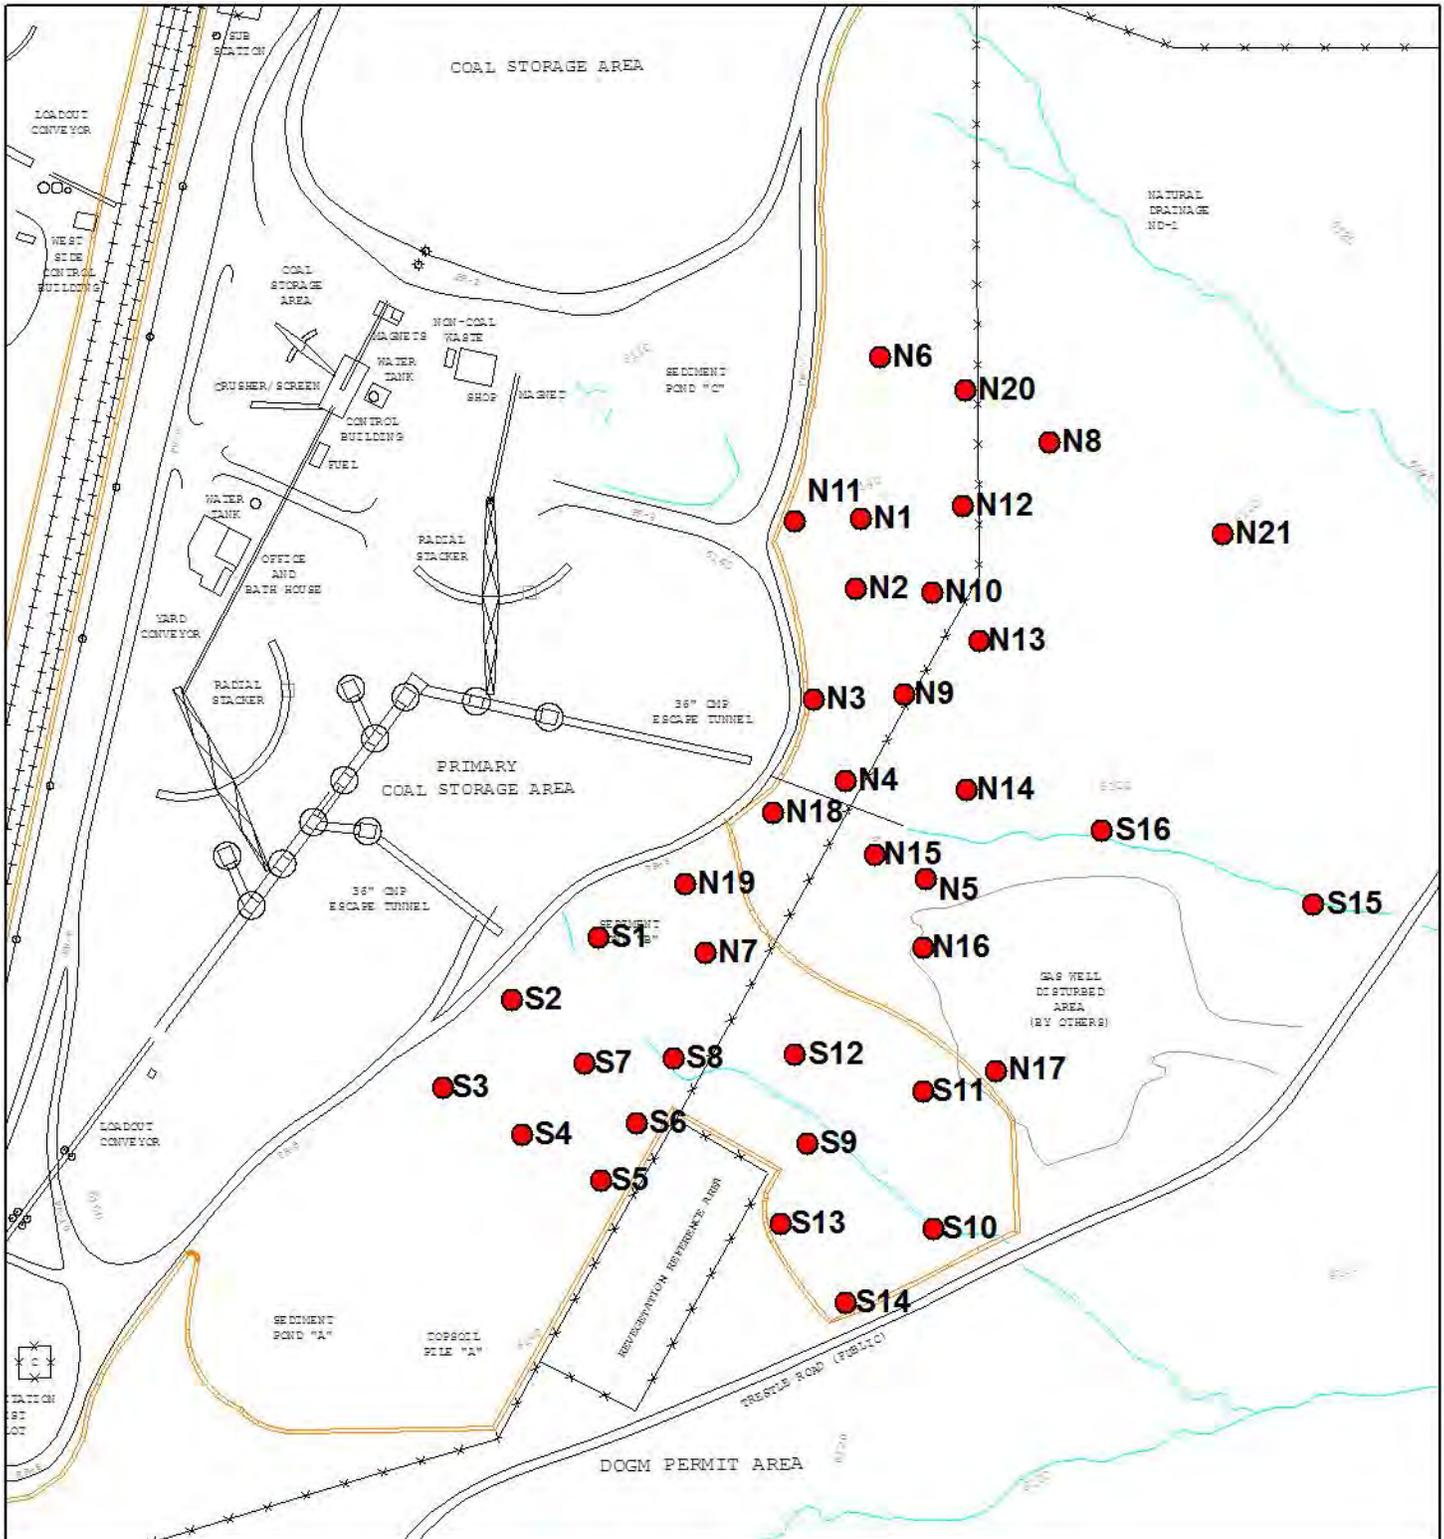
FIGURE 1

There are now 21 sampling points on the northern area and 16 sampling points on the southern area. Figure 1 shows the sampling points and Figure 2 shows the areas that are of concern. Each point was located with a GPS. Refer to Appendix 1 for the GPS coordinate location of each point.

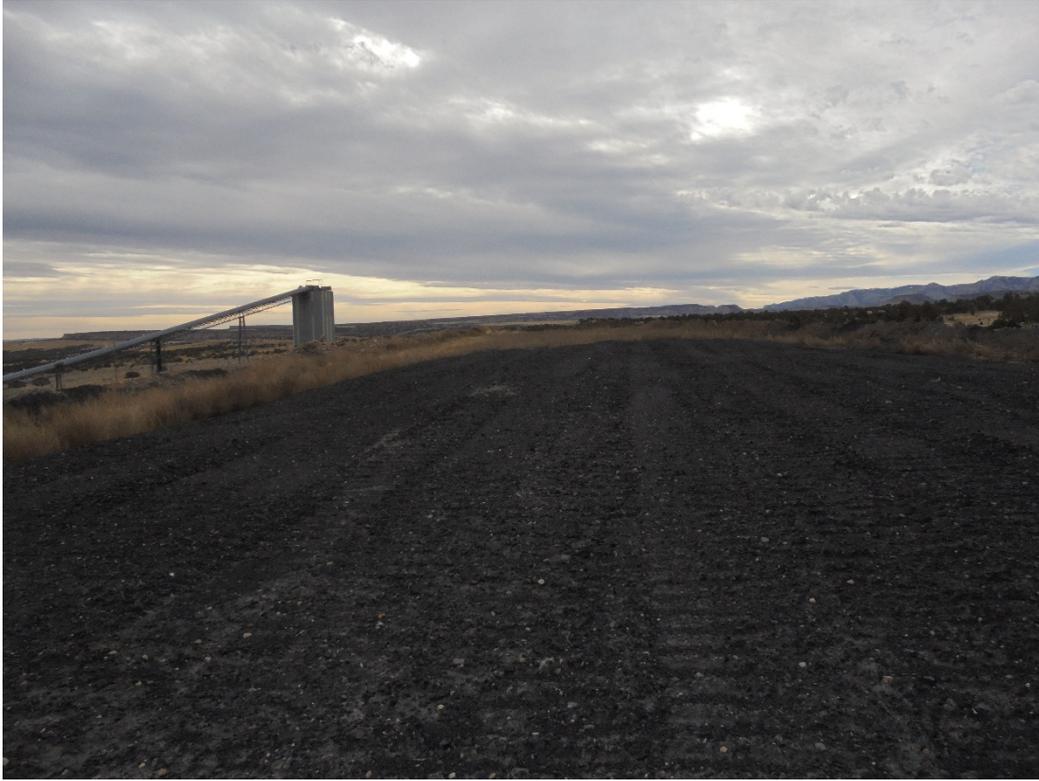
TOP OF REFUSE PILE LOOKING SOUTH

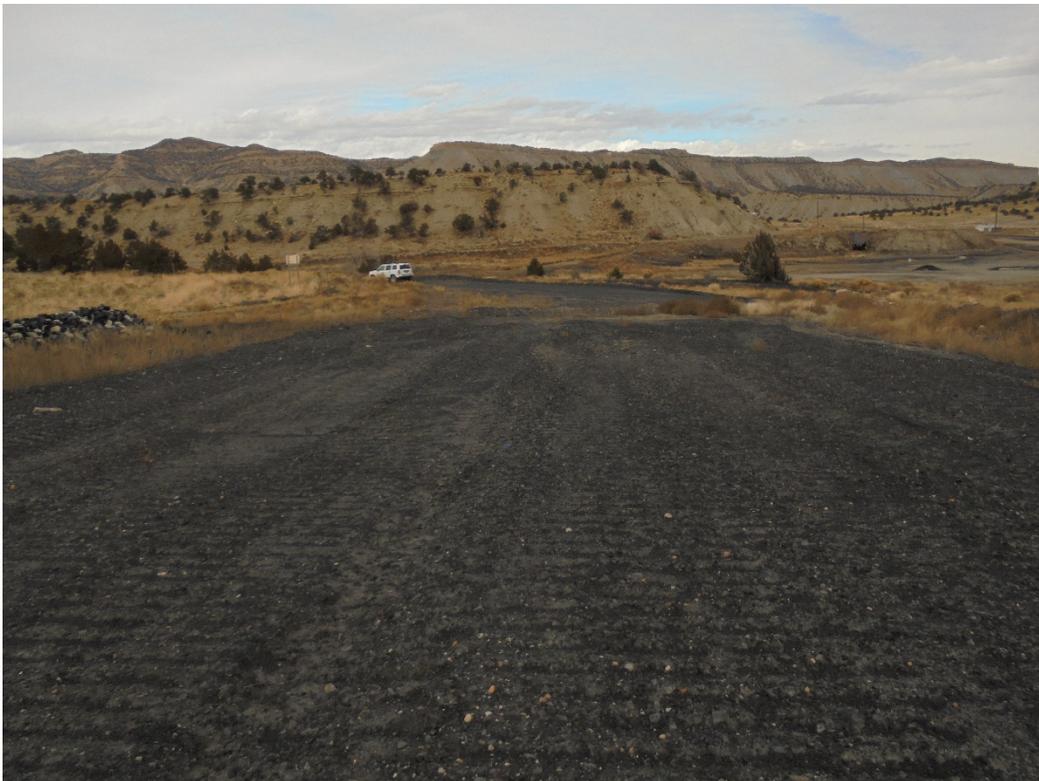
TOP OF REFUSE PILE LOOKING NORTH

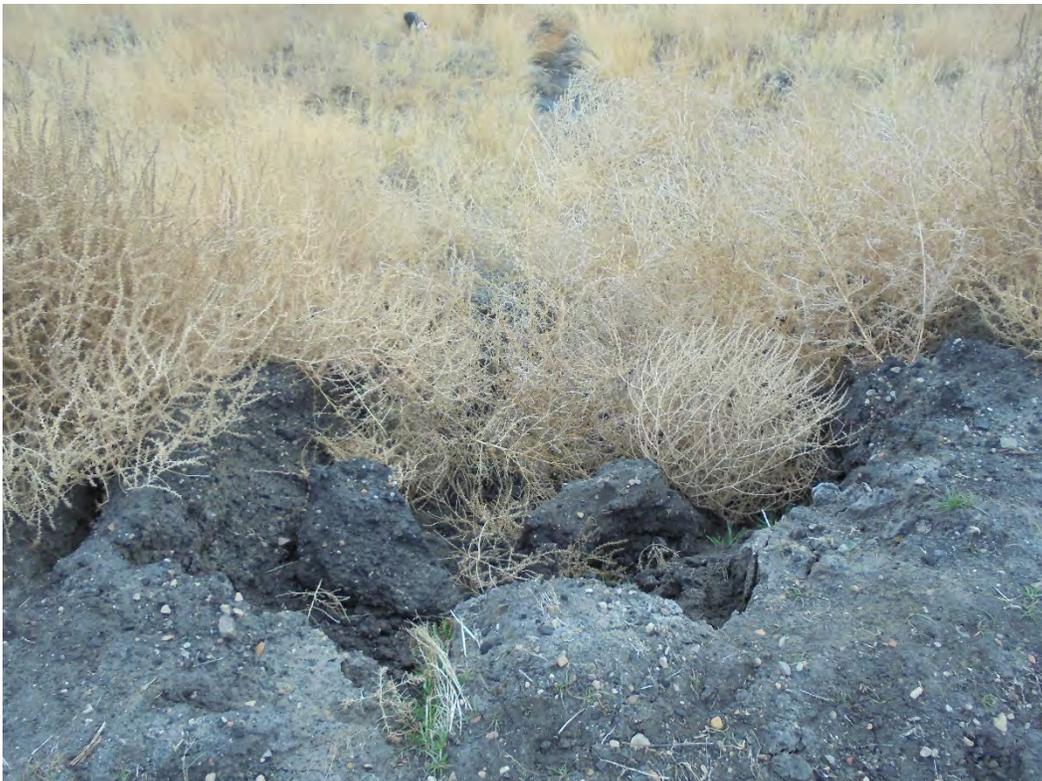
3. Principle and emergency spillway elevations		
	Principle spillway elevation: 6,149.0'		
	Emergency spillway elevation: 6,150.0'		
4. Field Information: Provide current water elevation, whether pond is discharging, type and number of samples taken, monitoring/instrumentation information, inlet/outlet conditions or other related activities associated with the pond including but not limited to sediment cleanout, pond decanting, embankment erosion/repairs, monitoring information, vegetation on out slopes of embankment erosion/repairs, monitoring information, vegetation on out slopes of embankments, etc.			
During the annual inspection, November 27, 2017, the vegetative cover looked good with no signs of erosion. Both spillways look good with no signs of stability problems.

POND A WEST INLET BANK EROSION

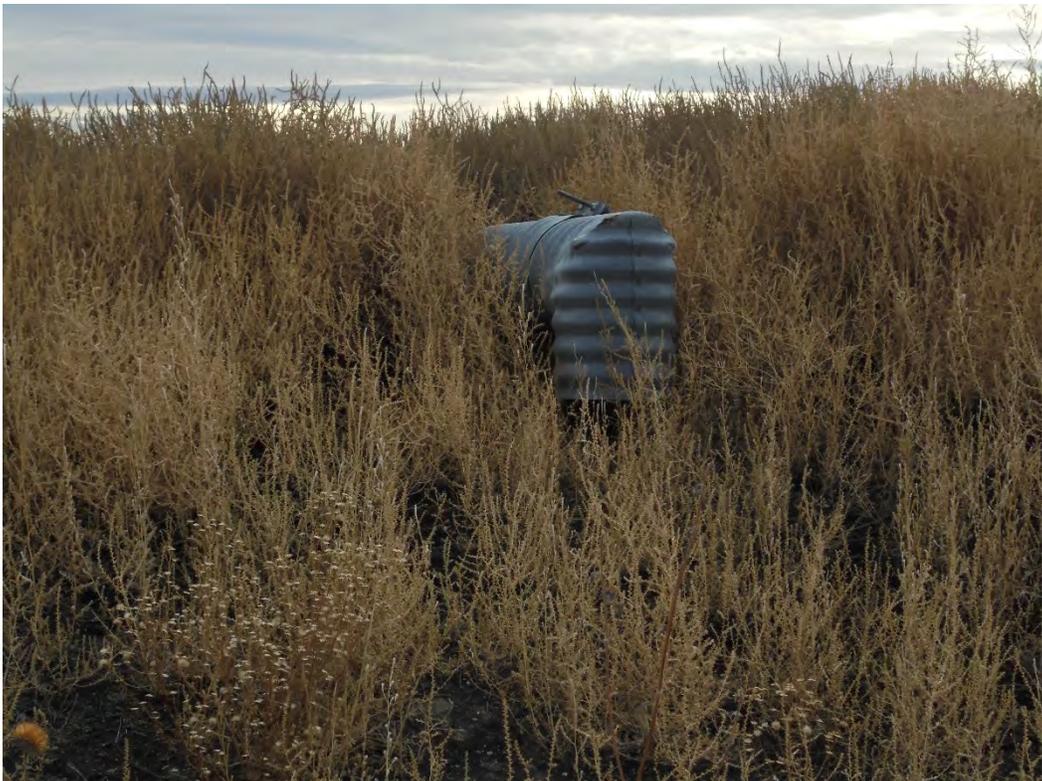
3. Principle and emergency spillway elevations		
	Principle spillway elevation: 6,138.0'		
	Emergency spillway elevation: 6,139.0'		
4. Field Information: Provide current water elevation, whether pond is discharging, type and number of samples taken, monitoring/instrumentation information, inlet/outlet conditions or other related activities associated with the pond including but not limited to sediment cleanout, pond decanting, embankment erosion/repairs, monitoring information, vegetation on outslopes of embankment erosion/repairs, monitoring information, vegetation on outslopes of embankments, etc.			
During the annual inspection, November 27, 2017, the vegetative cover looked good with no signs of erosion. Weeds in the emergency and by principle spillway need to be cleaned out. Refer to the attached photographs.

POND B WEEDS AT INLET PRINCIPLE SPILLWAY

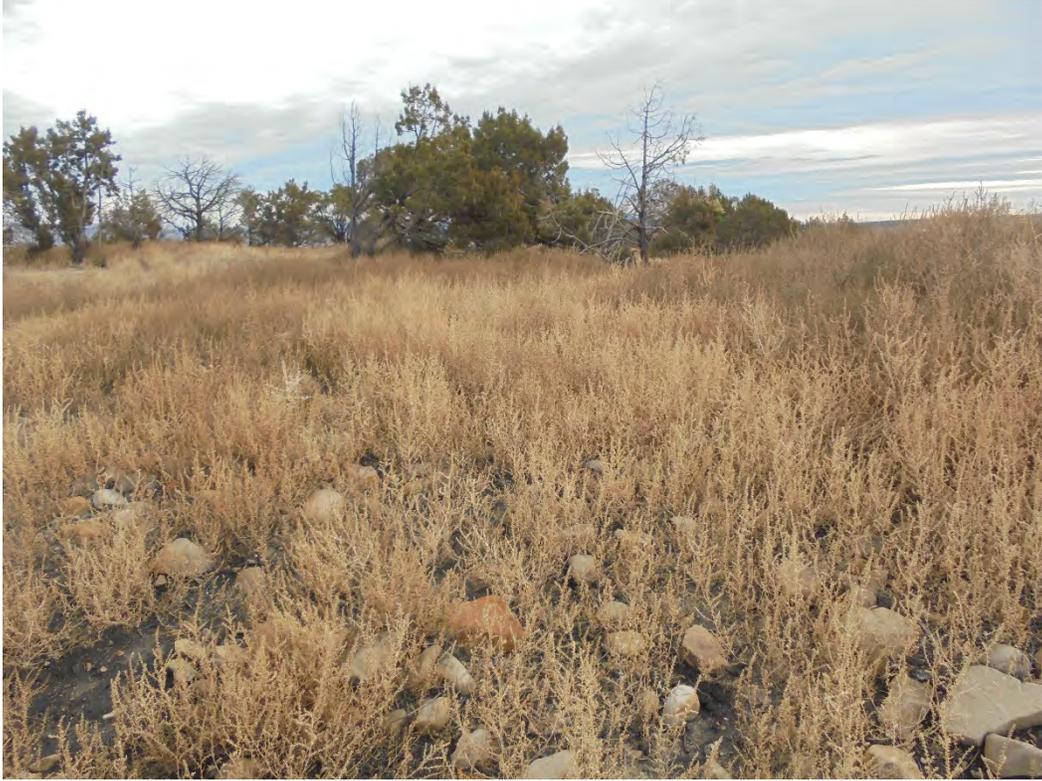
POND B WEEDS AT EMERGENCY SPILLWAY

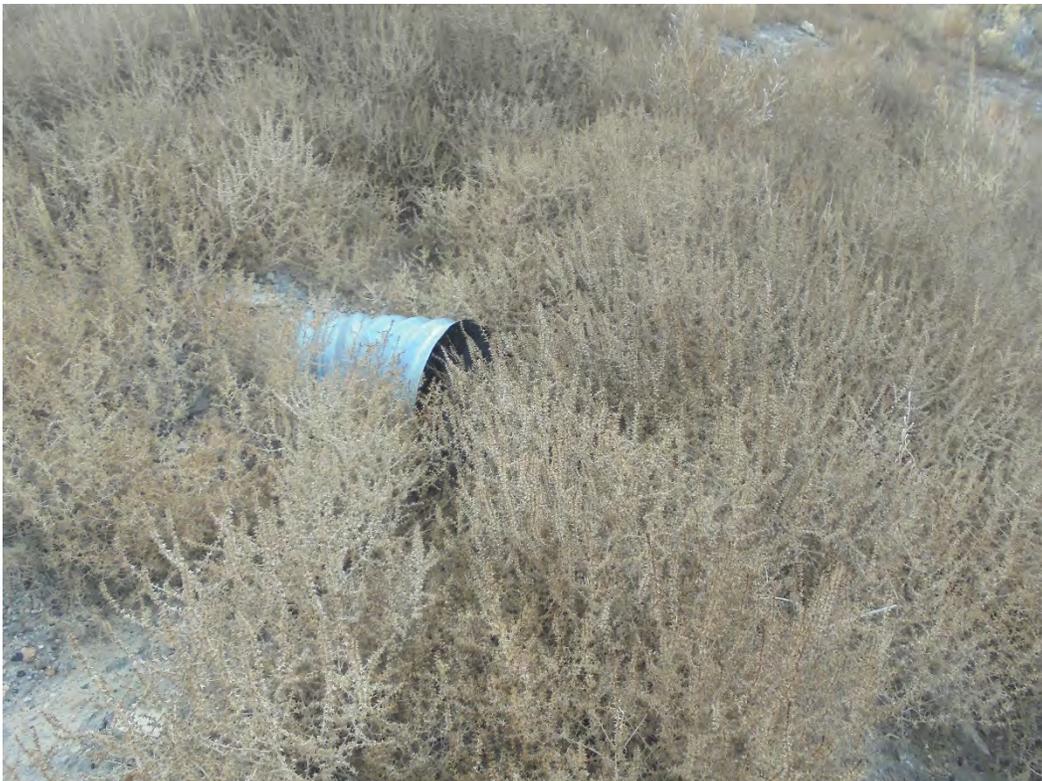
POND C WEEDS AT INLET PRINCIPLE SPILLWAY

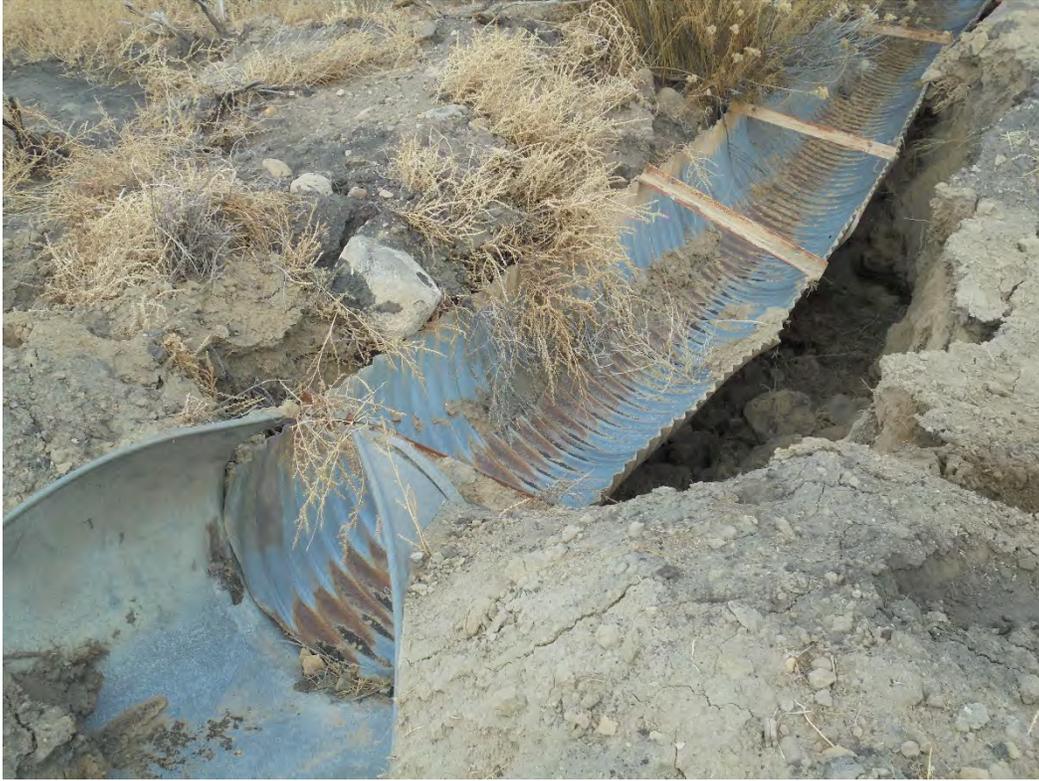
3. Principle and emergency spillway elevations		
	Principle spillway elevation: 6,137.0'		
	Emergency spillway elevation: 6,138.0'		
4. Field Information: Provide current water elevation, whether pond is discharging, type and number of samples taken, monitoring/instrumentation information, inlet/outlet conditions or other related activities associated with the pond including but not limited to sediment cleanout, pond decanting, embankment erosion/repairs, monitoring information, vegetation on outslopes of embankment erosion/repairs, monitoring information, vegetation on outslopes of embankments, etc.			
During the annual inspection, November 27, 2017, the vegetative cover looked good with no signs of erosion. Animal hole under inlet of principle spillway needs to be filled. Principle spillway inlet needs weeds removed and south pond inlet culvert is being undercut and should be repaired. See attached photographs.

POND C SOUTH INLET UNDERCUTTING

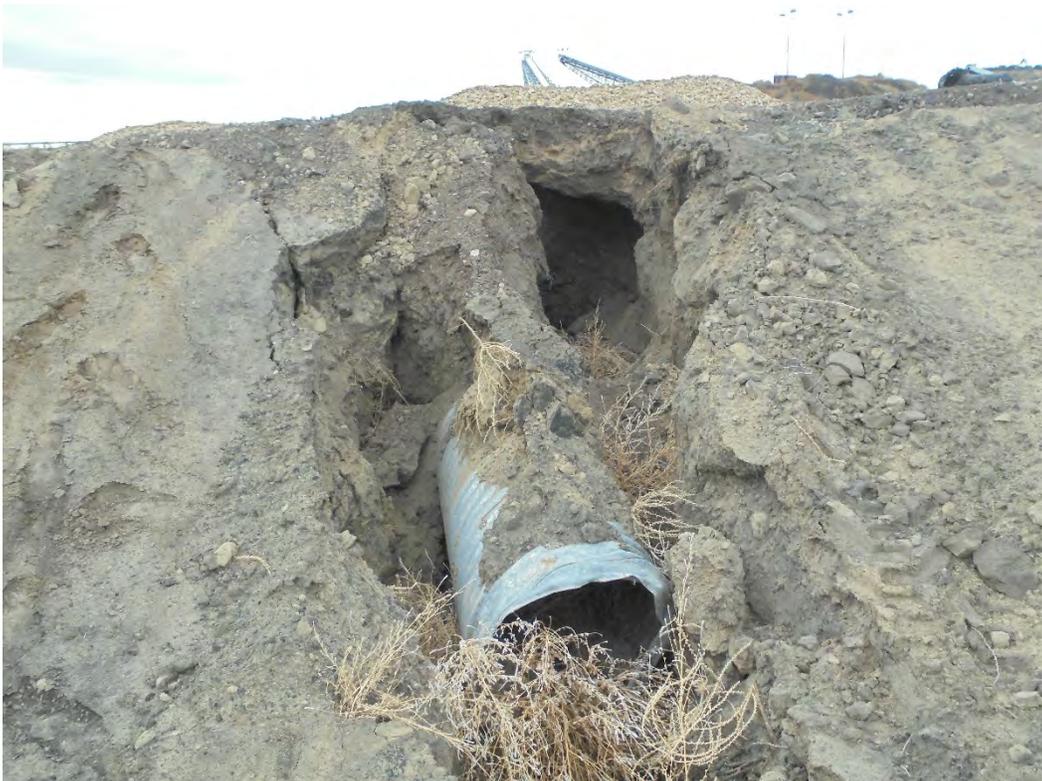
3. Principle and emergency spillway elevations		
	Principle spillway elevation: 6,139.0'		
	Emergency spillway elevation: 6,140.0'		
4. Field Information: Provide current water elevation, whether pond is discharging, type and number of samples taken, monitoring/instrumentation information, inlet/outlet conditions or other related activities associated with the pond including but not limited to sediment cleanout, pond decanting, embankment erosion/repairs, monitoring information, vegetation on out slopes of embankment erosion/repairs, monitoring information, vegetation on out slopes of embankments, etc.			
During the annual inspection, November 27, 2017, the vegetative cover looked good with no signs of erosion. Due to water level, approximately 18", it was not possible to determine the existing sediment storage capacity (to Cleanout). South inlet culvert is still undercutting. See the attached photographs.

POND D SOUTH INLET UNDERCUTTING

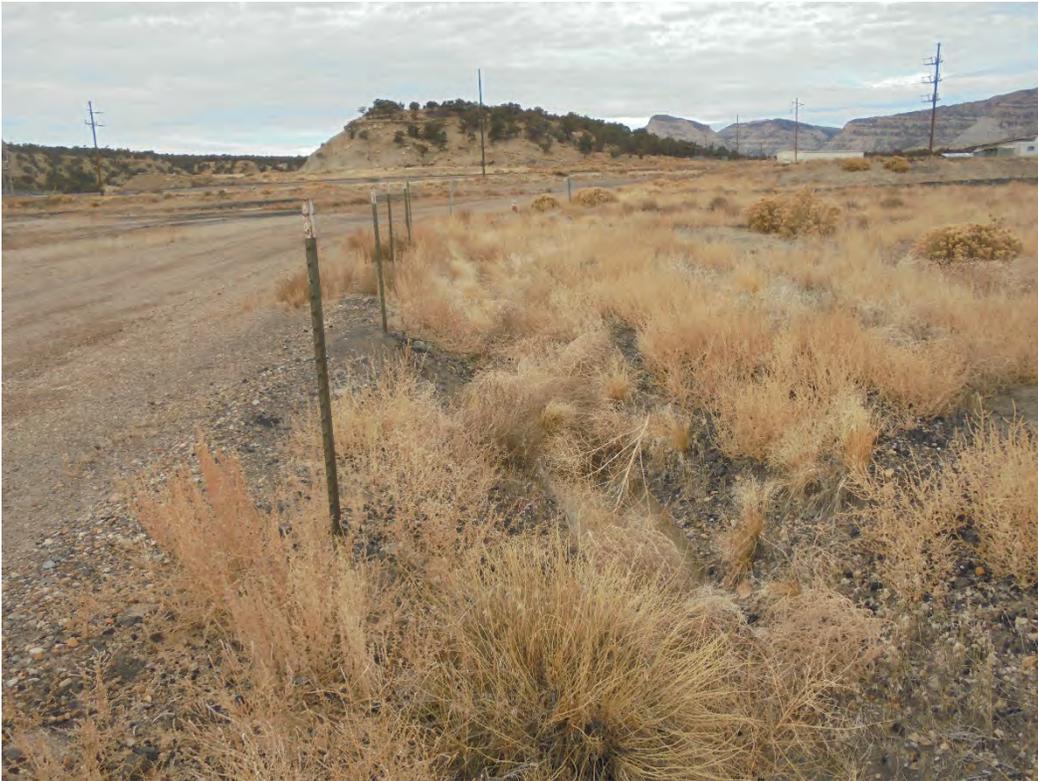
3. Principle and emergency spillway elevations		
	Principle spillway elevation: 6,145.0'		
	Emergency spillway elevation: 6,146.0'		
4. Field Information: Provide current water elevation, whether pond is discharging, type and number of samples taken, monitoring/instrumentation information, inlet/outlet conditions or other related activities associated with the pond including but not limited to sediment cleanout, pond decanting, embankment erosion/repairs, monitoring information, vegetation on out slopes of embankment erosion/repairs, monitoring information, vegetation on out slopes of embankments, etc.			
During the annual inspection, November 27, 2017, the vegetative cover looked good with no signs of erosion. Northeast and West inlets need weeds removed. See attached photographs.

POND E WEST INLET NEEDS WEEDS REMOVED

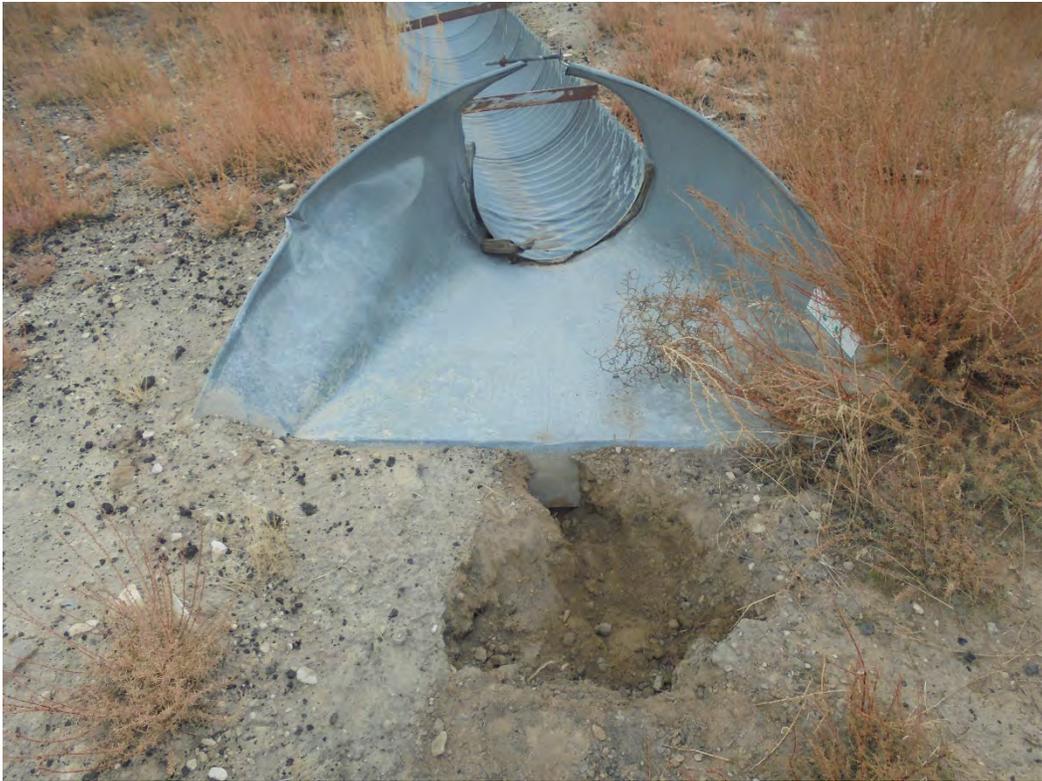
3. Principle and emergency spillway elevations		
	Principle spillway elevation: 6,173.0'		
	Emergency spillway elevation: 6,174.0'		
4. Field Information: Provide current water elevation, whether pond is discharging, type and number of samples taken, monitoring/instrumentation information, inlet/outlet conditions or other related activities associated with the pond including but not limited to sediment cleanout, pond decanting, embankment erosion/repairs, monitoring information, vegetation on outslopes of embankment erosion/repairs, monitoring information, vegetation on outslopes of embankments, etc.			
During the annual inspection, November 27, 2017, the vegetative cover looked good with no signs of erosion. There are weeds in the east inlet and the west inlet is starting to undercut. See attached photographs.

POND F WEST INLET UNDERCUTTING

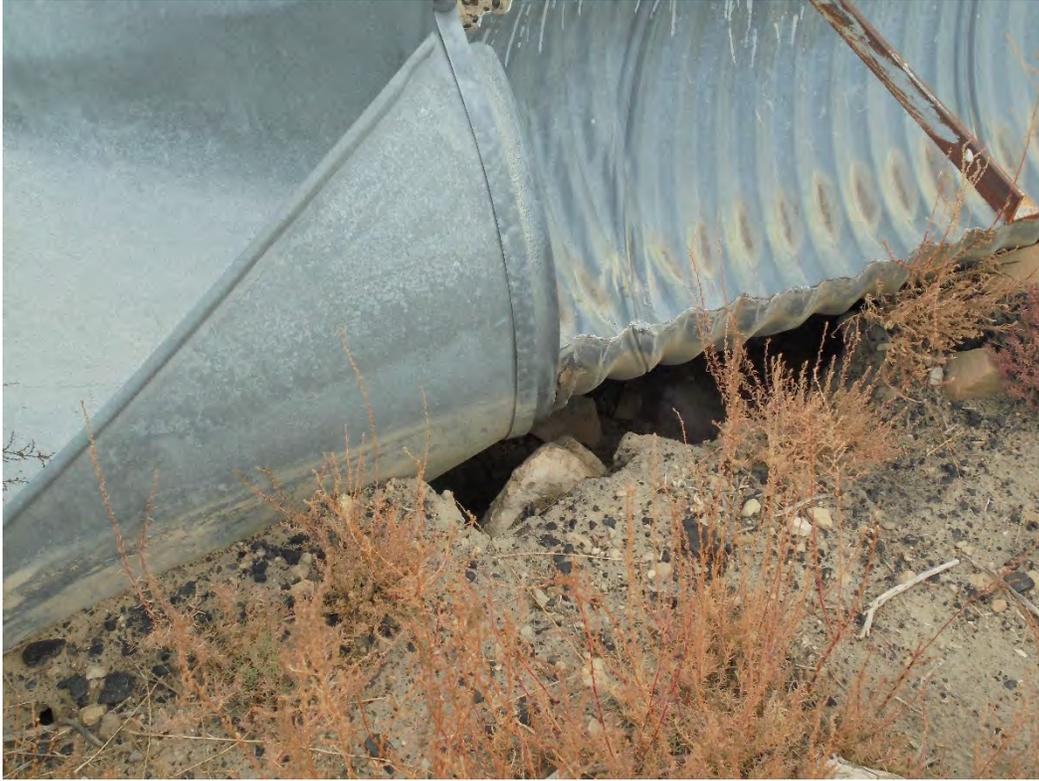
POND F WEST INLET UNDERCUTTING

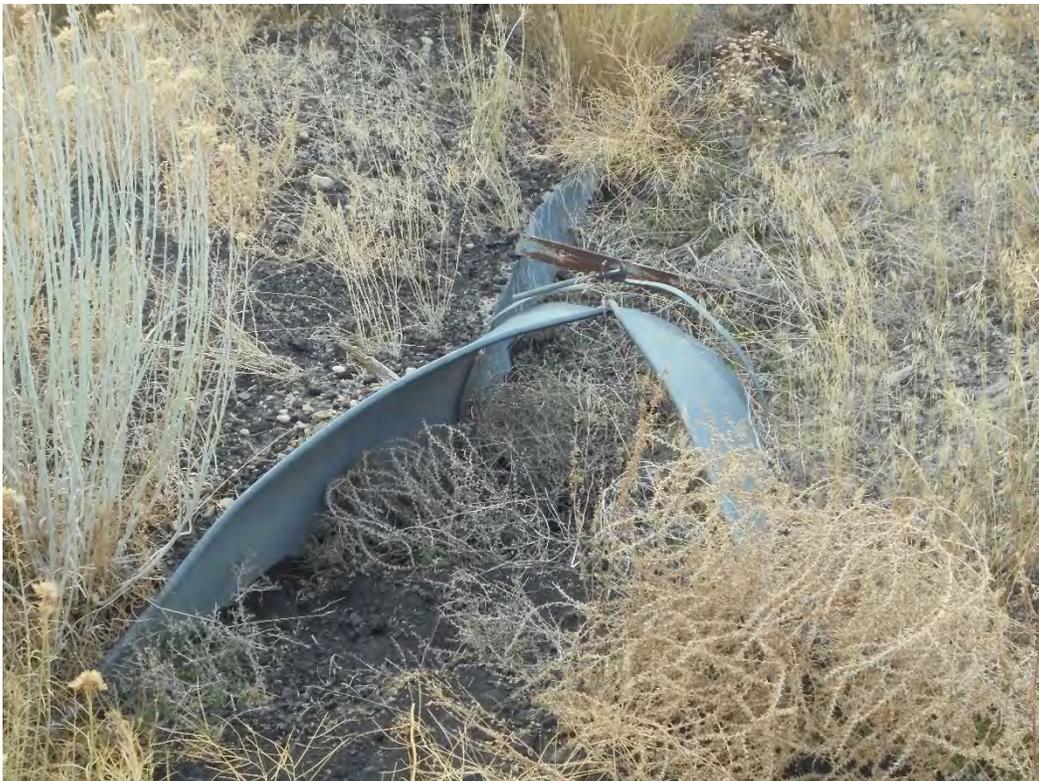
POND F EAST INLET NEEDS CLEANING
