Quarterly Inspection Form - Refuse Disposal Areas
 (please provide to DOGM promptly after inspection is complete)

Permit Number : C/007/0033 Inspection Date : March 9, 2019
 Mine Name : Wildcat Loadout Quarter / Year : 1st Quarter 2019
 Mine Operator (Permittee) : Coal Energy Group 2, LLC Inspector Name : J. T. Paluso
 MSHA ID # : 1211-UT-09-018664-01 Inspector Signature : Joseph T. Paluso
Digitally signed by Joseph T. Paluso
 DN: cn=Joseph T. Paluso, o=EIS, ou=
 email=jpaluso@doe.state.ut.us
 Date: 2019.04.02 09:17:29 -0600
 Facility Name / Location / Address : Wildcat Loadout/5495 West 3550 North, Helper, Utah 84526

Sedimentation Pond Inspection

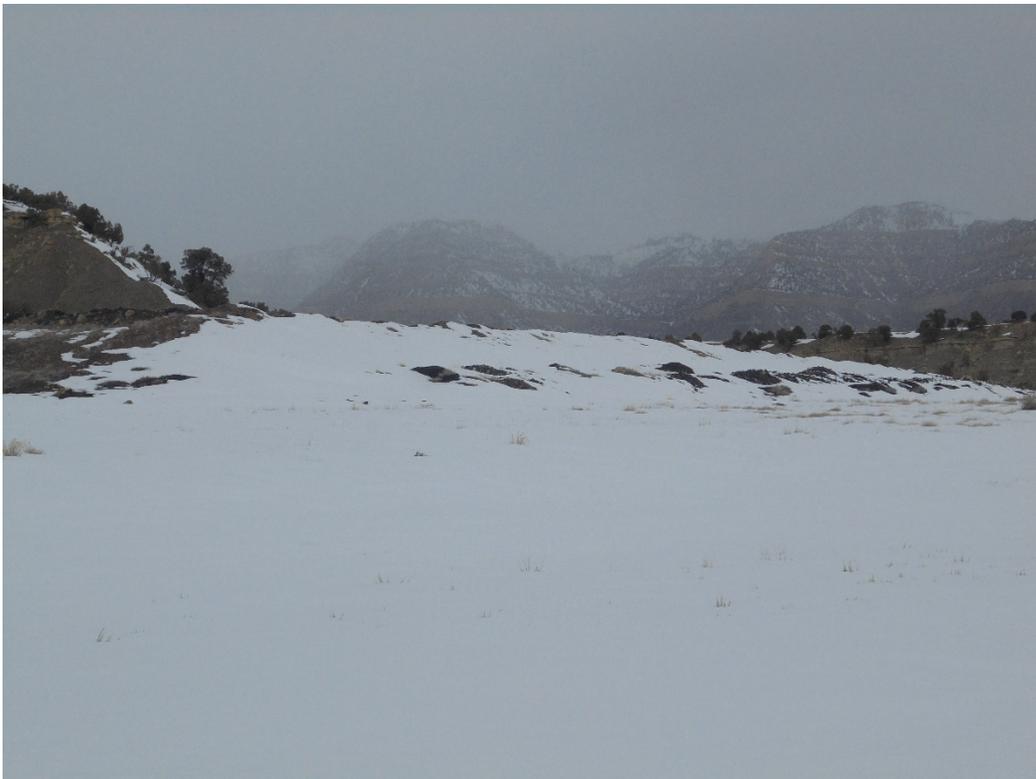
EAST SIDE OF REFUSE PILE

8. Describe placement of under drains, protective filter systems, and final surface drainage systems (report any seepage, including location, color, flow) :
None known. East drainage ditch needs cleaning shortly.

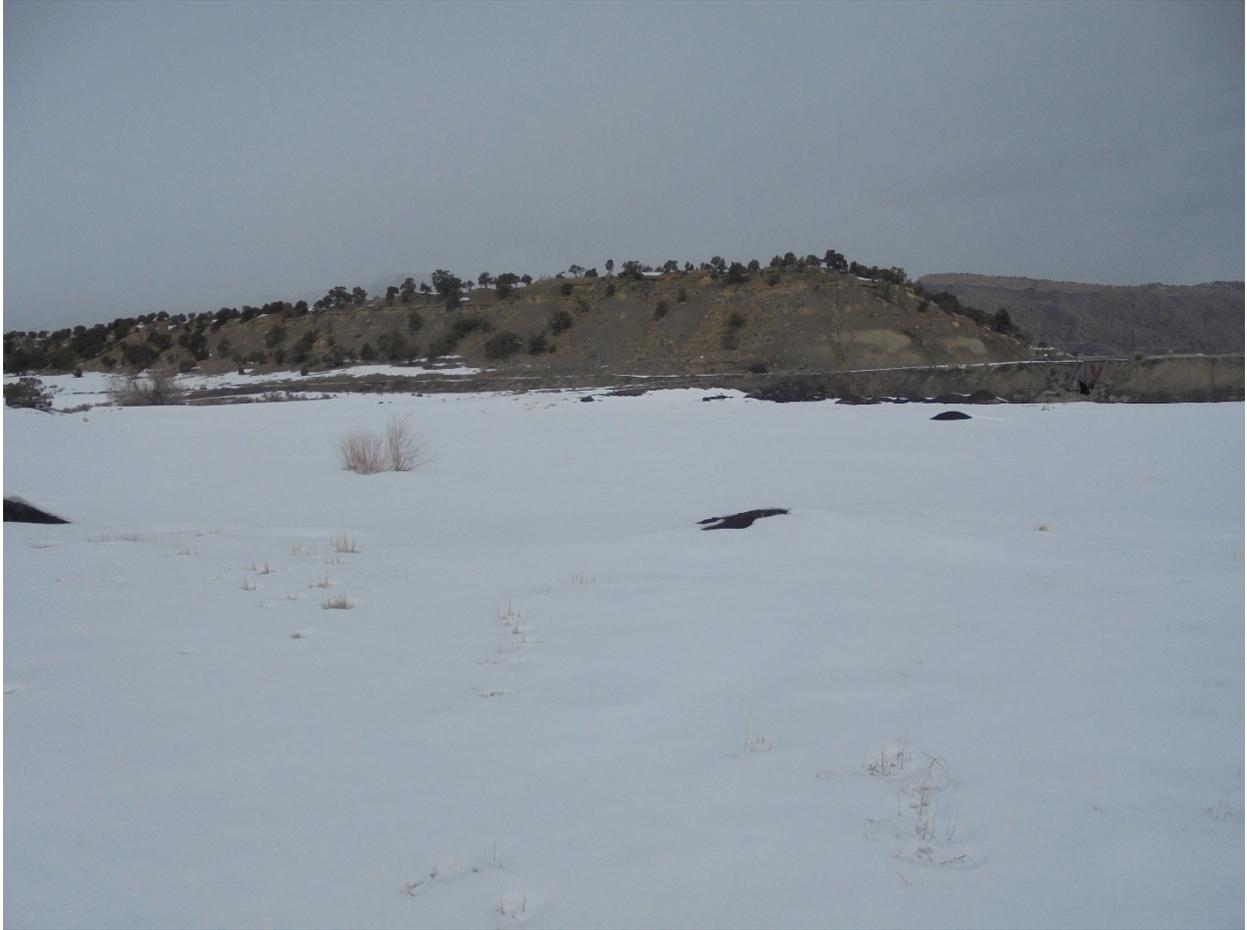
DEPRESSED AREA

AREA COVERED WITH APPROXIMATELY 1' OF SNOW.

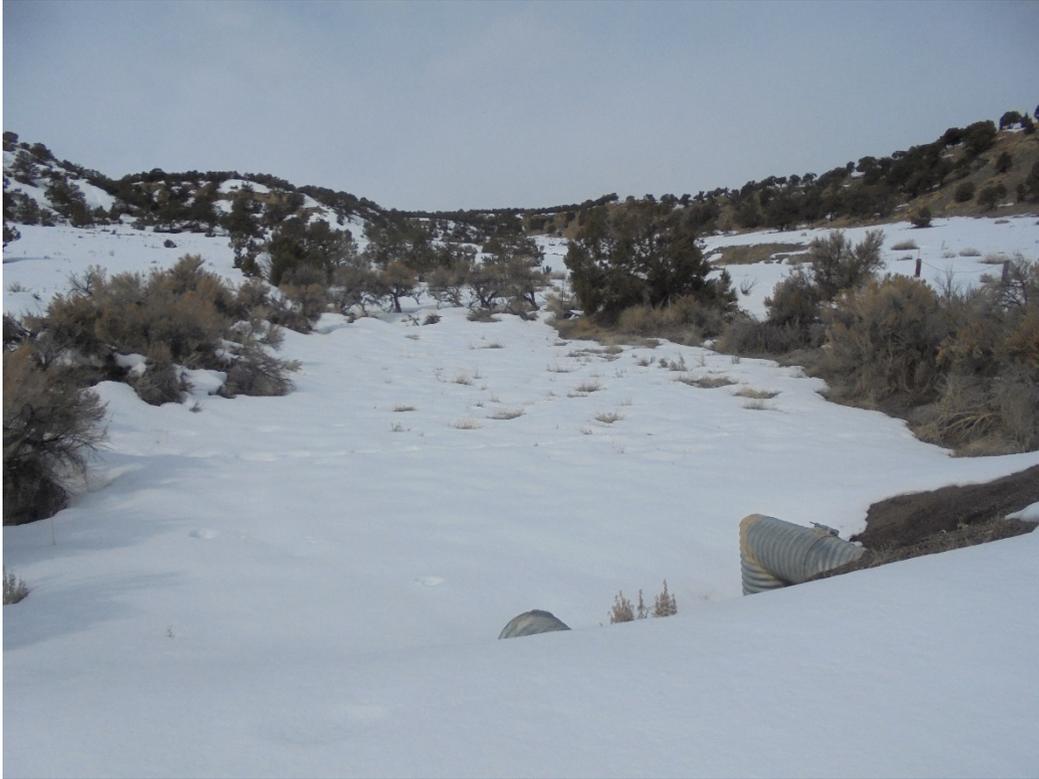
PERMANENT IMPOUNDMENT UPPER CELL

UPPER CELL HAS APPROXIMATELY 1' OF SNOW,
LOWER CELL HAS THE SAME AMOUNT OF SNOW,

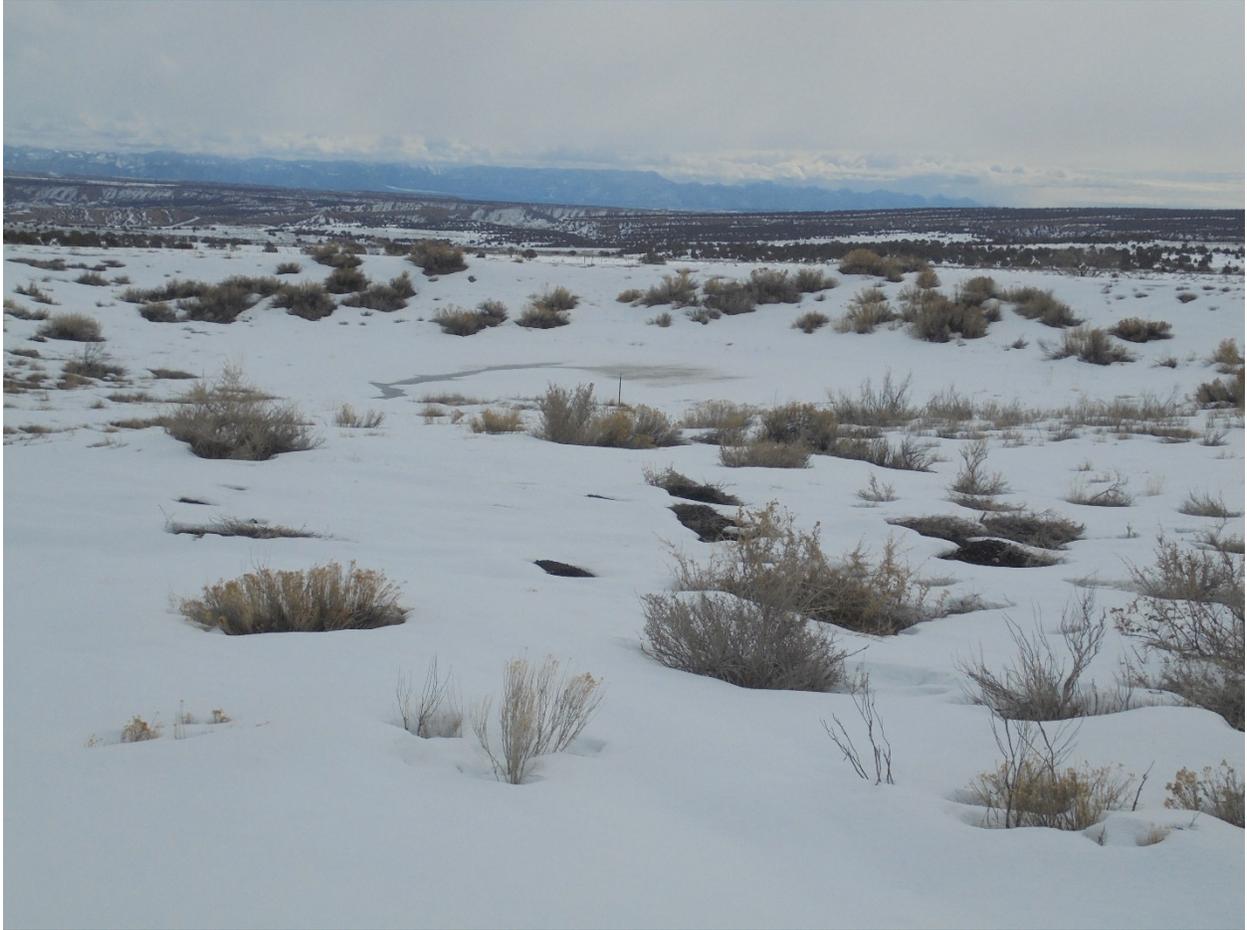
POND A LOOKING EAST

CANNOT DETERMINE SEDIMENT LEVEL DUE TO ICE & SNOW.

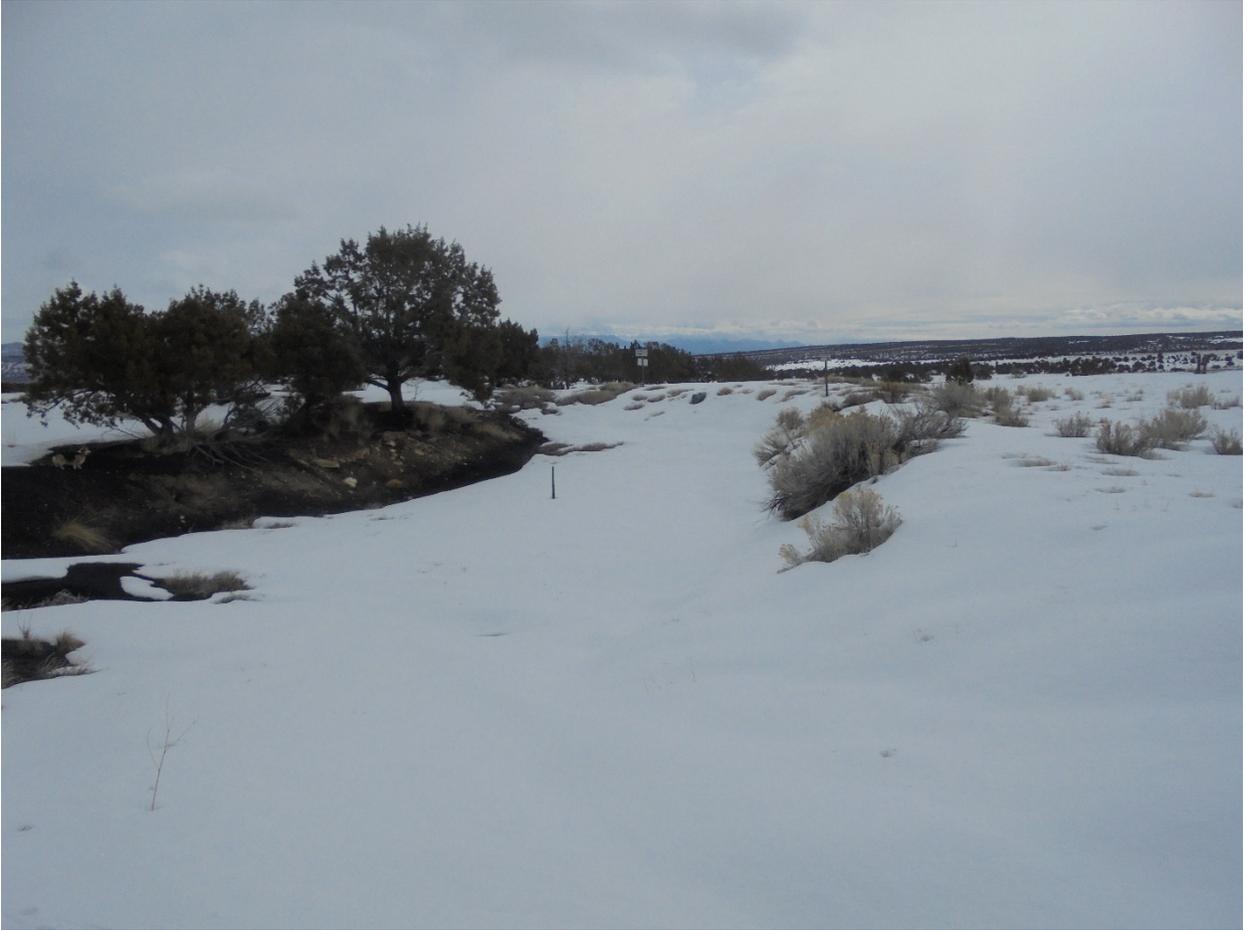
POND B LOOKING EAST

CANNOT DETERMINE SEDIMENT LEVEL DUE TO SNOW.

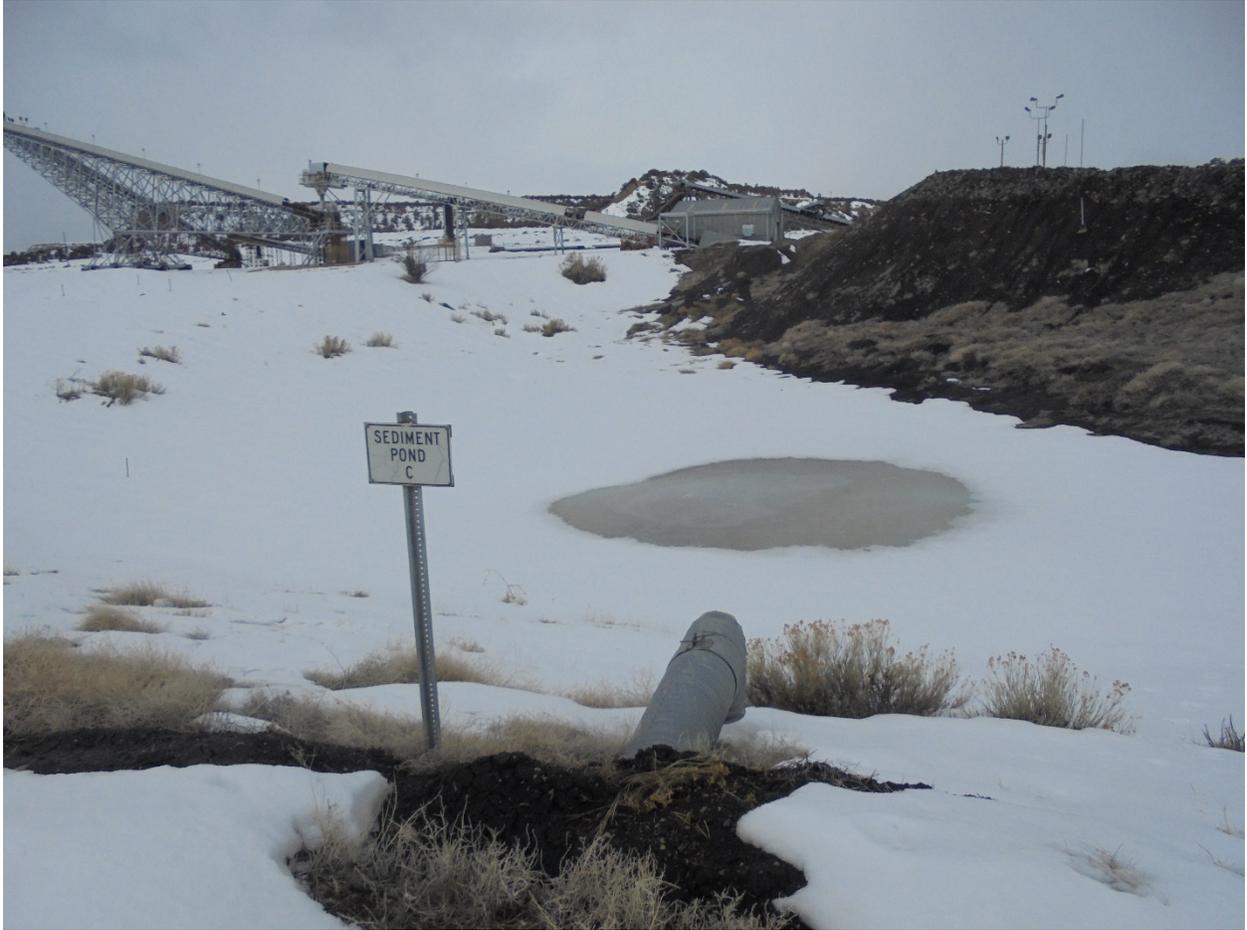
POND C

CANNOT DETERMINE SEDIMENT LEVEL DUE THE
AMOUNT OF SNOW.

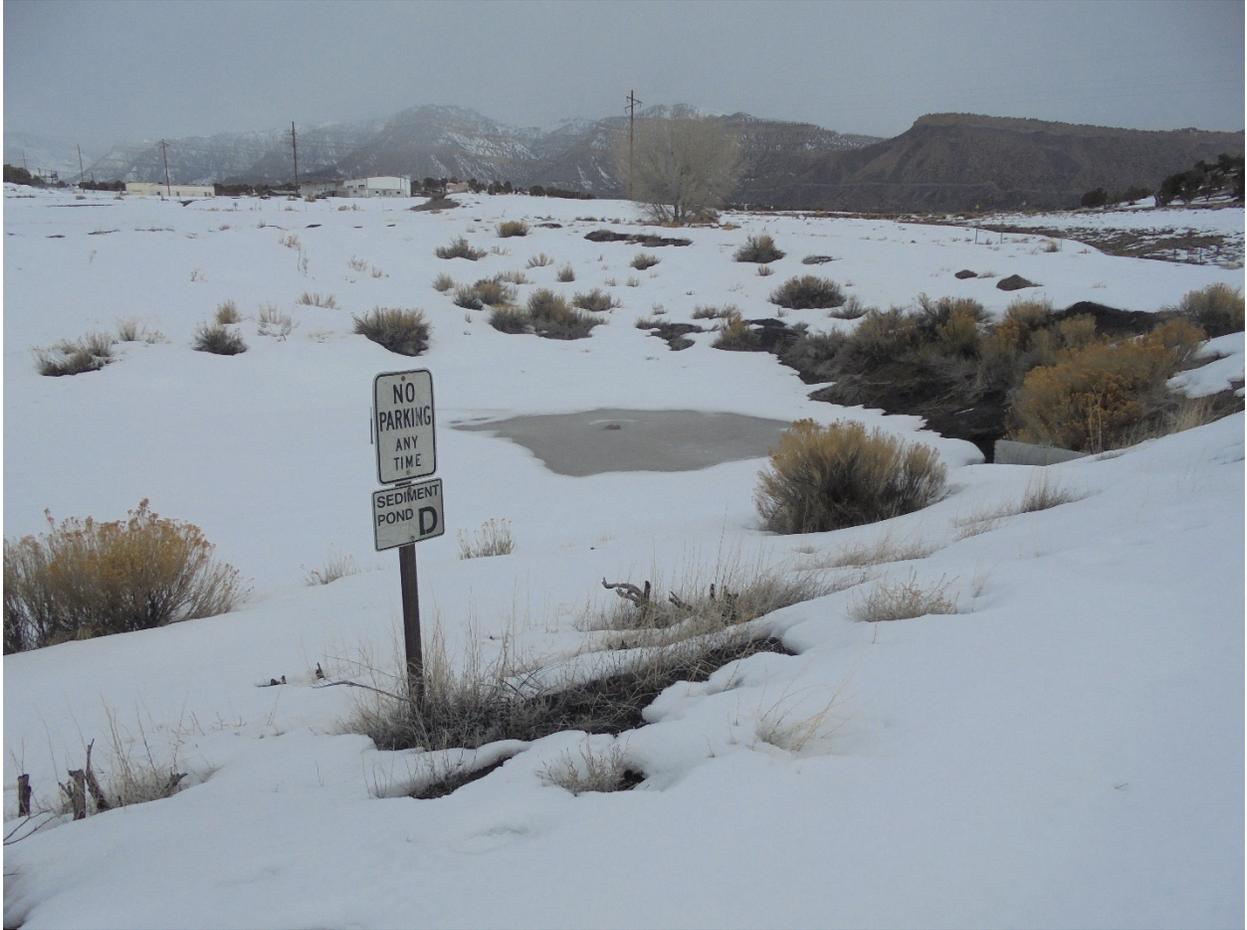
POND D

CANNOT DETERMINE SEDIMENT LEVEL DUE TO ICE & SNOW.

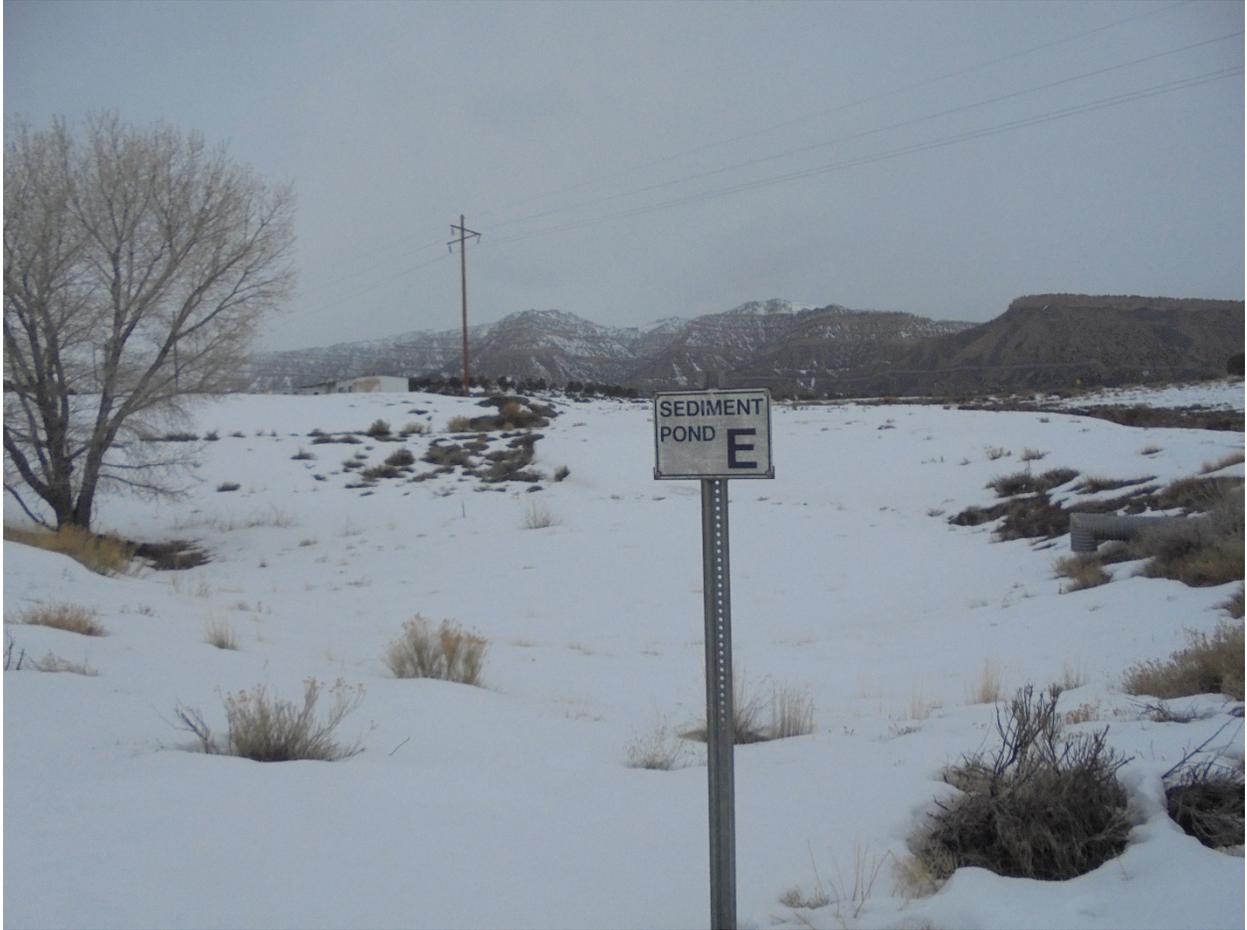
POND E

CANNOT DETERMINE SEDIMENT DUE TO THE AMOUNT
OF SNOW.

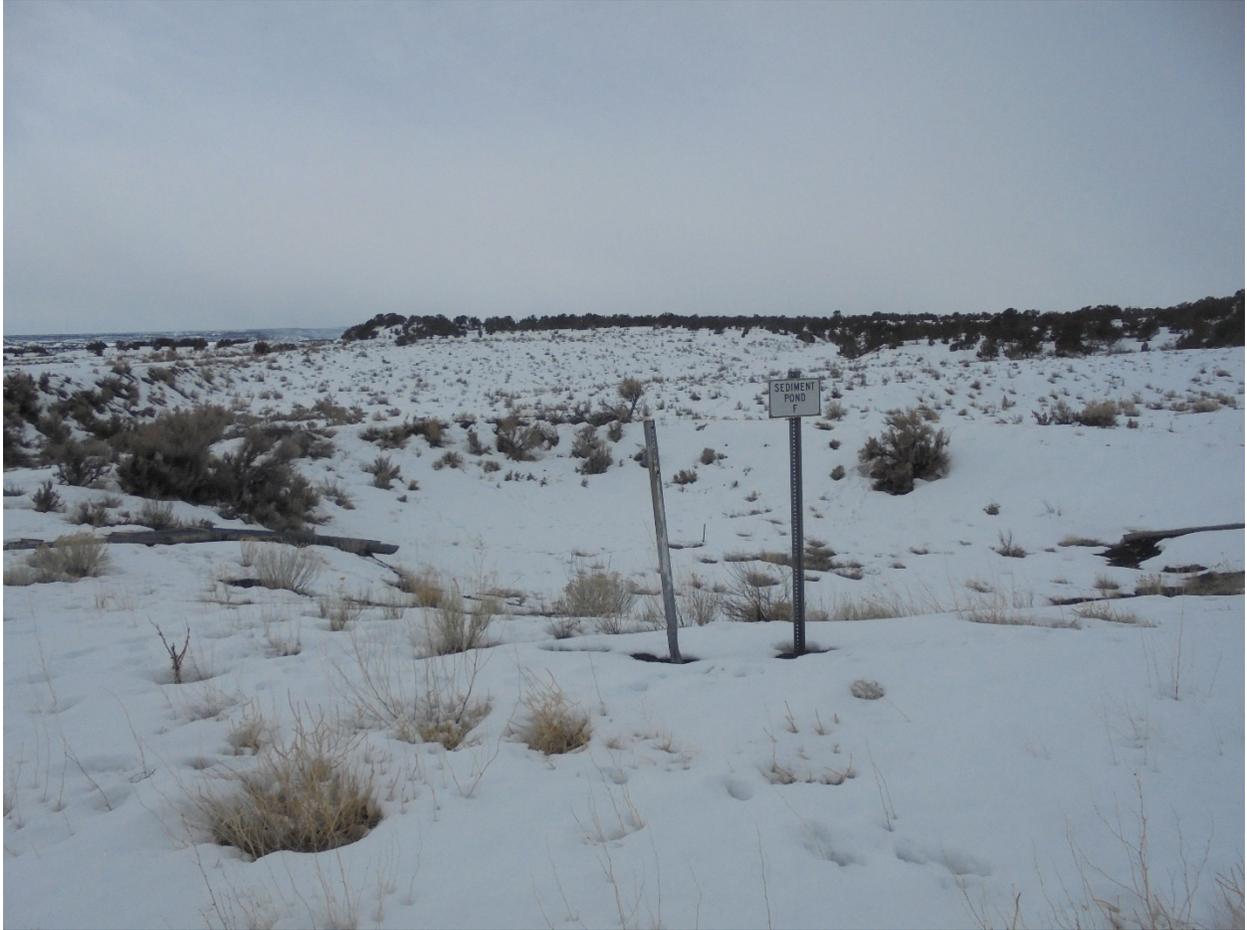
POND F

CANNOT DETERMINE SEDIMENT LEVEL DUE TO THE
AMOUNT OF SNOW,
