Re: **Annual Report, Wildcat Load Out, Coal Energy Group 2, LLC, Permit No. C/007/0033**

# 2018 ANNUAL REPORT

**WILDCAT COAL FINES ISSUE  
DIVISION ORDER-04 (WIND BLOWN FINES)  
SECOND QUARTER 2017**

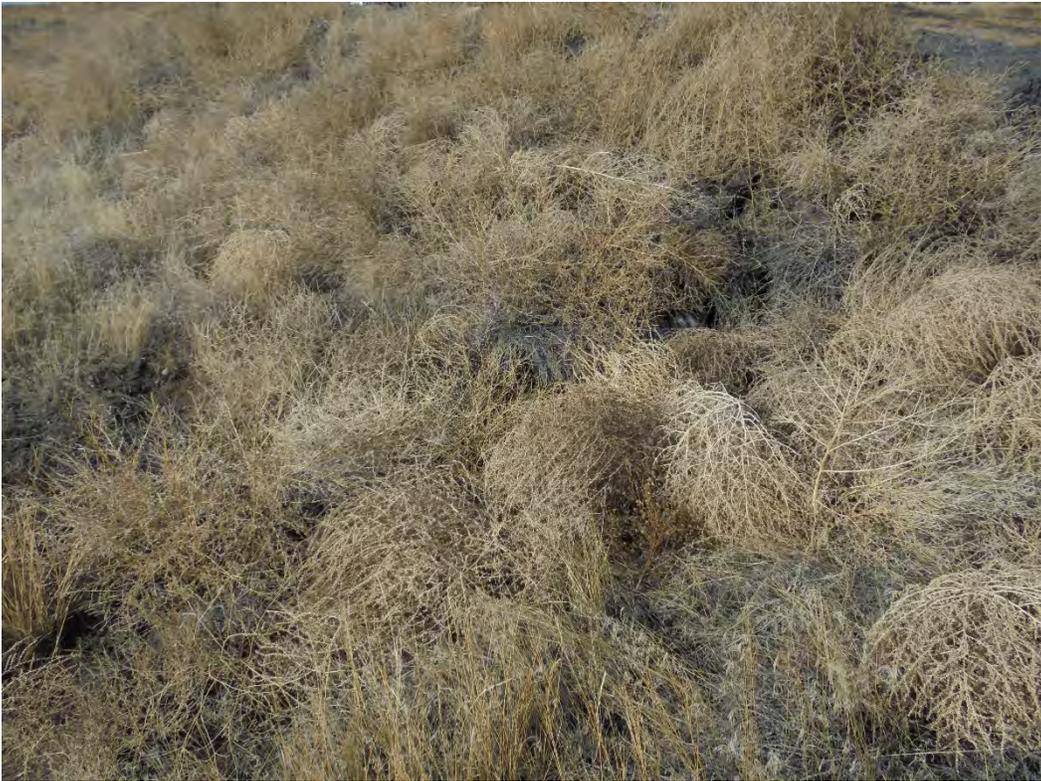
WEEDS BY OUTLET OF WEST POND INLET

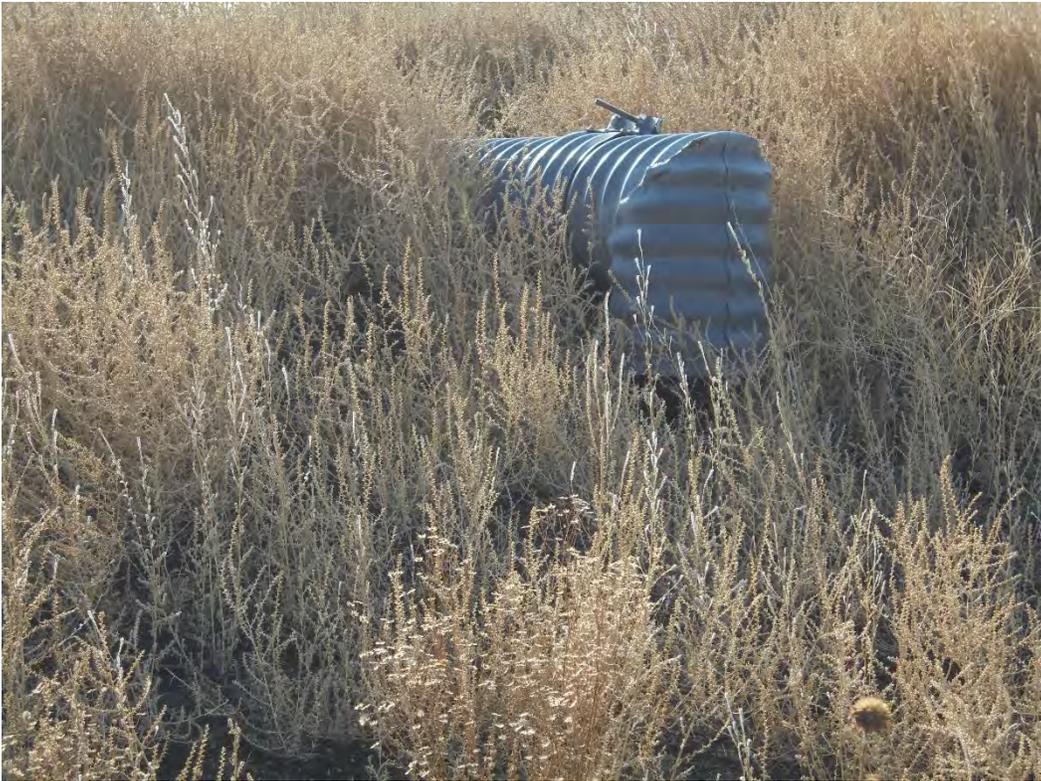
WEEDS BY INLET OF PRINCIPLE SPILLWAY

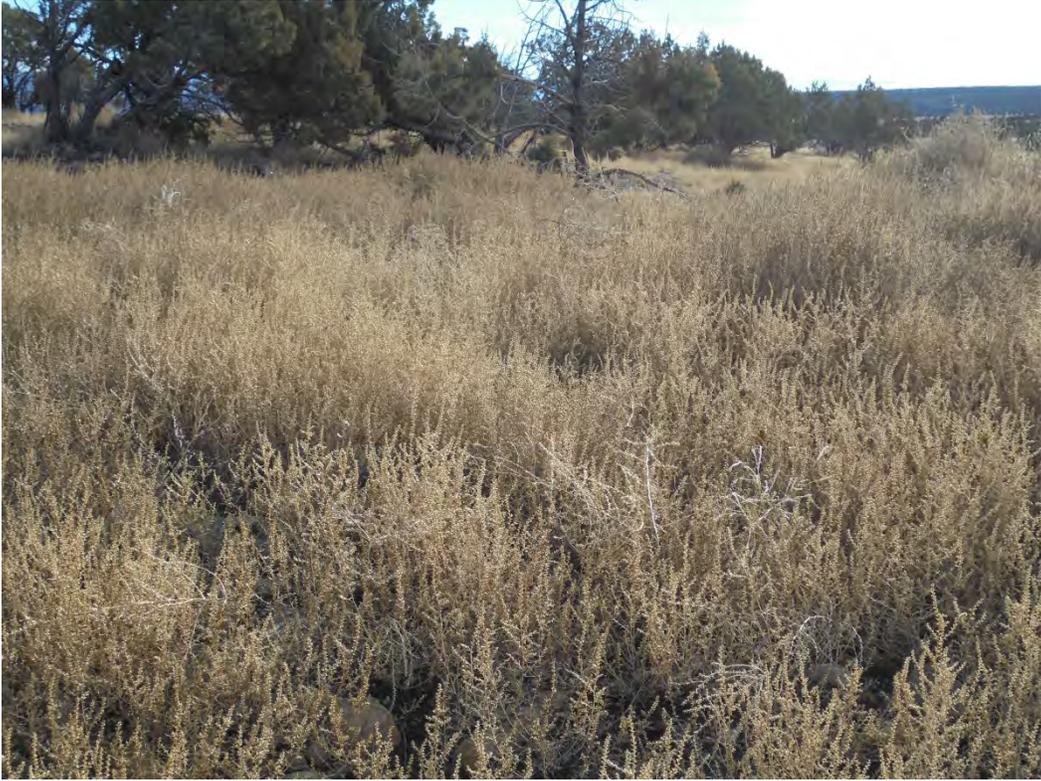
WEEDS IN EMERGENCY SPILLWAY

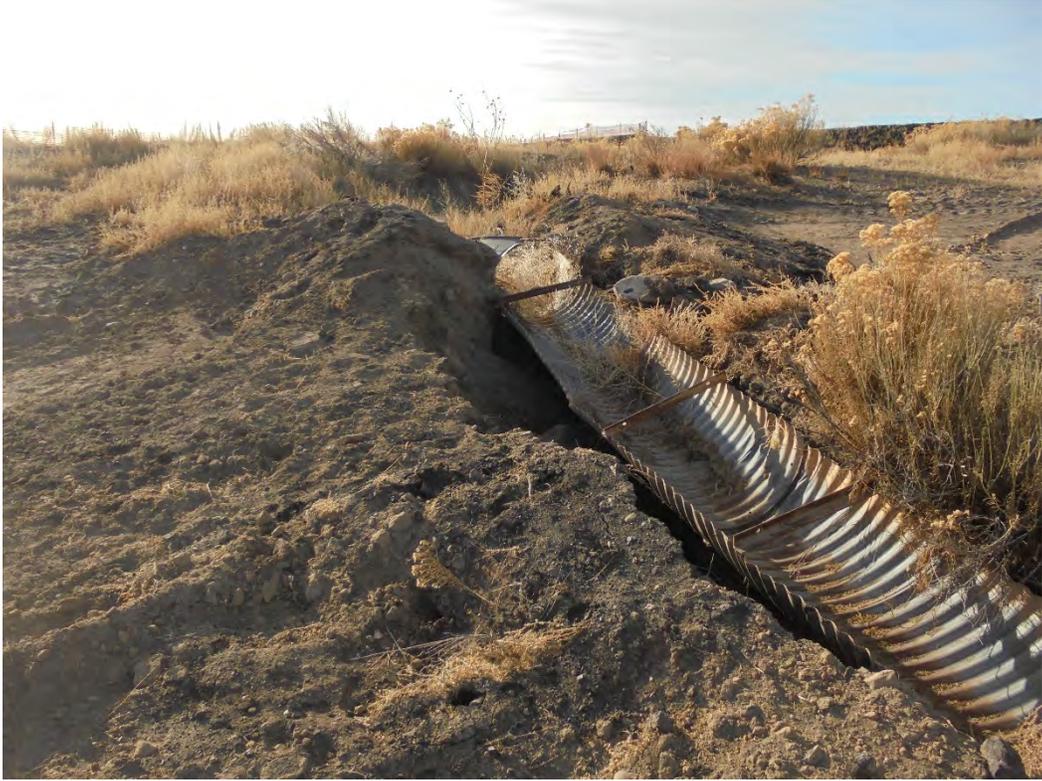
SOUTH INLET UNDERCUTTING

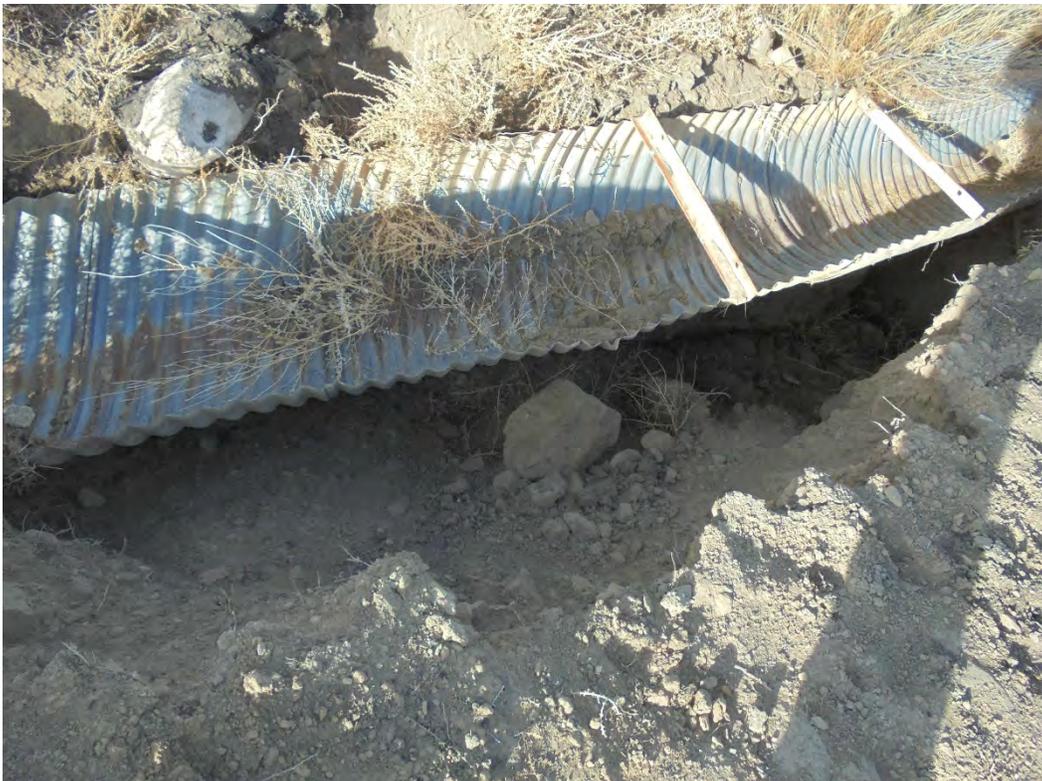
SOUTH INLET UNCERCUTTING (CLOSE-UP)

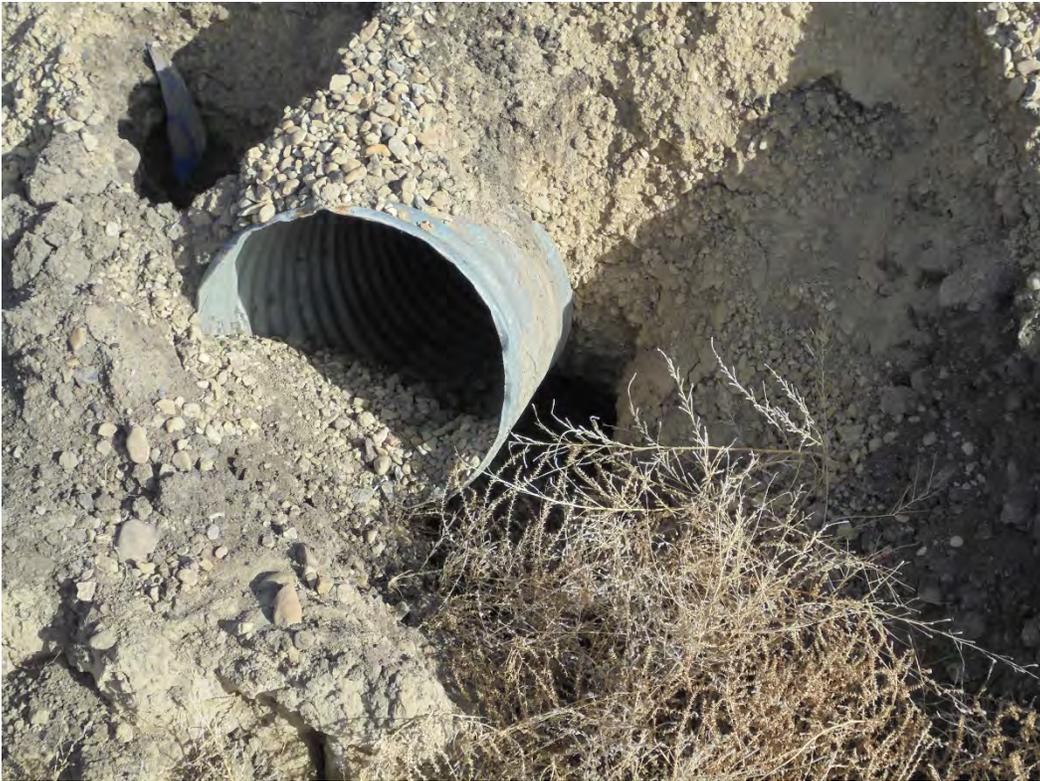
SOUTH INLET UNDERCUTTING

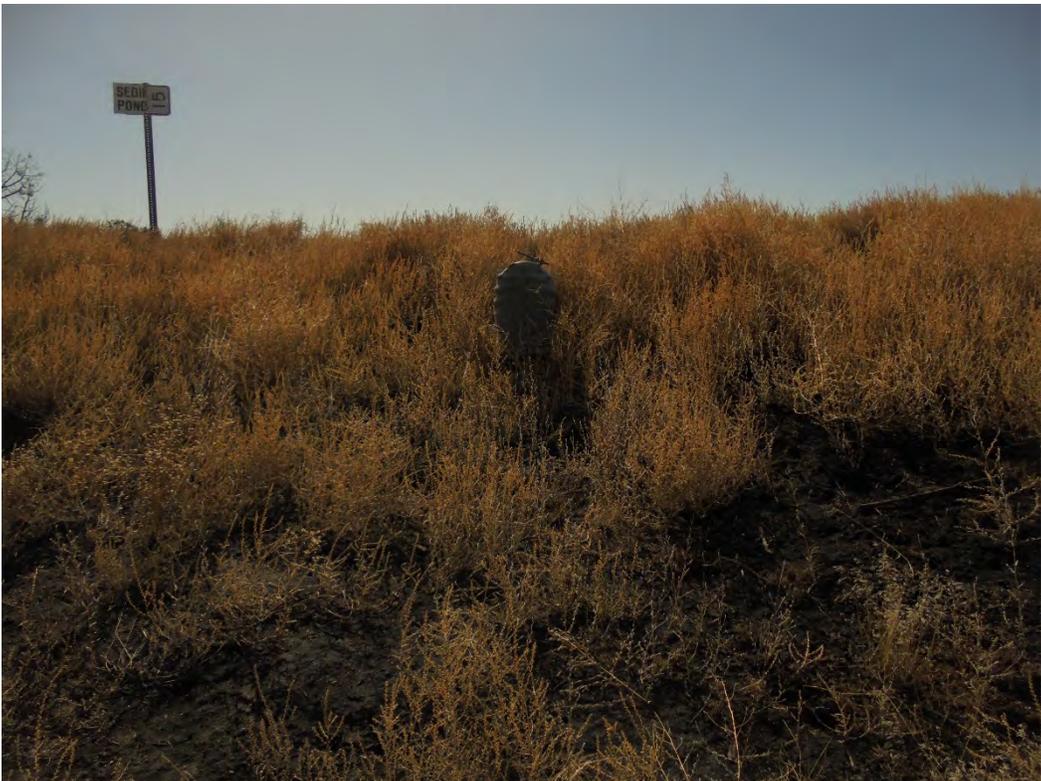
PRINCIPLE SPILLWAY WEEDS

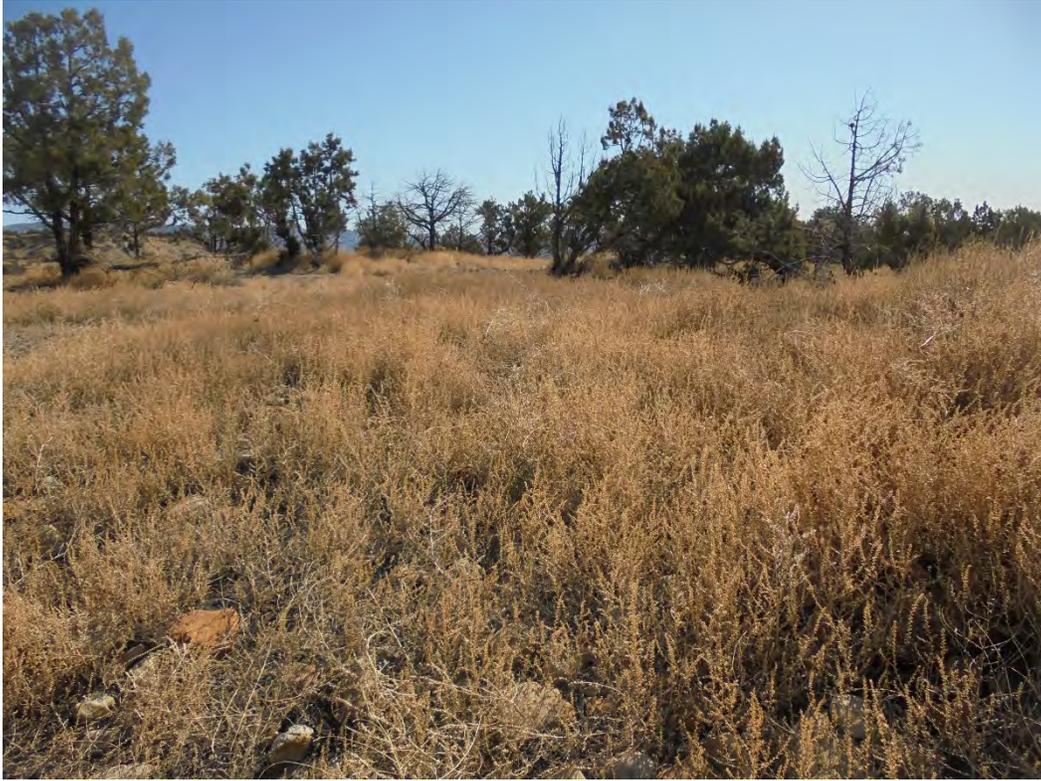
EMERGENCY SPILLWAY WEEDS

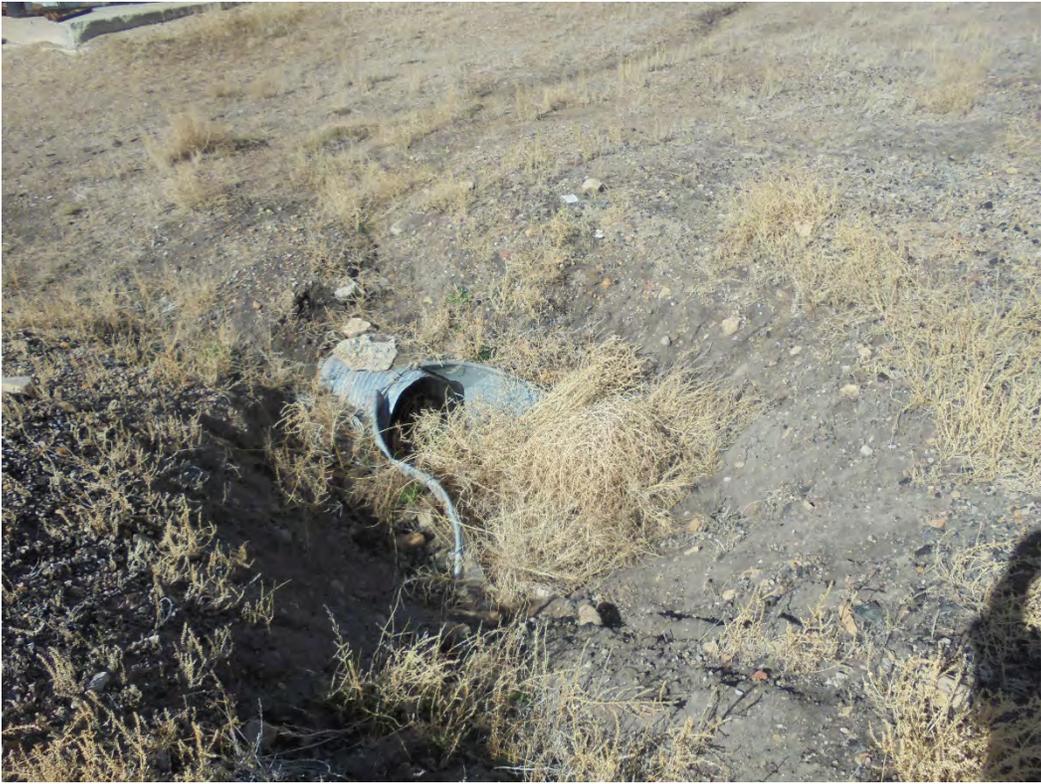
WEST INLET NEEDS WEEDS REMOVED

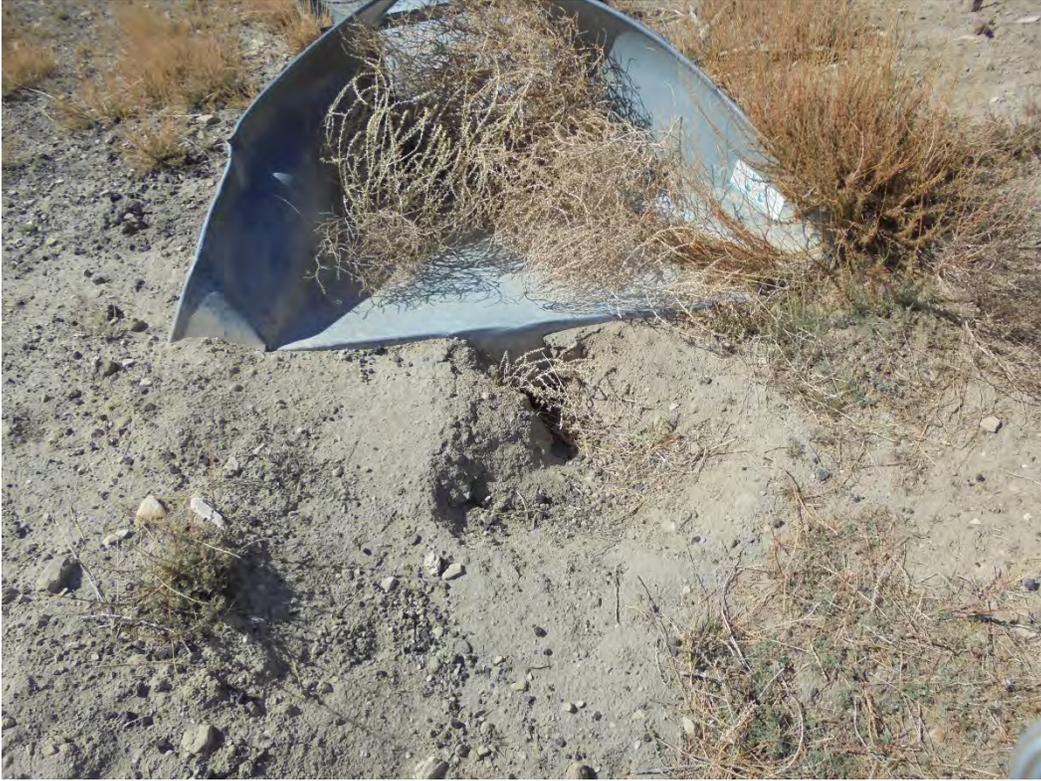
WEST INLET STARTING TO UNDERCUT

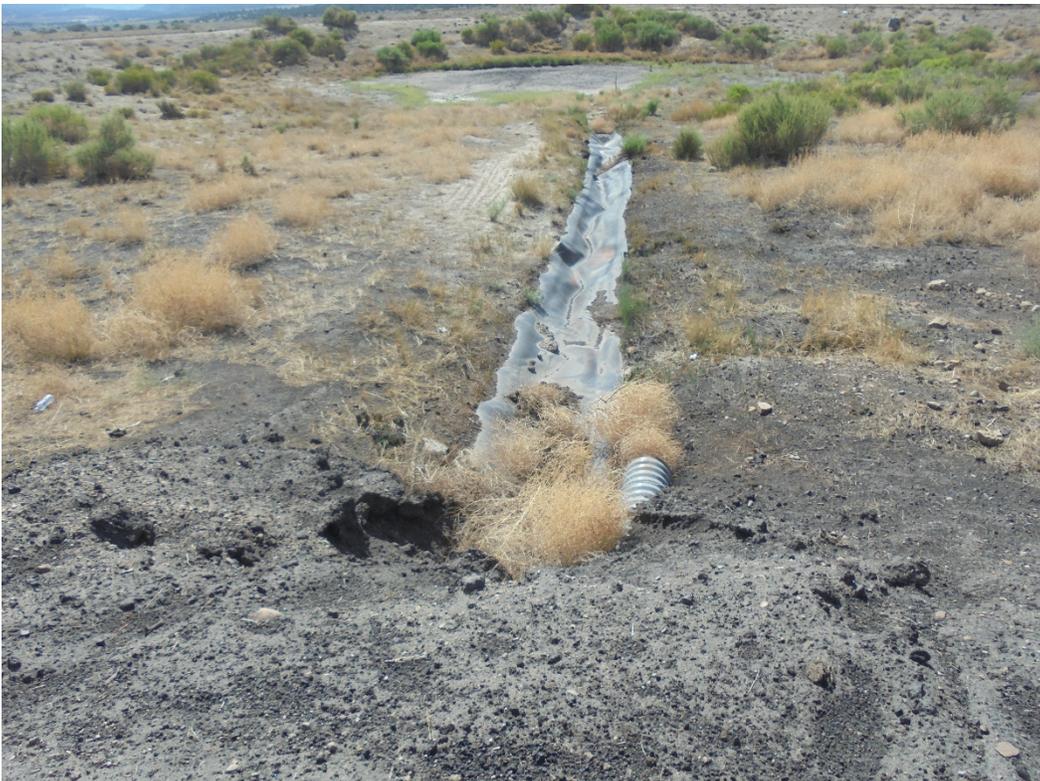
POND A WEST INLET BELT DOES NOT LINE UP WITH CMP

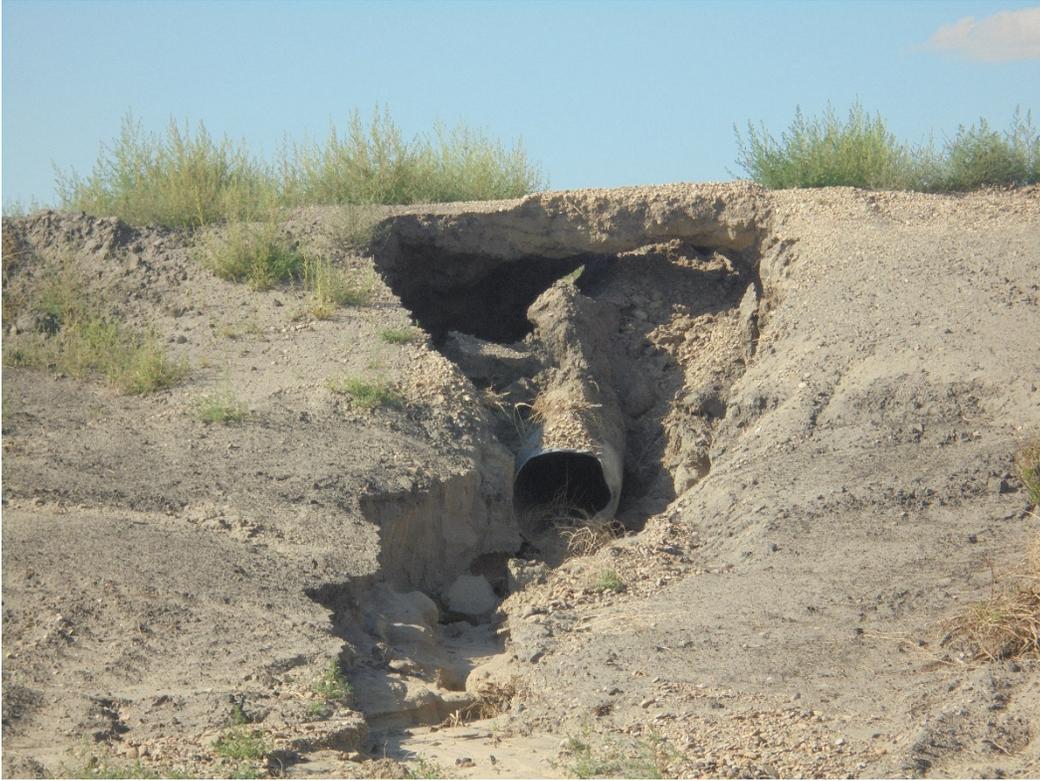
SOUTH INLET IS UNDERCUTTING

ANIMAL BURROW UNDER INLET OF PRINCIPAL SPILLWAY SHOULD  
BE FILLED, EMERGENCY SPILLWAY INLET WEEDS NEED TO BE  
REMOVED. EMERGENCY & PRINCIPLE OUTLET SPILLWAYS NEED  
TO HAVE WEEDS REMOVED. SOUTH INLET CMP IS BEING  
UNDERCUT AND SHOULD BE REPAIRED.

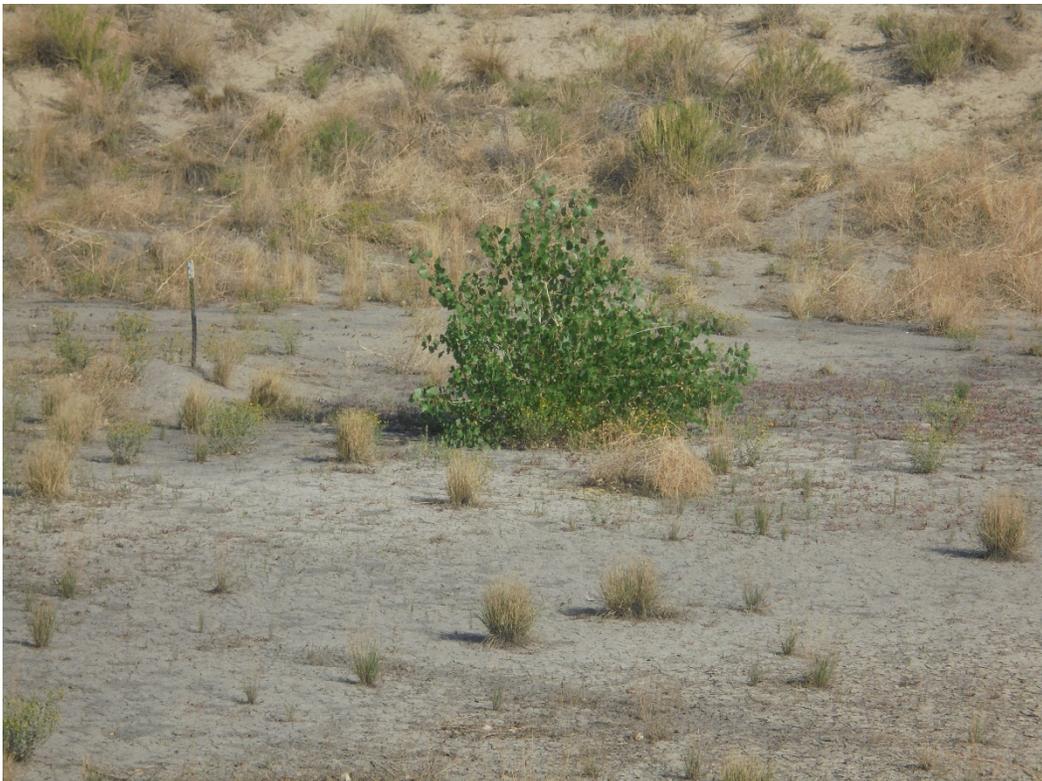
POND E TREES GROWING IN POND

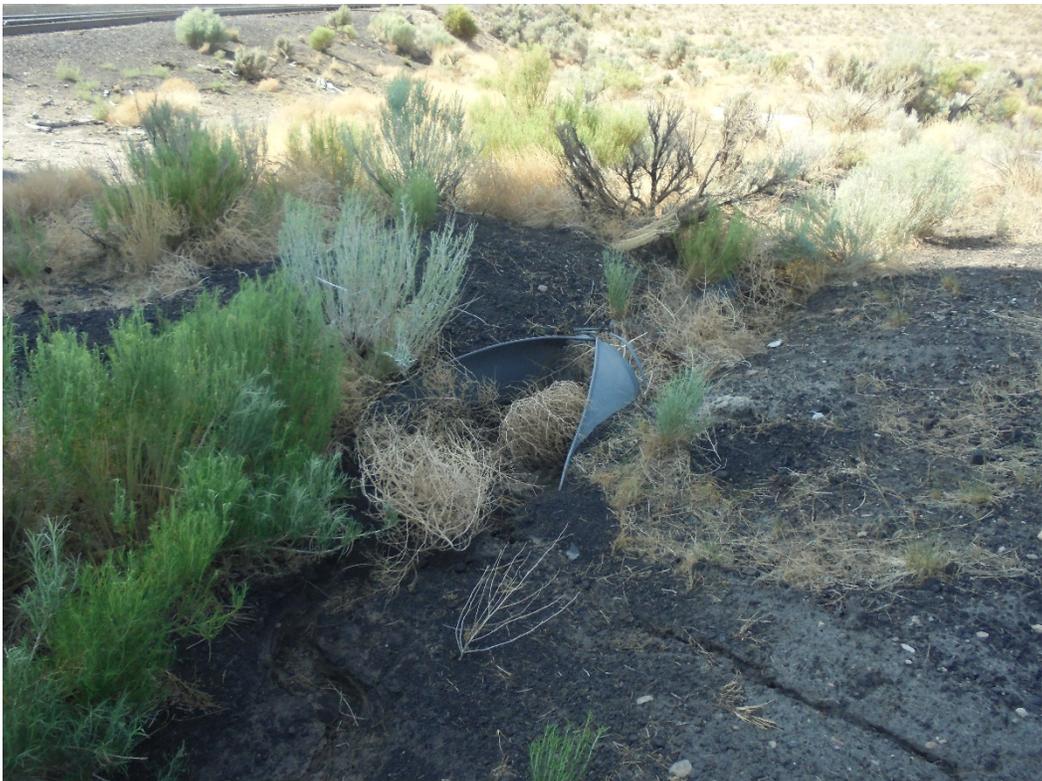
EAST INLET WEEDS AND COAL FINES NEED TO BE REMOVED

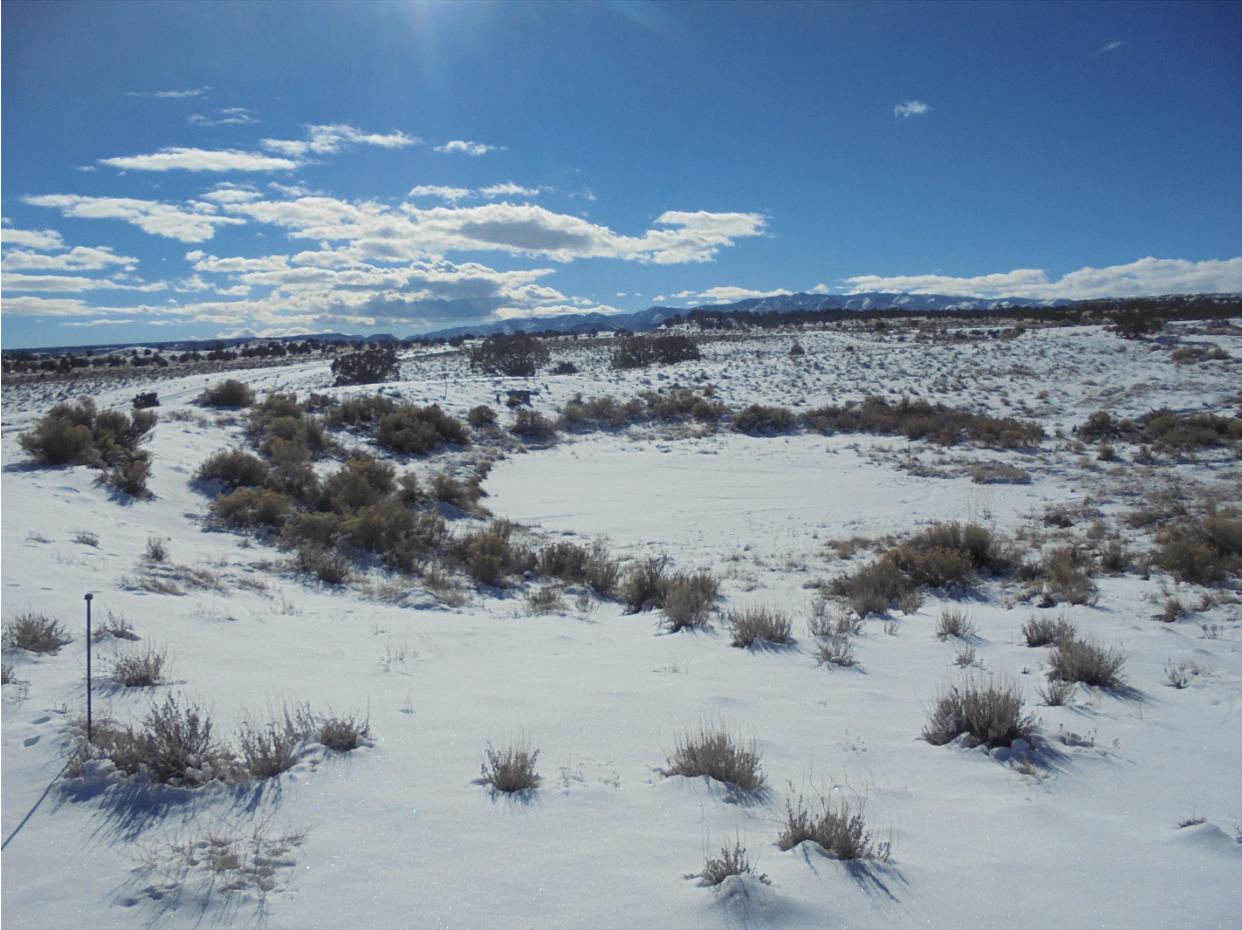
POND A

The pond was dry and the sediment is 32" below cleanout level. The west pond inlet needs more belting installed under the CMP to prevent erosion.			
<b>Qualified Statement</b>		I hereby certify that I am experienced in the construction of impoundments; I am qualified and authorized under the direction of a Registered Professional Engineer to inspect the condition and appearance of impoundments in accordance with the certified and approved designs for this structure, that the impoundment has been maintained in accordance with approved design and meet or exceed the minimum design requirements under all applicable federal, state and local regulations; and, that inspections and inspection reports are made by myself and include any appearances of instability, structural weakness or other hazardous conditions of the structure affecting stability.

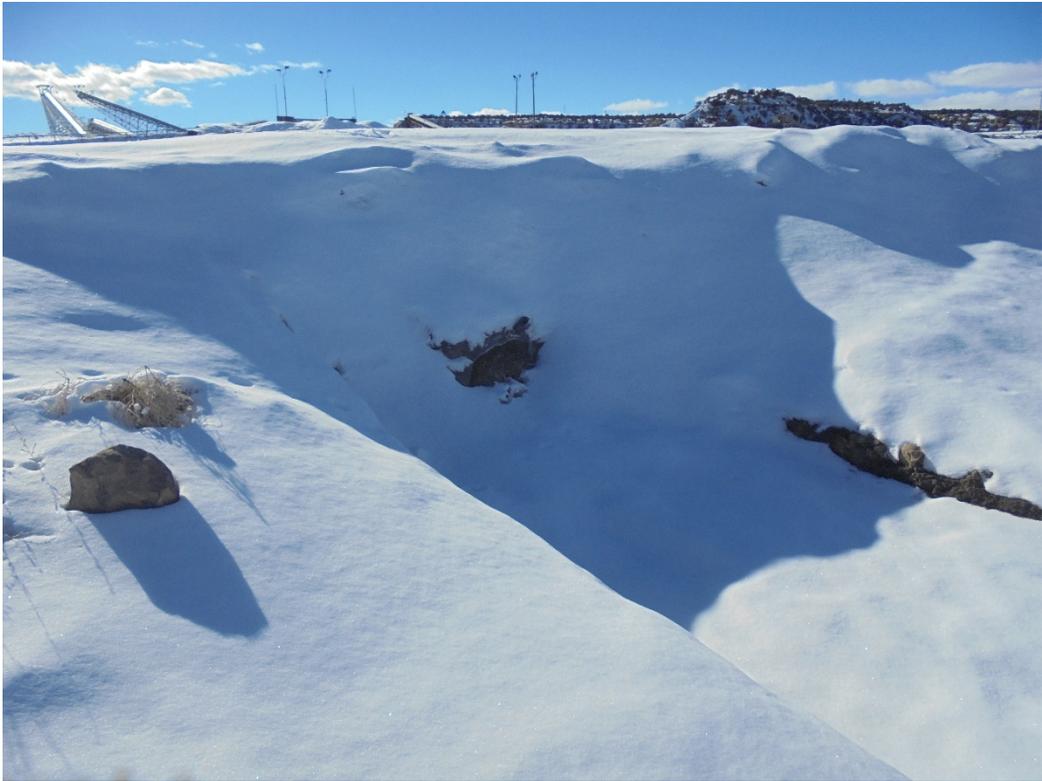
POND C SOUTH INLET

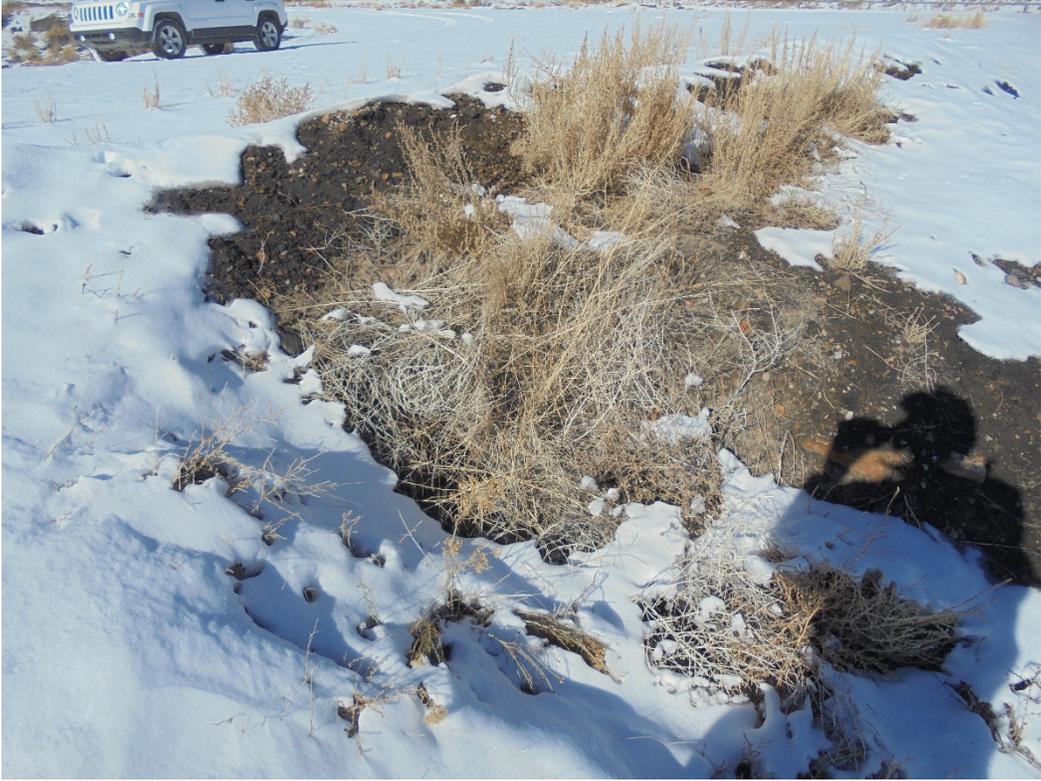
POND D WEEDS PLUGGING OUTLET

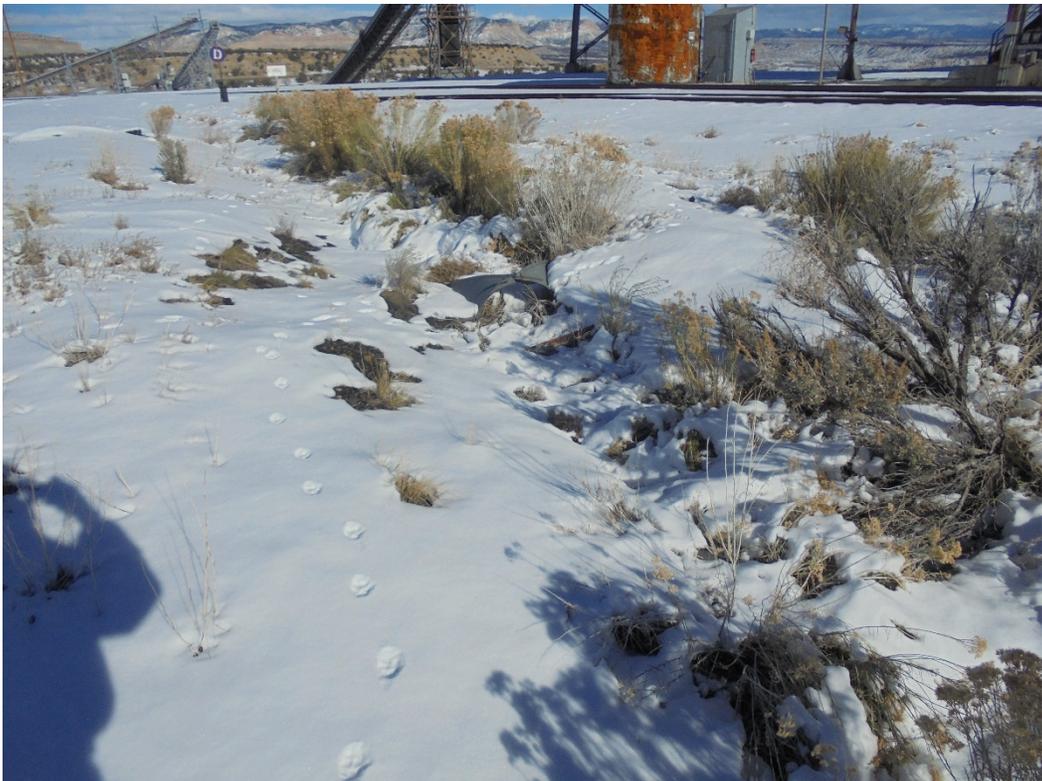
POND F WEEDS IN EAST INLET
