Quarterly Inspection Form - Refuse Disposal Areas

Permit Number :	<u>C/007/0033</u>	Inspection Date :	<u>May 13, 2019</u>
Mine Name :	<u>Wildcat Loadout</u>	Quarter / Year :	<u>2nd Quarter 2019</u>
Mine Operator (Permittee) :	<u>Coal Energy Group 2, LLC</u>	Inspector Name :	<u>J. T. Paluso</u>
MSHA ID # :	<u>1211-UT-09-018664-01</u>	Inspector Signature :	<u>Joseph T. Paluso</u>
Facility Name / Location / Address :	<u>Wildcat Loadout/5495 West 3550 North, Helper, Utah 84526</u>

Sedimentation Pond Inspection

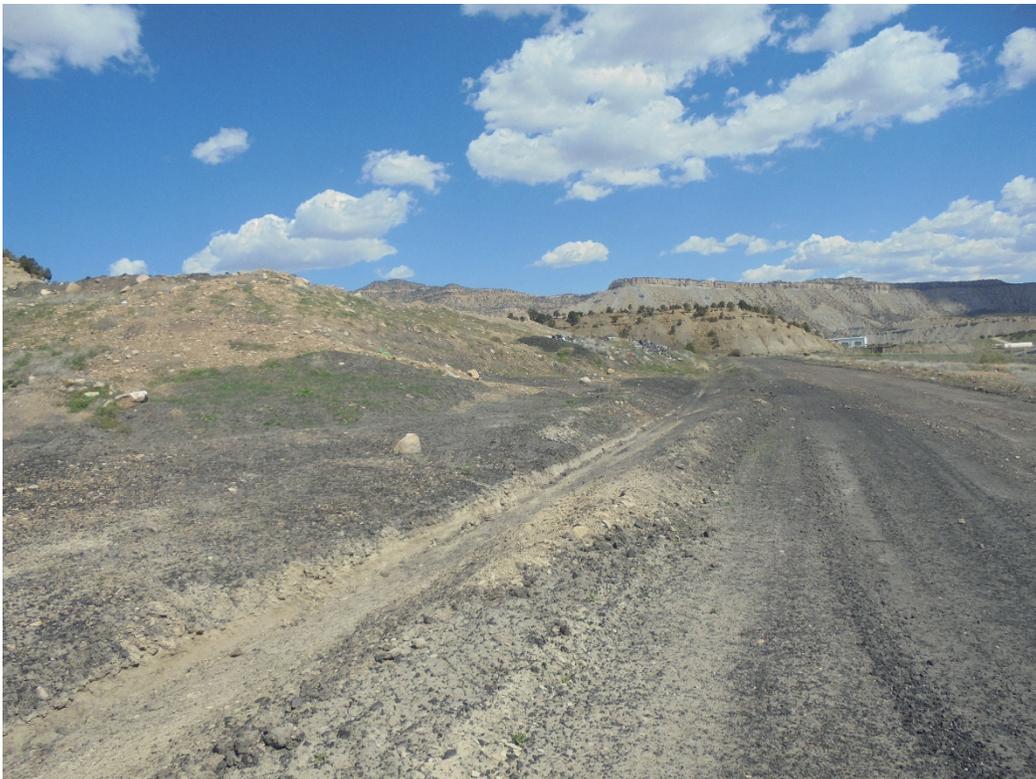
8. Describe placement of under drains, protective filter systems, and final surface drainage systems (report any seepage, including location, color, flow) :
None known. East drainage ditch needs cleaning shortly.

EAST DRAINAGE DITCH

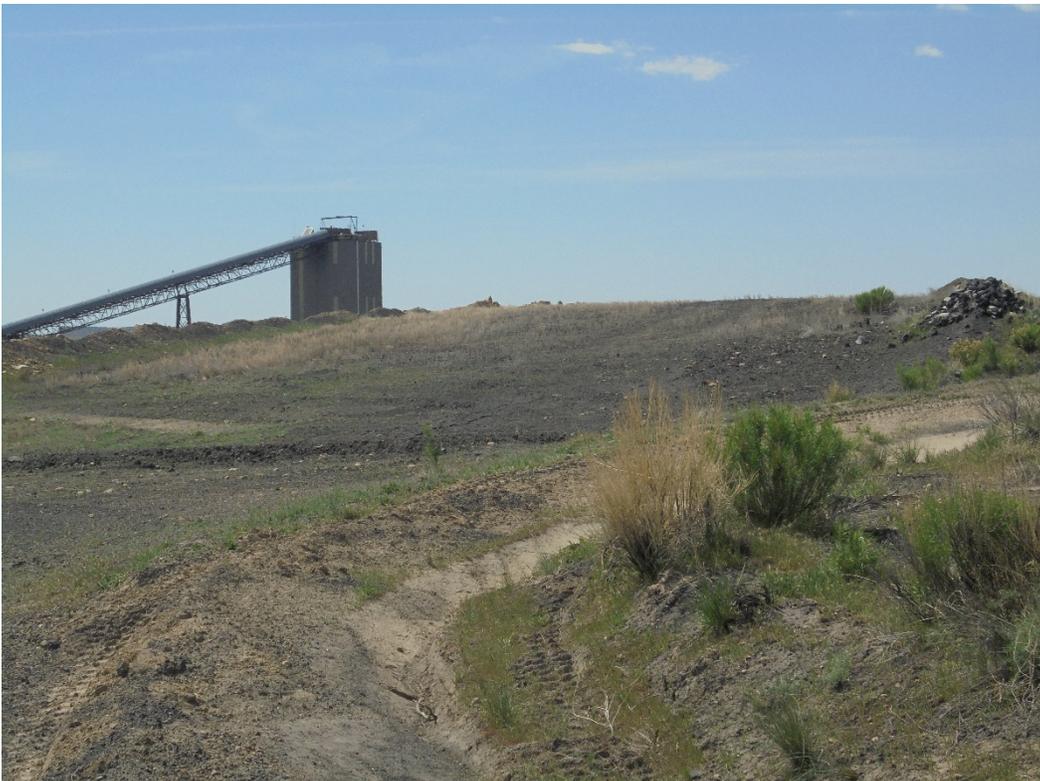
LOOKING SOUTH TOWARDS TOP OF REFUSE PILE

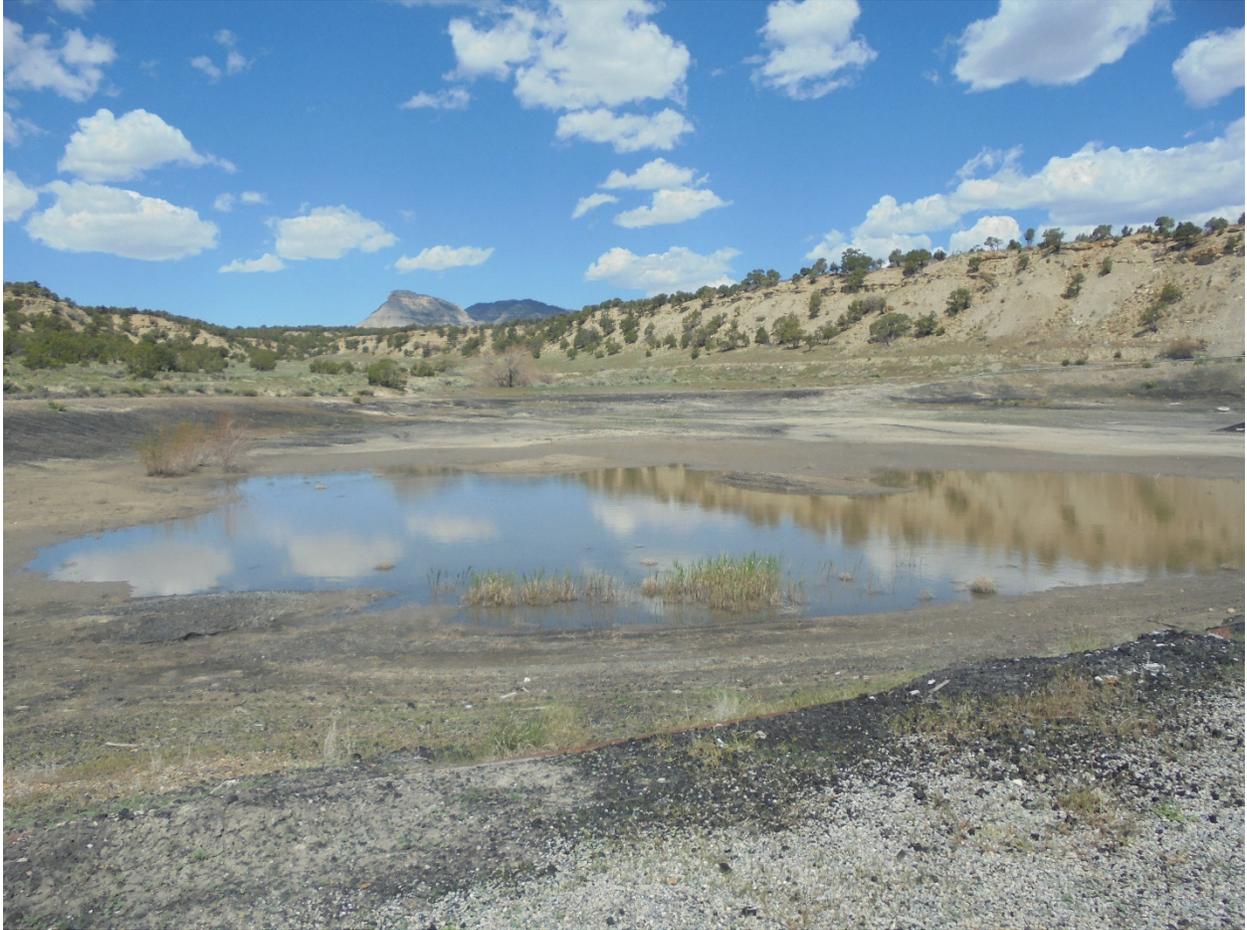
DEPRESSED AREA IMPOUNDMENT

Water ~ 18" WATER
Sediment

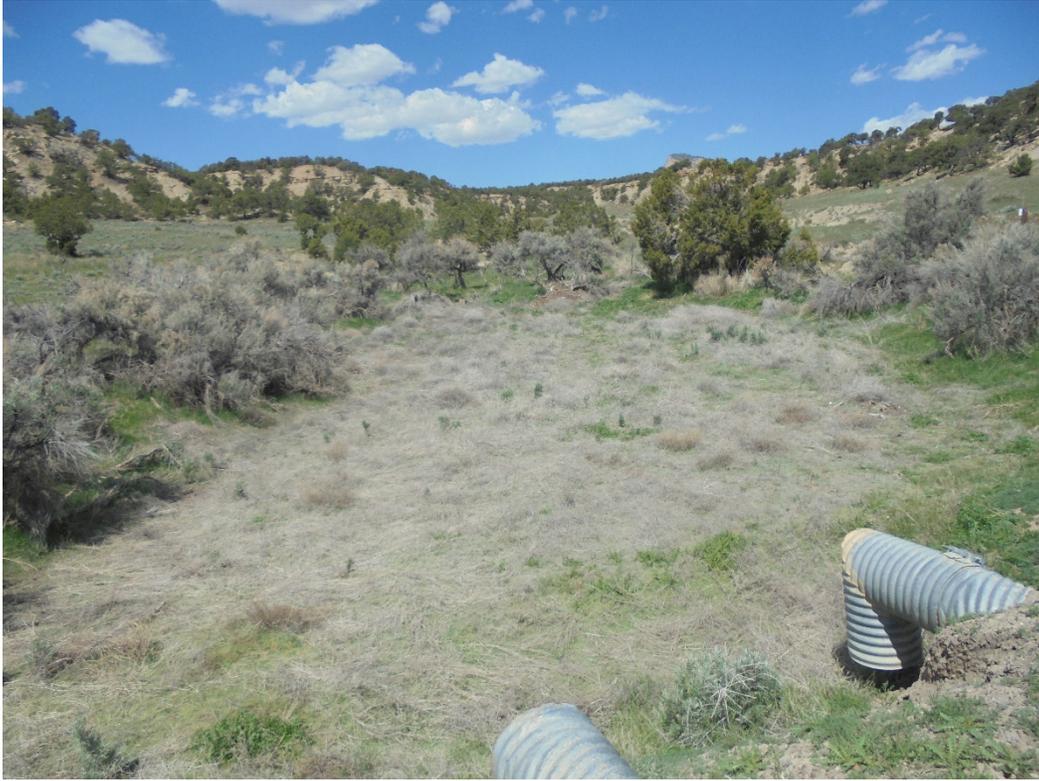
UPPER CELL HAS LOTS OF WEEDS.

PERMANENT IMPOUNDMENT (UPPER CELL)

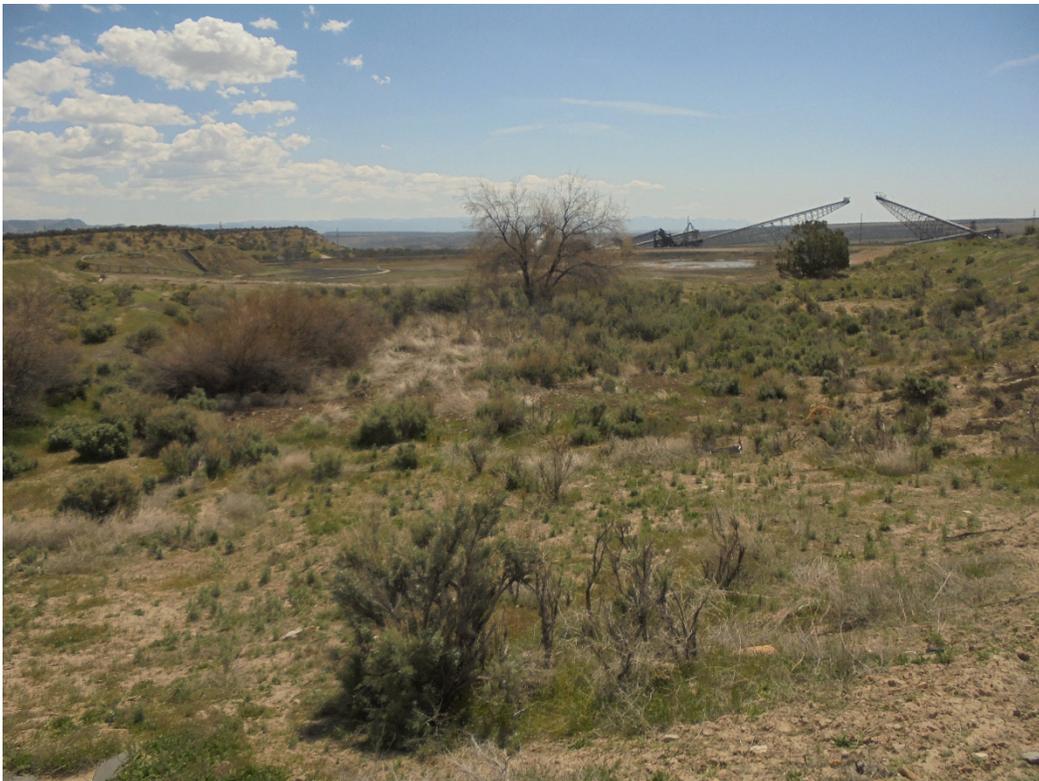
PERMANENT IMPOUNDMENT (LOWER CELL)

Water DRY BOTH CELLS
Sediment _____

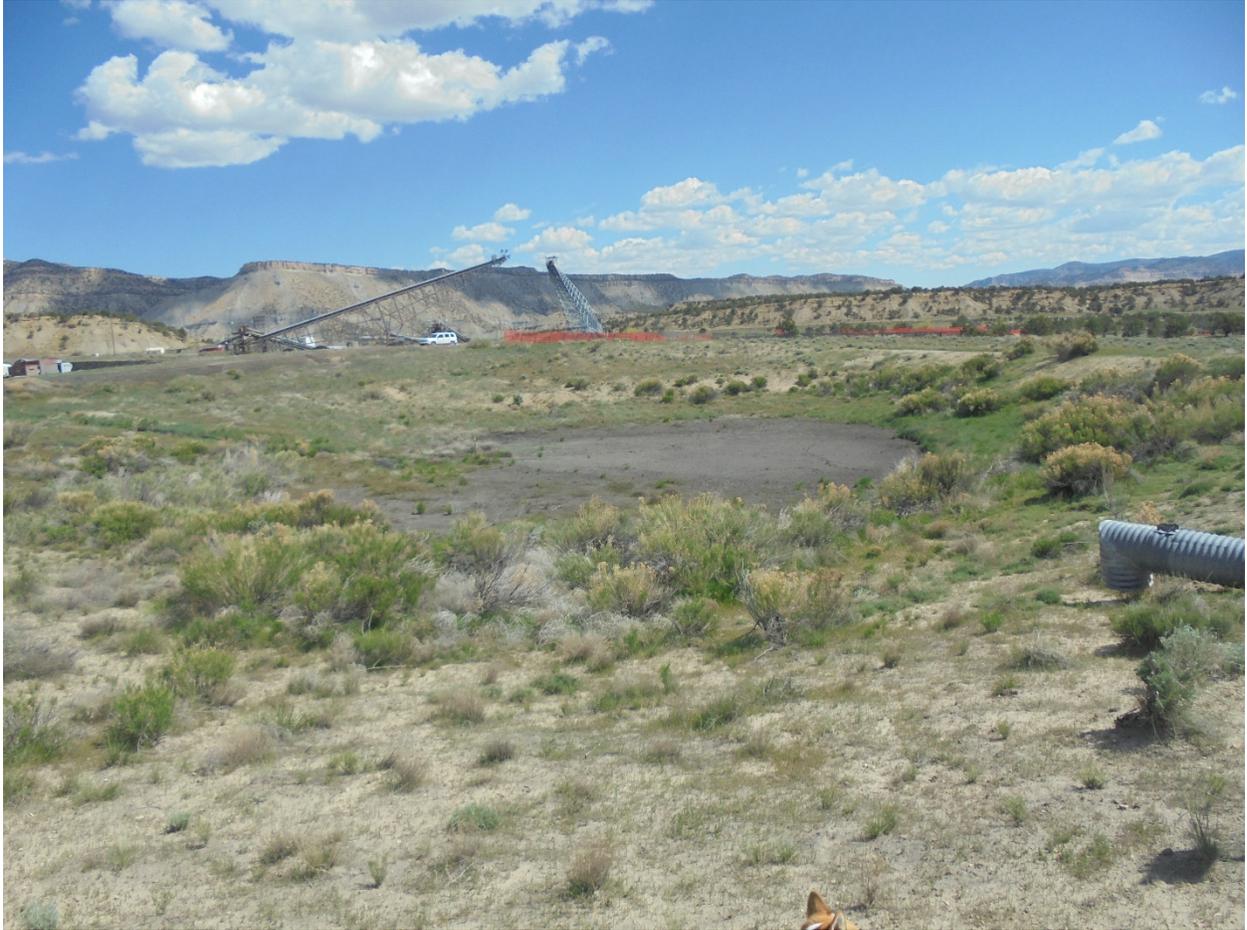
POND A

B. Capacity (0% / 100%) _____
Water _____
Sediment DRY
30" BELOW CLEANOUT LEVEL

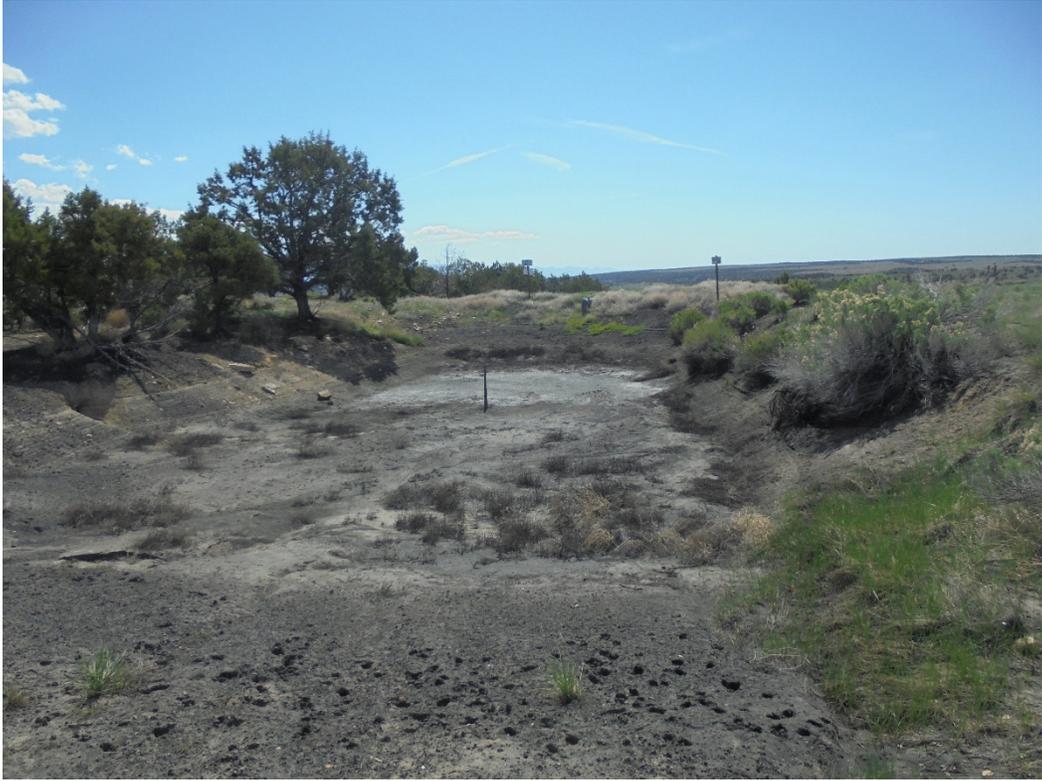
POND B

DRY
21" BELOW CLEANOUT LEVEL

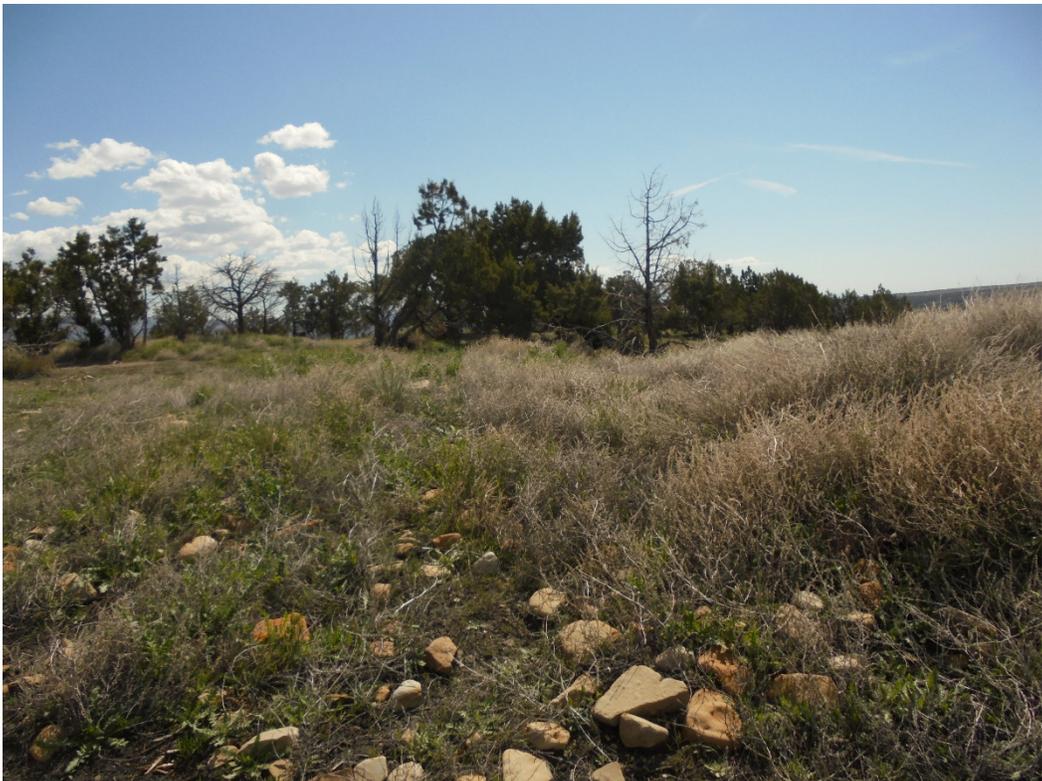
EMERGENCY SPILLWAY HAS WEEDS.

POND B EMERGENCY SPILLWAY WEEDS

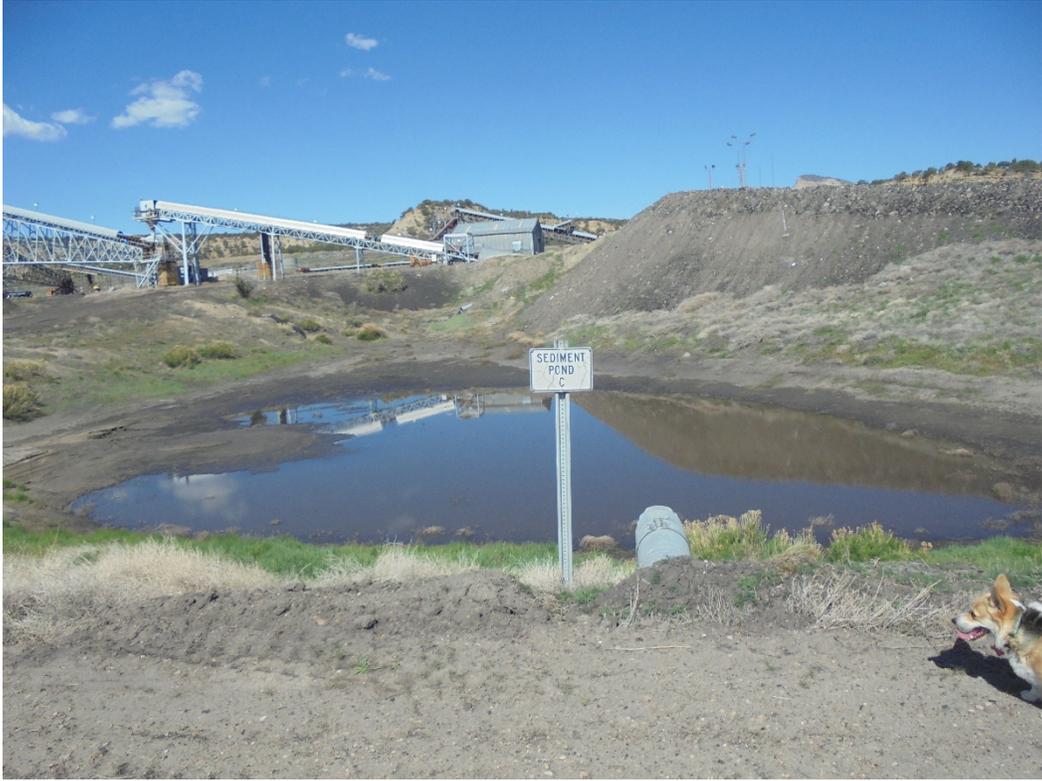
POND C

~ 24"
30.5" BELOW CLEANOUT LEVEL

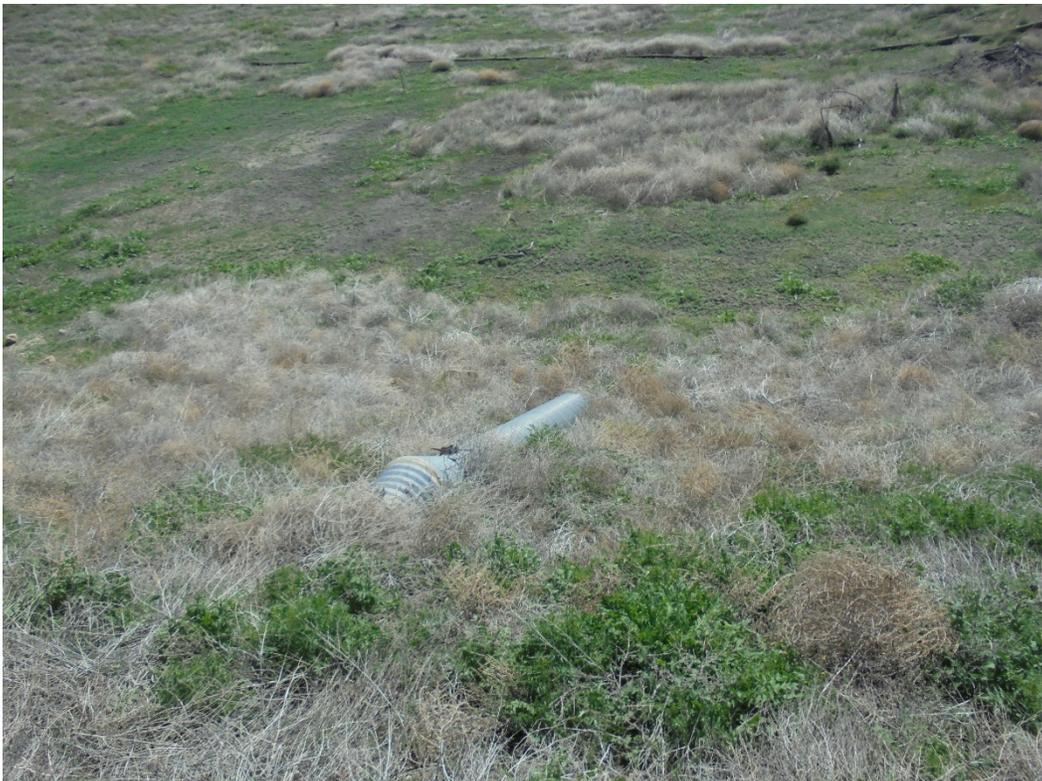
LOT OF WEEDS AT DISCHARGE PIPES.

POND C (WEEDS AT PRINCIPAL SPILLWAY OUTLET)

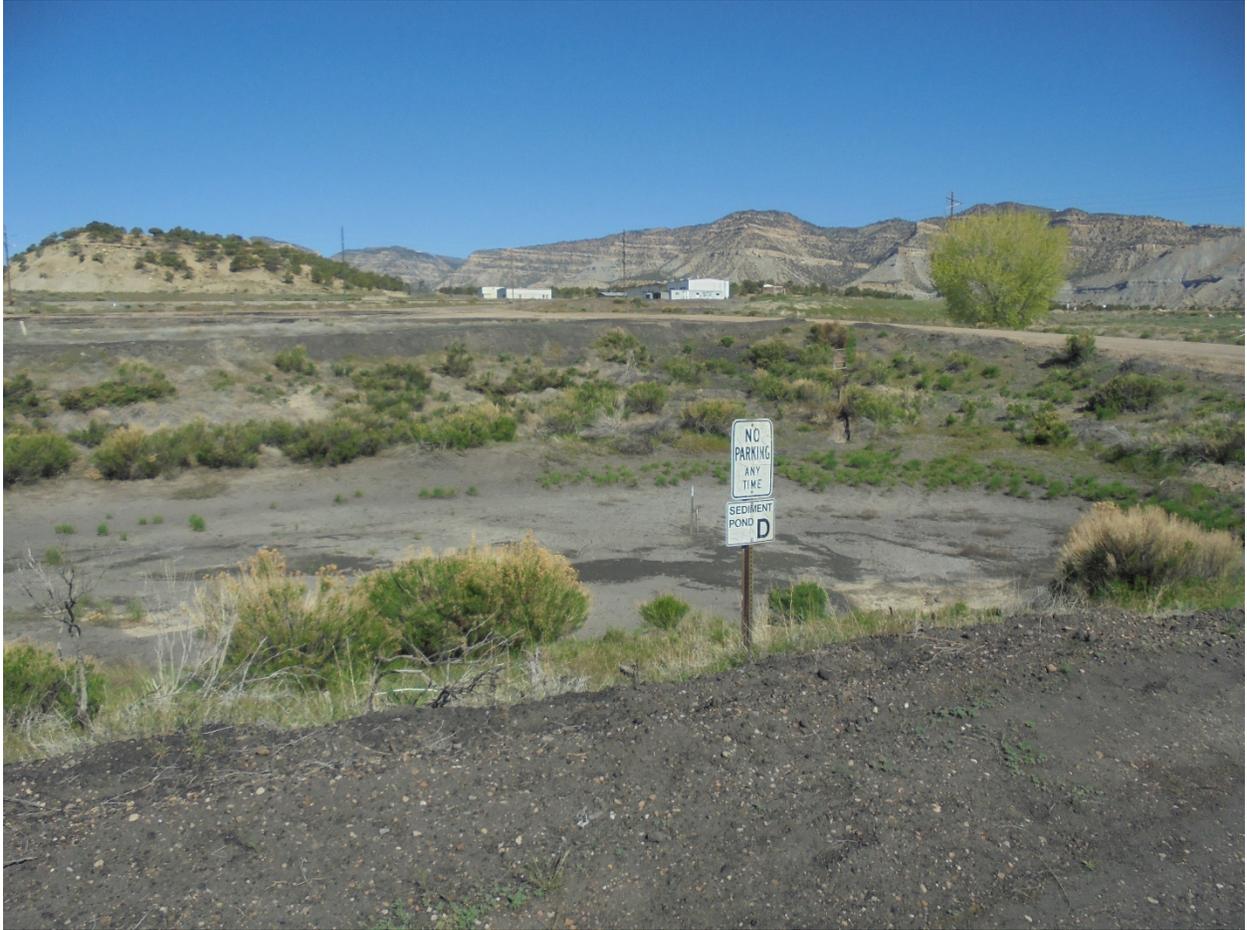
POND D

DRY
13 1/2" BELOW CLEANOUT LEVEL

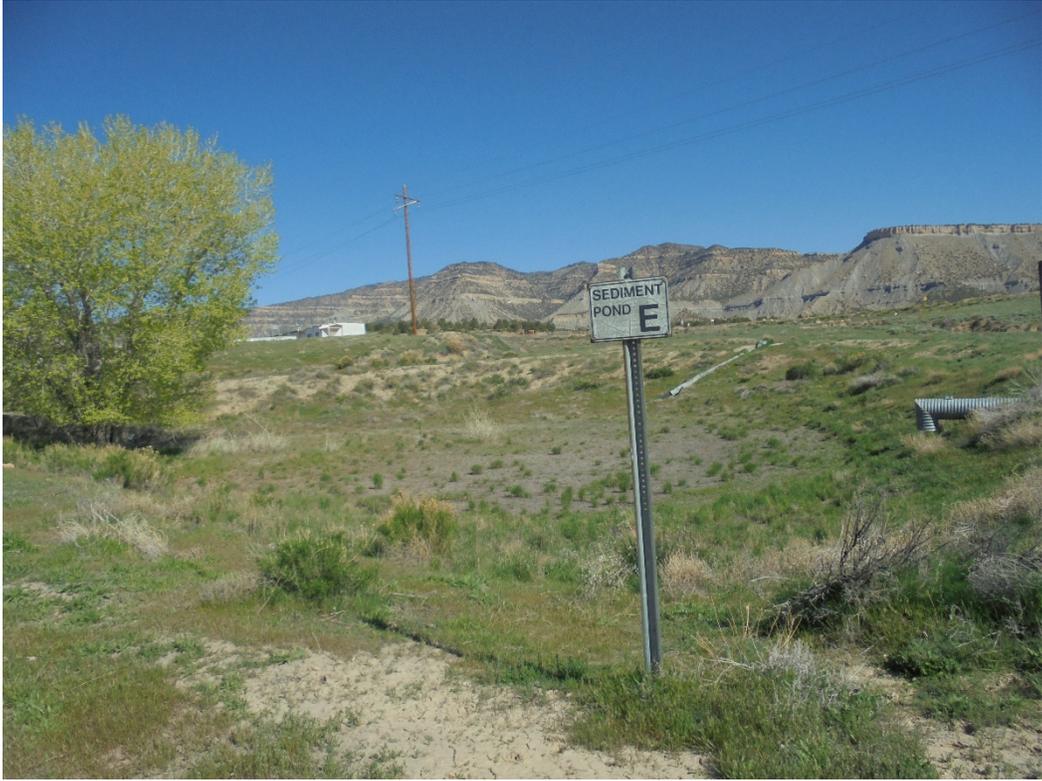
POND E

DRY
24" BELOW CLEANOUT LEVEL

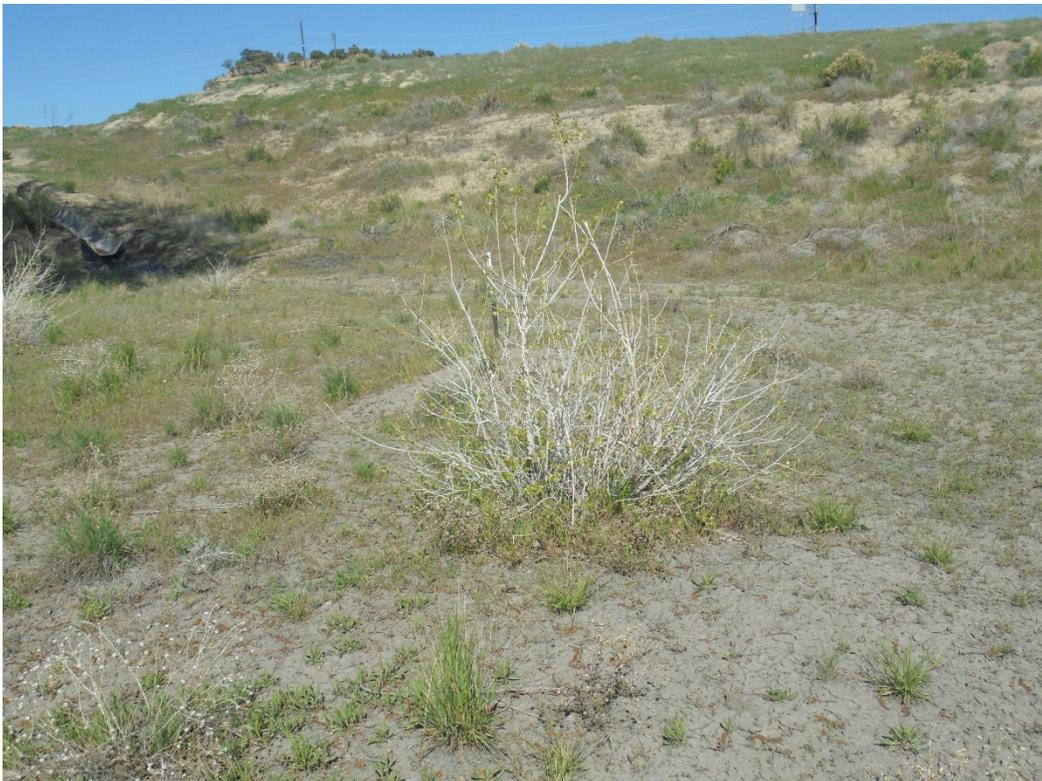
TREES ARE STARTING TO GROW IN SEDIMENT POND. THESE SHOULD BE REMOVED. WEST INLET HALF ROUND CULVERT IS BEING UNDER CUT AND NEEDS REPAIR.

POND E (TREES)

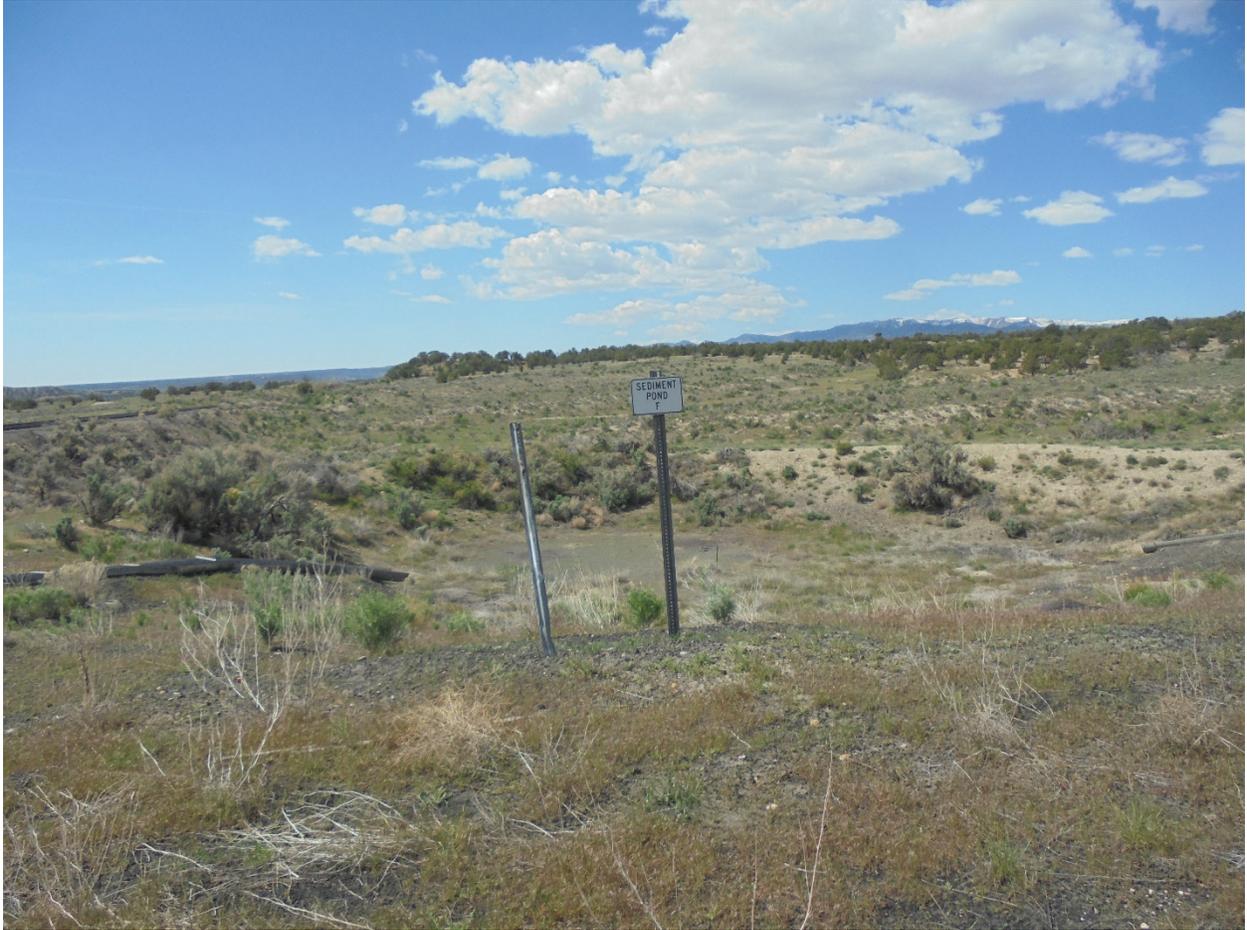
POND F

DRY

13" BELOW CLEANOUT LEVEL

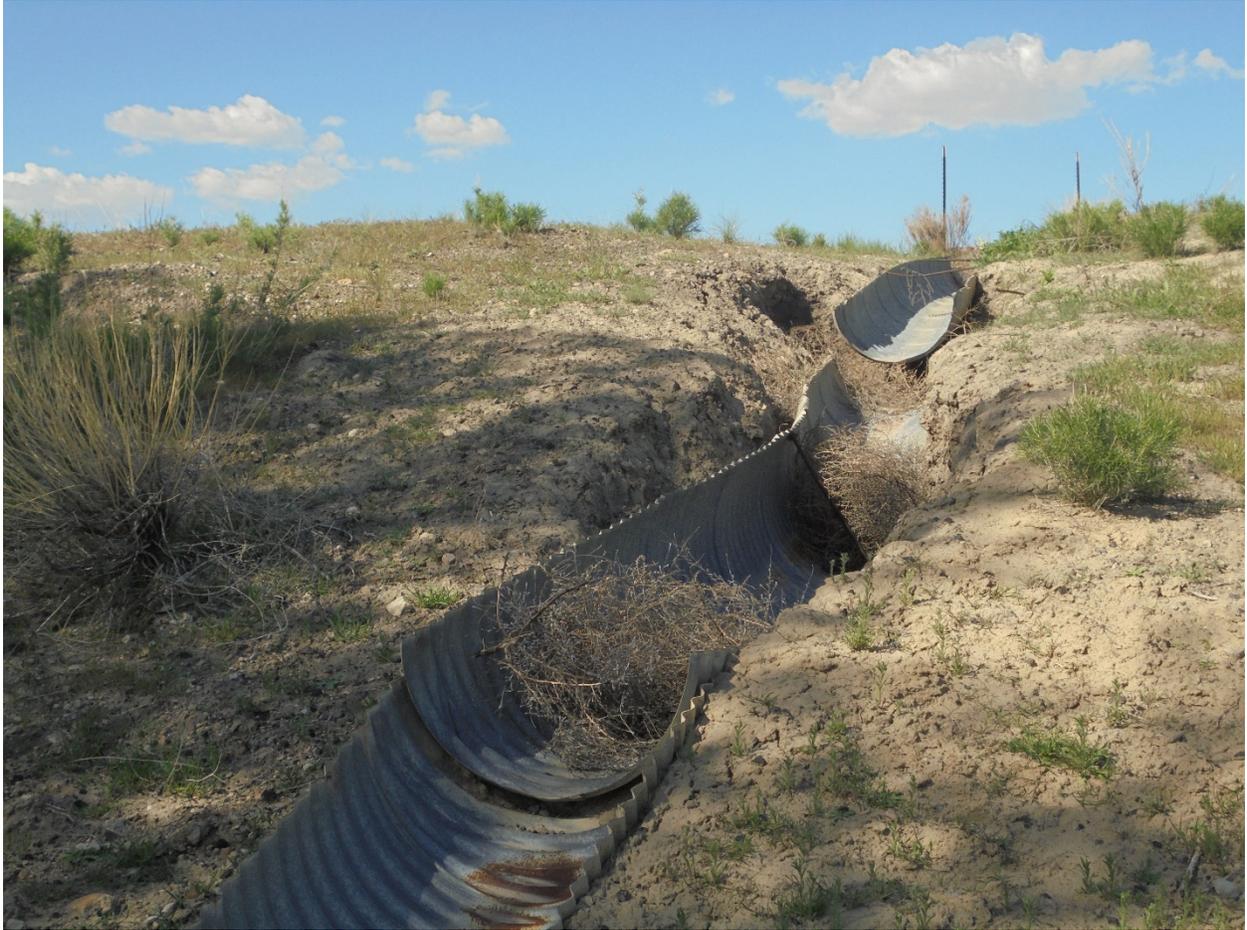
POND E (WEST INLET EROSION)
