Quarterly Inspection Form - Refuse Disposal Areas

Permit Number : C/007/0033 Inspection Date : November 26, 2019
 Mine Name : Wildcat Loadout Quarter / Year : 4th Quarter 2019
 Mine Operator (Permittee) : Coal Energy Group 2, LLC Inspector Name : J. T. Paluso
 MSHA ID # : 1211-UT-09-018664-01 Inspector Signature : Joseph T. Paluso

1. IMPOUNDMENT INSPECTION AND CERTIFIED REPORT			Page 1 of 2
Permit Number:	ACT/007/0033	Report Date: December 17, 2019	
Mine Name:	Wildcat Loadout		
Company Name	Coal Energy Group 2, LLC		
Impoundment Identification:	Impoundment Name	Permanent Impoundment	
	Impoundment Number:	Permanent Impoundment	
	UPDES Permit Number:	UTG040007	
	MSHA ID Number:	42-01864	
IMPOUNDMENT INSPECTION			
Inspection Date:	November 26, 2019		
Inspected By:	J.T. Paluso		
Reason for Inspection:	Annual Inspection		
(Annual, Quarterly or other Periodic Inspection, Critical Installation or Completion of Construction)

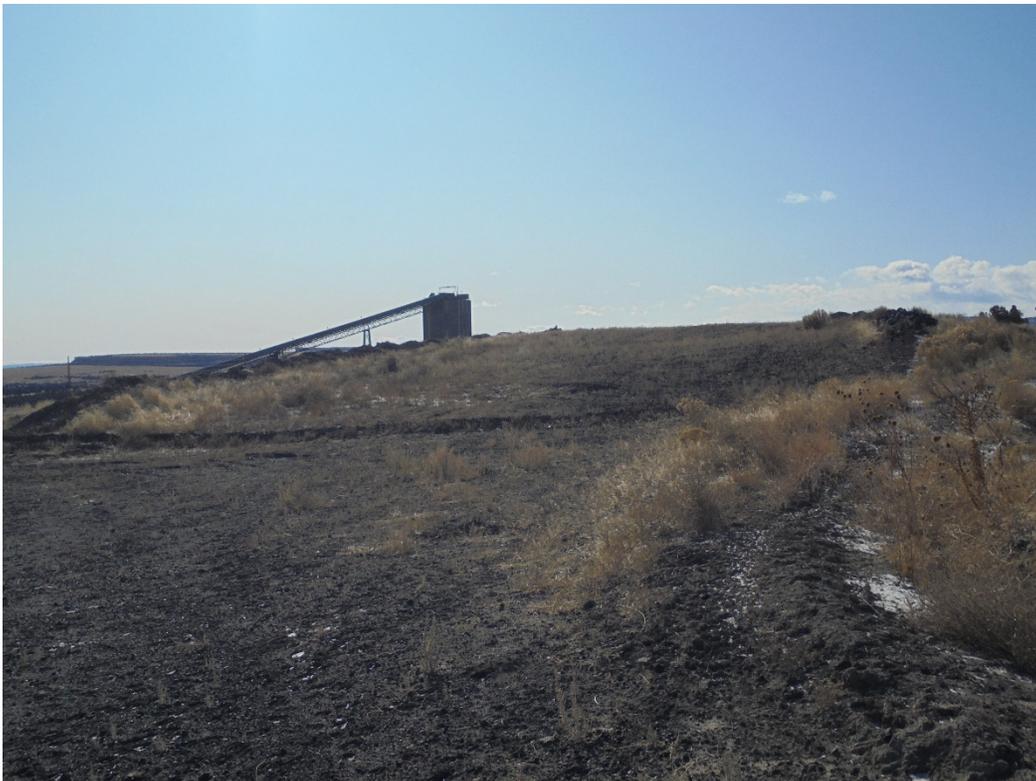
REFUSE PILE NORTH SIDE

1. Describe any changes in the geometry of the structure (as well as instrumentation, if any, used to monitor changes):
There has not been any changes made this quarter. Pile is covered with approximately 1' of snow.

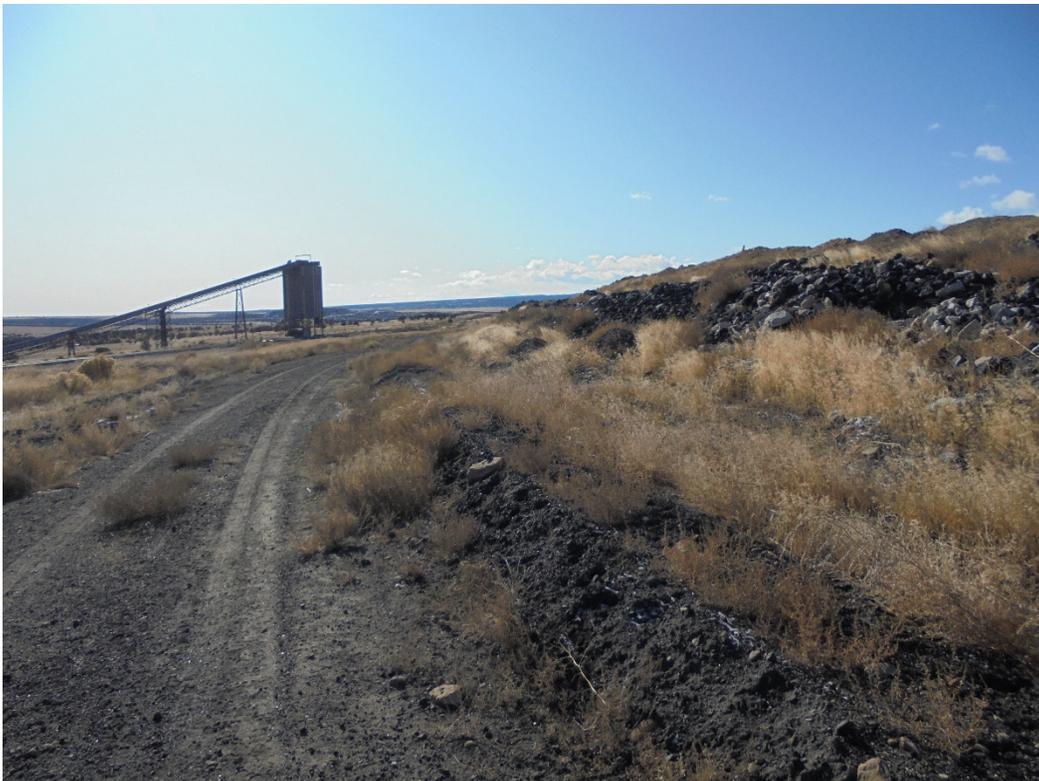
REFUSE PILE EAST DRAINAGE DITCH

8. Describe placement of under drains, protective filter systems, and final surface drainage systems (report any seepage, including location, color, flow) :
None known. East drainage ditch needs cleaning shortly.

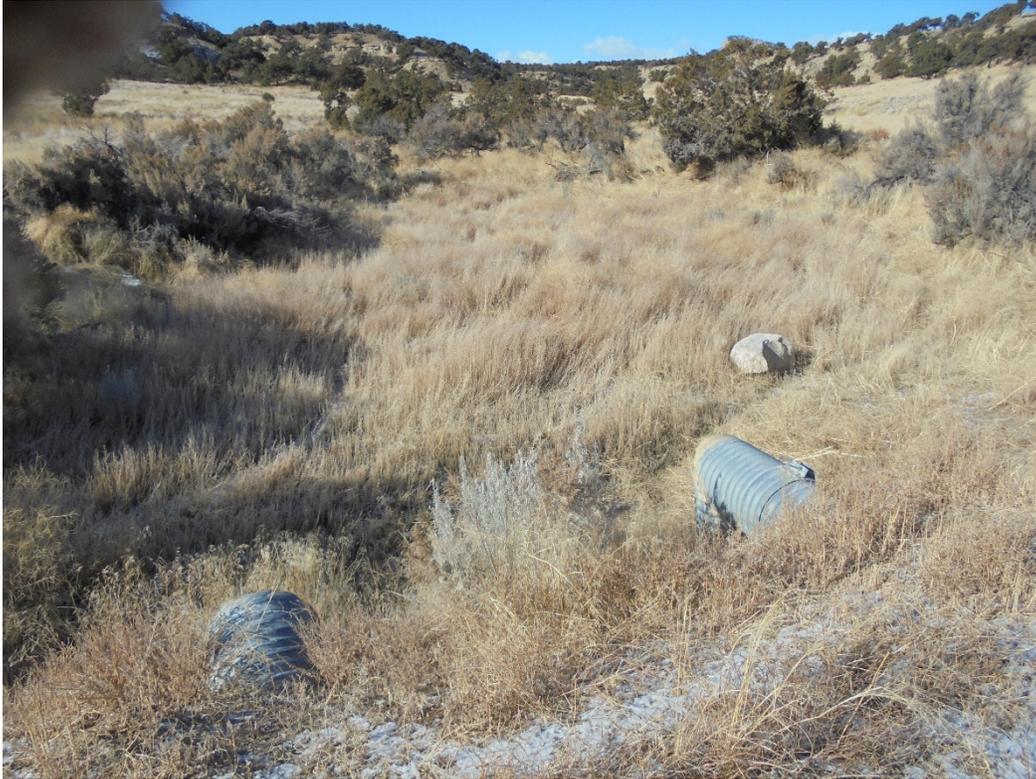
PERMANENT IMPOUNDMENT UPPER CELL

4. Field Information: Provide current water elevation, whether pond is discharging, type and number of samples taken, monitoring/instrumentation information, inlet/outlet conditions or other related activities associated with the pond including but not limited to sediment cleanout, pond decanting, embankment erosion/repairs, monitoring information, vegetation on out slopes of embankment erosion/repairs, monitoring information, vegetation on out slopes of embankments, etc.			
During the annual inspection, November 26, 2019, the vegetative cover looked good with no signs of erosion. There was a lot of weeds in upper cell.

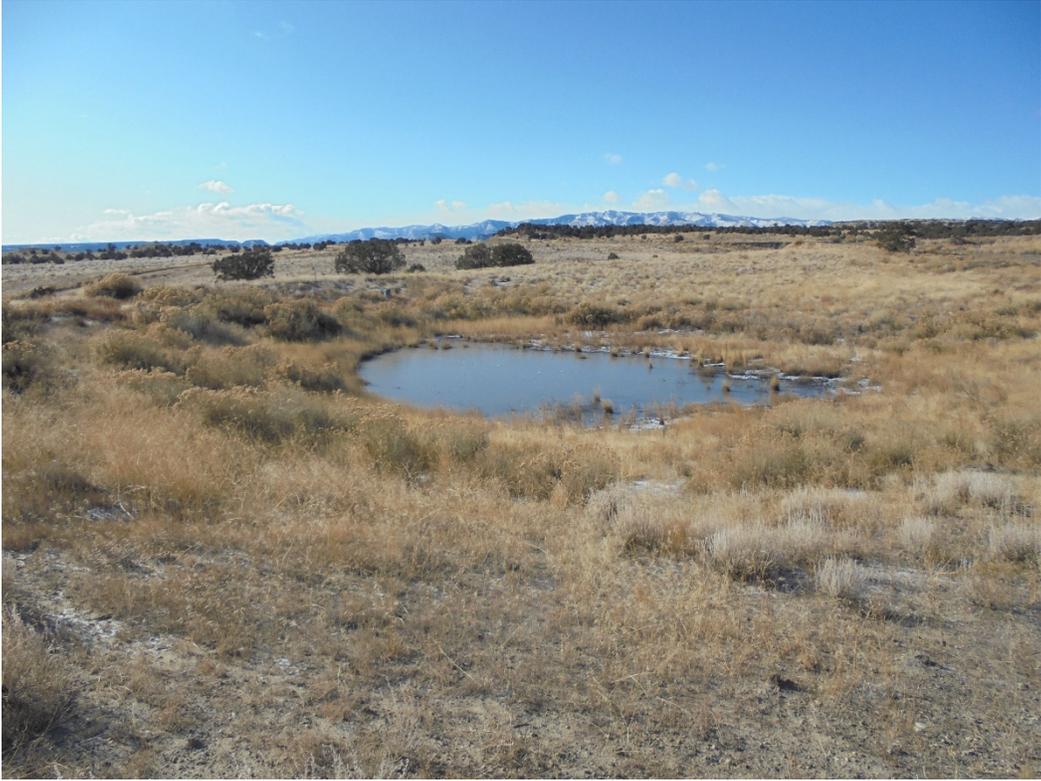
POND A

1. Describe any appearances of any instability, structural weakness, or any other hazardous condition.			
The pond's dam shows no signs of structural instability or other hazardous conditions.			
Required for an impoundment which functions as a SEDIMENTATION POND	2. Sediment storage capacity and storage volumes.		
	Existing Storage Capacity: 2.9 ac-ft		
	Existing Sediment Storage Capacity (To Cleanout): .78 ac-ft

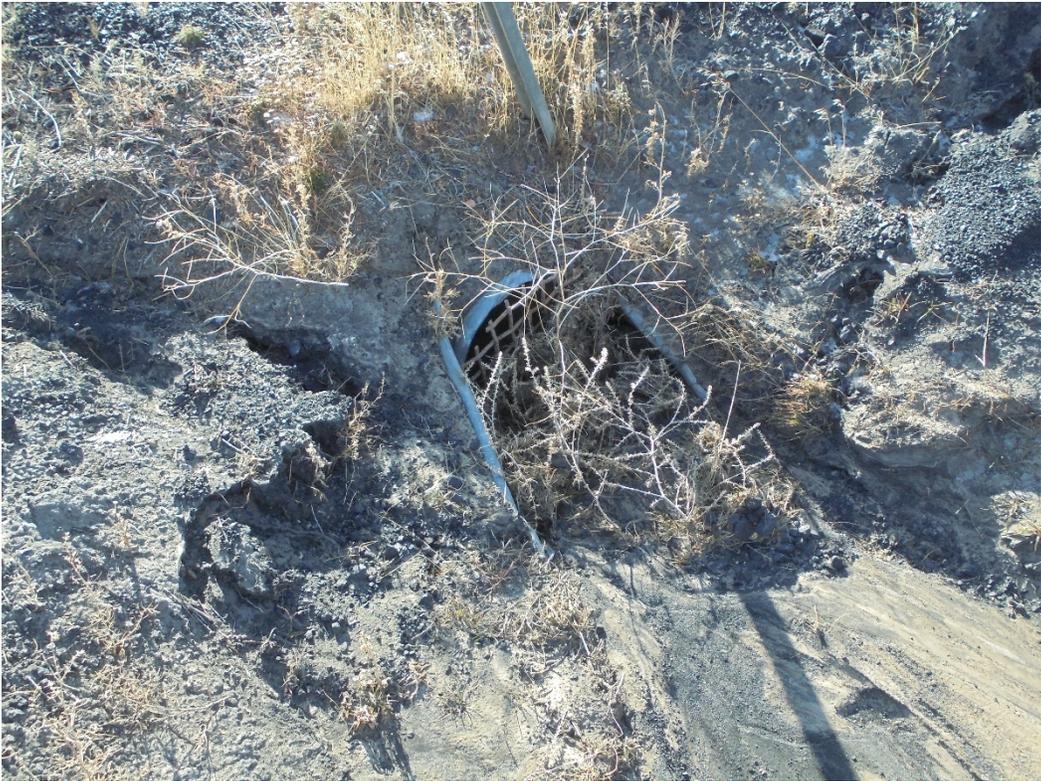
POND A WEST INLET WEEDS

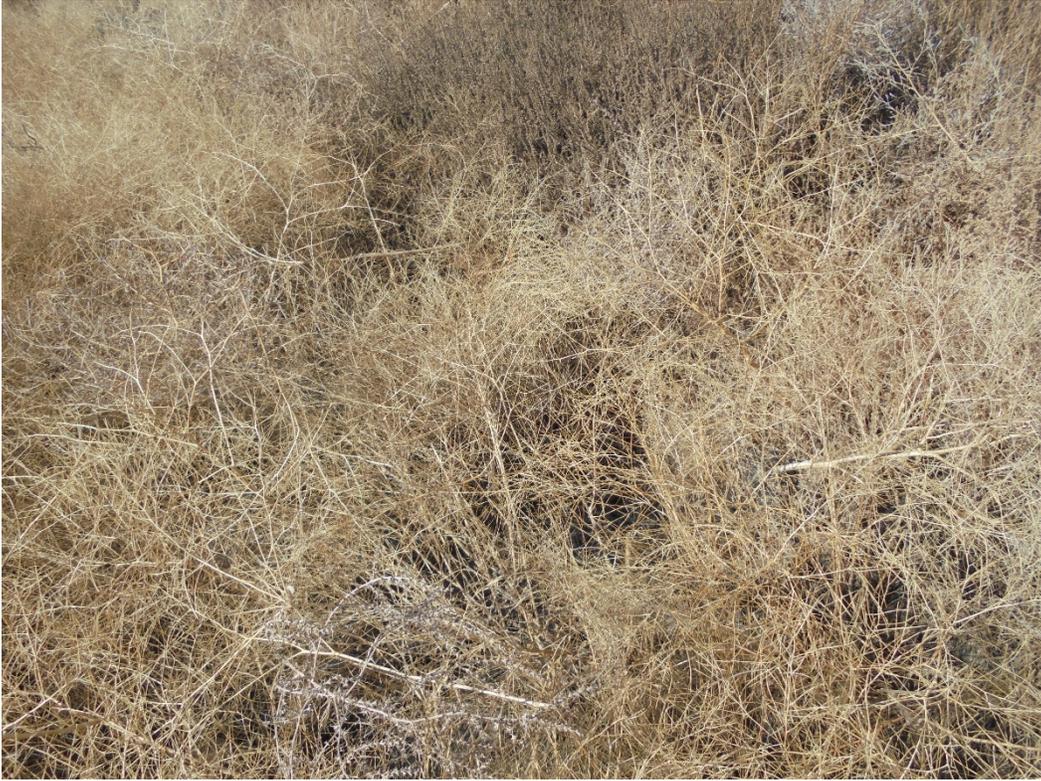
POND A WEST OUTLET WEEDS

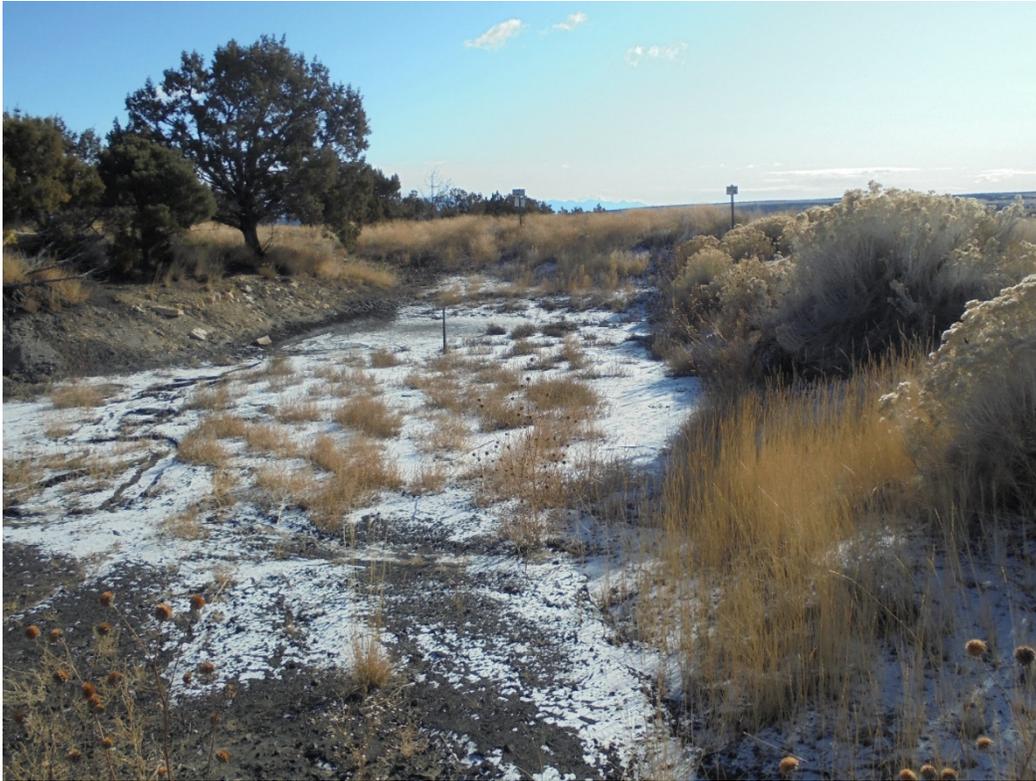
POND B

1. Describe any appearances of any instability, structural weakness, or any other hazardous condition.			
The pond's dam shows no signs of structural instability or other hazardous conditions.			
Required for an impoundment which functions as a SEDIMENTATION POND	2. Sediment storage capacity and storage volumes.		
	Existing Storage Capacity: 0.41 ac-ft		
	Existing Sediment Storage Capacity (To Cleanout): 0.12 ac-ft

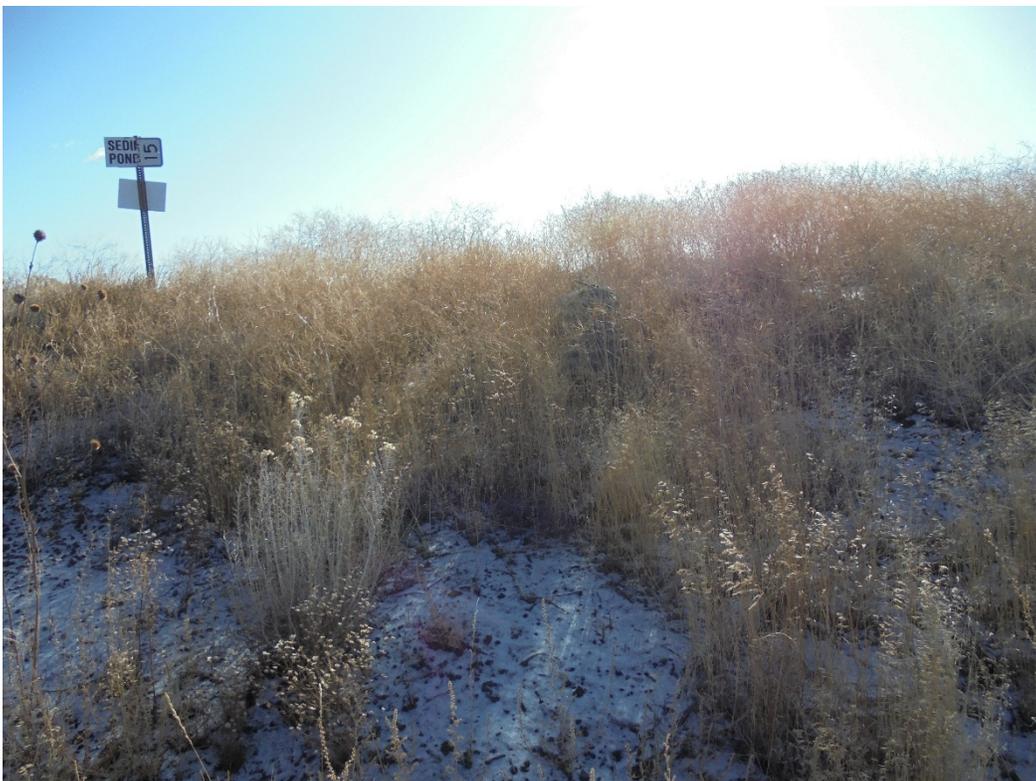
3. Principle and emergency spillway elevations		
	Principle spillway elevation: 6,138.0'		
	Emergency spillway elevation: 6,139.0'		
4. Field Information: Provide current water elevation, whether pond is discharging, type and number of samples taken, monitoring/instrumentation information, inlet/outlet conditions or other related activities associated with the pond including but not limited to sediment cleanout, pond decanting, embankment erosion/repairs, monitoring information, vegetation on out slopes of embankment erosion/repairs, monitoring information, vegetation on out slopes of embankments, etc.			
During the annual inspection, November 26, 2019, there were no signs of erosion. Weeds in the emergency and by principle spillway need to be cleaned out.

POND B WEEDS AT PRINCIPLE SPILLWAY

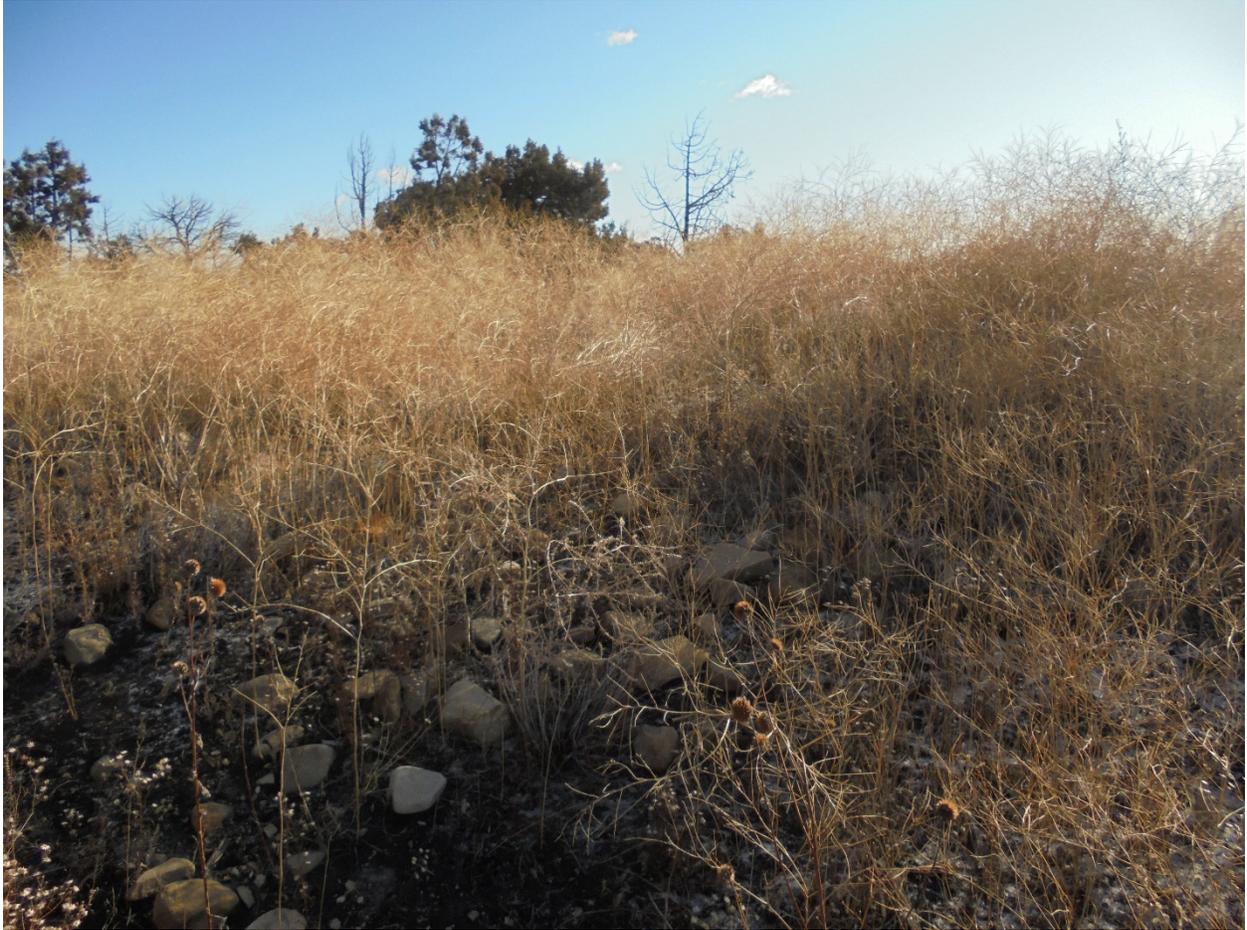
POND B WEEDS AT EMERGENCY SPILLWAY

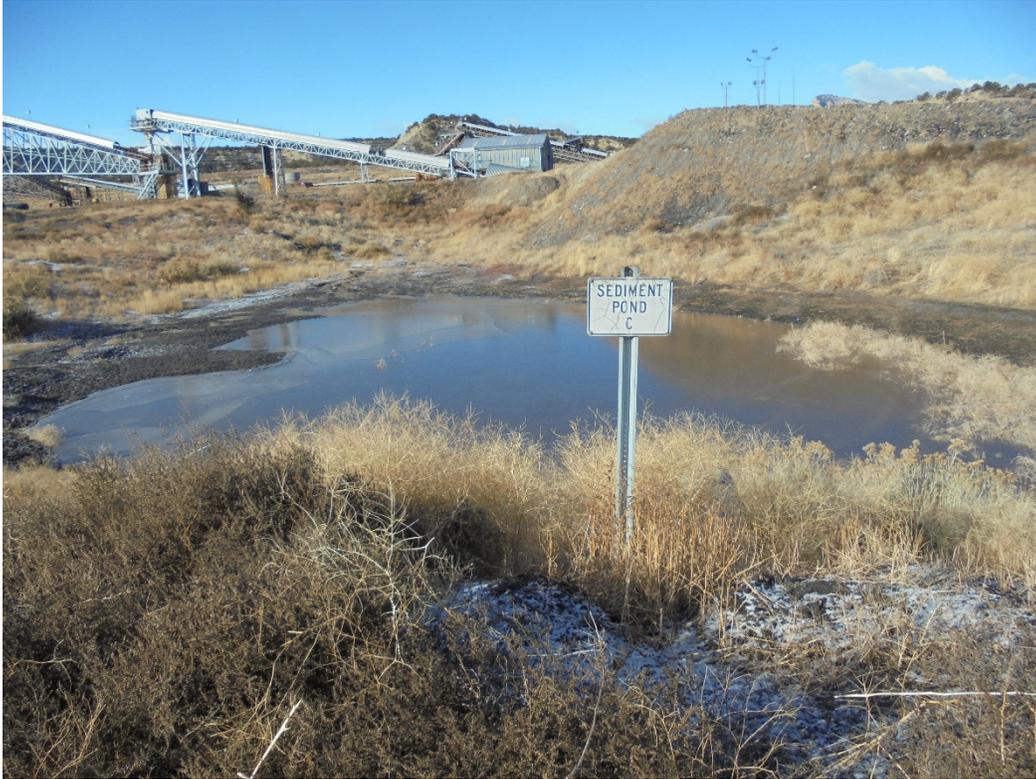
POND C

1. Describe any appearances of any instability, structural weakness, or any other hazardous condition.			
The pond's dam shows no signs of structural instability or other hazardous conditions.			
Required for an impoundment which functions as a SEDIMENTATION POND	2. Sediment storage capacity and storage volumes.		
	Existing Storage Capacity: 4.174 ac-ft		
	Existing Sediment Storage Capacity (To Cleanout): 1.08 ac-ft (From 2018)

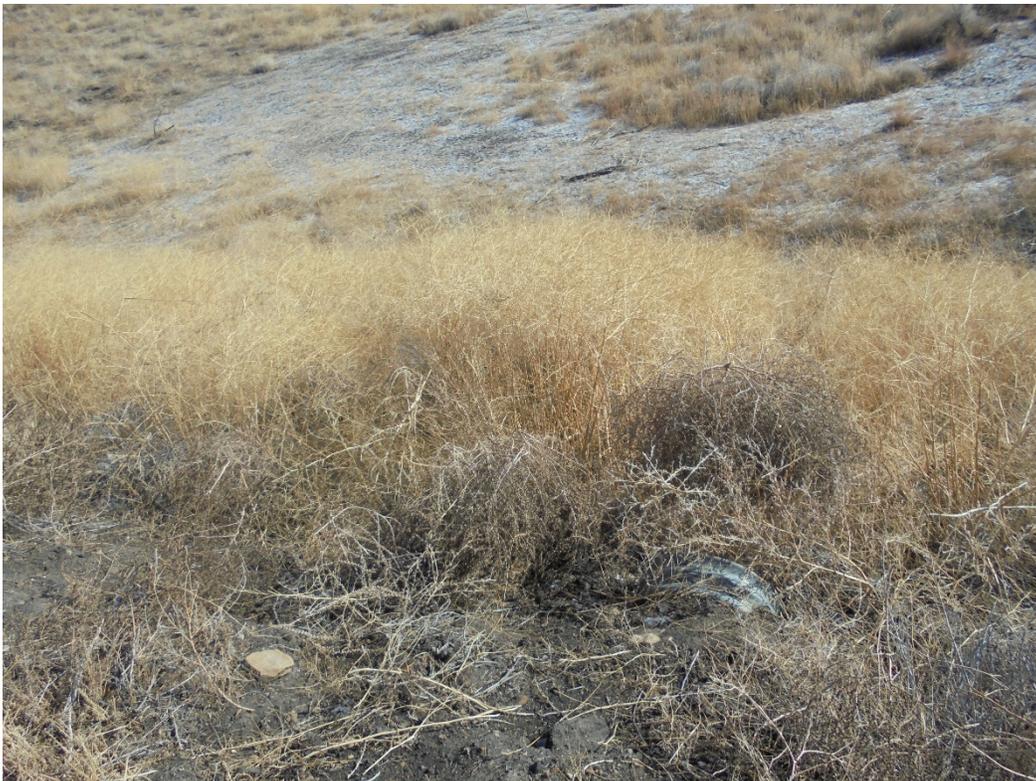
3. Principle and emergency spillway elevations		
	Principle spillway elevation: 6,137.0'		
	Emergency spillway elevation: 6,138.0'		
4. Field Information: Provide current water elevation, whether pond is discharging, type and number of samples taken, monitoring/instrumentation information, inlet/outlet conditions or other related activities associated with the pond including but not limited to sediment cleanout, pond decanting, embankment erosion/repairs, monitoring information, vegetation on outslopes of embankment erosion/repairs, monitoring information, vegetation on outslopes of embankments, etc.			
During the annual inspection, November 26, 2019, the vegetative looked good. Animal hole under inlet of principle spillway needs to be filled. Emergency and principle spillway outlets need to have weeds removed.

POND C WEEDS AT PRINCIPLE SPILLWAY OUTLET

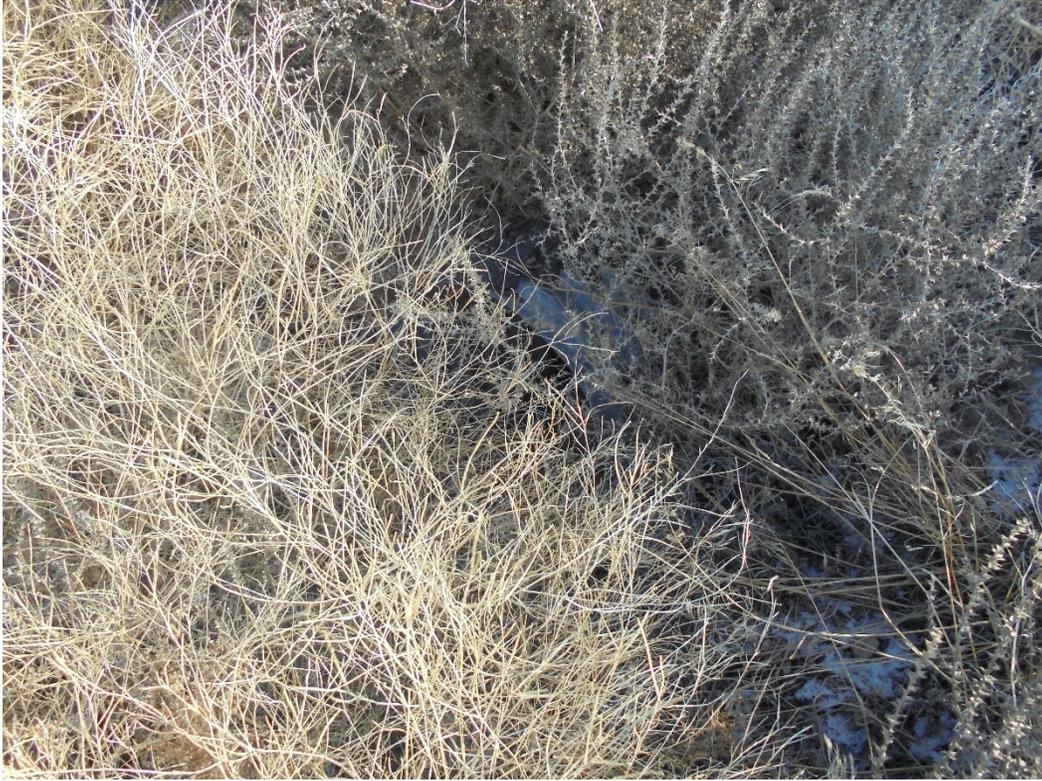
POND C WEEDS AT EMERGENCY SPILLWAY OUTLET

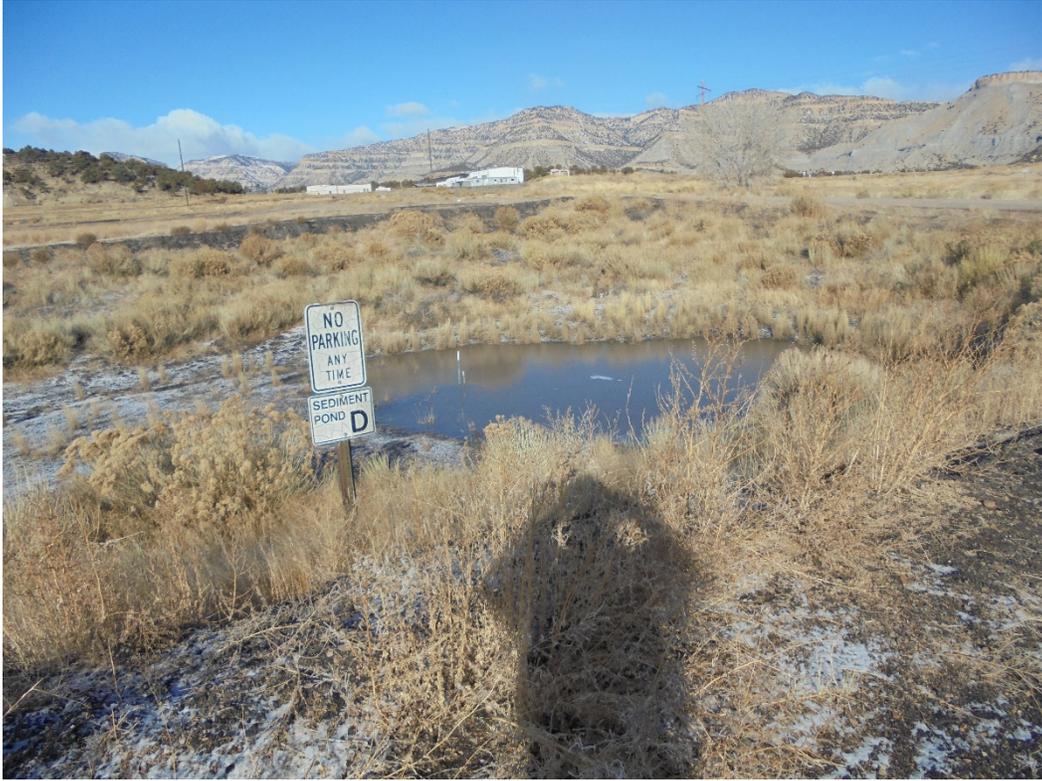
POND D

1. Describe any appearances of any instability, structural weakness, or any other hazardous condition.			
The pond's dam shows no signs of structural instability or other hazardous conditions.			
Required for an impoundment which functions as a SEDIMENTATION POND	2. Sediment storage capacity and storage volumes.		
	Existing Storage Capacity: 1.131 ac-ft		
	Existing Sediment Storage Capacity (To Cleanout): 0.34 ac-ft (From 2018)

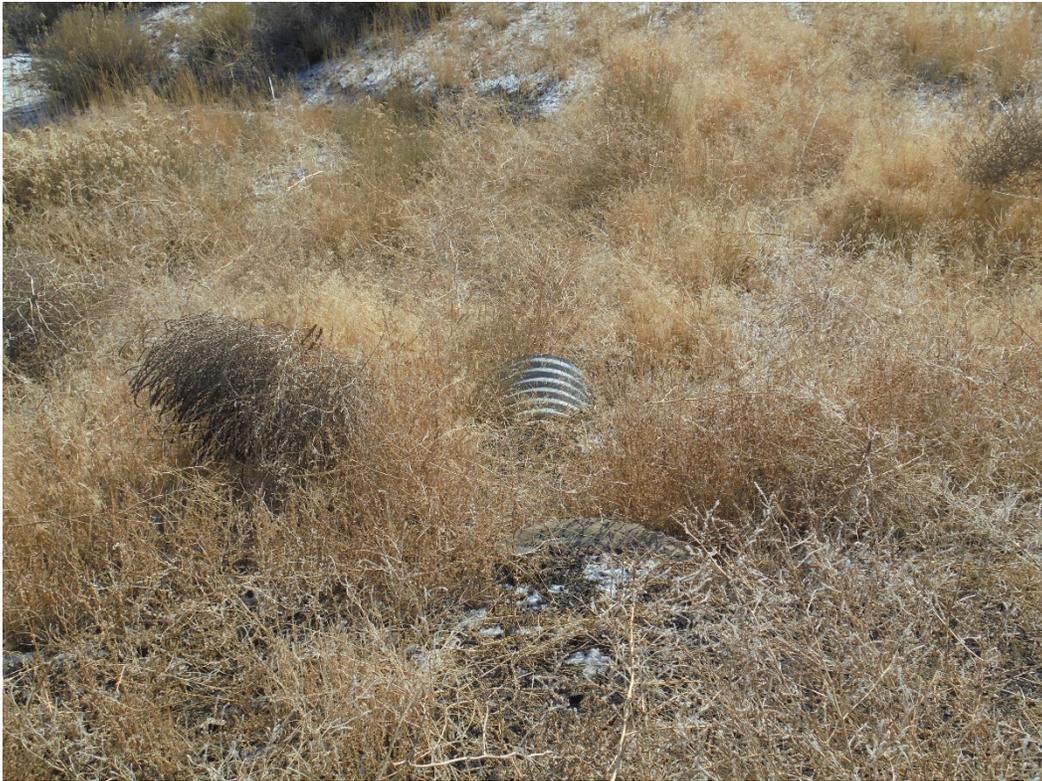
3. Principle and emergency spillway elevations		
	Principle spillway elevation: 6,139.0'		
	Emergency spillway elevation: 6,140.0'		
4. Field Information: Provide current water elevation, whether pond is discharging, type and number of samples taken, monitoring/instrumentation information, inlet/outlet conditions or other related activities associated with the pond including but not limited to sediment cleanout, pond decanting, embankment erosion/repairs, monitoring information, vegetation on outslopes of embankment erosion/repairs, monitoring information, vegetation on outslopes of embankments, etc.			
During the annual inspection, November 26, 2019, the vegetation looked good with no signs of erosion. The emergency and principle spillway outlets need to have weeds removed. Also, the south inlet needs weeds removed. See the attached photographs.

POND D WEEDS AT PRINCIPLE SPILLWAY OUTLET

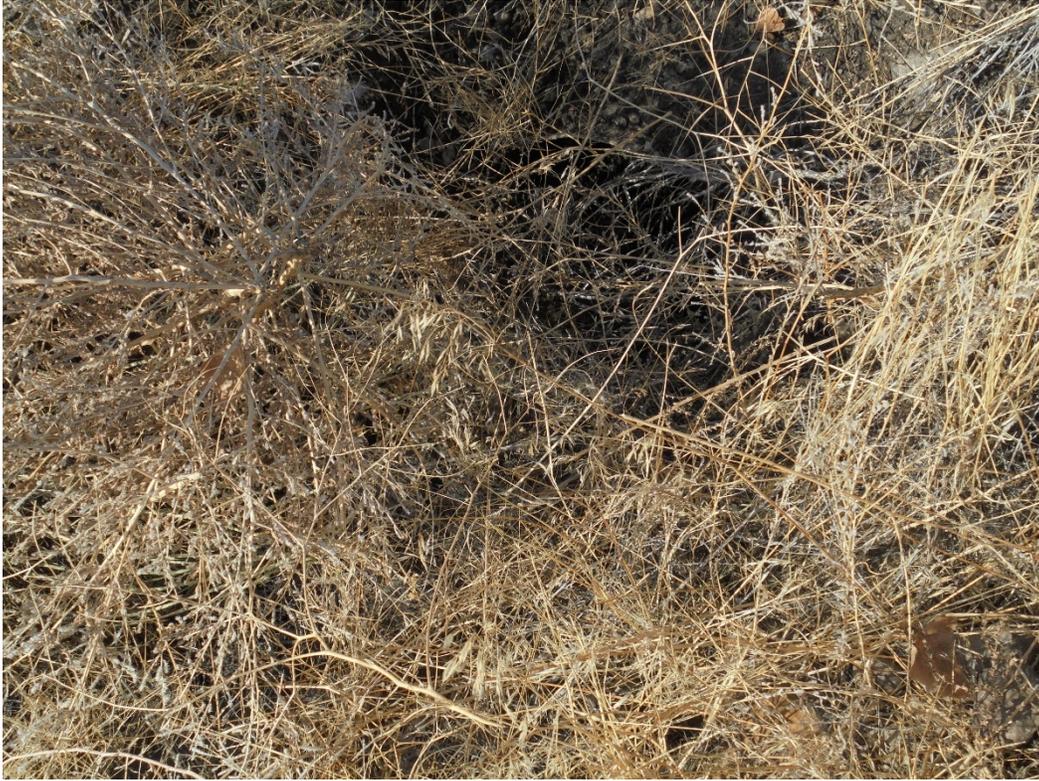
POND D WEEDS AT EMERGENCY SPILLWAY OUTLET

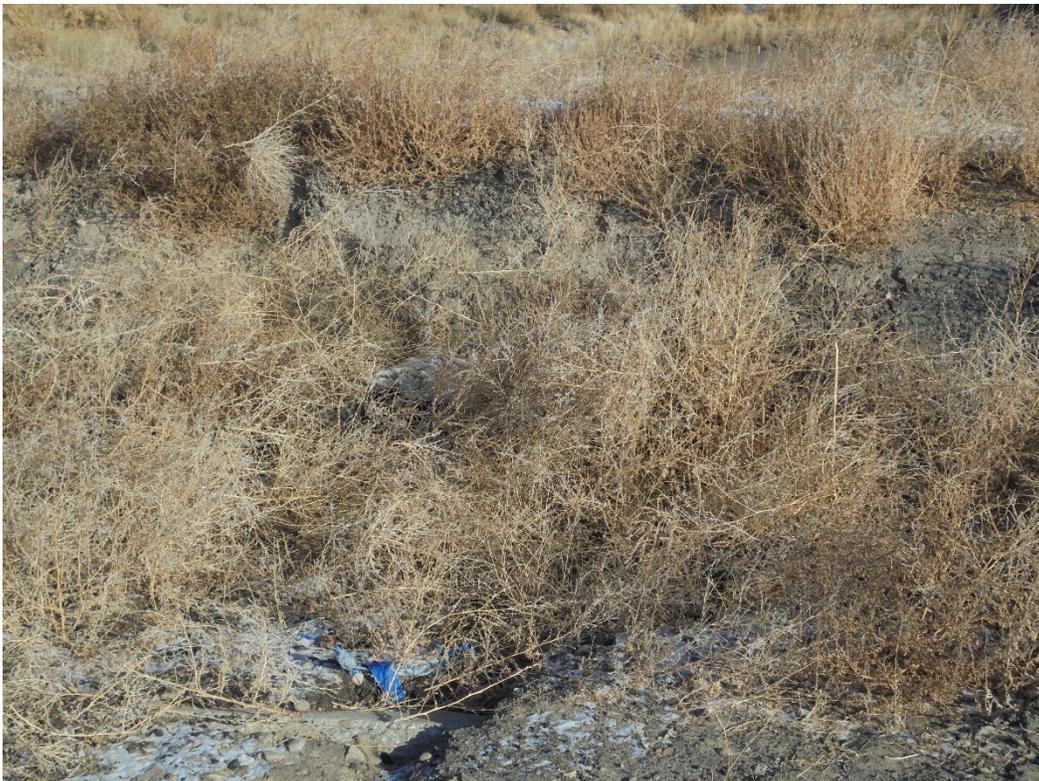
POND D WEEDS AT SOUTH INLET

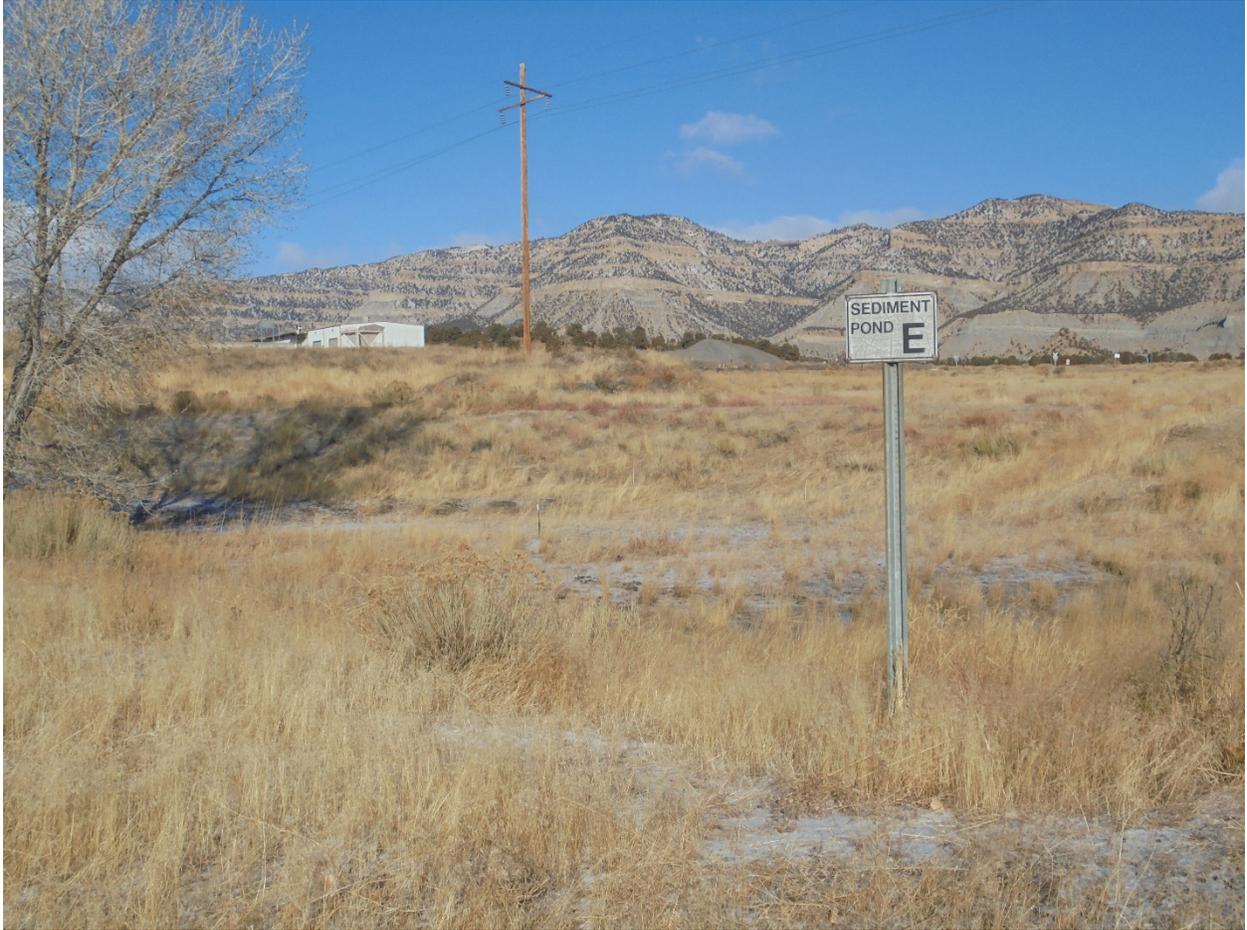
POND E

3. Principle and emergency spillway elevations		
	Principle spillway elevation: 6,145.0'		
	Emergency spillway elevation: 6,146.0'		
4. Field Information: Provide current water elevation, whether pond is discharging, type and number of samples taken, monitoring/instrumentation information, inlet/outlet conditions or other related activities associated with the pond including but not limited to sediment cleanout, pond decanting, embankment erosion/repairs, monitoring information, vegetation on out slopes of embankment erosion/repairs, monitoring information, vegetation on out slopes of embankments, etc.			
During the annual inspection, November 26, 2019, the vegetative cover looked good with no signs of erosion.

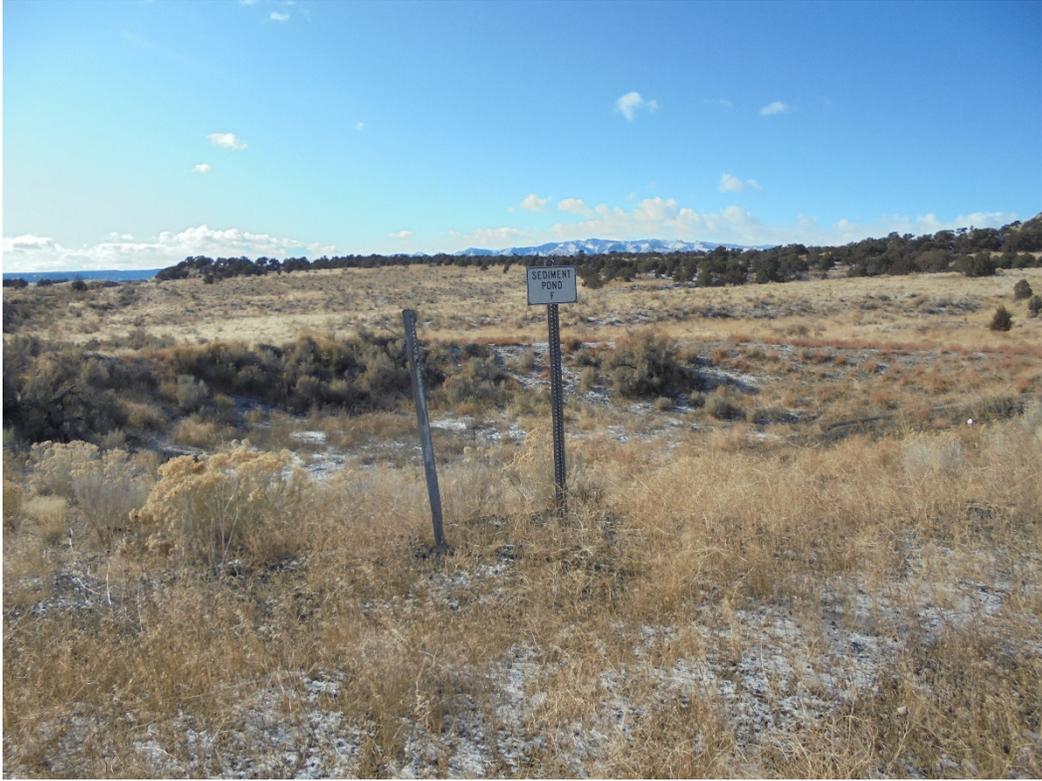
POND F

1. Describe any appearances of any instability, structural weakness, or any other hazardous condition.			
The pond's dam shows no signs of structural instability or other hazardous conditions.			
Required for an impoundment which functions as a SEDIMENTATION POND	2. Sediment storage capacity and storage volumes.		
	Existing Storage Capacity: 0.869 ac-ft		
	Existing Sediment Storage Capacity (To Cleanout): 0.10 ac-ft

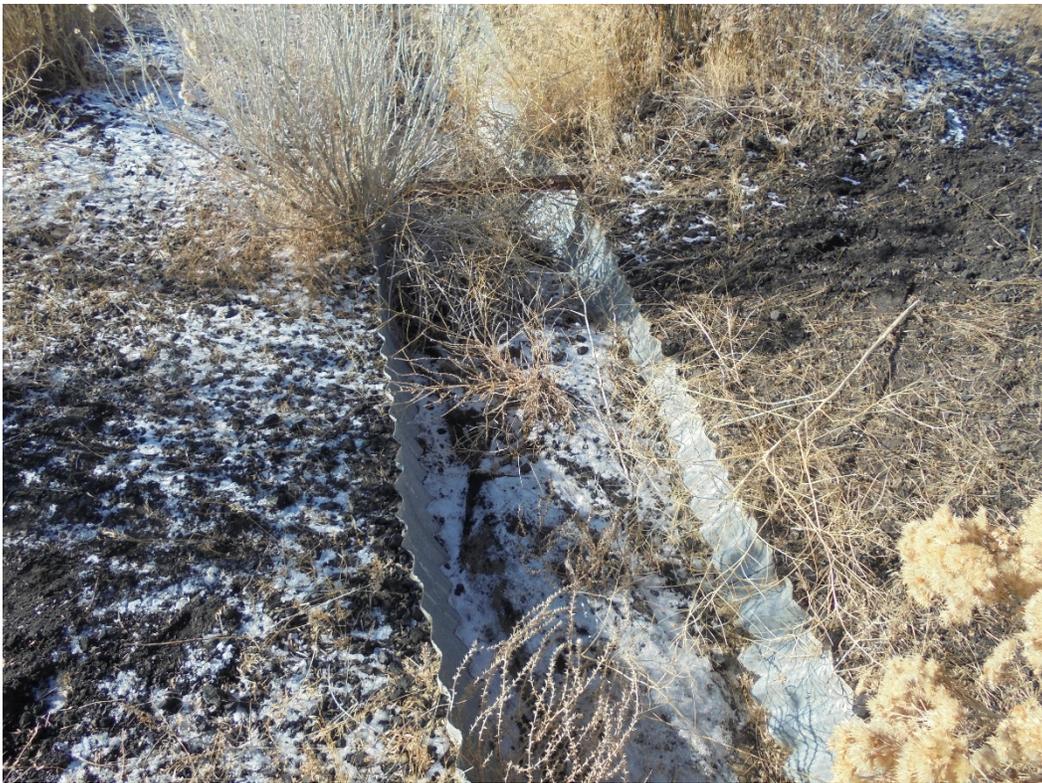
3. Principle and emergency spillway elevations		
	Principle spillway elevation: 6,173.0'		
	Emergency spillway elevation: 6,174.0'		
4. Field Information: Provide current water elevation, whether pond is discharging, type and number of samples taken, monitoring/instrumentation information, inlet/outlet conditions or other related activities associated with the pond including but not limited to sediment cleanout, pond decanting, embankment erosion/repairs, monitoring information, vegetation on out slopes of embankment erosion/repairs, monitoring information, vegetation on out slopes of embankments, etc.			
During the annual inspection, November 26, 2019, the vegetative cover looked good with no signs of erosion. There was sediment in the east inlet that needs to be removed. See attached photographs.

POND F EAST INLET FILLING WITH SEDIMENT
