Coal Energy Group 2

Re: **2019 Annual Report, Permit No. C/007/0033**

On behalf of Coal Energy Group 2, LLC, Attached to this letter is the 2019 annual report for the Wildcat Loadout, Permit No. C/007/0033.

2019 ANNUAL REPORT

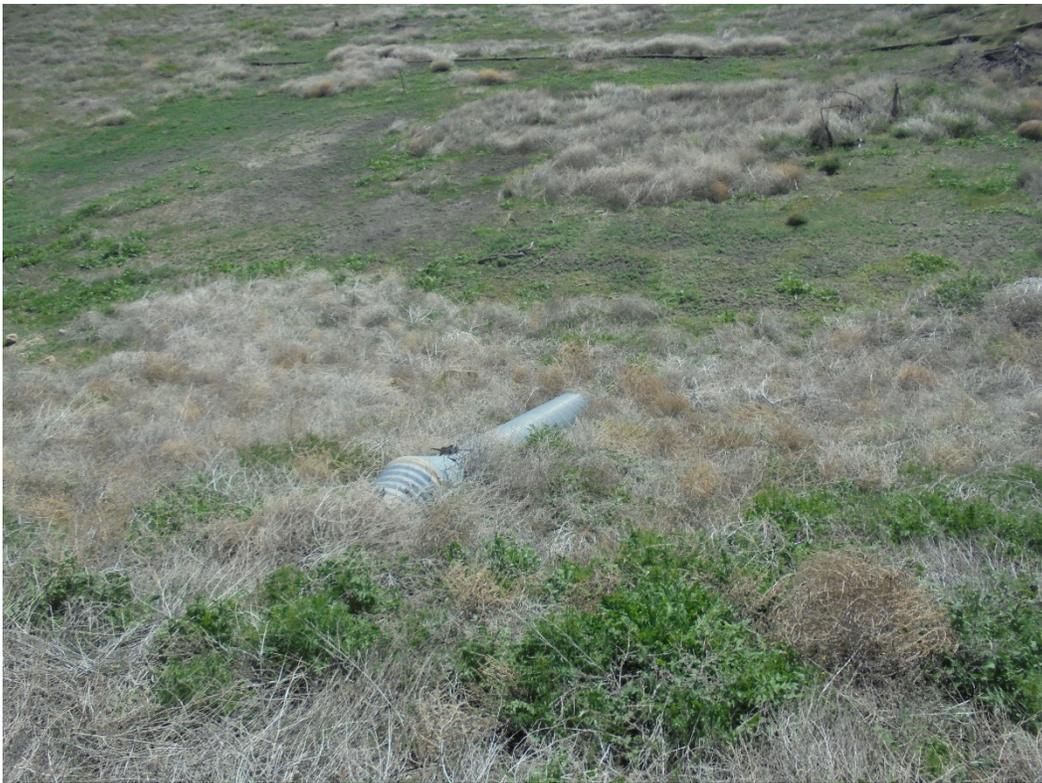
LOT OF WEEDS AT DISCHARGE PIPES.

POND C (WEEDS AT PRINCIPAL SPILLWAY OUTLET)

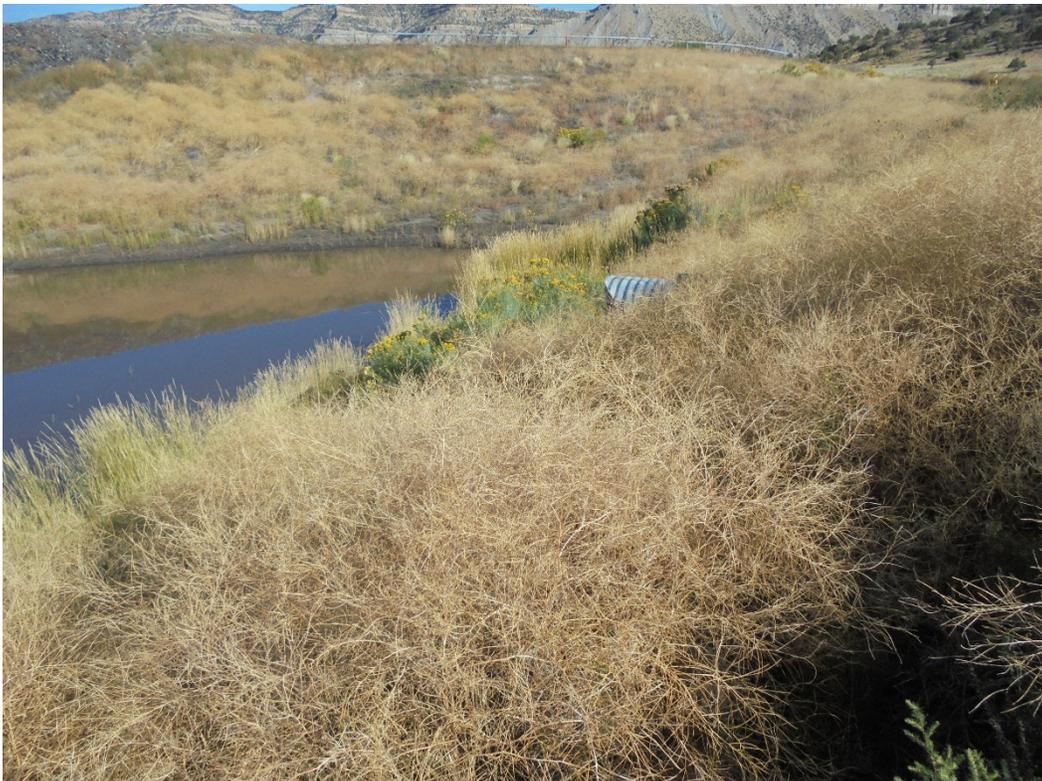
POND C INLET WEEDS

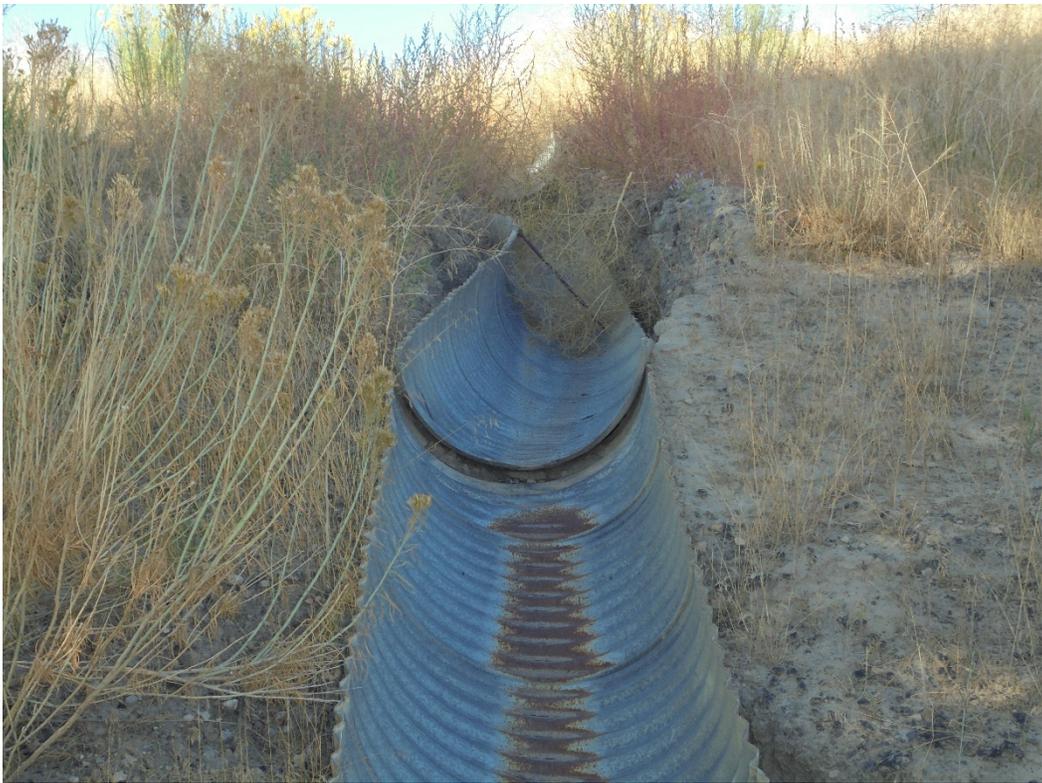
POND E WEST INLET UNDERCUTTING

TREES ARE STARTING TO GROW IN SEDIMENT POND.
THESE SHOULD BE REMOVED. WEST INLET HALF ROUND
CULVERT IS BEING UNDERCUT AN NEEDS TO BE
REPAIRED.

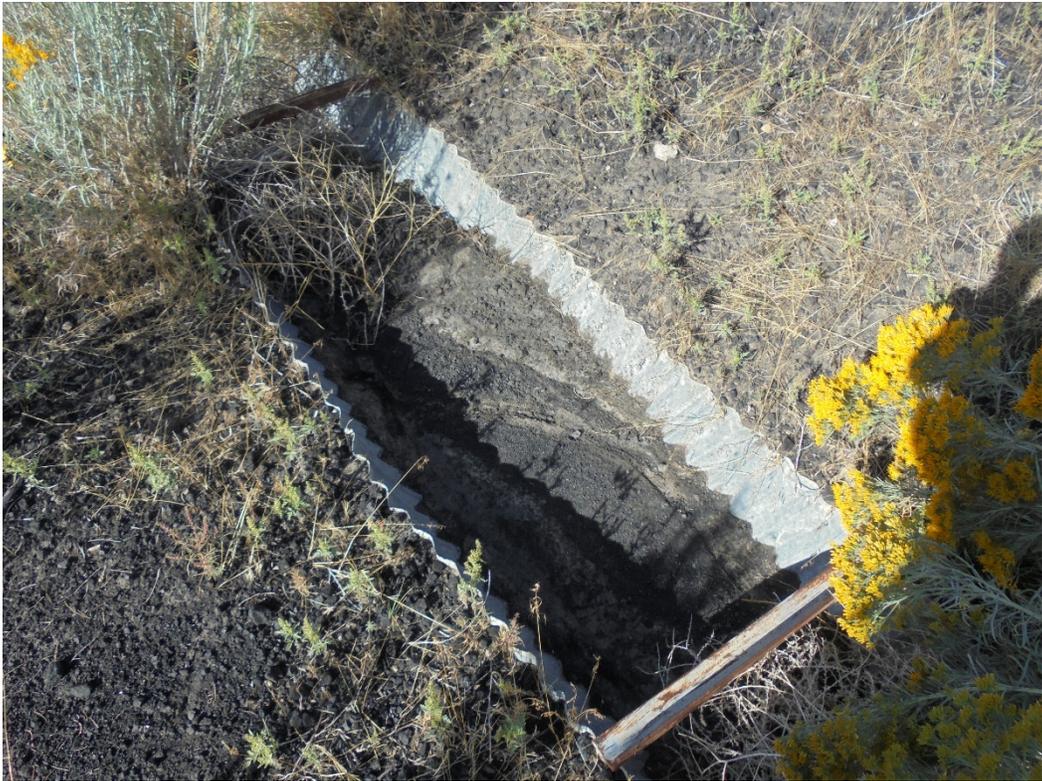
POND F EAST INLET SEDIMENT

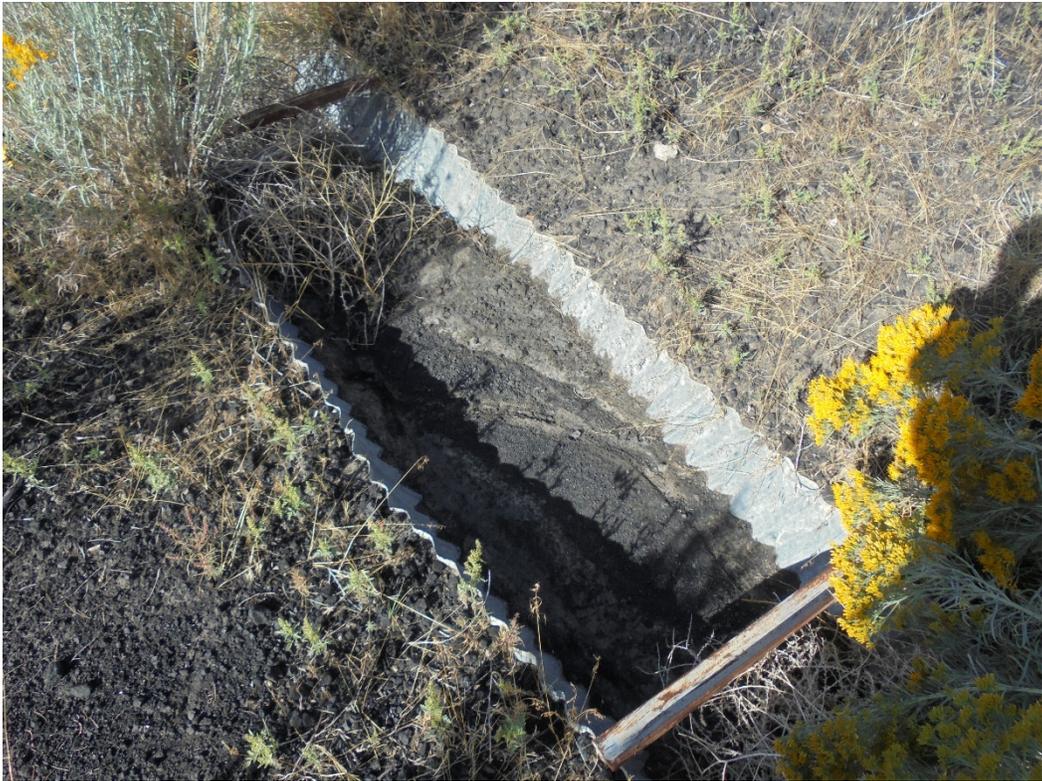
POND F EAST INLET SEDIMENT

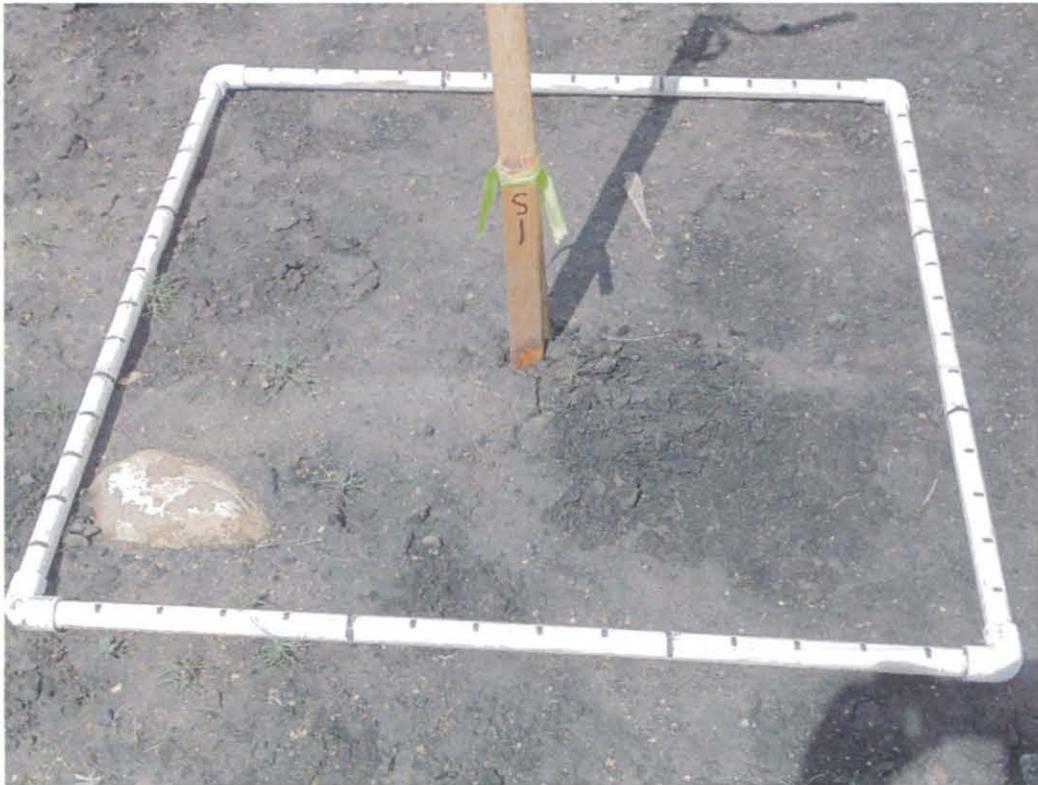
The coal fines and vegetation measurements were taken on June 12, 2019. The results of the measurements indicated that the average coal fines cover on the Northern Area has remained stable at 0.14 inches. The Southern Area has also remained stable at 0.19 inches. Only one train has been loaded since January 1, 2015, at the Wildcat Loadout. This lack of train loading and the wind and precipitation events have caused the average coal ground cover to change. The coal fines coverage in the Northern Area has decrease compared to the second quarter of 2018. The Northern Area went from 4.07% to 0.46%. The Southern Area increased from 0.81% to 8.07%. This increase was due the author classifying S1 as coal rather than soil.
