### Quarterly Inspection Form - Refuse Disposal Areas

Permit Number : C/007/0033 Inspection Date : February 14, 2020  
Mine Name : Wildcat Loadout Quarter / Year : 1st Quarter 2020  
Mine Operator (Permittee) : Coal Energy Group 2, LLC Inspector Name : J. T. Paluso  
MSHA ID # : 1211-UT-09-018664-01 Inspector Signature : Joseph T. Paluso  
Facility Name / Location / Address : Wildcat Loadout/5495 West 3550 North, Helper, Utah 84526

**Sedimentation Pond Inspection**

Company/Mine Name: Wildcat Loadout-Coal Energy Group, LLC Permit No: C/007/0033

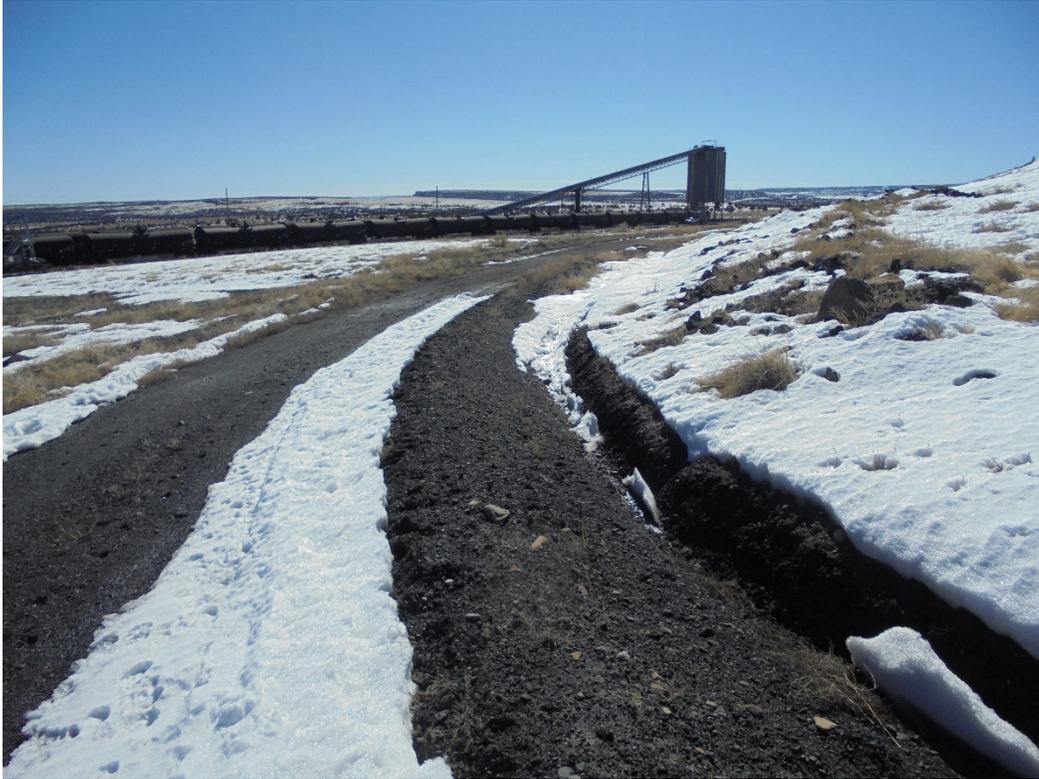
EAST DRAINAGE LOOKING SOUTH

None known. East drainage ditch needs cleaning shortly.

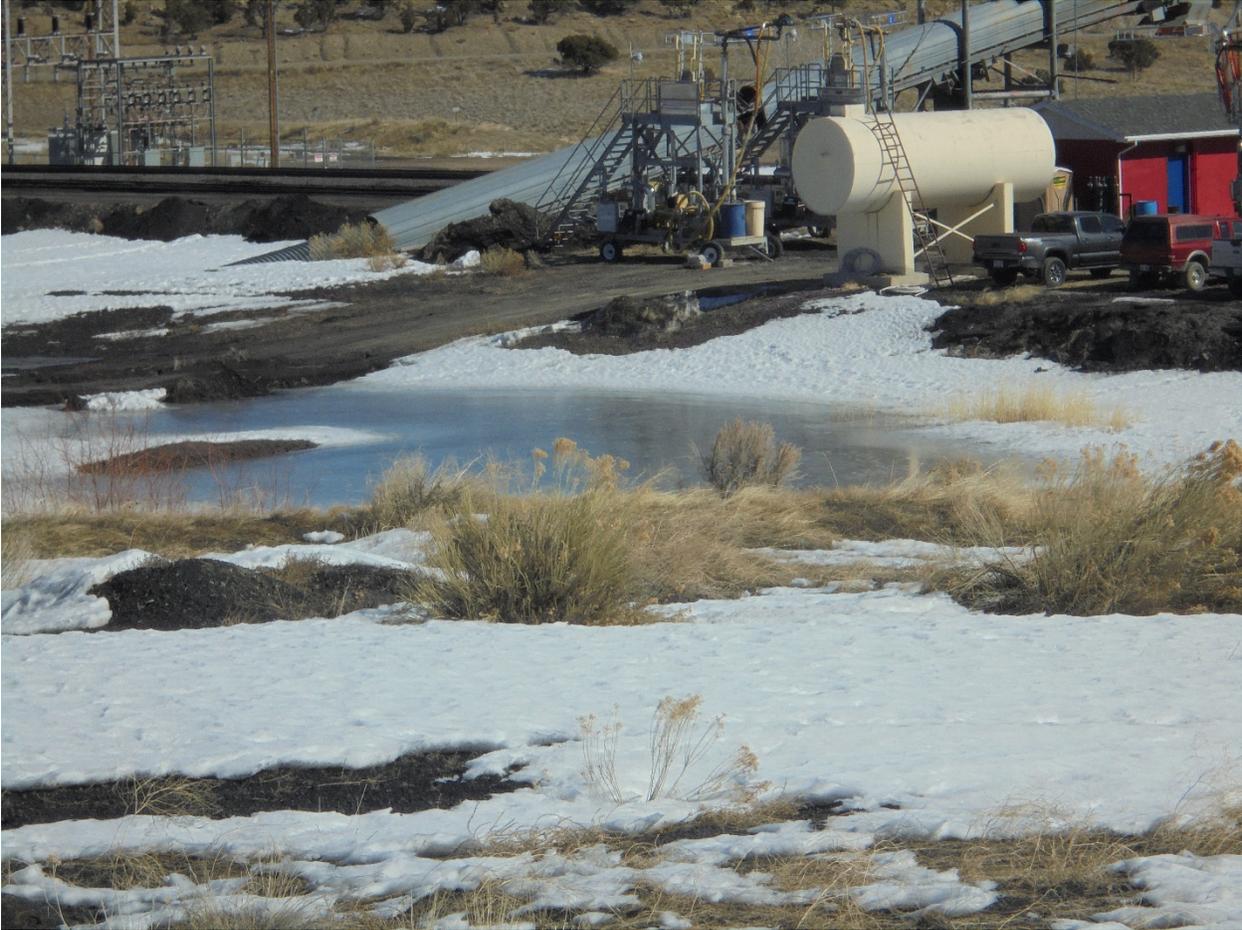
DEPRESSED AREA IMPOUNDMENT

Water ~ 6" ICE  
Sediment NA

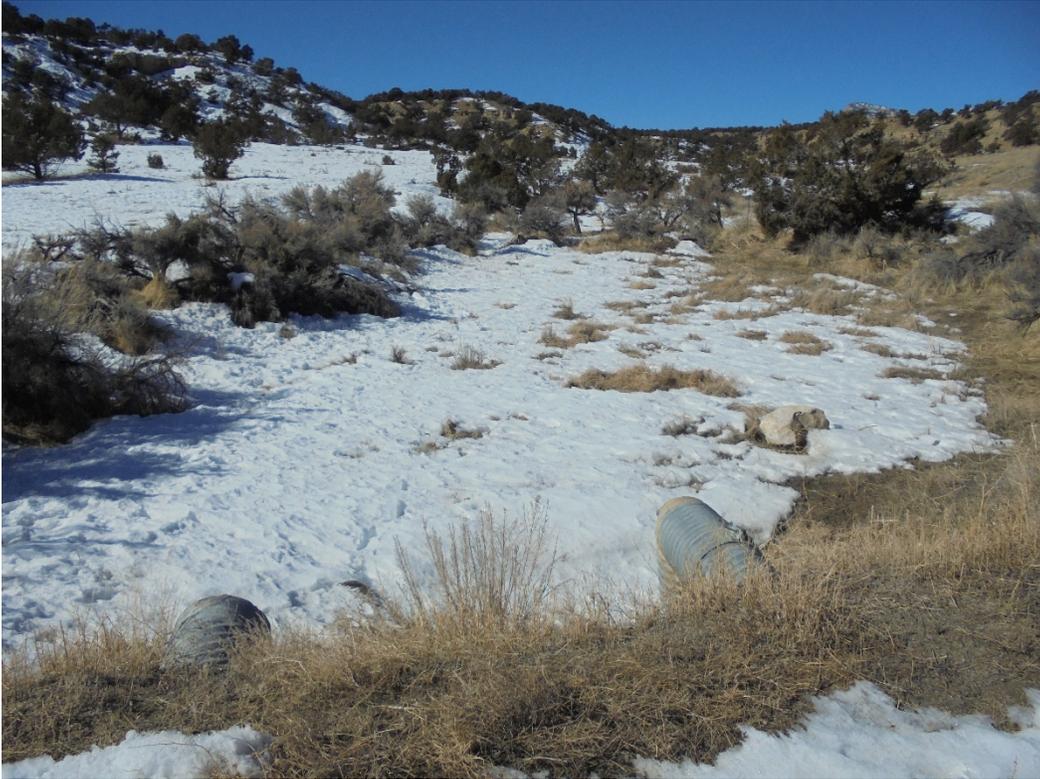
PERMANENT IMPOUNDMENT UPPER CELL

BOTH CELLS ARE DRY  
NA

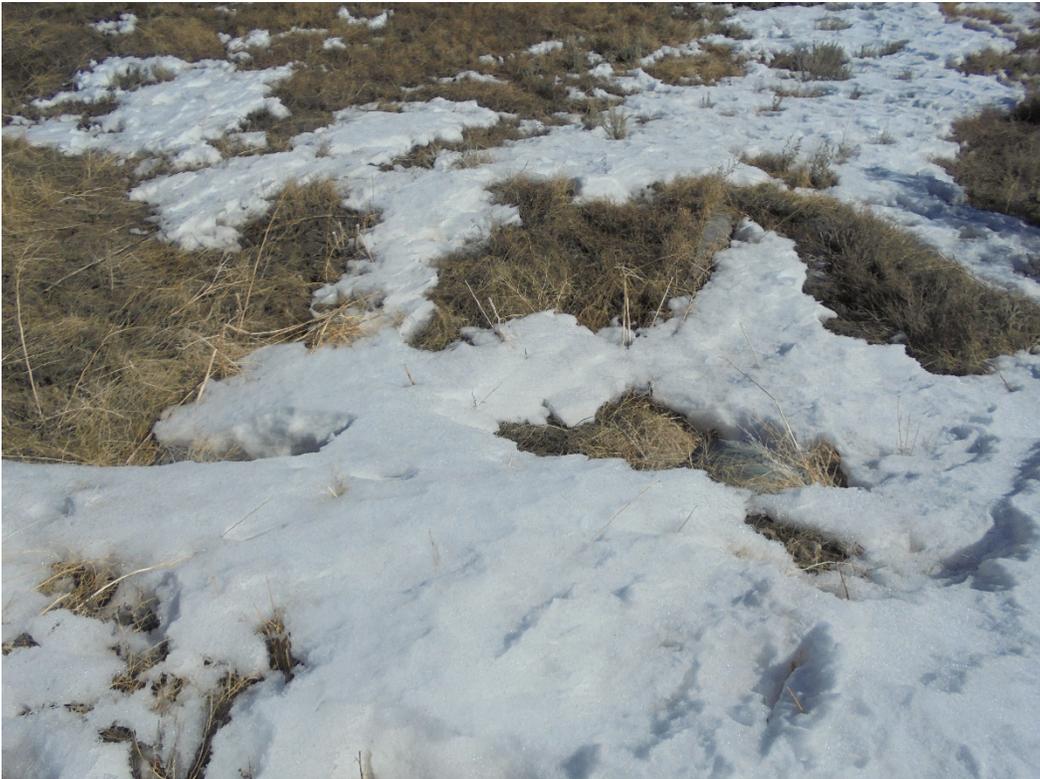
UPPER CELL OUTLET PIPES ARE COVERED WITH SNOW.

PERMANENT IMPOUNDMENT UPPER CELL OUTLET PIPES COVERED WITH SNOW

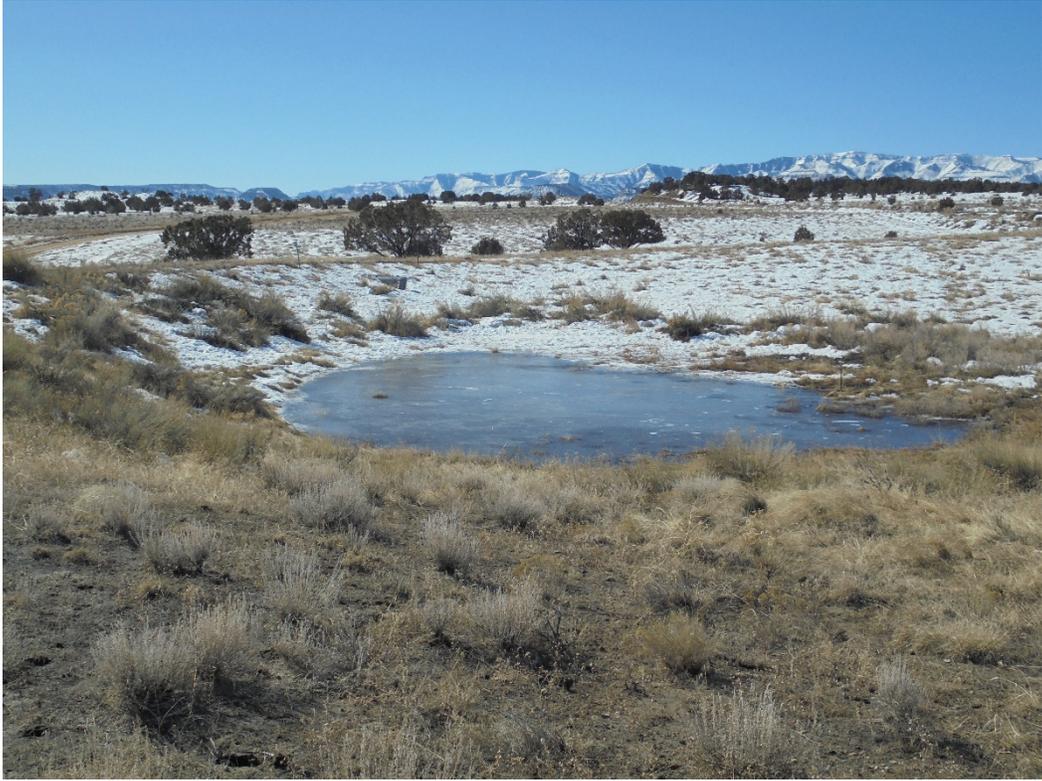
POND A

~2' ICE

BECAUSE OF ICE LEVEL IT IS NOT POSSIBLE TO DETERMINE  
THE SEDIMENT LEVEL. WEST INLET IS COVERED BY WEEDS.

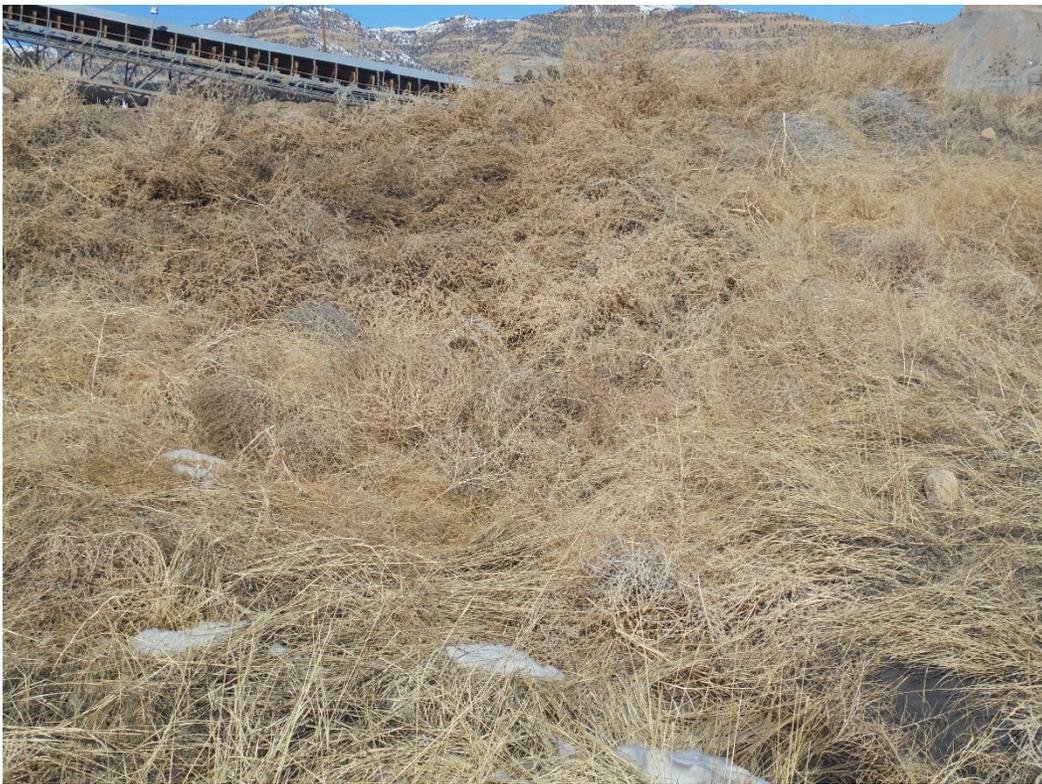
POND A WEST INLET WEEDS

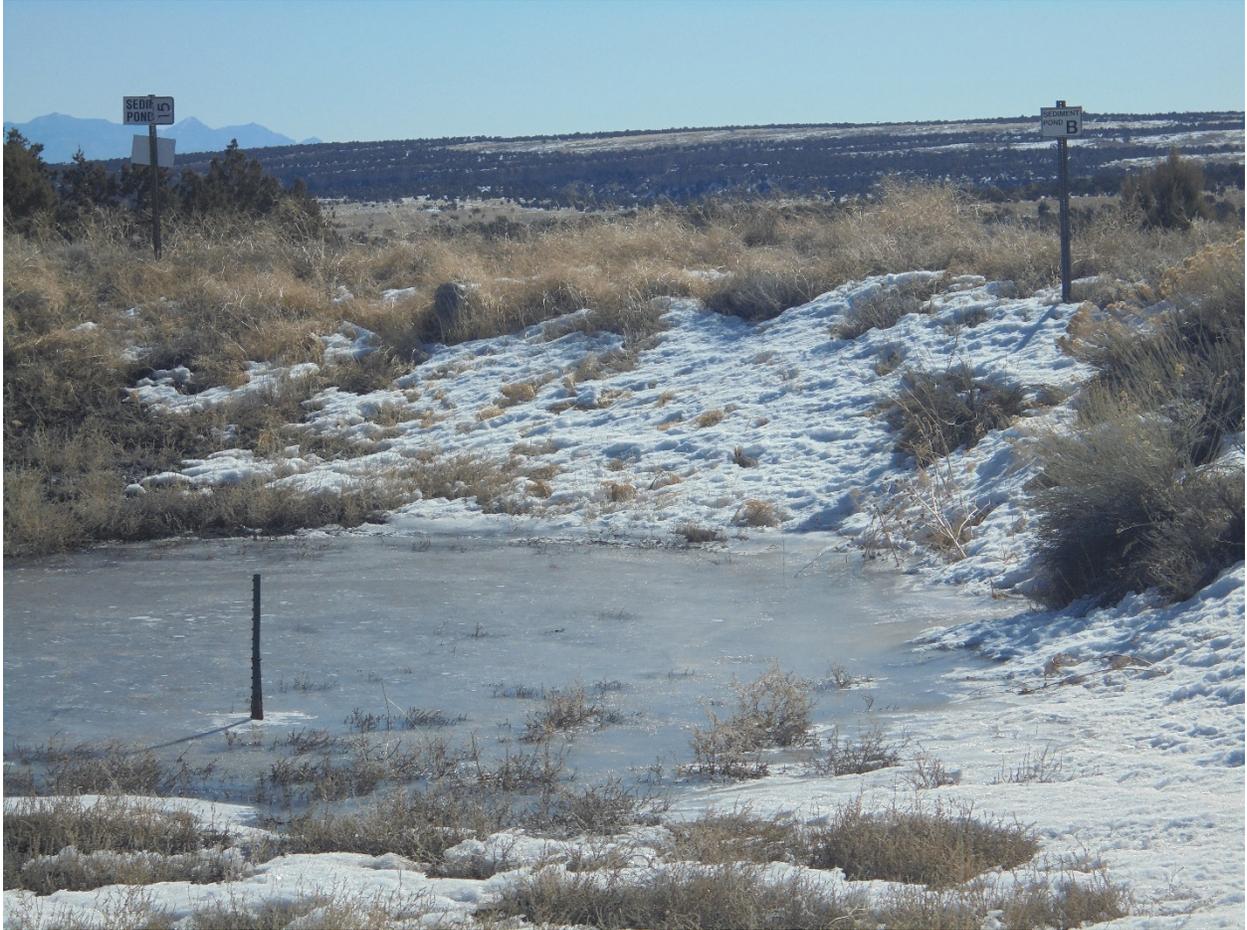
POND B

~ 1' ICE

EMERGENCY & PRINCIPAL SPILLWAYS SHOULD HAVE WEEDS REMOVED.

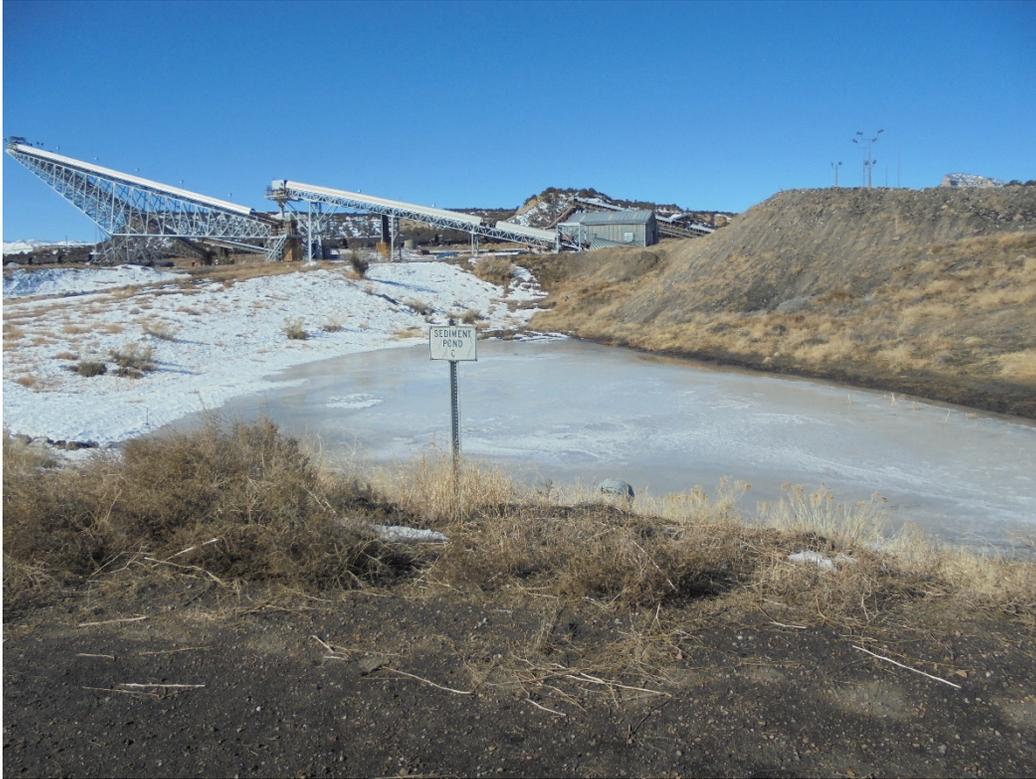
POND C

~ 30" ICE

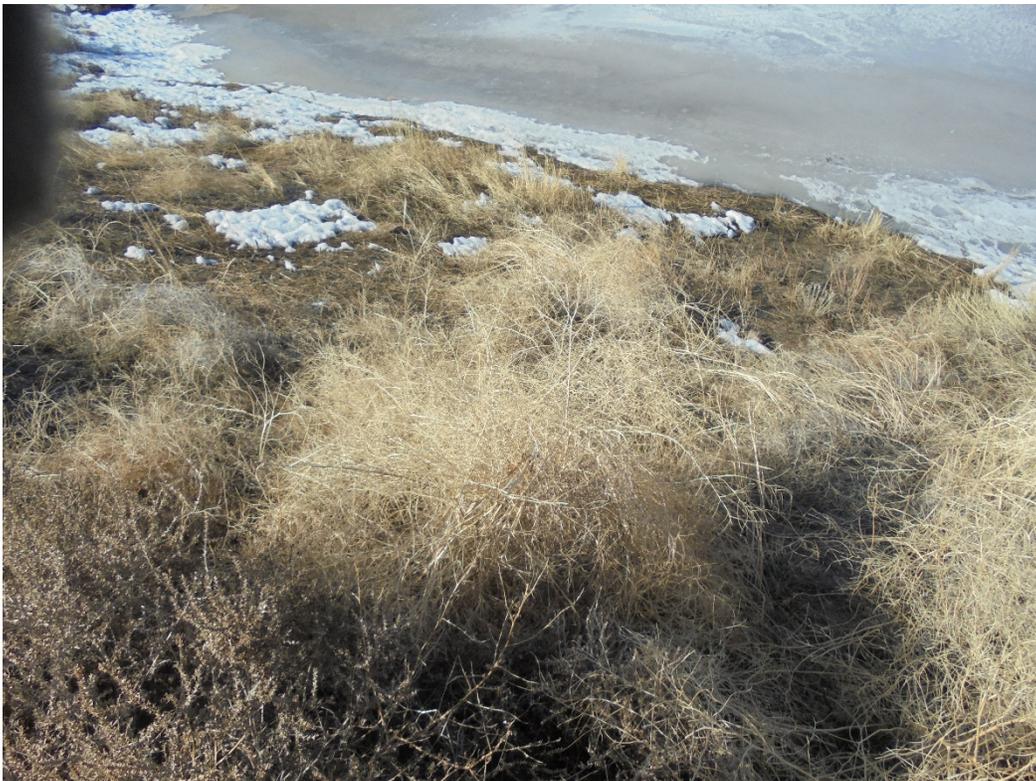
WEEDS ARE COVERING INLET OF PRINCIPLE & EMERGENCY  
SPILLWAYS. SEE ATTACHED PHOTOGRAPH. THERE IS  
STILL AN ANIMAL HOLE UNDER INLET OF PRINCIPAL  
SPILLWAY. THIS HOLE SHOULD BE FILLED.

POND C WEEDS COVERING INLET TO BOTH OUTLET CULVERTS

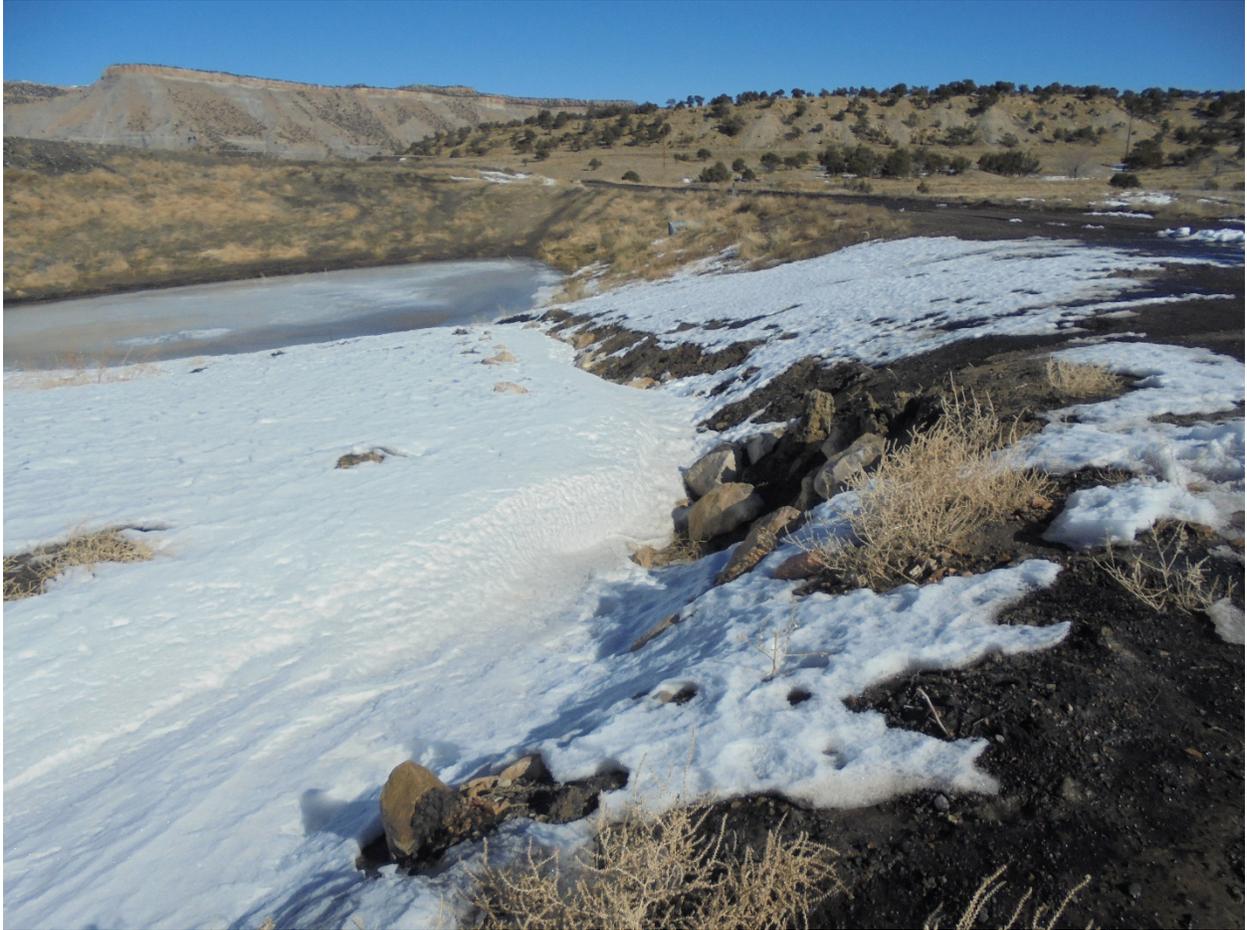
POND C SOUTH INLET COVERED WITH SNOW

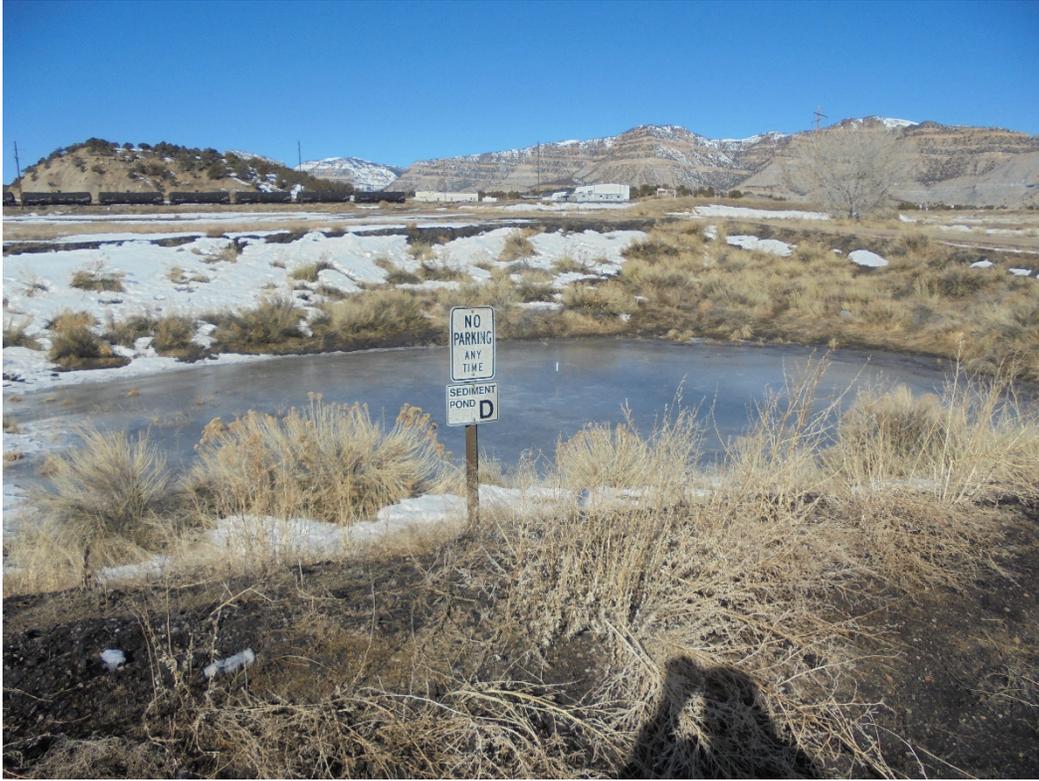
POND D

~ 2' ICE

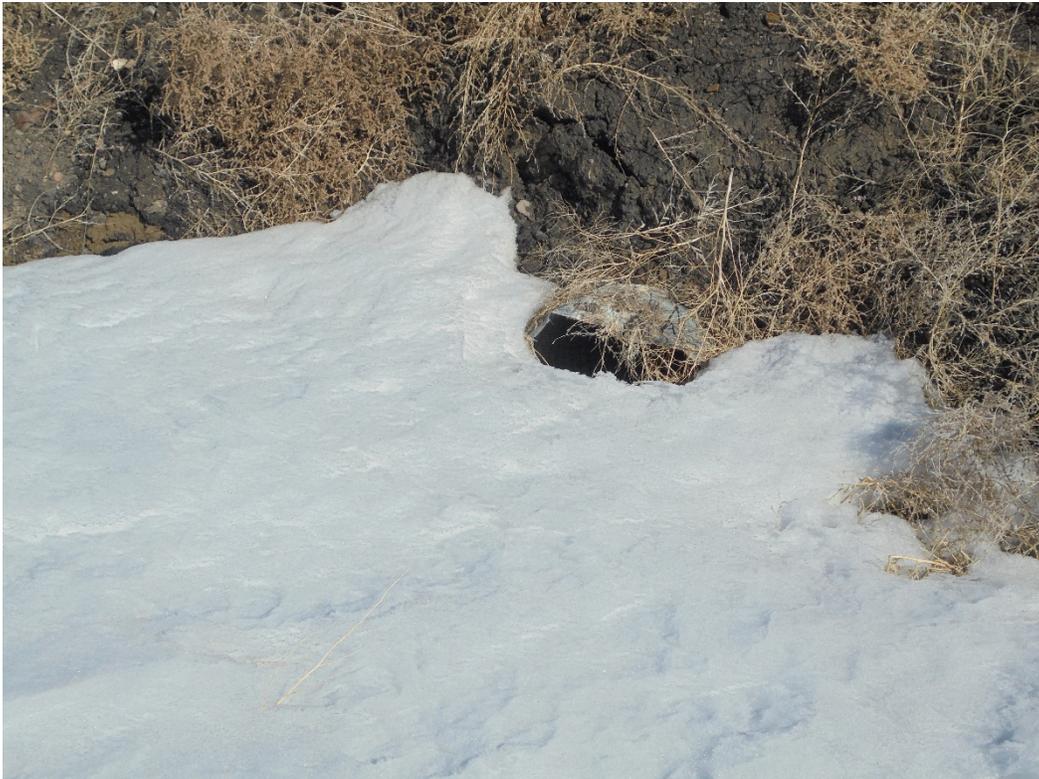
SNOW WAS STILL COVERING SOME OF THE CULVERTS

POND D SOUTH INLET COVERED WITH SNOW

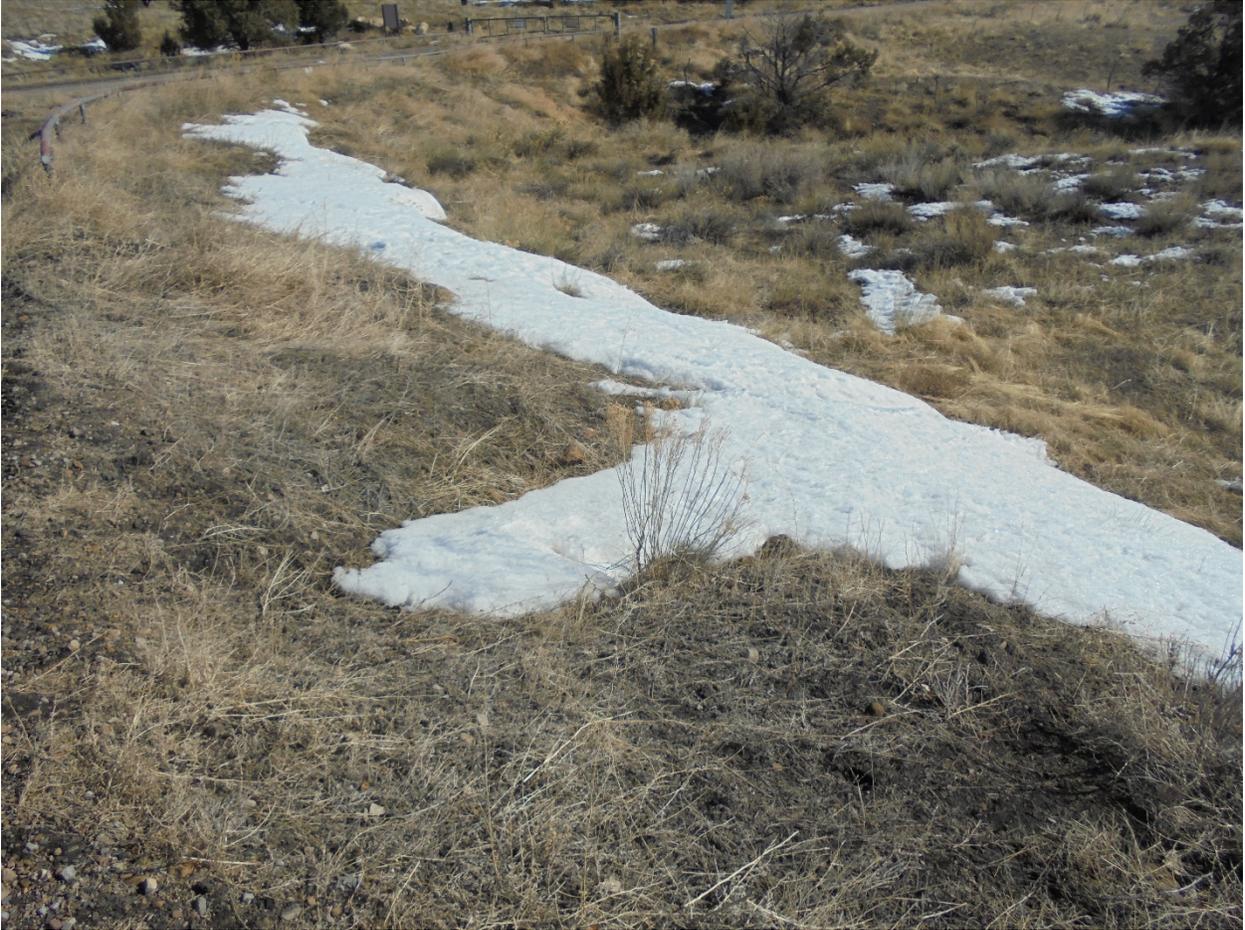
POND D OUTLETS COVERED WITH SNOW

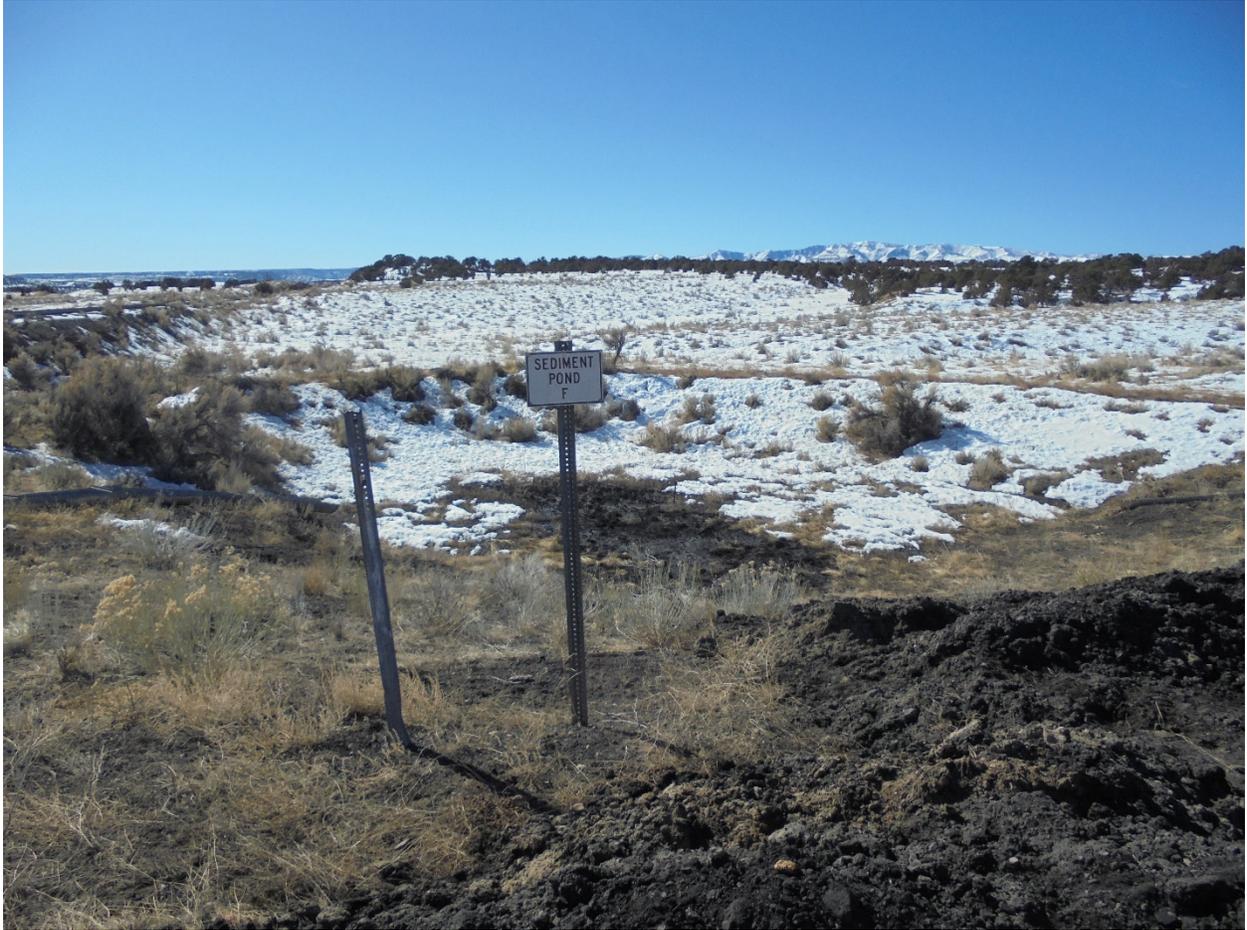
POND F

11.5" TO CLEANOUT

THERE IS A SEDIMENT BUILDUP IN EAST INLET.
