Quarterly Inspection Form - Refuse Disposal Areas
 (please provide to DOGM promptly after inspection is complete)

Permit Number : C/007/0033 Inspection Date : May 19, 2020
 Mine Name : Wildcat Loadout Quarter / Year : 2nd Quarter 2020
 Mine Operator (Permittee) : Coal Energy Group 2, LLC Inspector Name : J. T. Paluso
 MSHA ID # : 1211-UT-09-018664-01 Inspector Signature : Joseph T. Paluso
Digitally signed by Joseph T. Paluso
 DN: cn=Joseph T. Paluso, o=ES, ou=
 email=jtppaluso@pnet.com.net, c=US
 Date: 2015.04.02 09:17:29 -0600

Facility Name / Location / Address : Wildcat Loadout/5495 West 3550 North, Helper, Utah 84526

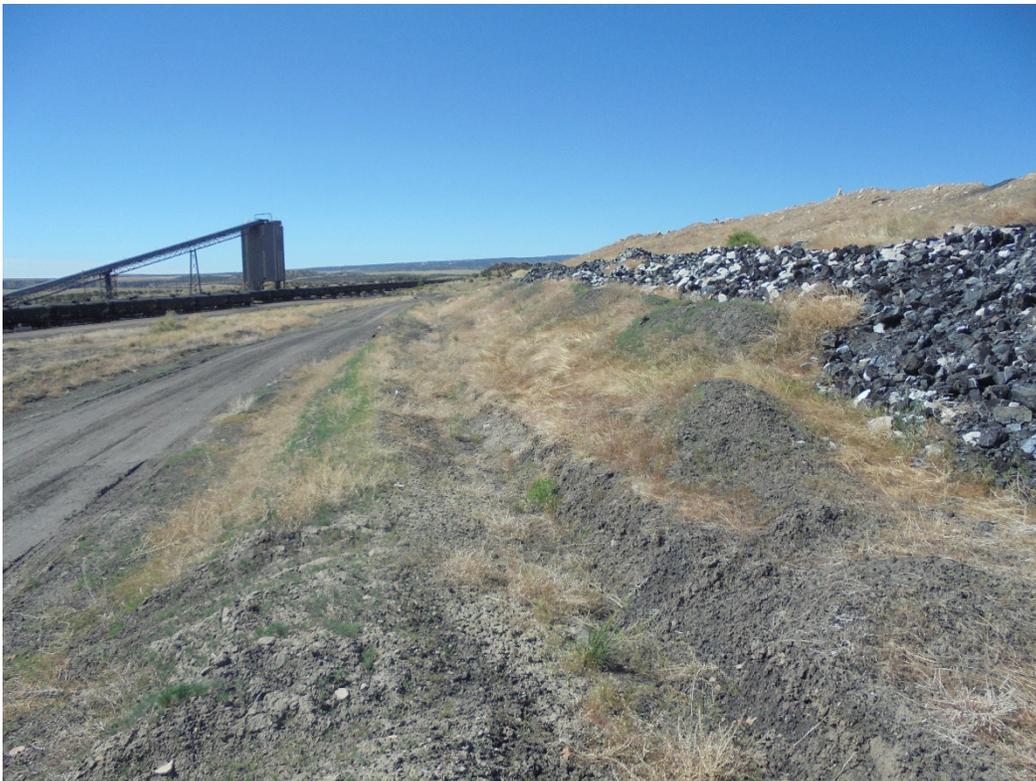
8. Describe placement of under drains, protective filter systems, and final surface drainage systems (report any seepage, including location, color, flow) :
None known. East drainage ditch needs cleaning shortly.

REFUSE PILE EAST SIDE DRAINAGE DITCH LOOKING SOUTH

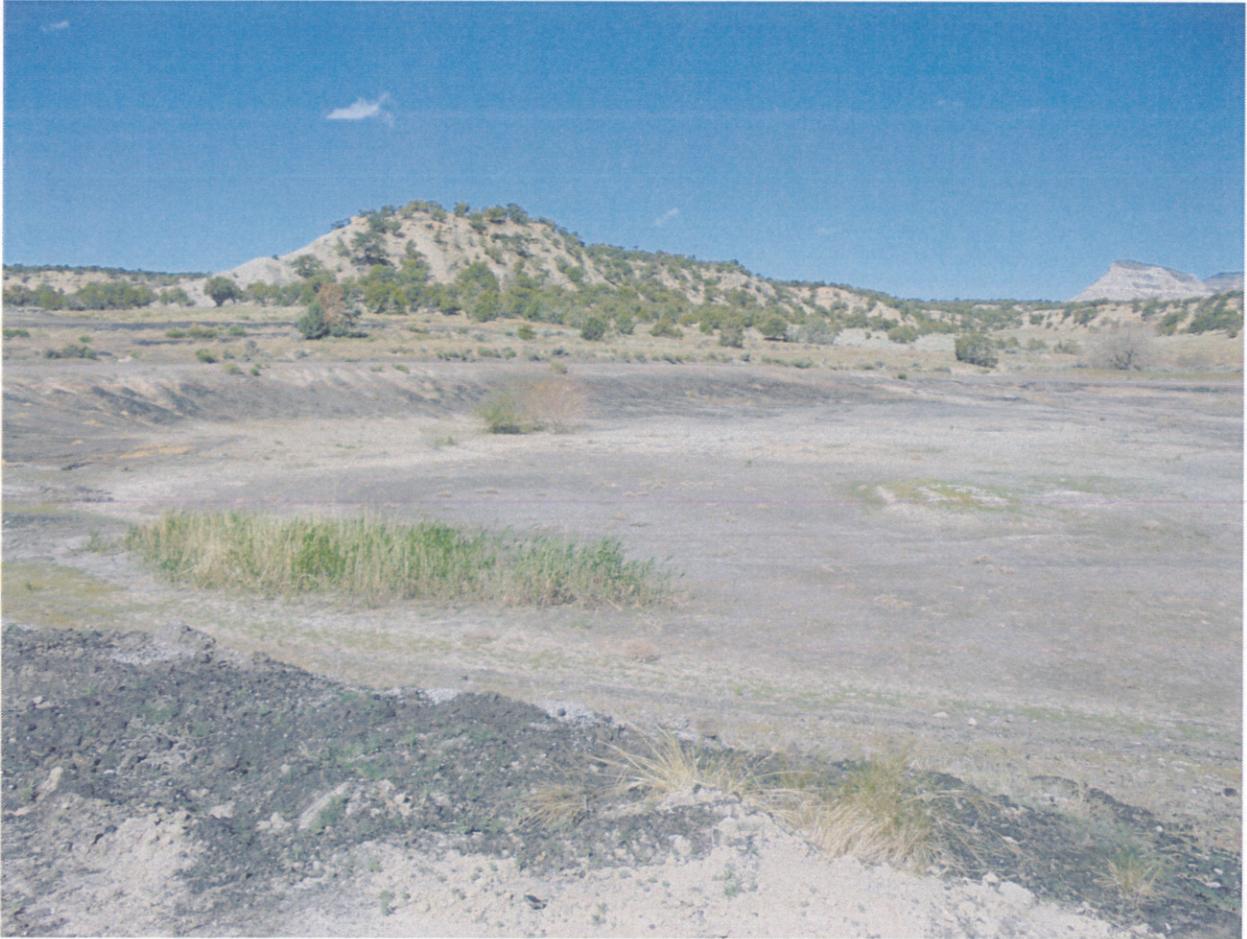
DEPRESSED AREA IMPOUNDMENT

B. Capacity (0% / 100%)
Water DRY
Sediment NA

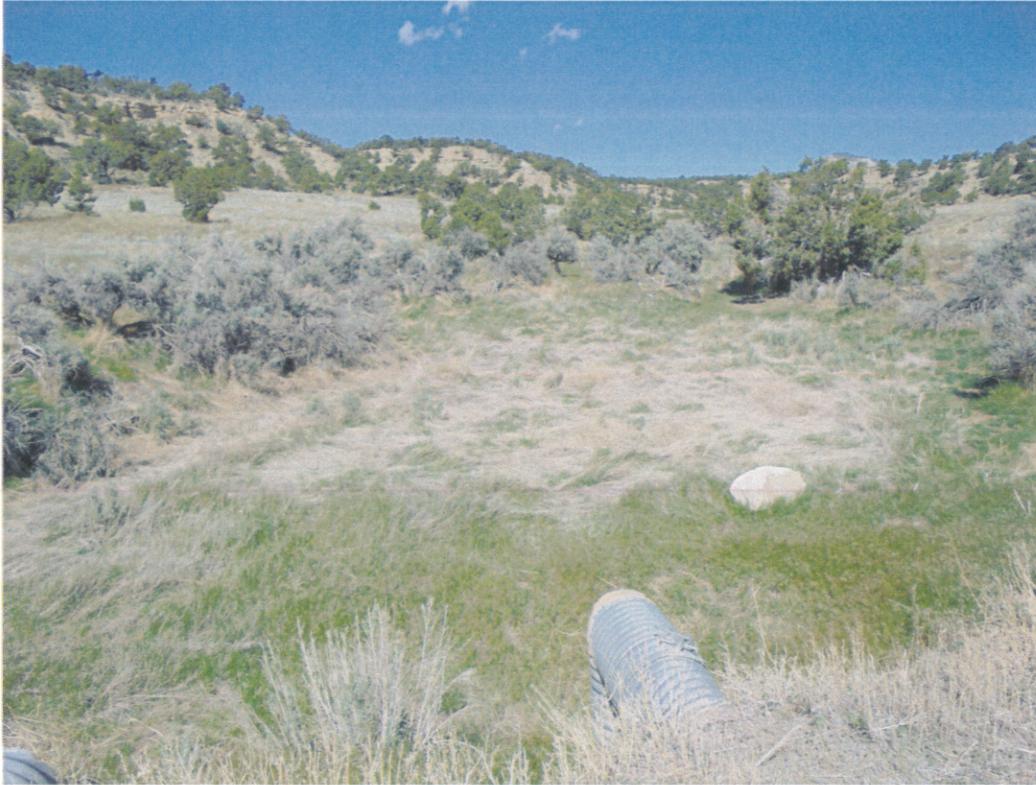
PERMANENT IMPOUNDMENT (UPPER CELL)

BOTH CELLS ARE DRY

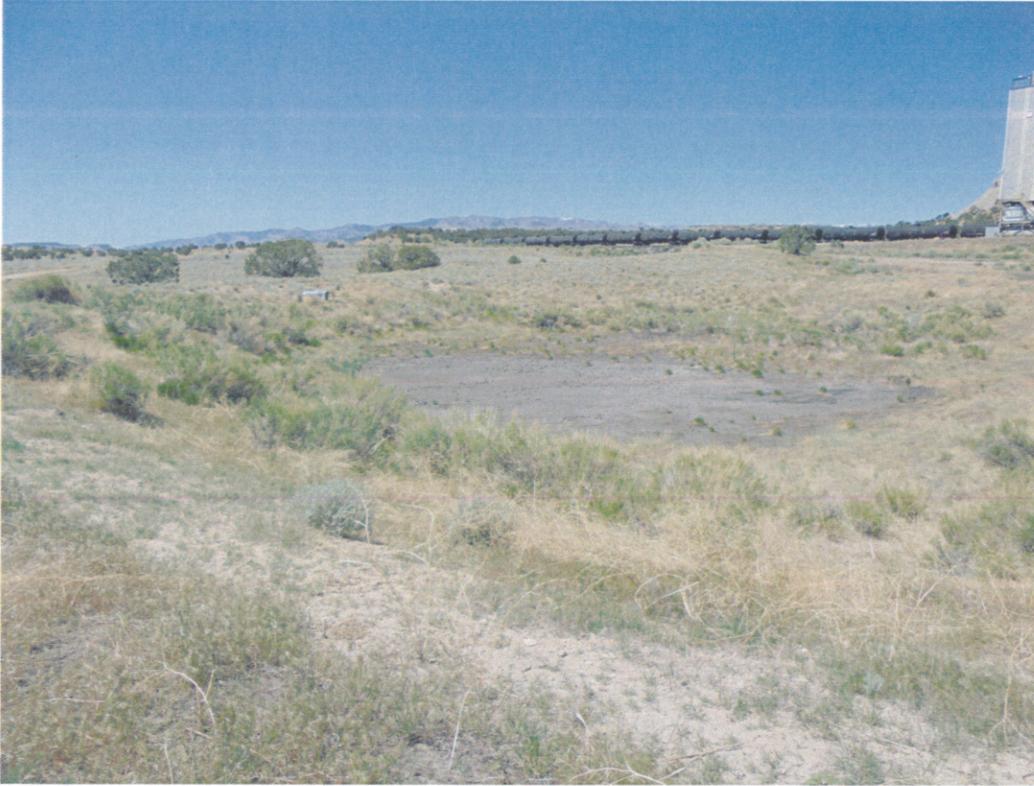
POND A

DRY
29" BEFORE CLEANOUT

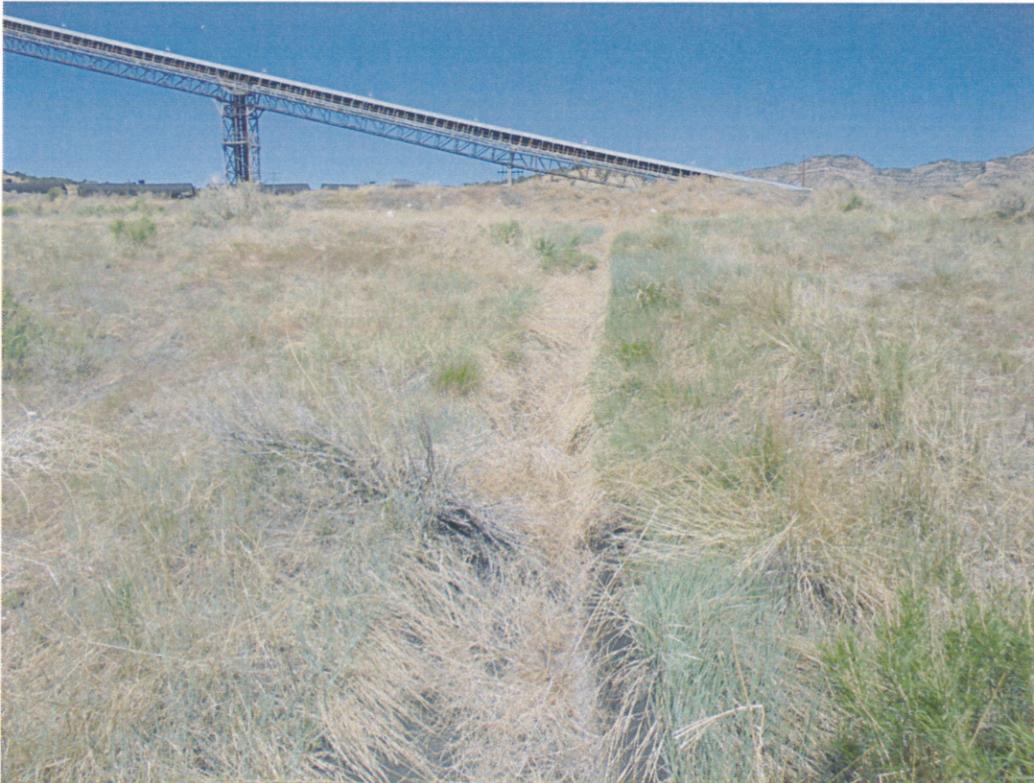
WEST INLET IS COVERED BY WEEDS.

POND A WEST INLET WEEDS

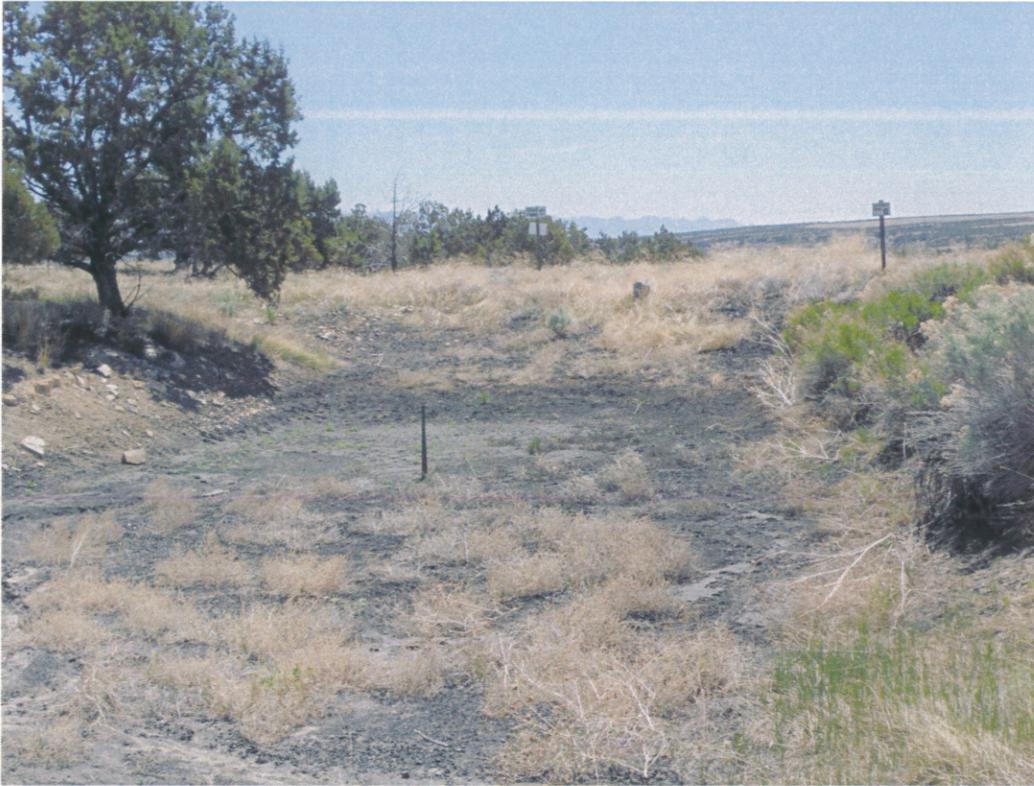
POND B

DRY
18 1/2" BEFORE CLEANOUT

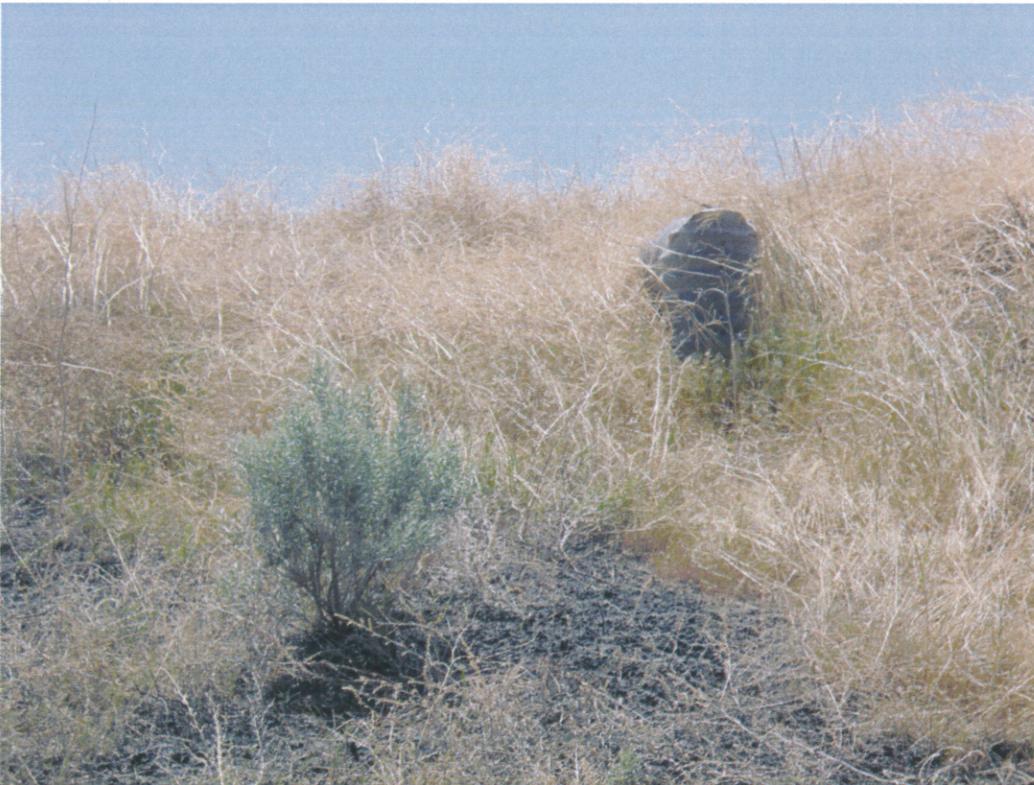
POND B PRINCIPLE SPILLWAY WEEDS

EMERGENCY & PRINCIPLE SPILLWAYS SHOULD HAVE
WEEDS REMOVED

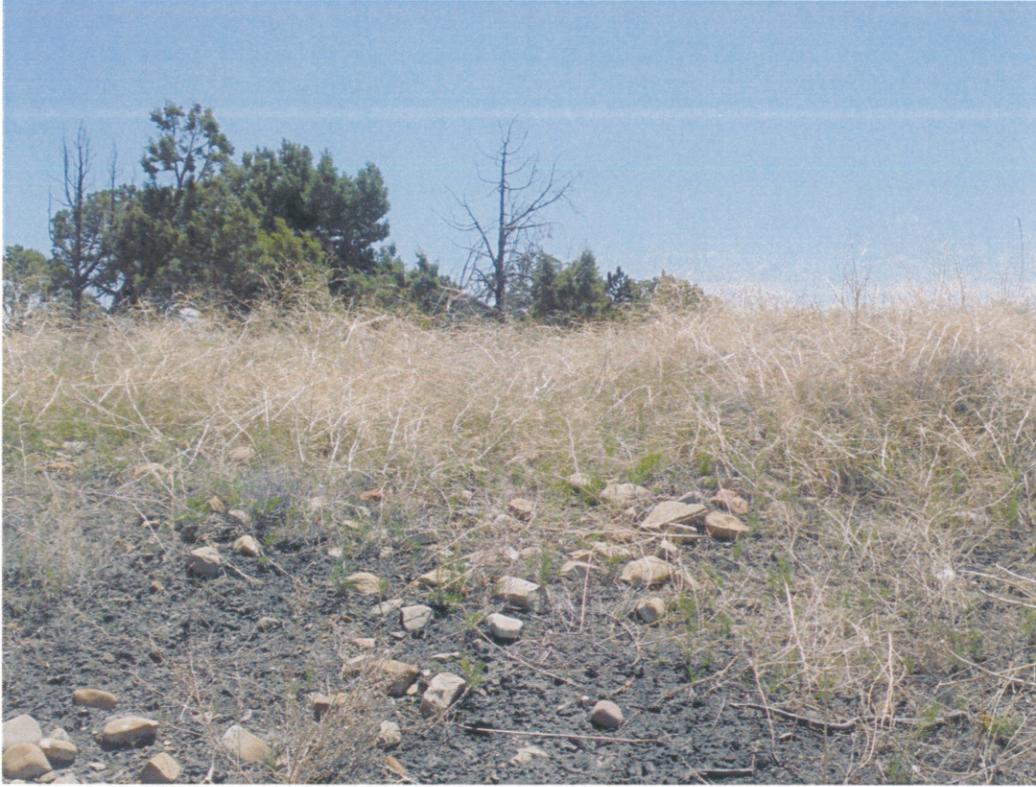
POND B EMERGENCY SPILLWAY WEEDS

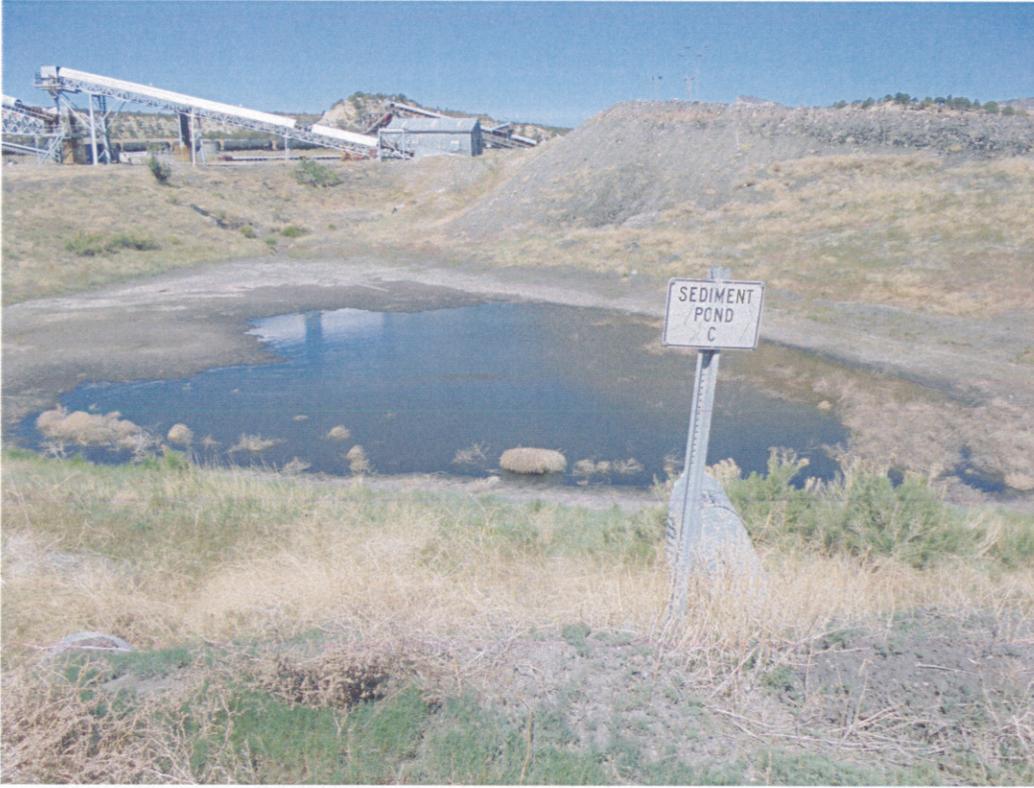
POND C

WEEDS ARE COVERING INLET OF EMERGENCY SPILLWAY,
WEST INLET NEEDS TO HAVE WEEDS REMOVED.
THERE IS STILL AN ANIMAL HOLE UNDER INLET OF
PRINCIPLE SPILLWAY. THIS HOLE SHOULD BE FILLED.

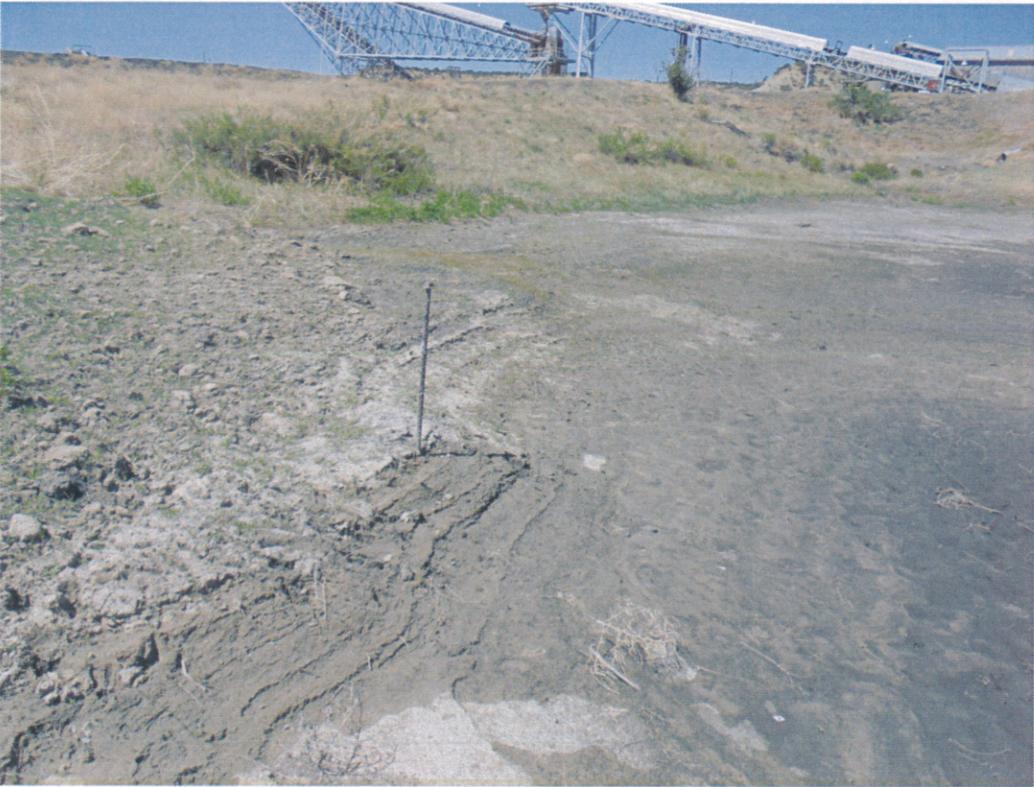
POND C SEDIMENT STAKE

~ 18"

23" BEFORE CLEANOUT

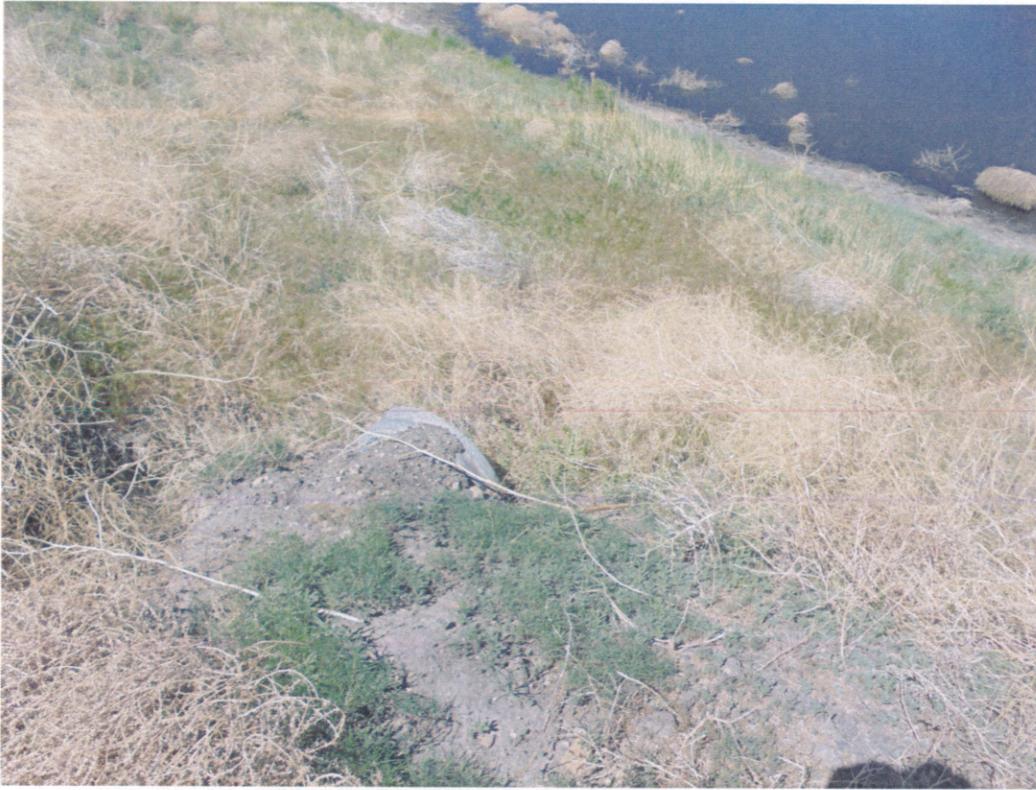
POND C EMERGENCY SPILLWAY INLET WEEDS

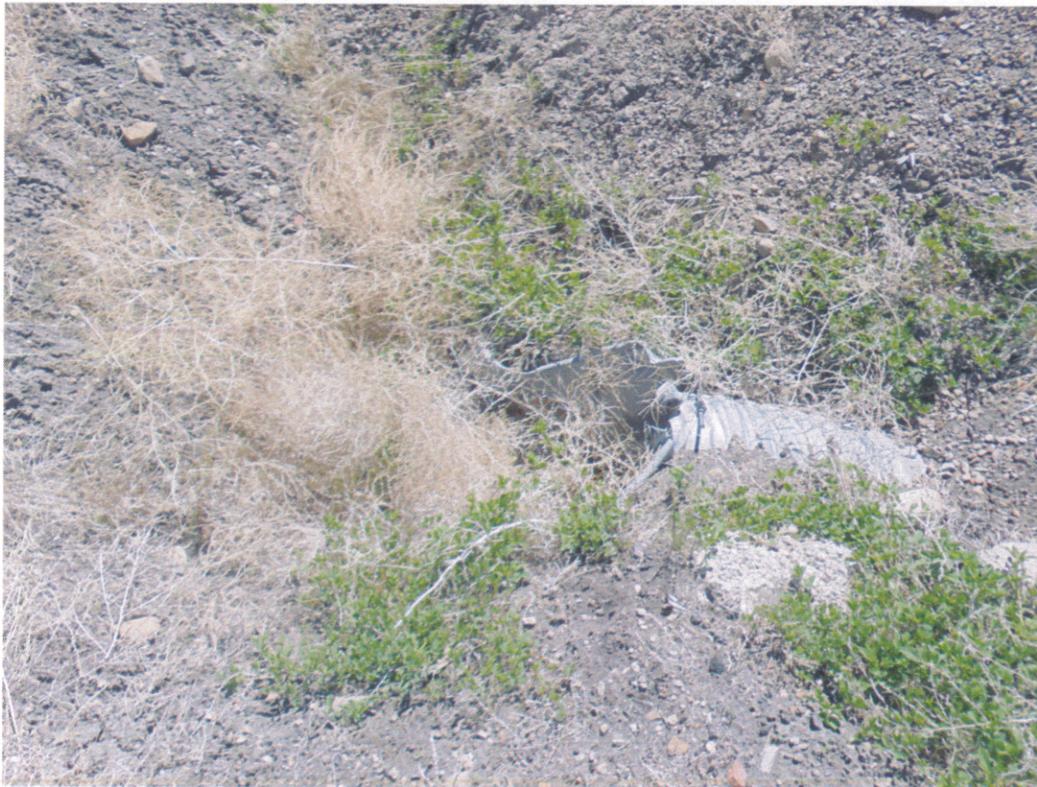
POND C WEST INLET WEEDS

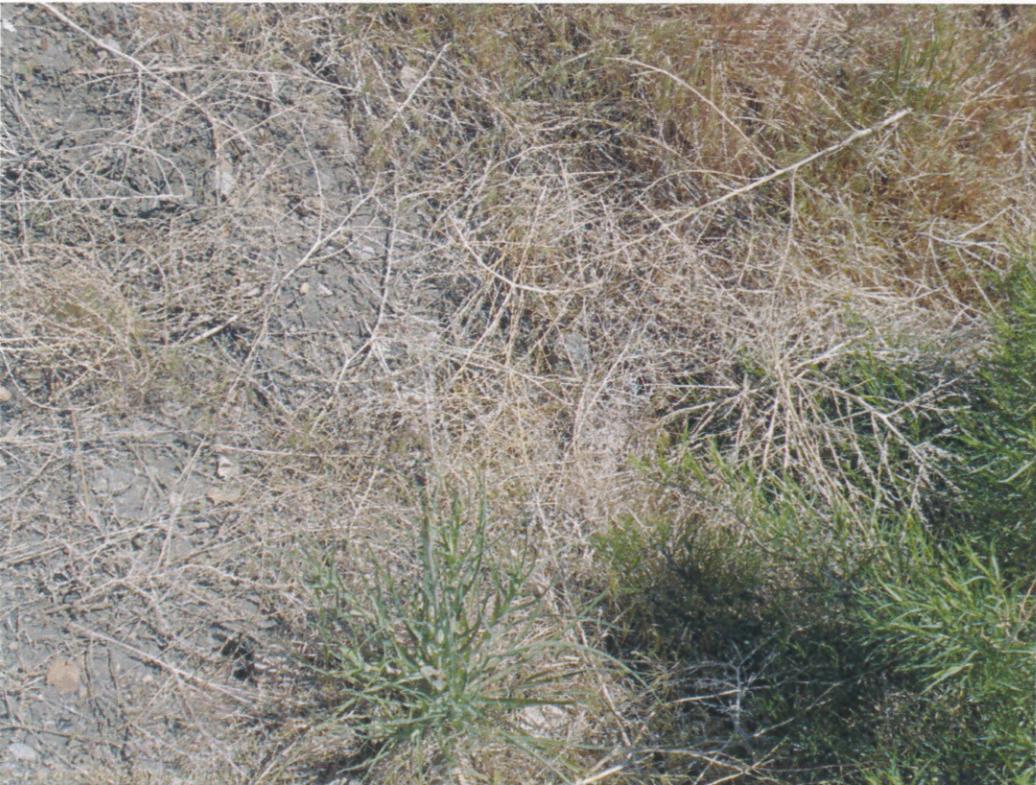
POND D PRINCIPLE SPILLWAY OUTLET WEEDS

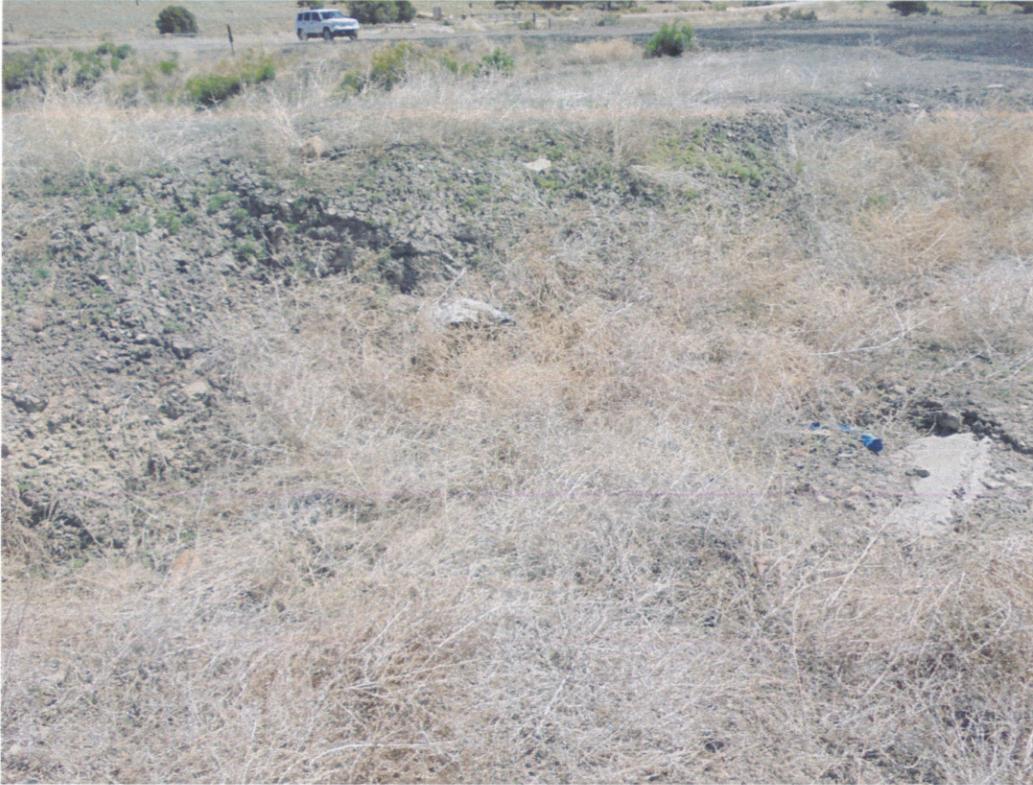
POND D SOUTH INLET WEEDS

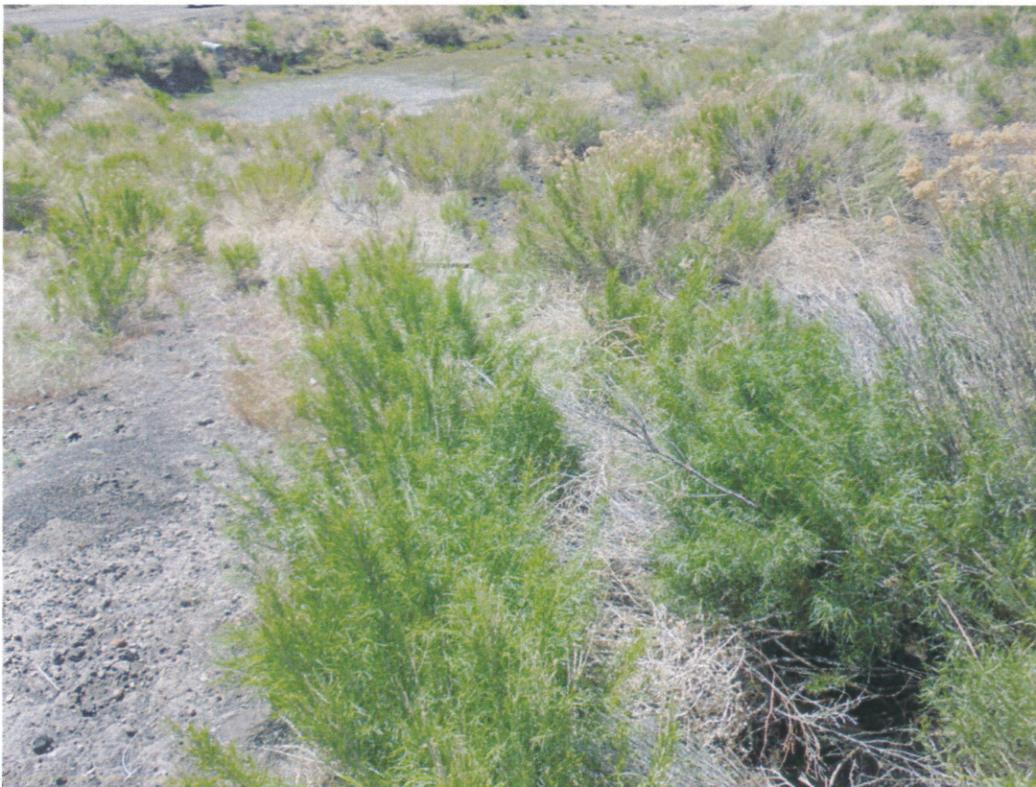
POND D WEST INLET WEEDS

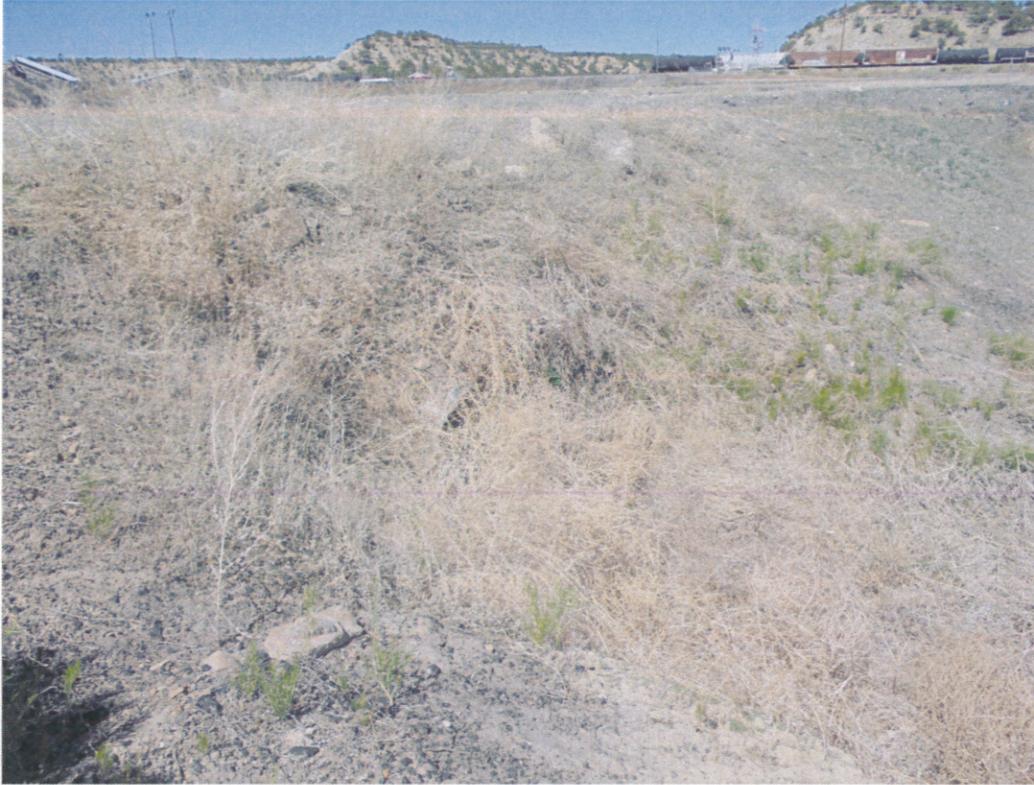
POND D EMERGENCY SPILLWAY OUTLET WEEDS

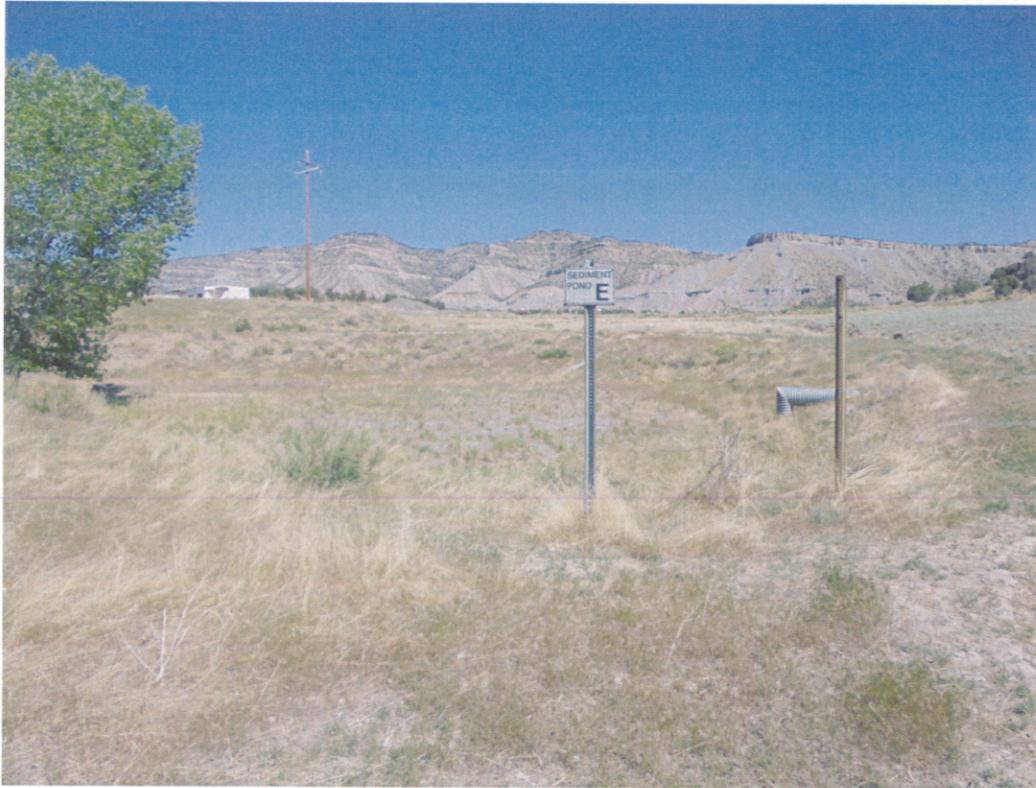
POND E

DRY
15 1/2" BEFORE CLEANOUT

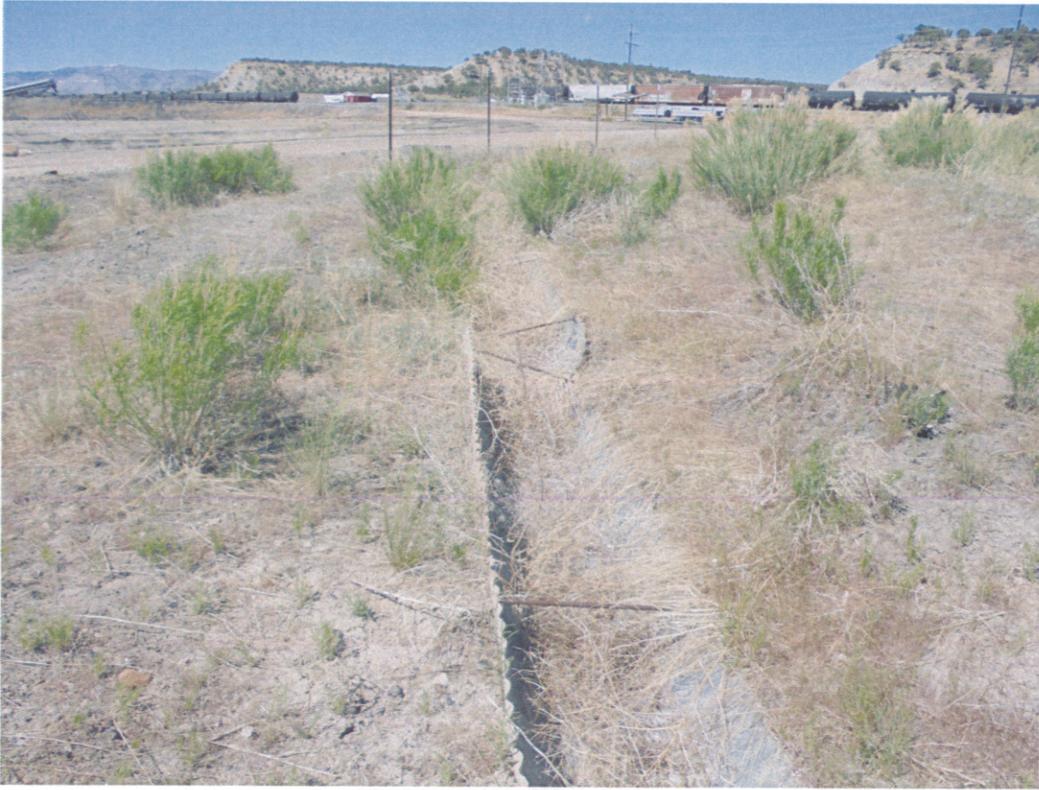
WEST INLET HAS WEEDS.

POND E WEST INLET WEEDS

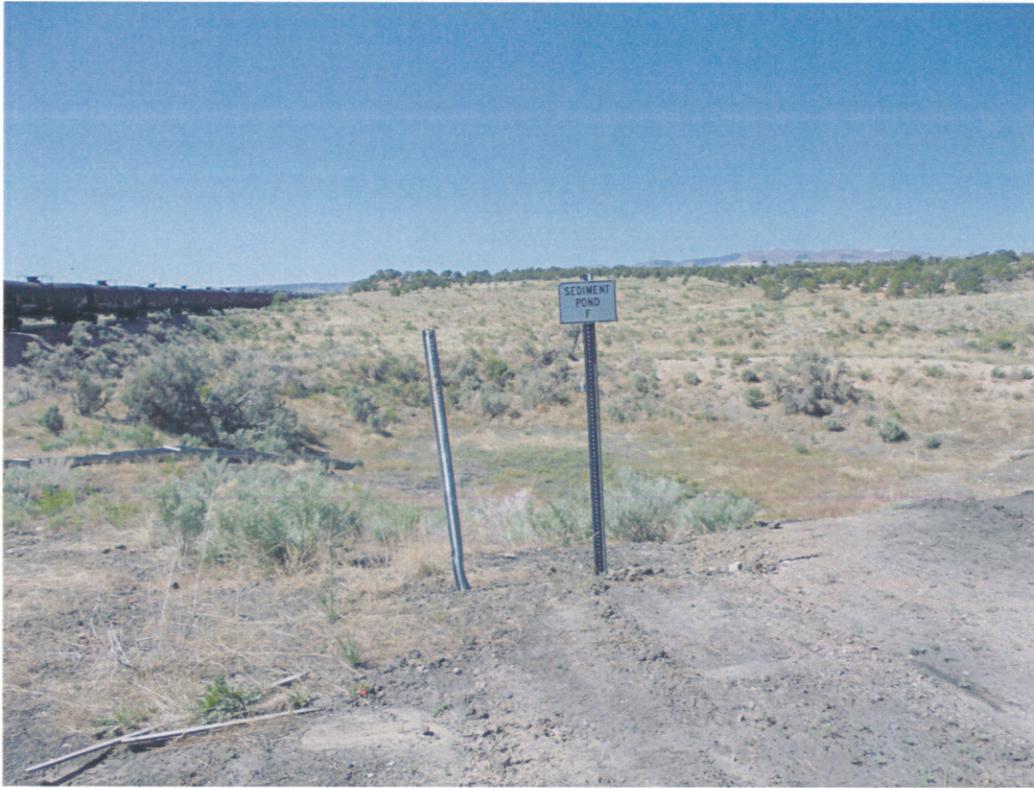
POND F

DRY

11.5" BEFORE CLEANOUT
