## Sunnyside Cogeneration Associates

RE: Third Quarter 1996 Inspection Report

RE: 3rd Quarter 1996 Certified Inspection of Impoundments, Refuse Pile & Excess Spoil Arca

SUNNYSIDE COGENERATION ASSOCIATES ACT/007/035 QUARTERLY INSPECTION OF IMPOUNDMENTS AND REFUSE PILE							Quarter <u>Third (Inspected 9/20)</u> Year <u>1996</u> Weather Condition <u>Fair</u>	
IMPOUNDMENT	INSTABILITY (YES/NO)	STRUCTURAL WEAKNESS (YES/NO)	HAZARDOUS CONDITIONS (YES/NO)	WATER DEPTH (FEET)	WATER ELEVATION (FEET)	STORAGE CAPACITY (ACRE-FEET)	*OTHER	COMMENTS
Clear Water Pond (004)	No	No	No	<1'	0	4.9	---	Add'l riprap placed at surface inlet.
Railcut Sediment Pond (007)	No	No	No	Wet	0	4.8	---	---
Old Coarse Refuse Road Sediment Pond (008)	No	No	No	Wet	0	0.9	---	---
Pasture Sediment Pond (009)	No	No	No	1'	6486	1.0	---	---
New Coarse Refuse Toe Sediment Pond (012)	No	No	No	3'	6178	1.6	---	---
Borrow Area Pond (016)	No	No	No	Dry	0	8.3	---	---
Slurry Pond #1	No	No	No	Wet	0	16.4	Does not receive surface drainage	Inactive
Slurry Pond #2	No	No	No	<1'	0	15.3	Received some surface drainage from slurry ditch	Inactive

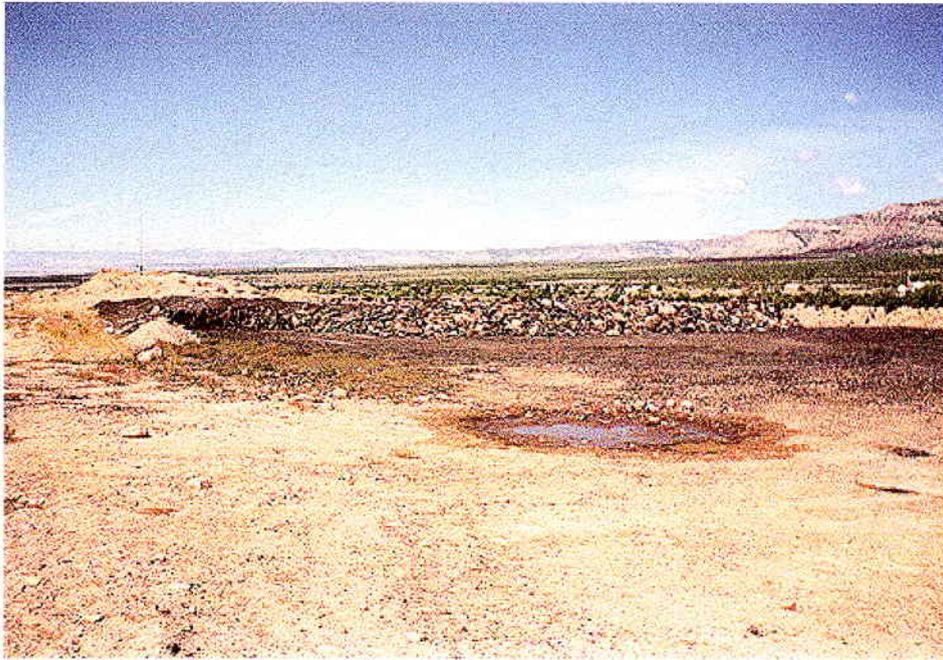
Sunnyside Cogeneration Associates Excess Spoil Disposal Area, September 1996

Approximately 400 cubic yards of boulders were placed in the Excess Spoil Disposal Area. These appear to have been placed in accordance with the design and permit requirements. The permit requirements concerning the Excess Spoil Disposal Area require that material placed in the Disposal Area be sampled and analyzed for acid/toxic parameters at a frequency of one sample per acre per four foot lift. As you continue to place material in the Disposal Area and you approach the one acre volume, it will be necessary to analyze a sample for the entire list of parameters itemized in the Permit.

East Slurry Cell	No	No	No	Dry	0	NA	Received minimal surface drainage from slurry ditch	Inactive
West Slurry Cell	No	No	No	Dry	0	NA	---	Refuse Removal
Coal Runoff Sediment Pond (014)	No	No	No	1'	6475	1.5	---	---
REFUSE PILE	INSTABILITY (YES/NO)	STRUCTURAL WEAKNESS (YES/NO)	HAZARDOUS CONDITIONS (YES/NO)				*OTHER	COMMENTS
Coarse Refuse Pile	No	No	No				---	Waste Coal Removal
Excess Spoil Area	No	No	No				---	Received approximately 400 yards of spoils material. See attached pictures.
