Sunnyside Cogeneration Associates

RE: Third Quarter 2000 Inspection Report

Please find enclosed a copy of the Third Quarter 2000 Inspection Report for Sunnyside Cogeneration Associates' impoundments, refuse pile and excess spoil areas. The inspection was performed by a professional engineer from Psomas and Associates Engineering.

RE: Third Quarter 2000 Inspections

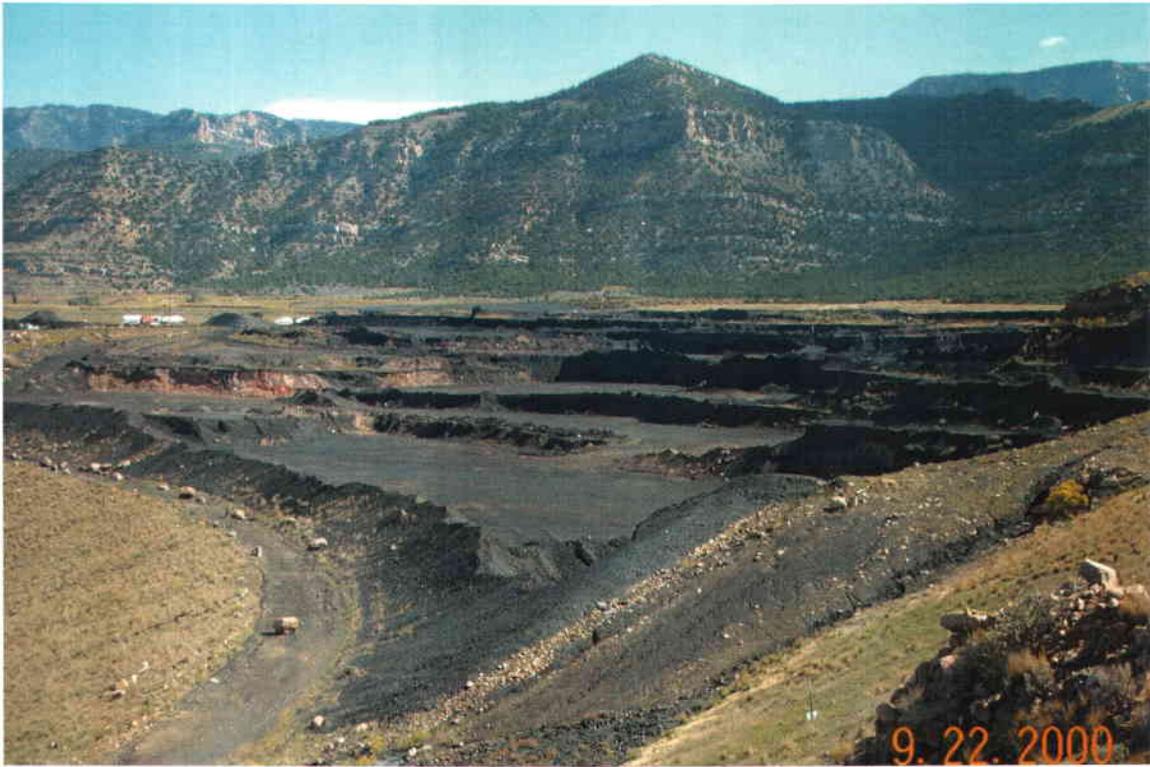
Coarse Refuse Pile / West Slurry Cell (from North West)

September 22, 2000

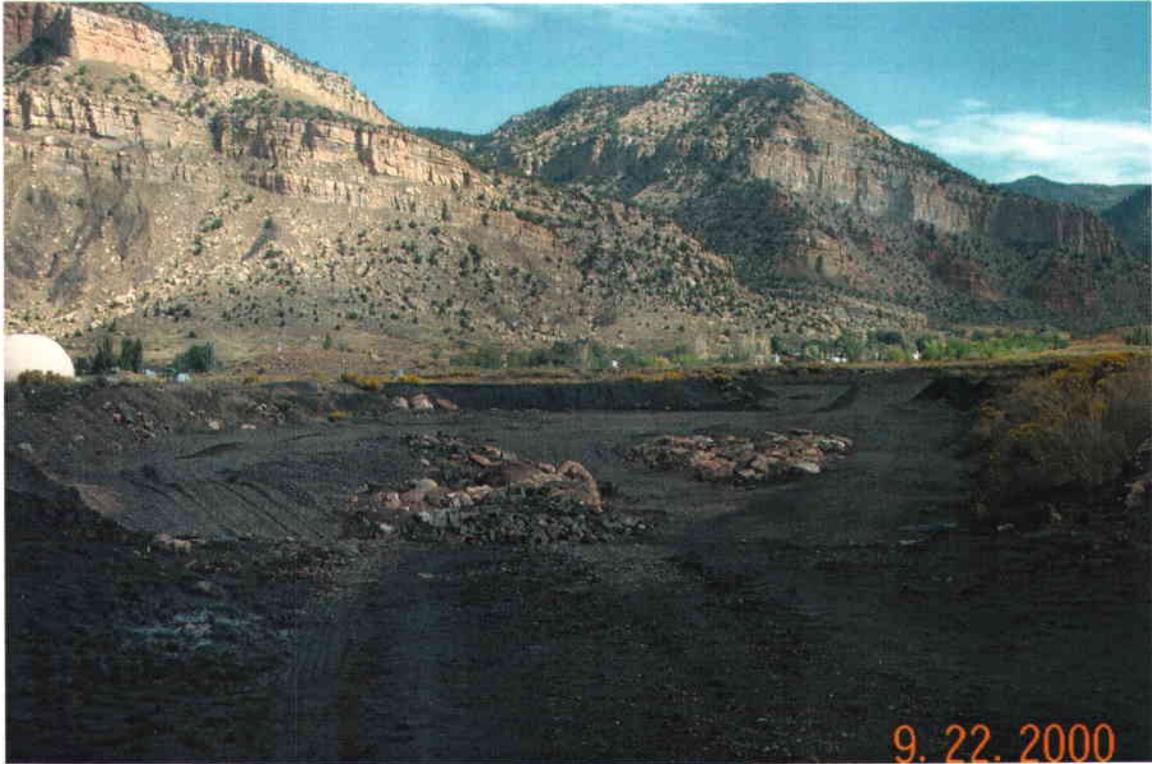
Excess Spoil Disposal Area #2 (Slurry Pond #2 Area) from South September 22, 2000

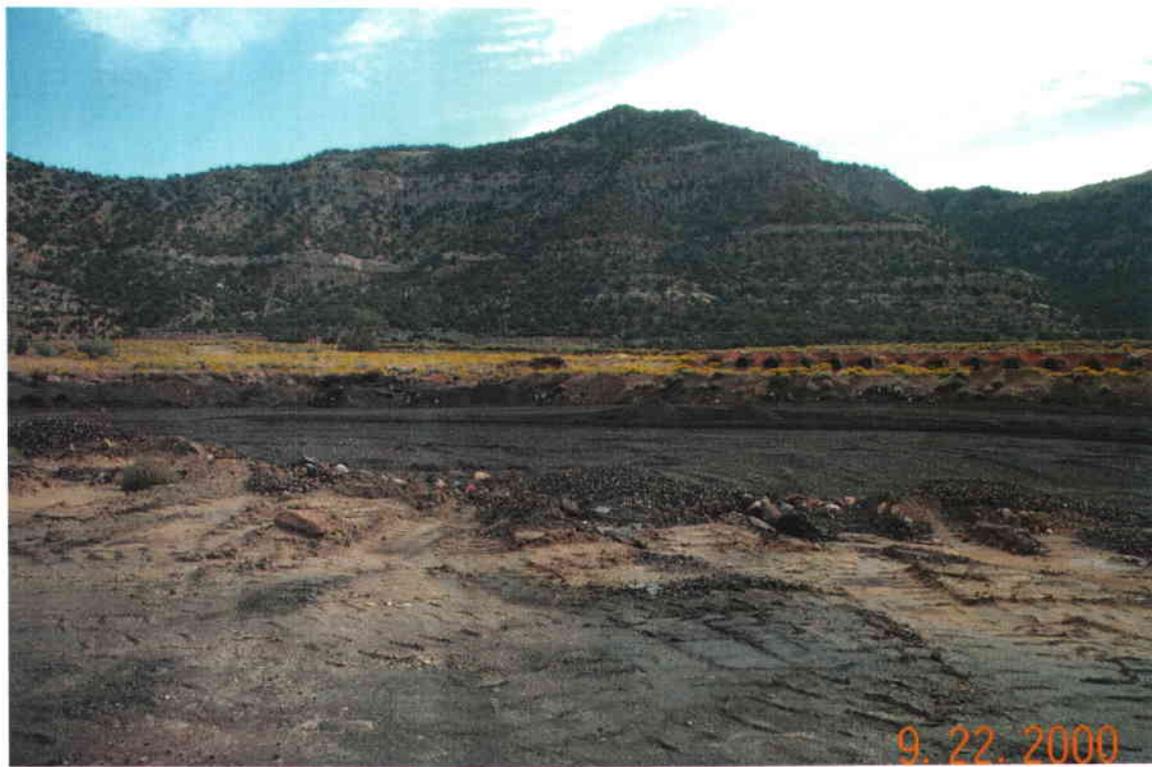
Excess Spoil Disposal Area #2 (Slurry Pond #1 Area) from Northwest Sept 22, 2000
