Sunnyside Cogeneration Associates

RE: Second Quarter 2002 Inspection Report

IMPOUNDMENT INSPECTION AND CERTIFIED REPORT		Clear Water Pond	
Permit Number	ACT/007/035	Report Date 7/3/02	
Mine Name	SUNNYSIDE REFUSE AND SLURRY		
Company Name	SUNNYSIDE COGENERATION ASSOCIATES		
Impoundment Identification	Impoundment Name	Clear Water Pond	
	Impoundment Number	004	
	UPDES Permit Number	UT 024759	
	MSHA ID Number	N/A	
IMPOUNDMENT INSPECTION			
Inspection Date	6/18/02		
Inspected By	Scott Carlson		
Reason for Inspection (Annual, Quarterly or Other Periodic Inspection, Critical Installation, or Completion of Construction)		Second Quarter Inspection 2002	
<p>1. Describe any appearance of any instability, structural weakness, or any other hazardous condition.</p> <p>NONE</p>			
<p>Required for an impoundment which functions as a SEDIMENTATION POND.</p>	<p>2. Sediment storage capacity, including elevation of 60% and 100% sediment storage volumes, and, estimated average elevation of existing sediment.</p> <p>Storage Capacity = 4.9 acre-feet Maximum Sediment Depth Elevation = 6527 Existing Sediment Elevation = 6523+-</p>

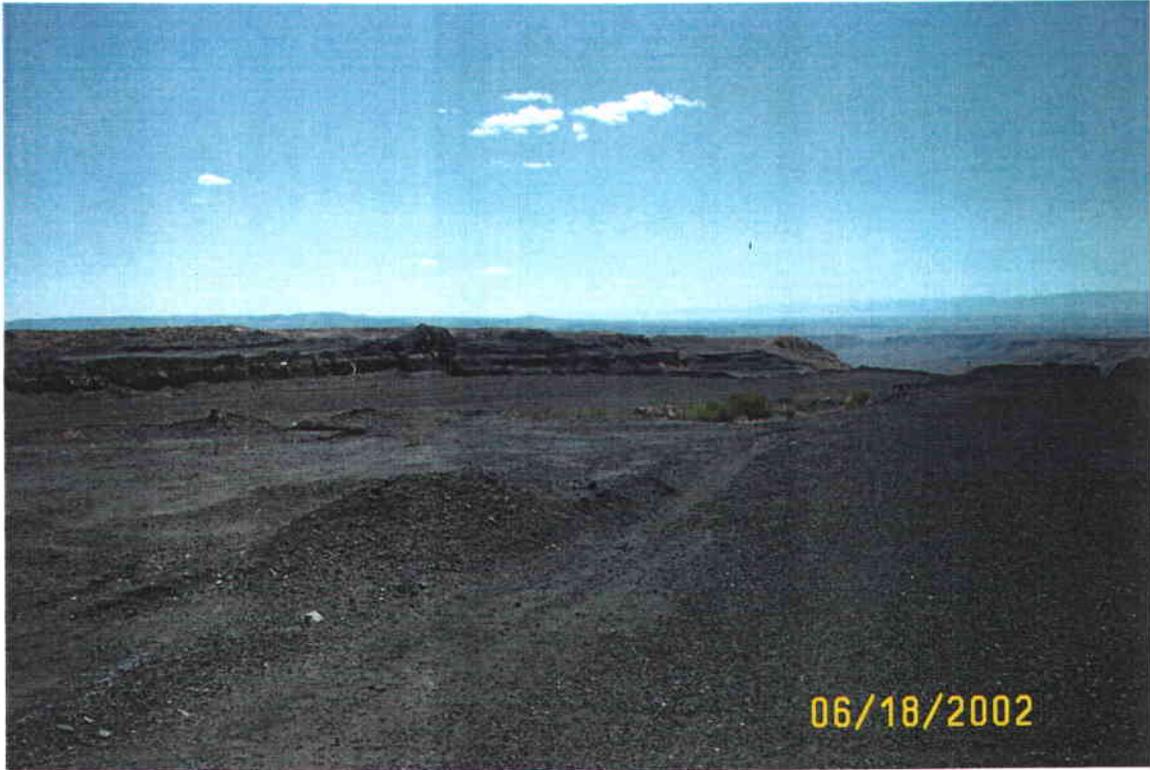
Coarse Refuse Pile Looking to the West

No smokers visible

Waste Coal Removal
