Sunnyside Cogeneration Associates

RE: Second Quarter 2003 Inspection Report

IMPOUNDMENT INSPECTION AND CERTIFIED REPORT		Clear Water Pond	
Permit Number	ACT/007/035	Report Date	7/10/2003
Mine Name	SUNNYSIDE REFUSE AND SLURRY		
Company Name	SUNNYSIDE COGENERATION ASSOCIATES		
Impoundment Identification	Impoundment Name	Clear Water Pond	
	Impoundment Number	004	
	UPDES Permit Number	UT 024759	
	MSHA ID Number	N/A	
IMPOUNDMENT INSPECTION			
Inspection Date	June 12, 2003		
Inspected By	Scott Carlson		
Reason for Inspection (Annual, Quarterly or Other Periodic Inspection, Critical Installation, or Completion of Construction)	Second Quarter Inspection 2003		
<p>1. Describe any appearance of any instability, structural weakness, or any other hazardous condition.</p> <p>NONE</p>			
Required for an impoundment which functions as a SEDIMENTATION POND.	<p>2. Sediment storage capacity, including elevation of 60% and 100% sediment storage volumes, and, estimated average elevation of existing sediment.</p> <p>Storage Capacity = 4.9 acre-feet Maximum Sediment Depth Elevation = 6527 Existing Sediment Elevation = 6523+-</p>

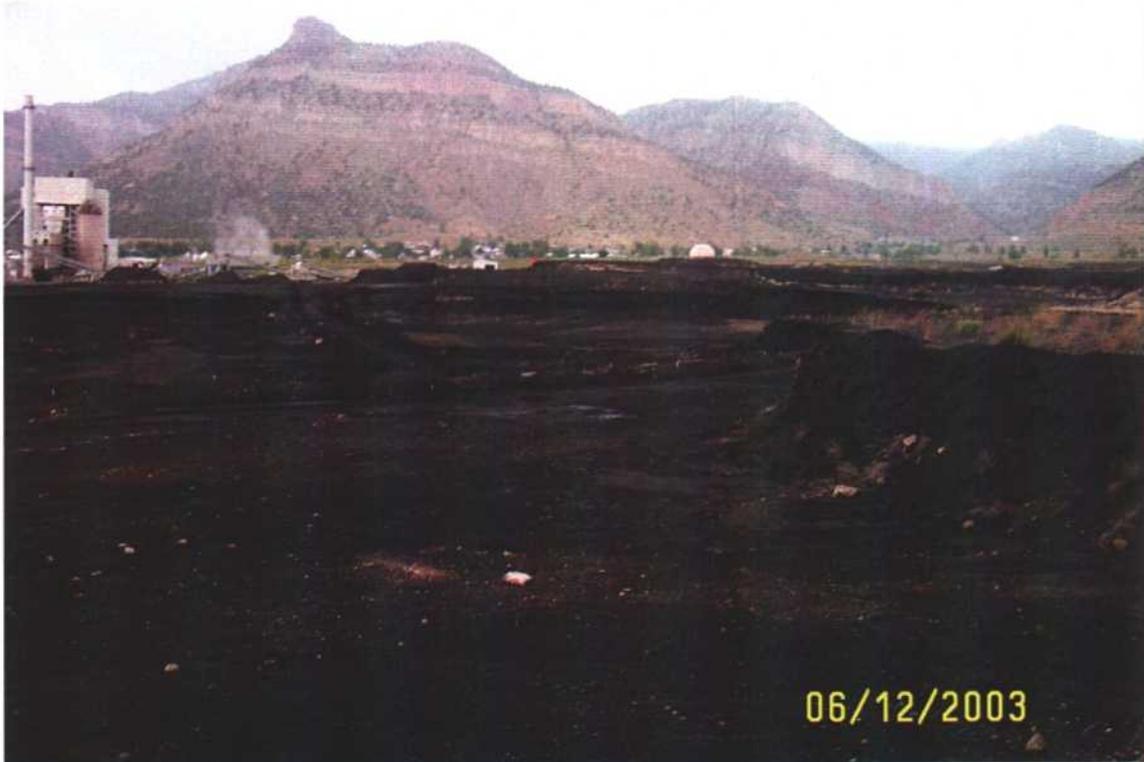
No smokers visible

Coarse Refuse Pile – Looking northeasterly

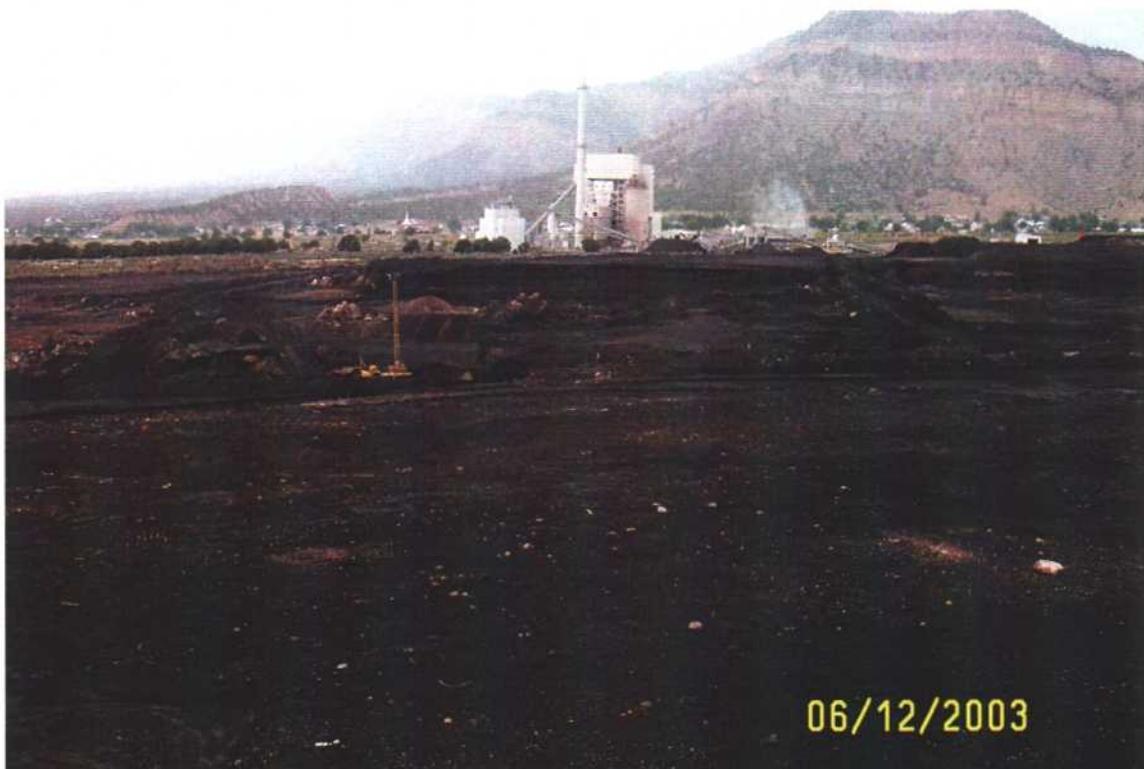
Coarse Refuse Pile – Looking northerly

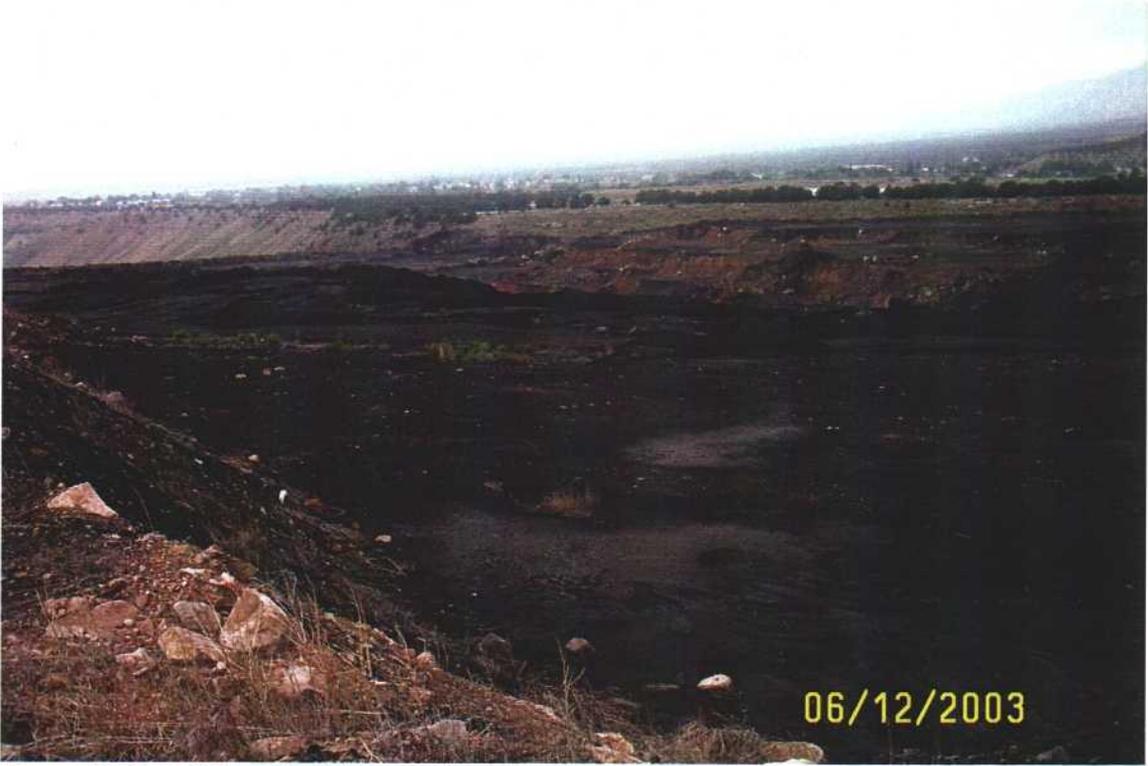
Coarse Refuse Pile – Looking northwesterly

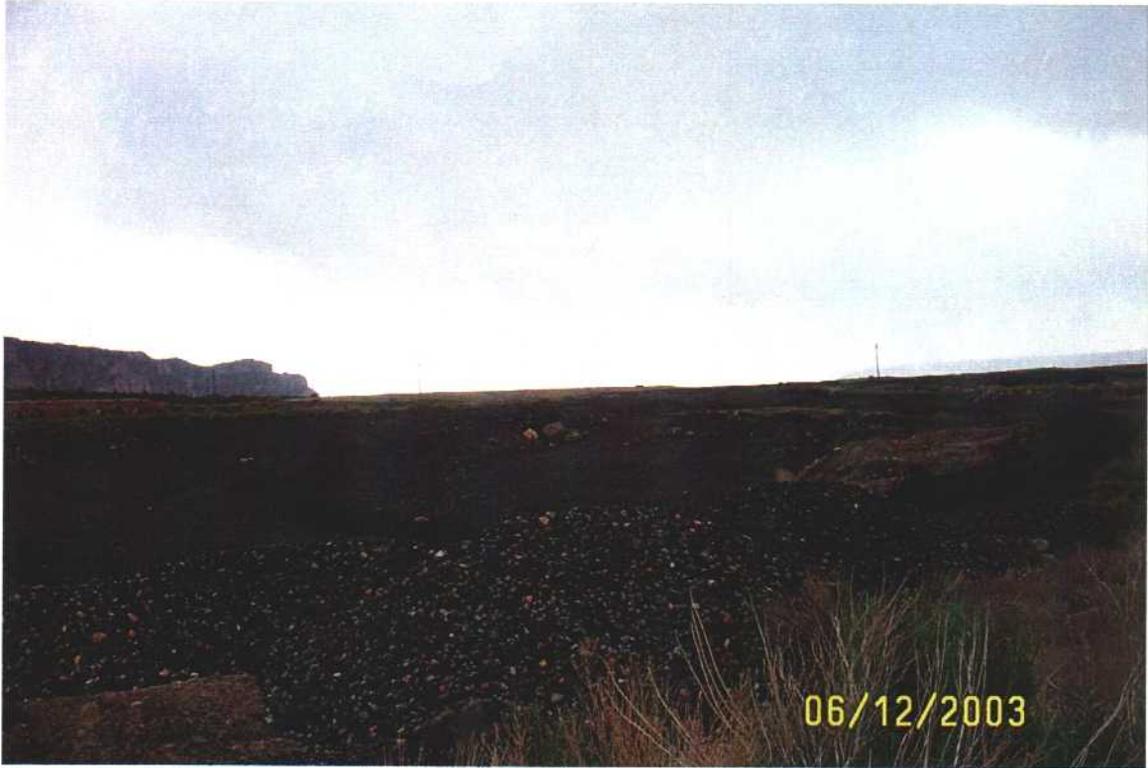
3.	Installation of final surface drainage systems. N/A	
4.	Placement and compaction of fill materials. Placement and compaction of fill material continues in this disposal area. Material consists generally of coarse refuse rejects and is being placed in general conformance with the approved plan. Approximately 1014 tons of material were placed during the Quarter.

Excess Spoil Disposal Area #2 – North end looking southwesterly

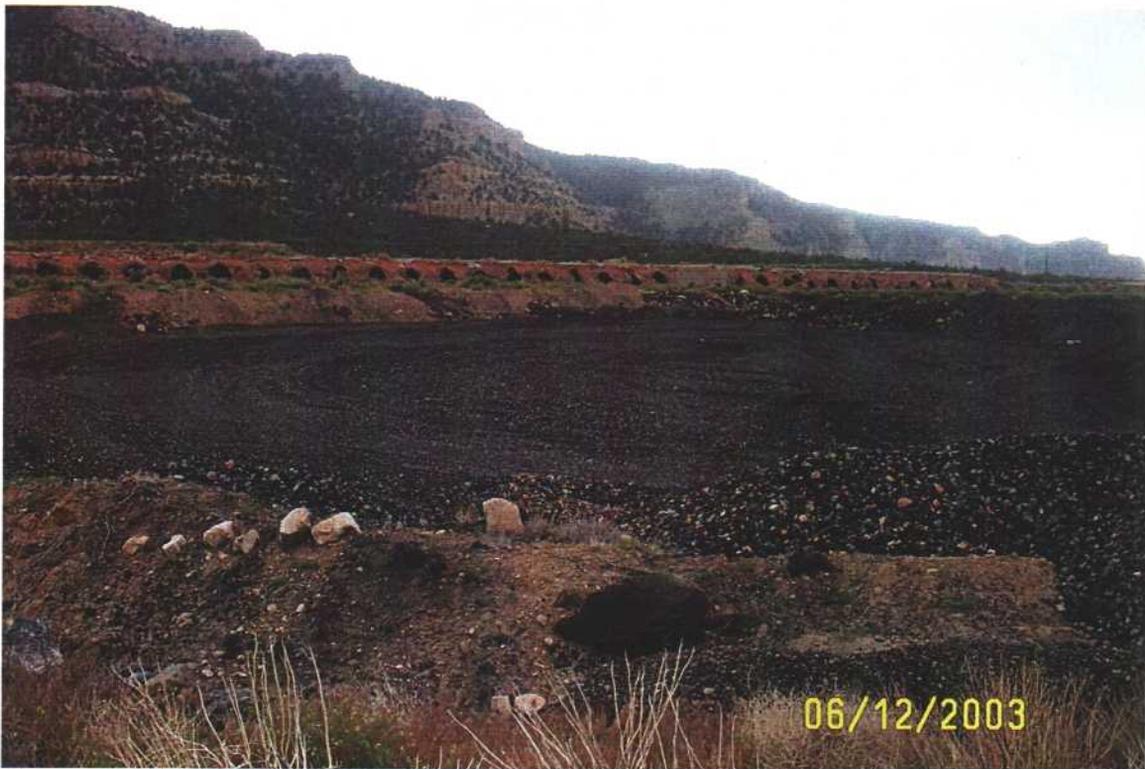
Excess Spoil Disposal Area #2 – North end looking southeasterly
