Sunnyside Cogeneration Associates

RE: Third Quarter 2003 Inspection Report

IMPOUNDMENT INSPECTION AND CERTIFIED REPORT		Clear Water Pond	
Permit Number	ACT/007/035	Report Date	10/6/03
Mine Name	SUNNYSIDE REFUSE AND SLURRY		
Company Name	SUNNYSIDE COGENERATION ASSOCIATES		
Impoundment Identification	Impoundment Name	Clear Water Pond	
	Impoundment Number	004	
	UPDES Permit Number	UT 024759	
	MSHA ID Number	N/A	
IMPOUNDMENT INSPECTION			
Inspection Date	September 12, 2003		
Inspected By	Scott Carlson		
Reason for Inspection (Annual, Quarterly or Other Periodic Inspection, Critical Installation, or Completion of Construction)		Third Quarter Inspection 2003	
<p>1. Describe any appearance of any instability, structural weakness, or any other hazardous condition.</p> <p>NONE</p>			
Required for an impoundment which functions as a SEDIMENTATION POND.	<p>2. Sediment storage capacity, including elevation of 60% and 100% sediment storage volumes, and, estimated average elevation of existing sediment.</p> <p>Storage Capacity = 4.9 acre-feet Maximum Sediment Depth Elevation = 6527 Existing Sediment Elevation = 6523+-</p>

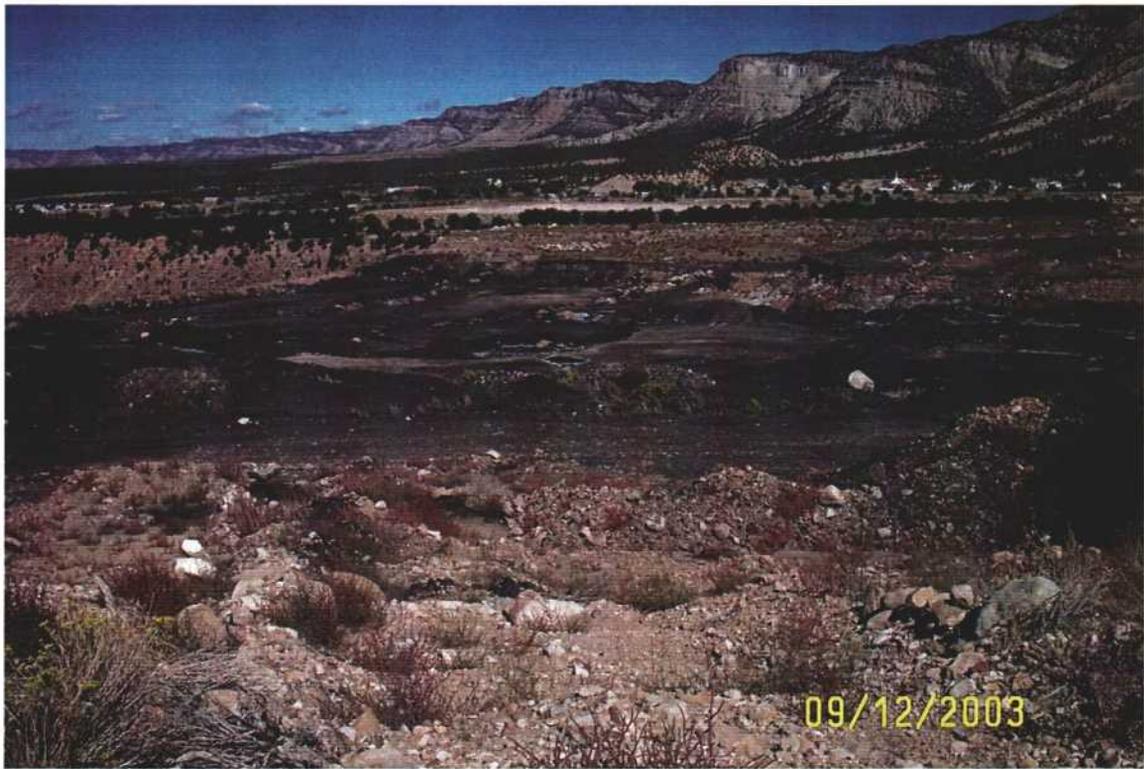
No smokers visible

Waste Coal Removal

Coarse Refuse Pile, looking northwesterly

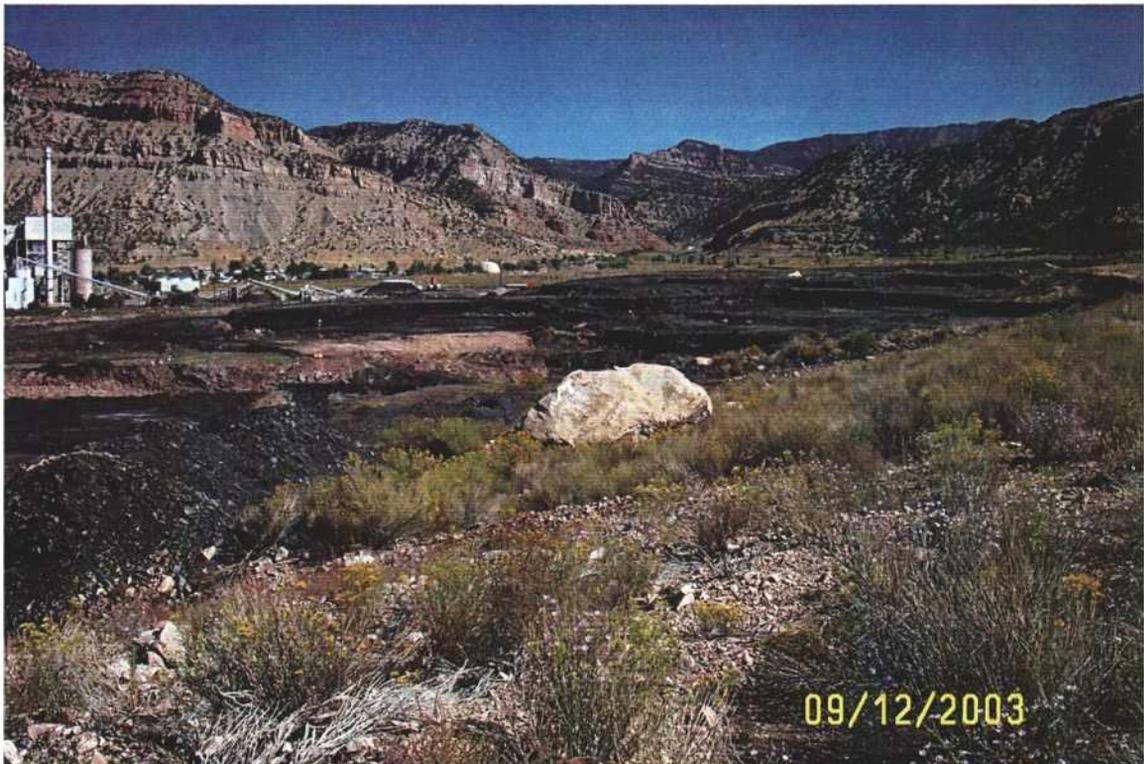
Coarse Refuse Pile, looking northeasterly

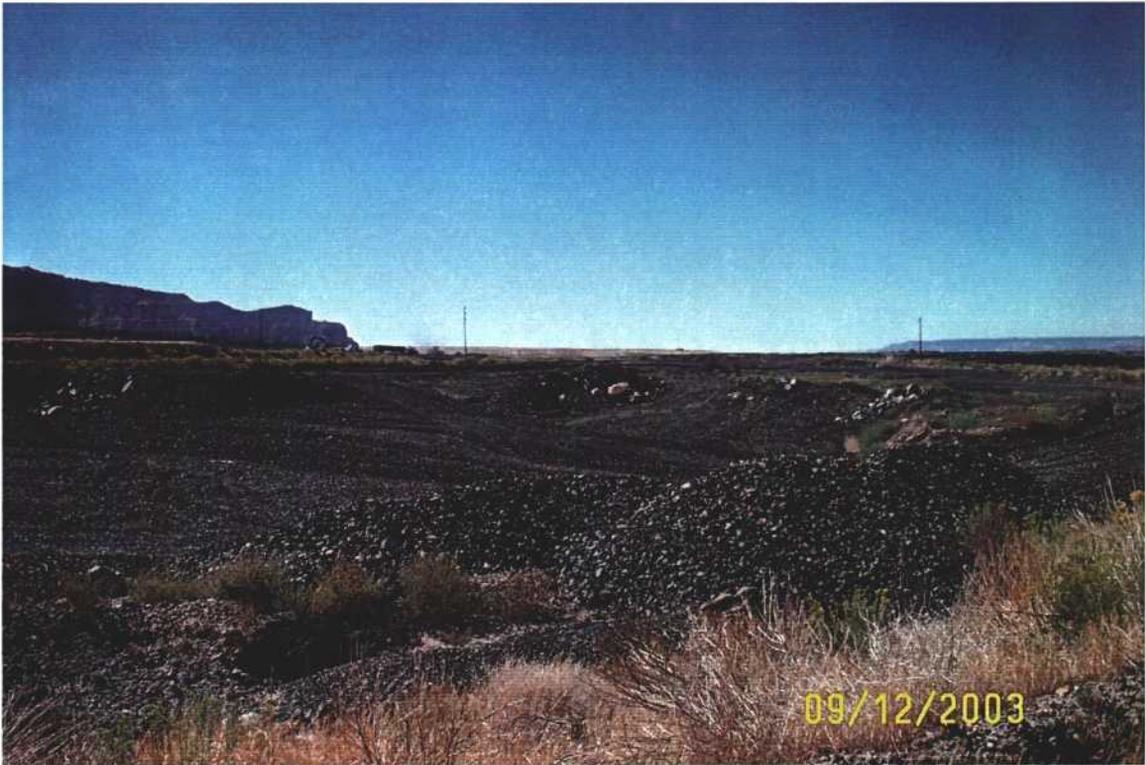
3.	Installation of final surface drainage systems. N/A	
4.	Placement and compaction of fill materials. Placement and compaction of fill material continues in this disposal area. Material consists generally of coarse refuse rejects and is being placed in general conformance with the approved plan. Approximately 4615 tons of material were placed during the Quarter.

None

Both Slurry Pond #1 and Slurry Pond #2 have been approved to be and are being filled with coal mine waste and excess spoil in connection with construction of the Excess Spoil Disposal Area # 2.

Excess Spoil Area #2, Looking Southerly

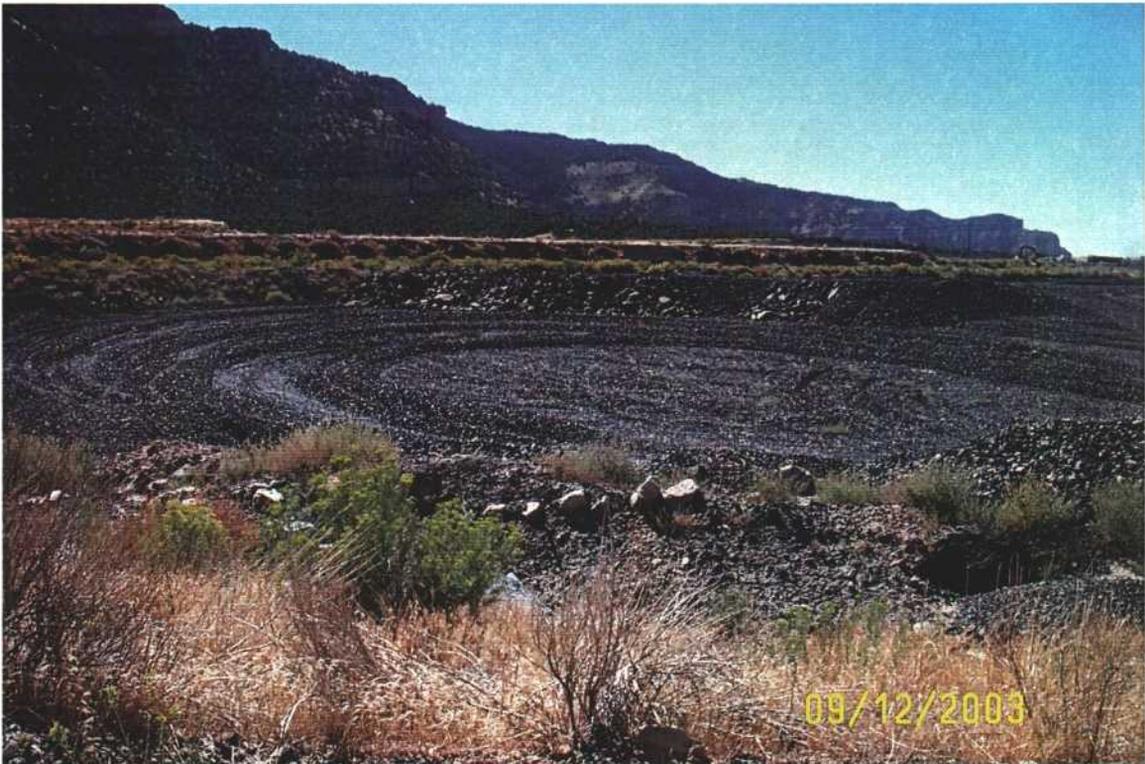
Excess Spoil Area #2, Looking Easterly
