Sunnyside Cogeneration Associates

RE: First Quarter 2004 Inspection Report
Sunnyside Refuse Pile C/007/035

Please find enclosed a copy of the First Quarter 2004 Inspection Report for Sunnyside Cogeneration Associates' impoundments, refuse pile and excess spoil areas. The inspection was performed by a professional engineer from Twin Peaks Engineering.

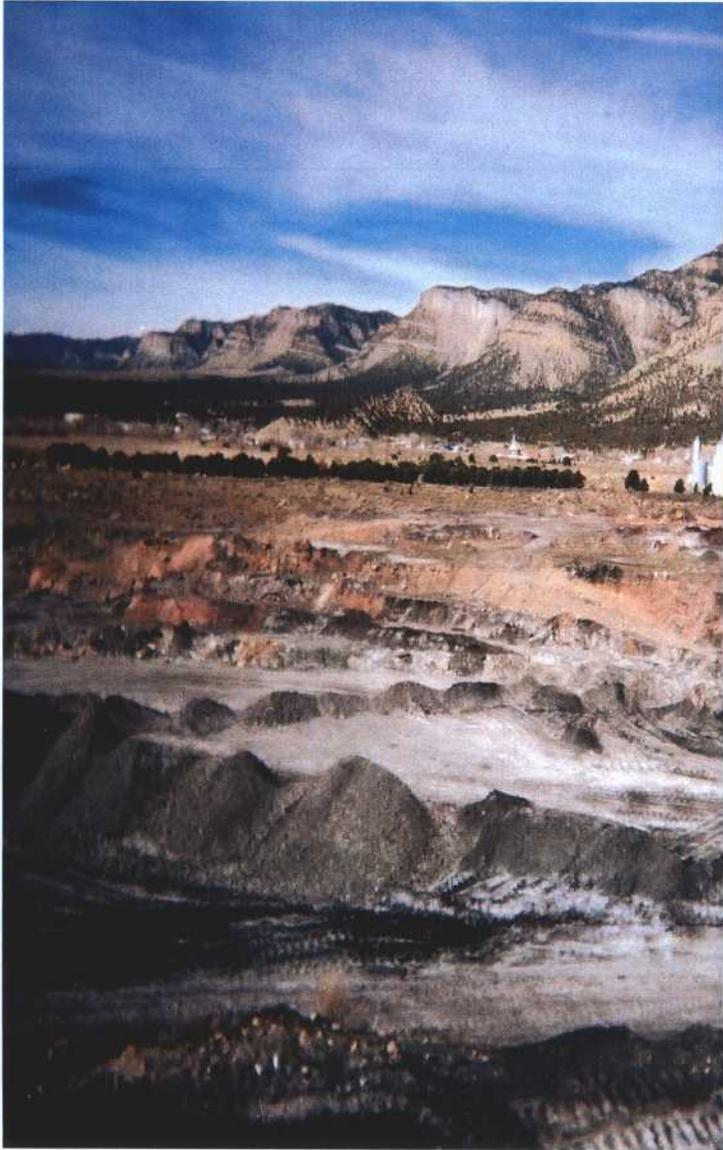
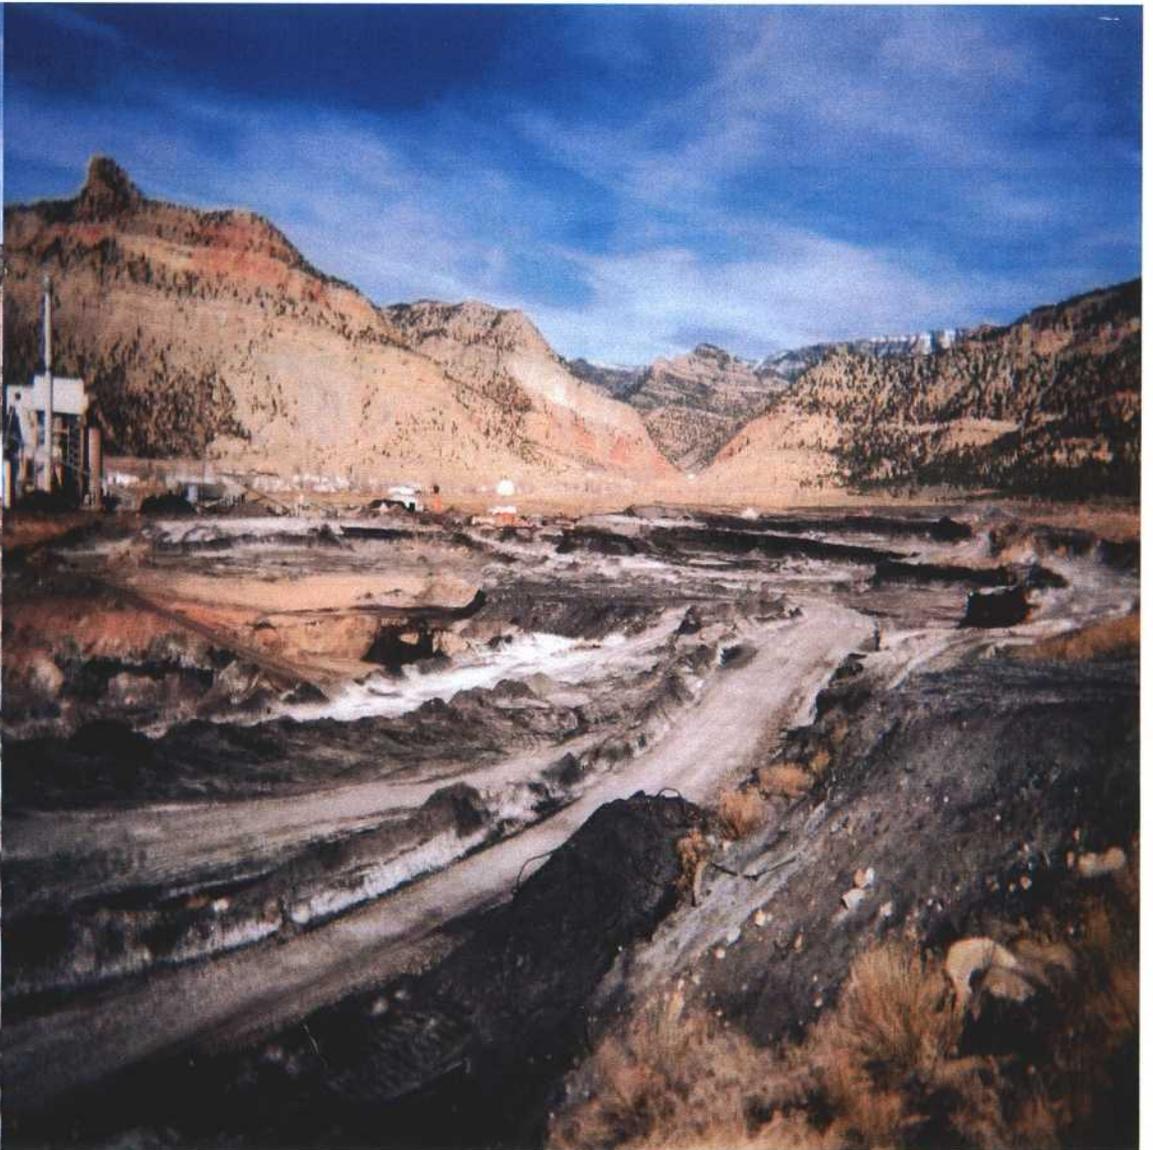
Coarse Refuse Pile

No smokers visible

Waste Coal Removal

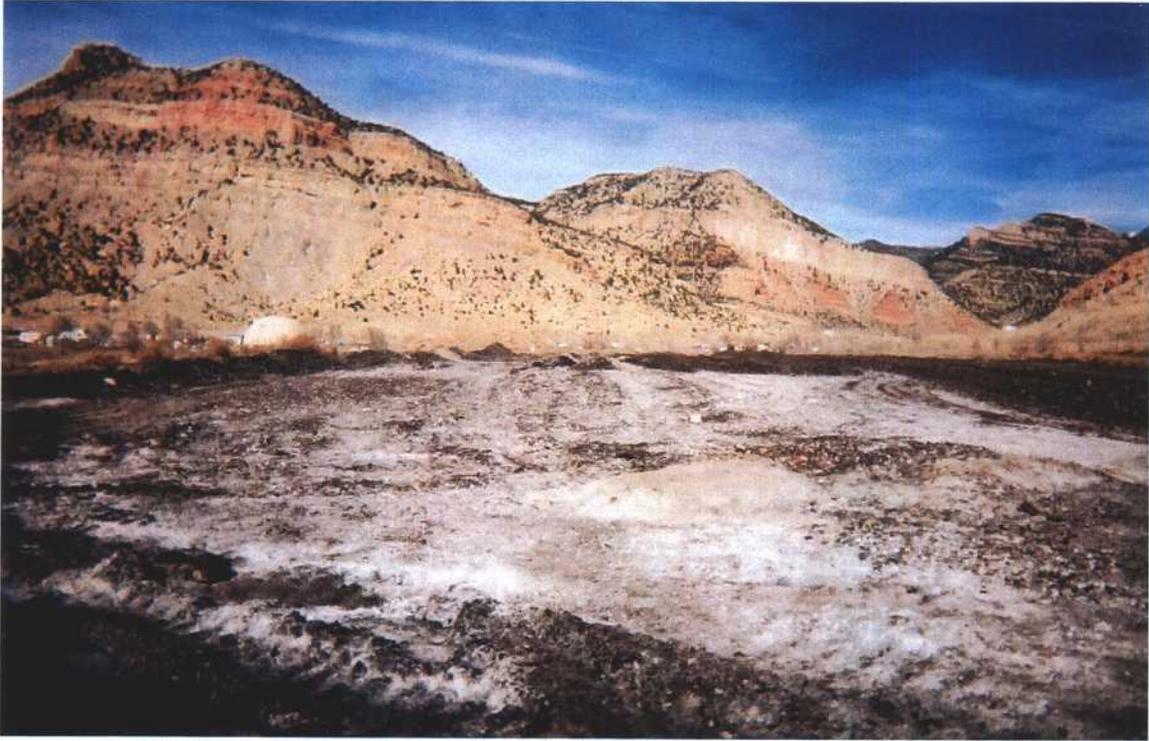
Both Slurry Pond #1 and Slurry Pond #2 have been approved to be and are being filled with coal mine waste and excess spoil in connection with construction of the Excess Spoil Disposal Area # 2.

Excess Spoil Disposal Area #2 Looking North

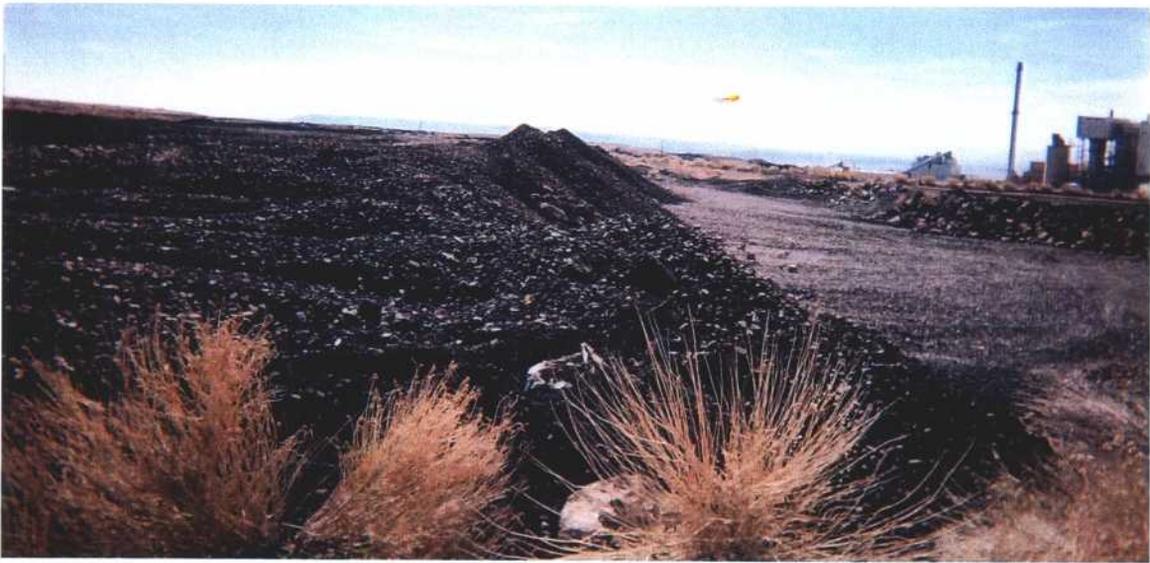
Excess Spoil Disposal Area #2 Looking South
