Sunnyside Cogeneration Associate

RE: Fourth Quarter 2003 Inspection Report
Sunnyside Refuse and Slurry C/007/035

Please find enclosed a copy of the Fourth Quarter 2003 Inspection Report for the Sunnyside refuse pile, impoundments, and excess spoil areas. The inspection was performed by a professional engineer from Psomas and Associates Engineering.

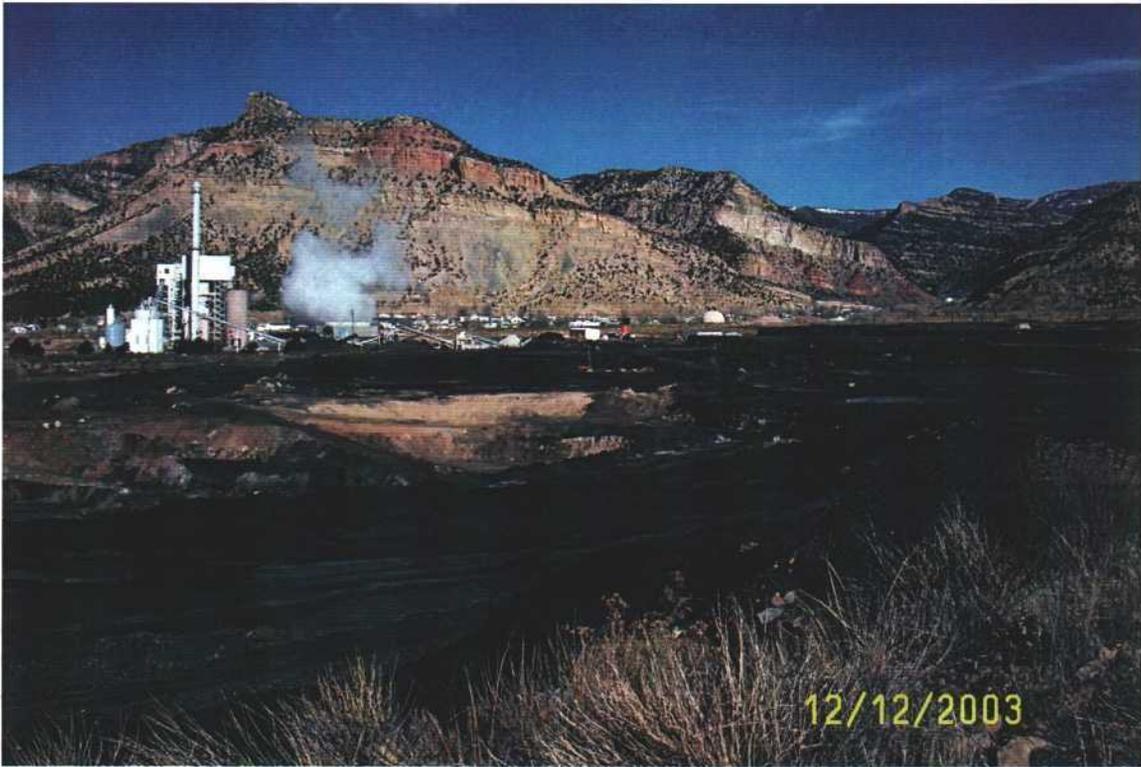
No smokers visible

Coarse Refuse Pile – Looking north/northeast

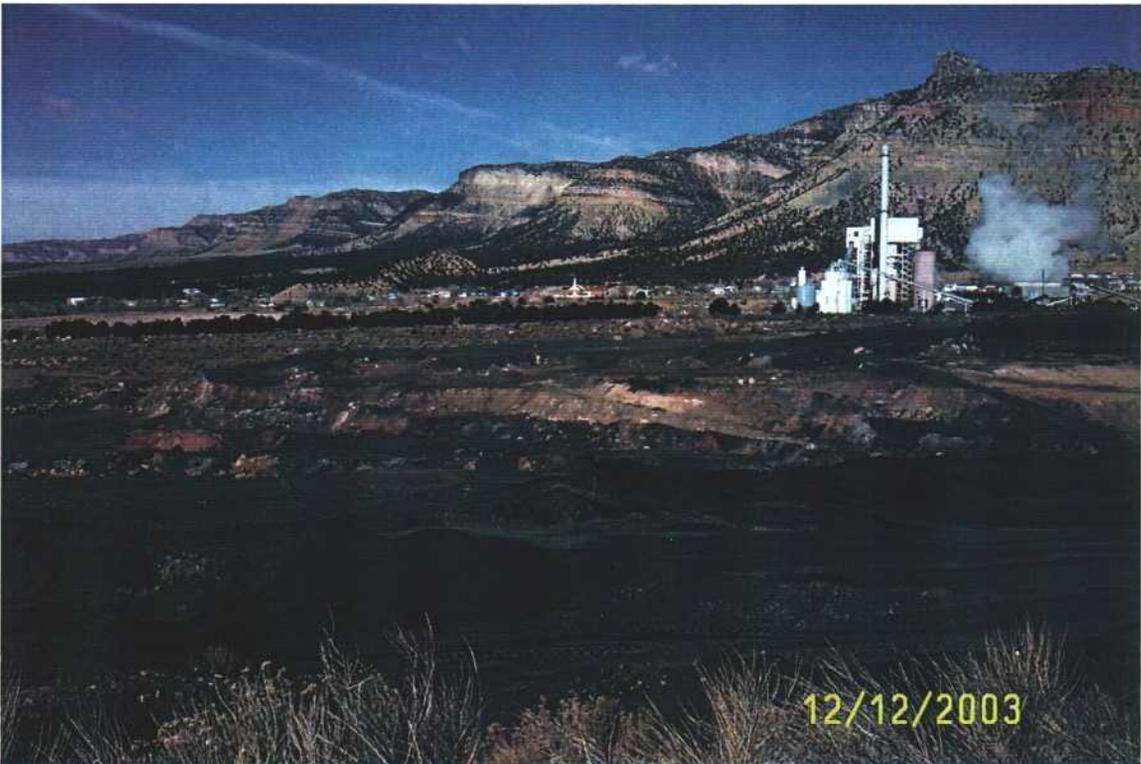
Coarse Refuse Pile – Looking north

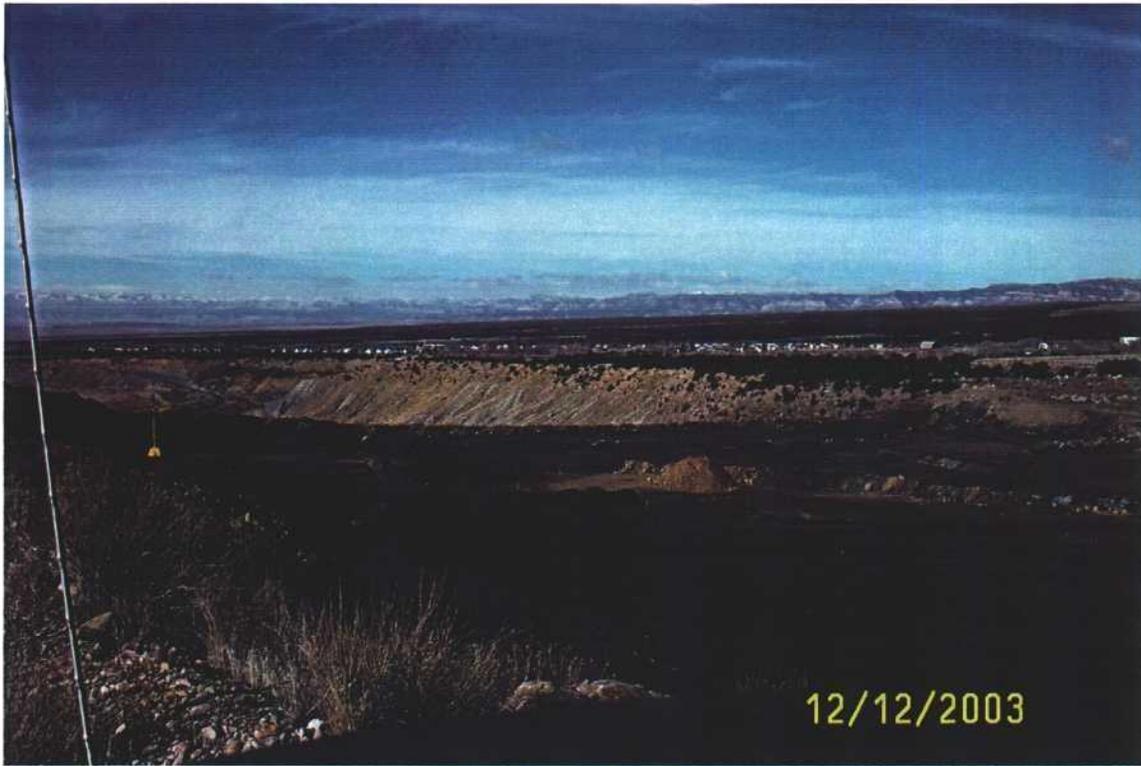
Coarse Refuse Pile – Looking north/northwest

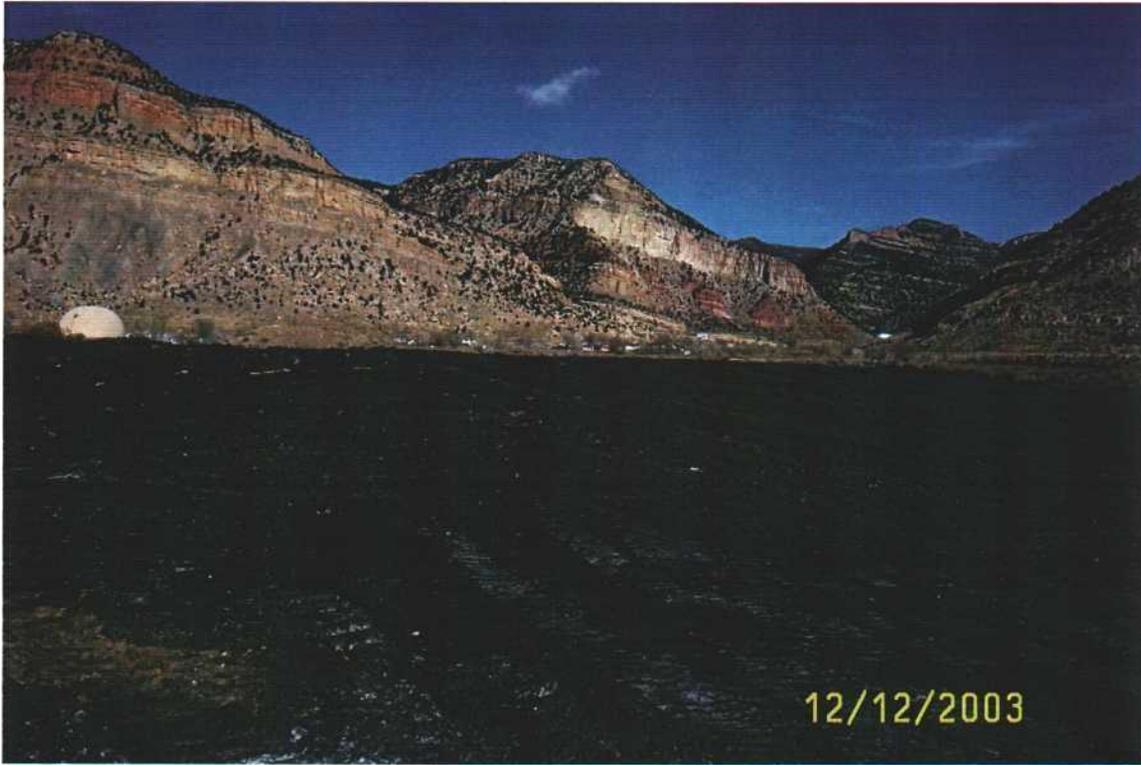
Both Slurry Pond #1 and Slurry Pond #2 have been approved to be and are being filled with coal mine waste and excess spoil in connection with construction of the Excess Spoil Disposal Area # 2.

Excess Spoil Disposal Area # 2 – Looking Northerly

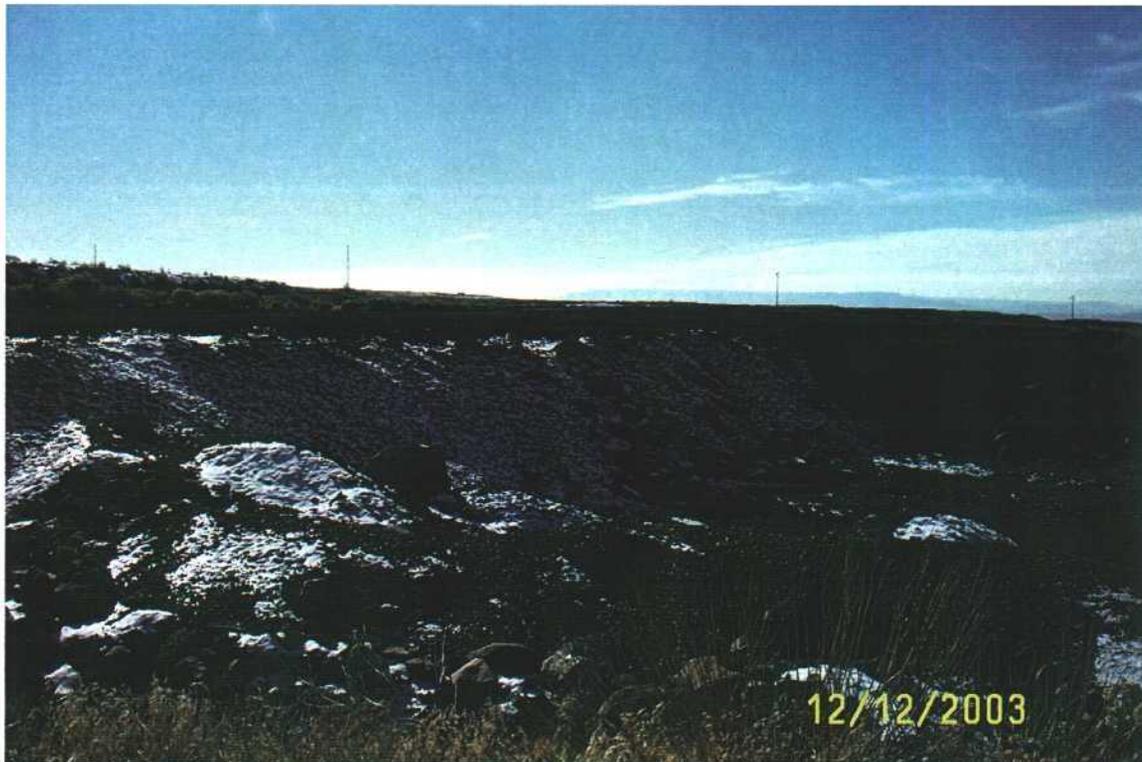
Excess Spoil Disposal Area # 2 – Looking Southerly
