Sunnyside Cogeneration Associates

RE: Annual 2003 Inspection Report
 Sunnyside Refuse and Slurry C/007/035

Please find enclosed a copy of the Annual 2003 Inspection Report for the Sunnyside refuse pile, impoundments, and excess spoil areas. The inspection was performed by a professional engineer from Psomas and Associates Engineering.

IMPOUNDMENT INSPECTION AND CERTIFIED REPORT		Clear Water Pond	
Permit Number	ACT/007/035	Report Date	1/6/04
Mine Name	SUNNYSIDE REFUSE AND SLURRY		
Company Name	SUNNYSIDE COGENERATION ASSOCIATES		
Impoundment Identification	Impoundment Name	Clear Water Pond	
	Impoundment Number	004	
	UPDES Permit Number	UT 024759	
	MSHA ID Number	N/A	
IMPOUNDMENT INSPECTION			
Inspection Date	December 12, 2003		
Inspected By	Scott Carlson		
Reason for Inspection (Annual, Quarterly or Other Periodic Inspection, Critical Installation, or Completion of Construction)	Annual Inspection 2003		
<p>1. Describe any appearance of any instability, structural weakness, or any other hazardous condition.</p> <p>NONE</p>			
Required for an impoundment which functions as a SEDIMENTATION POND.	<p>2. Sediment storage capacity, including elevation of 60% and 100% sediment storage vol

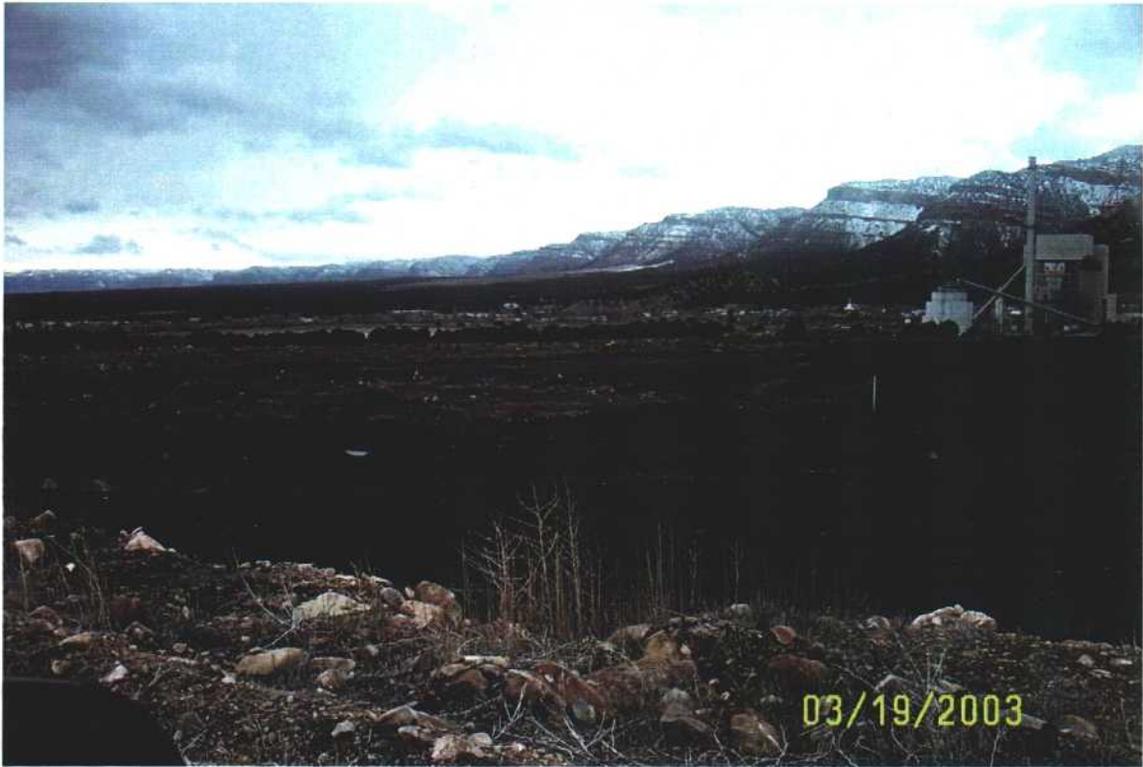
No smokers visible

Coarse Refuse Pile – Looking North/Northwest

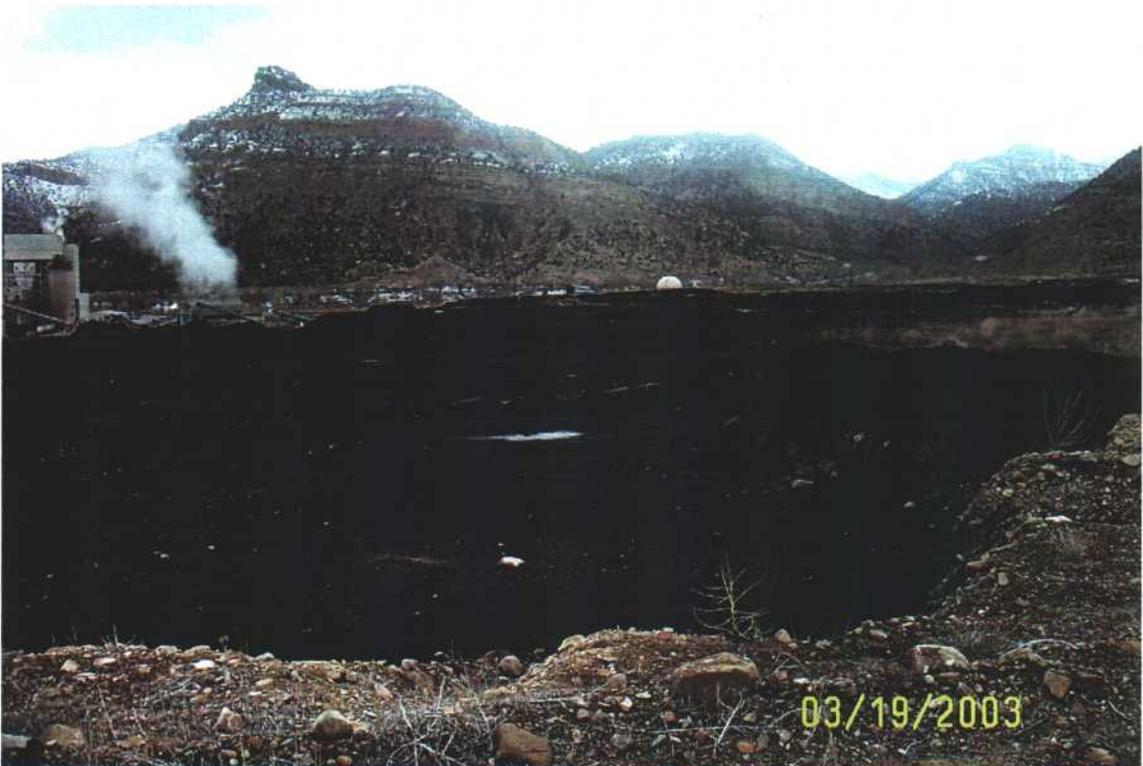
Coarse Refuse Pile – Looking North/Northeast

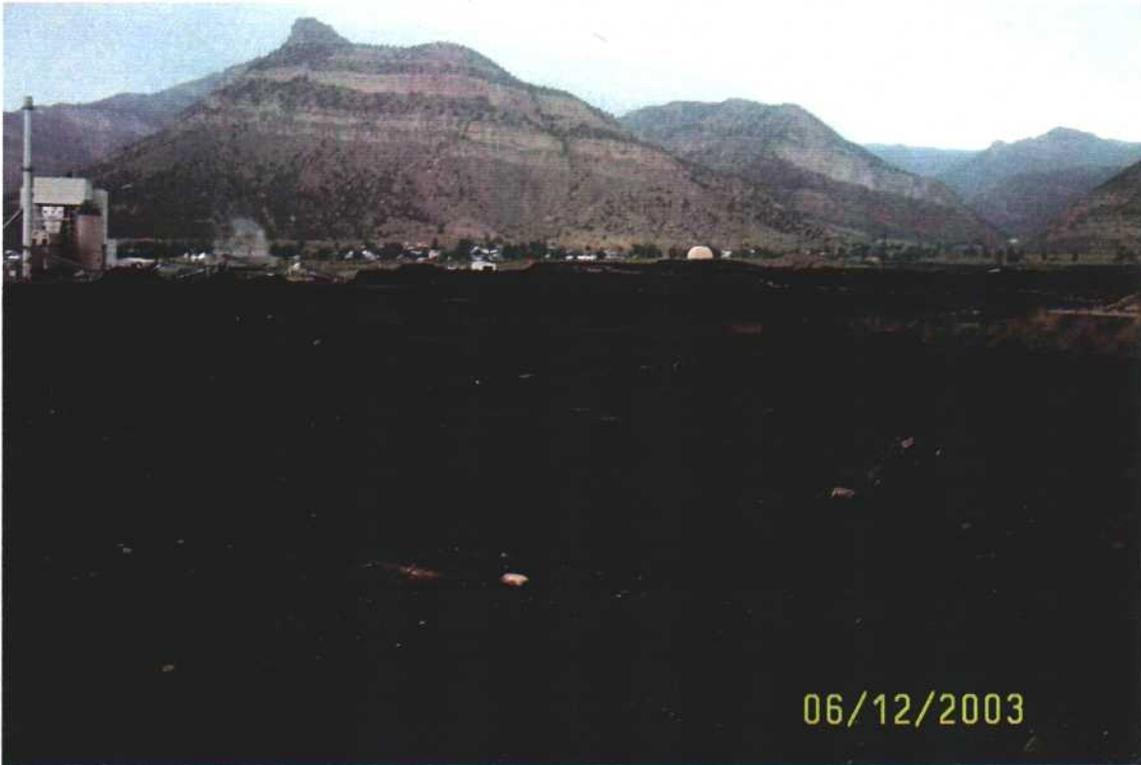
Coarse Refuse Pile – Looking northeasterly

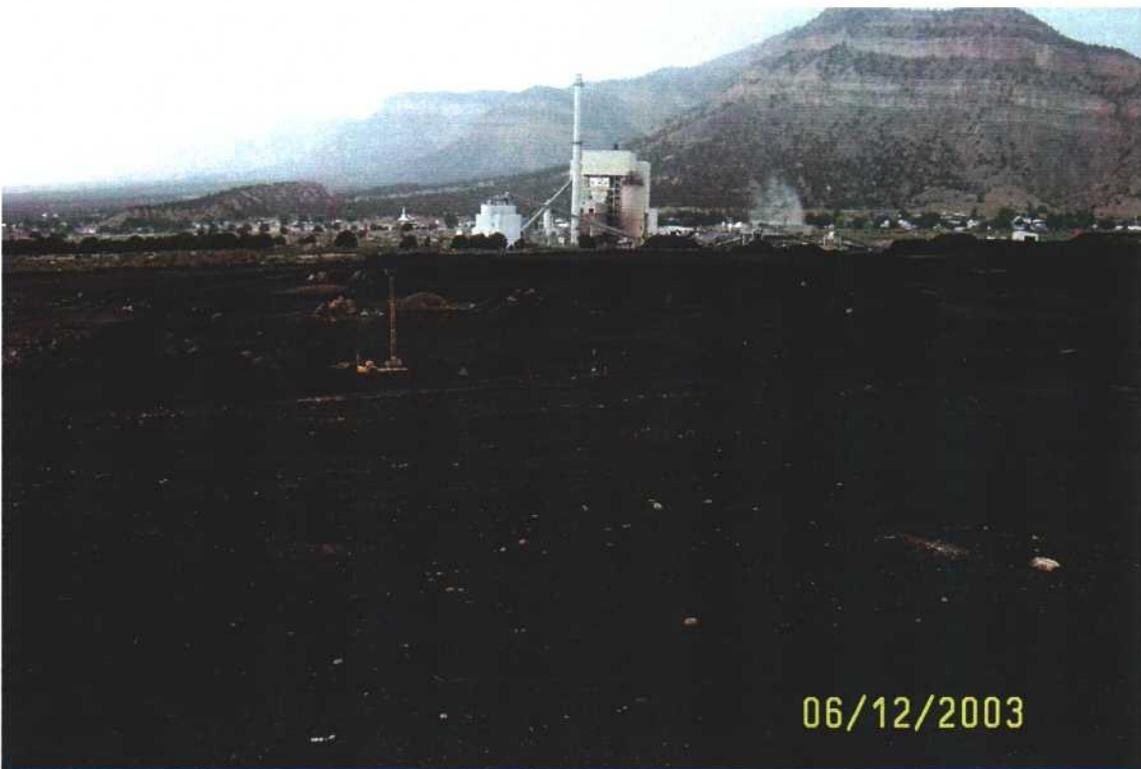
Coarse Refuse Pile – Looking northerly

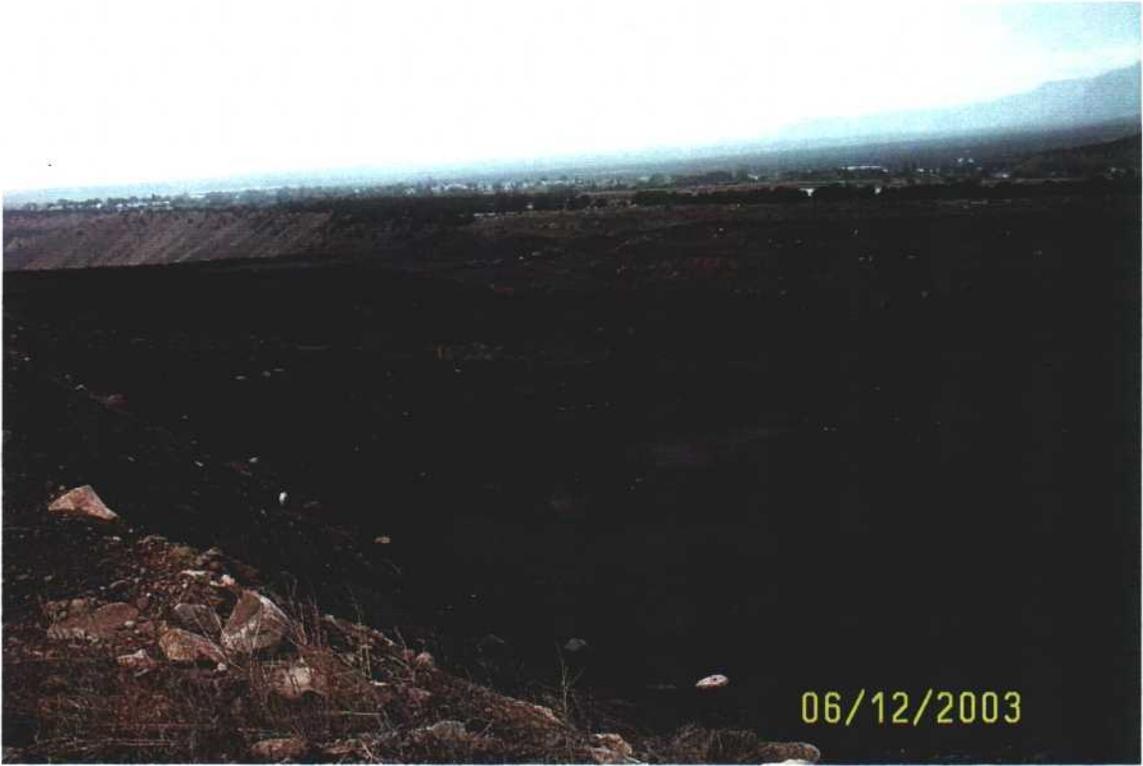
Coarse Refuse Pile – Looking northwesterly

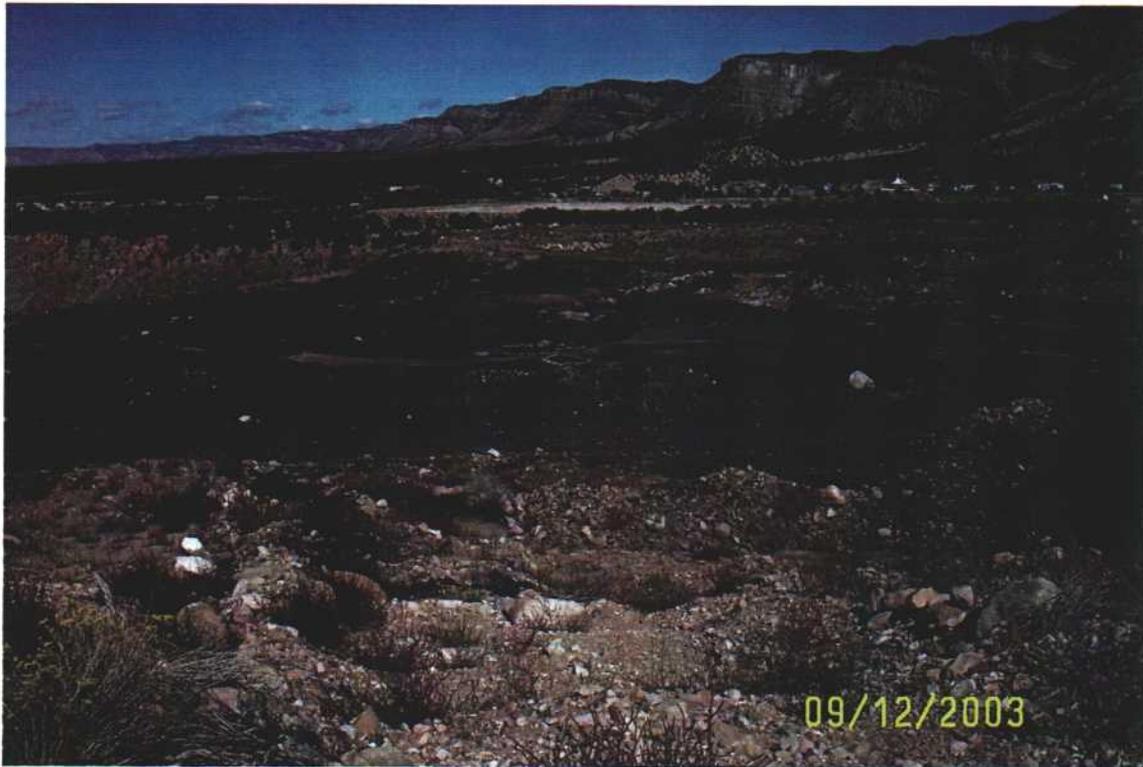
Coarse Refuse Pile, looking northwesterly

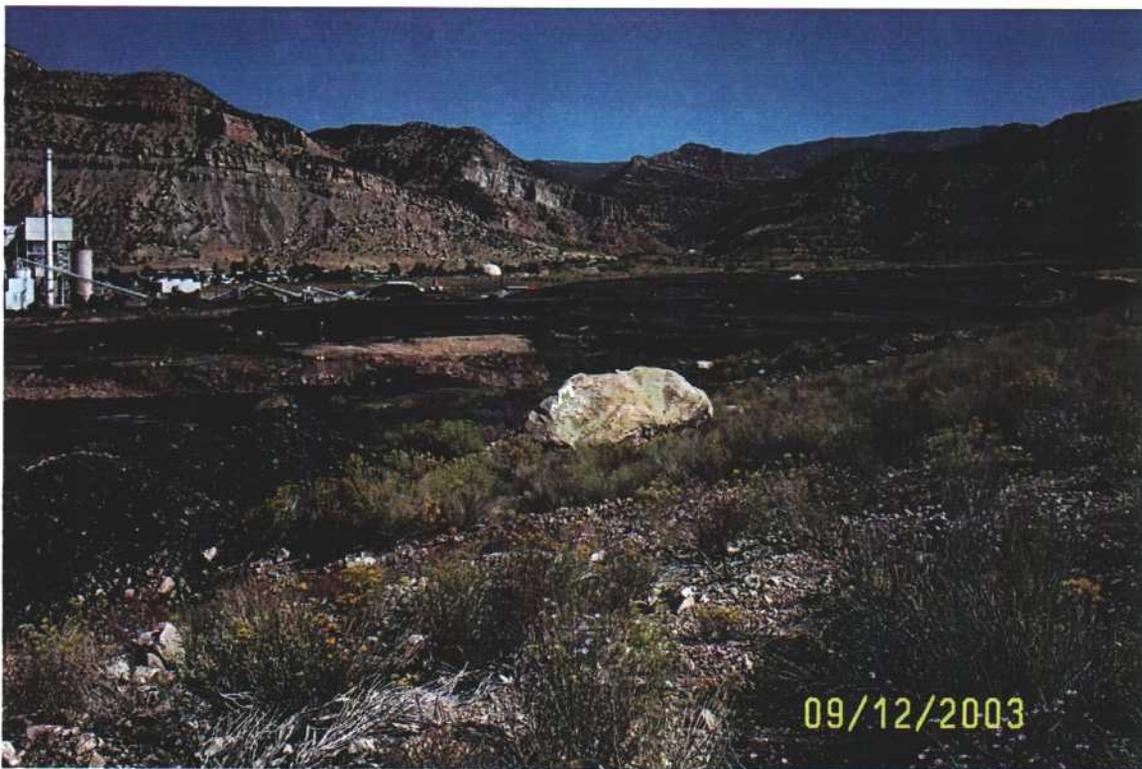
Coarse Refuse Pile, looking northeasterly

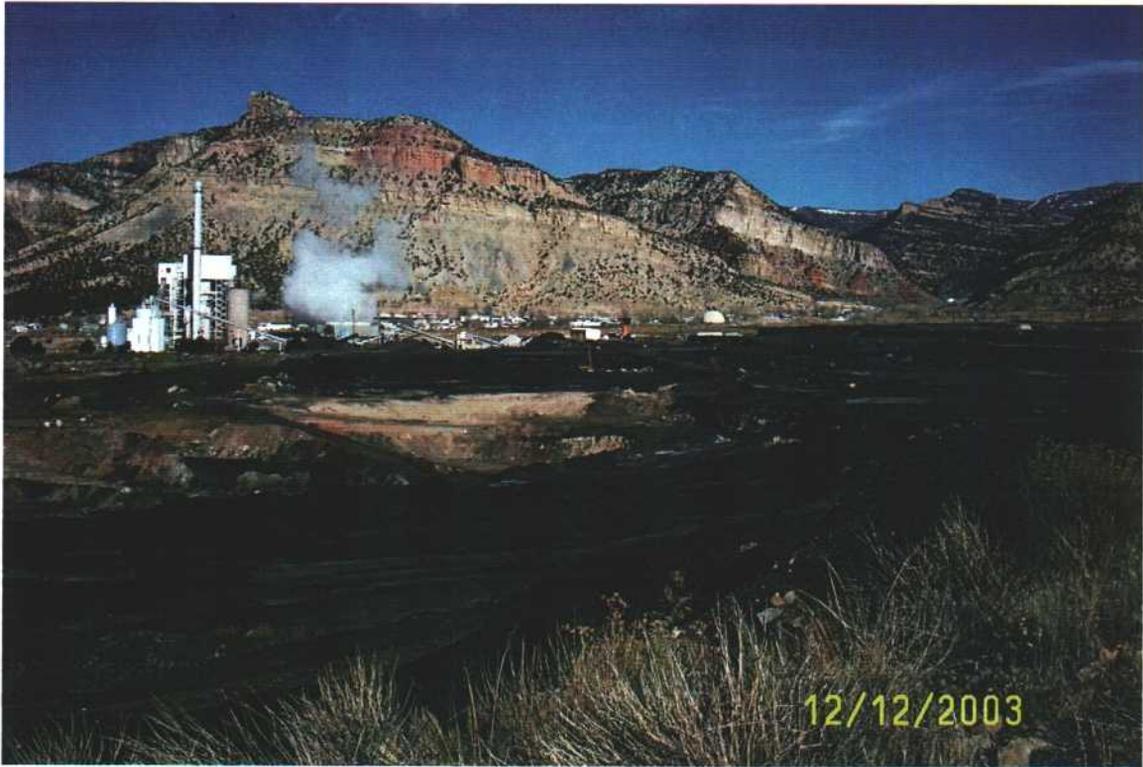
Coarse Refuse Pile – Looking north/northeast

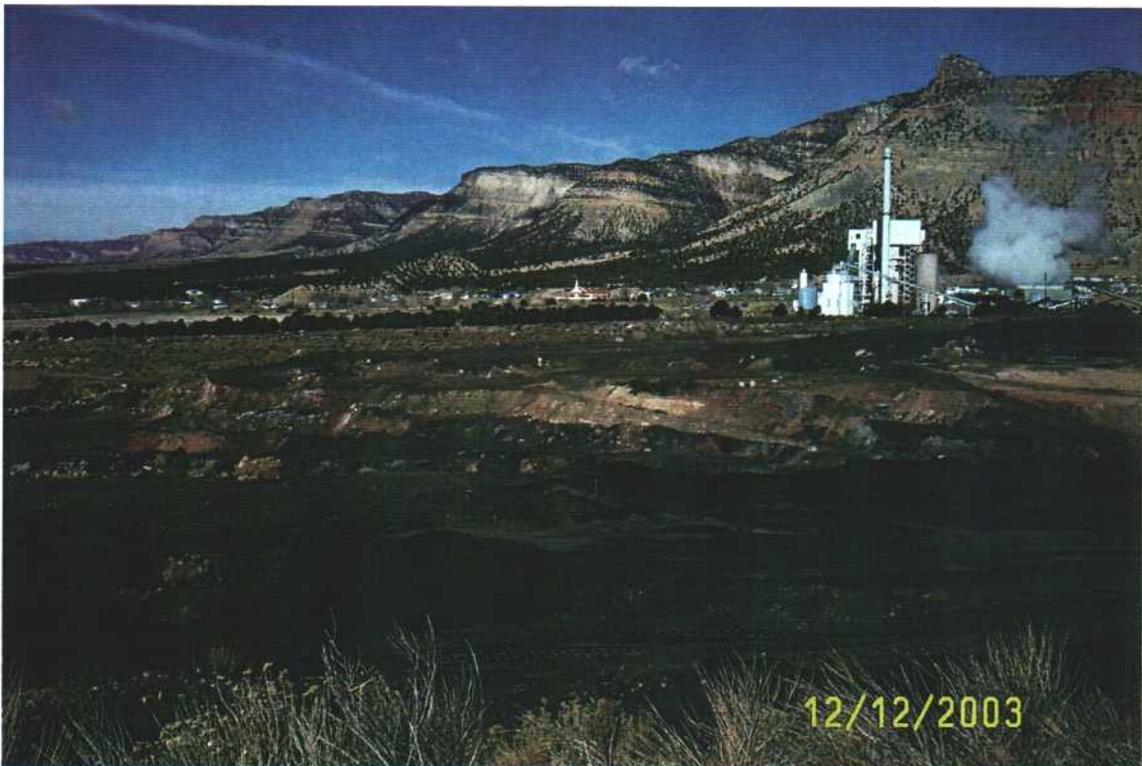
Coarse Refuse Pile – Looking north

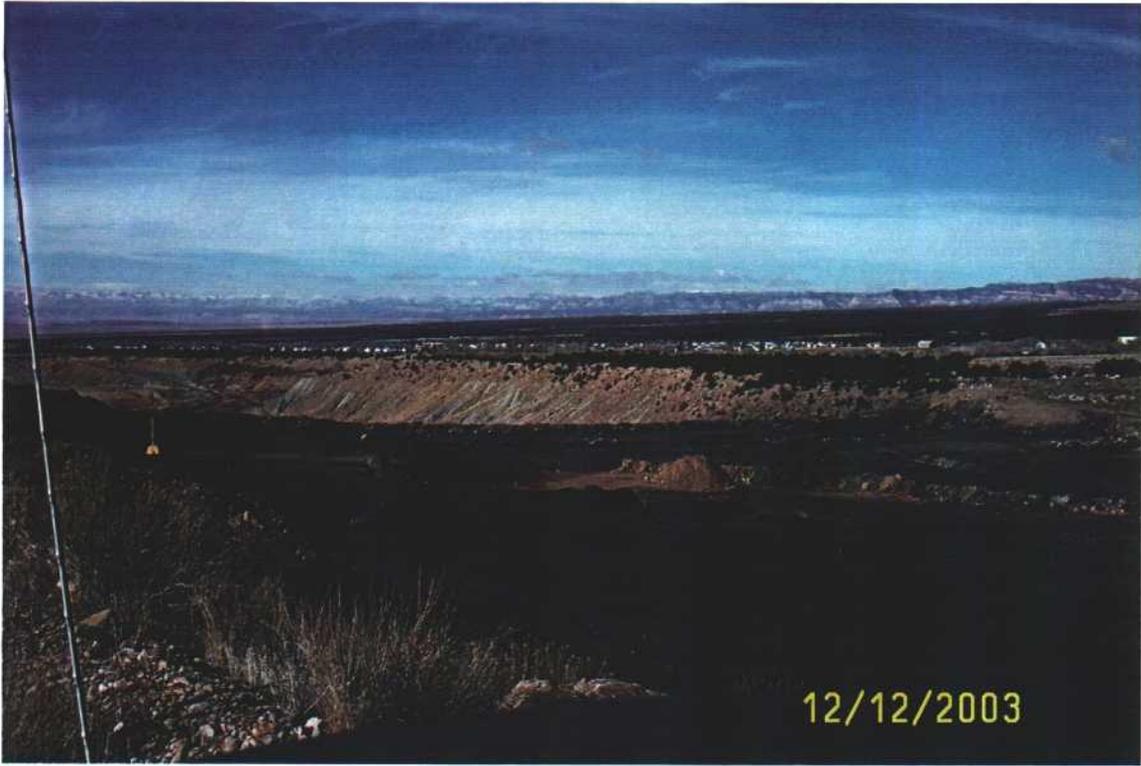
Coarse Refuse Pile – Looking north/northwest

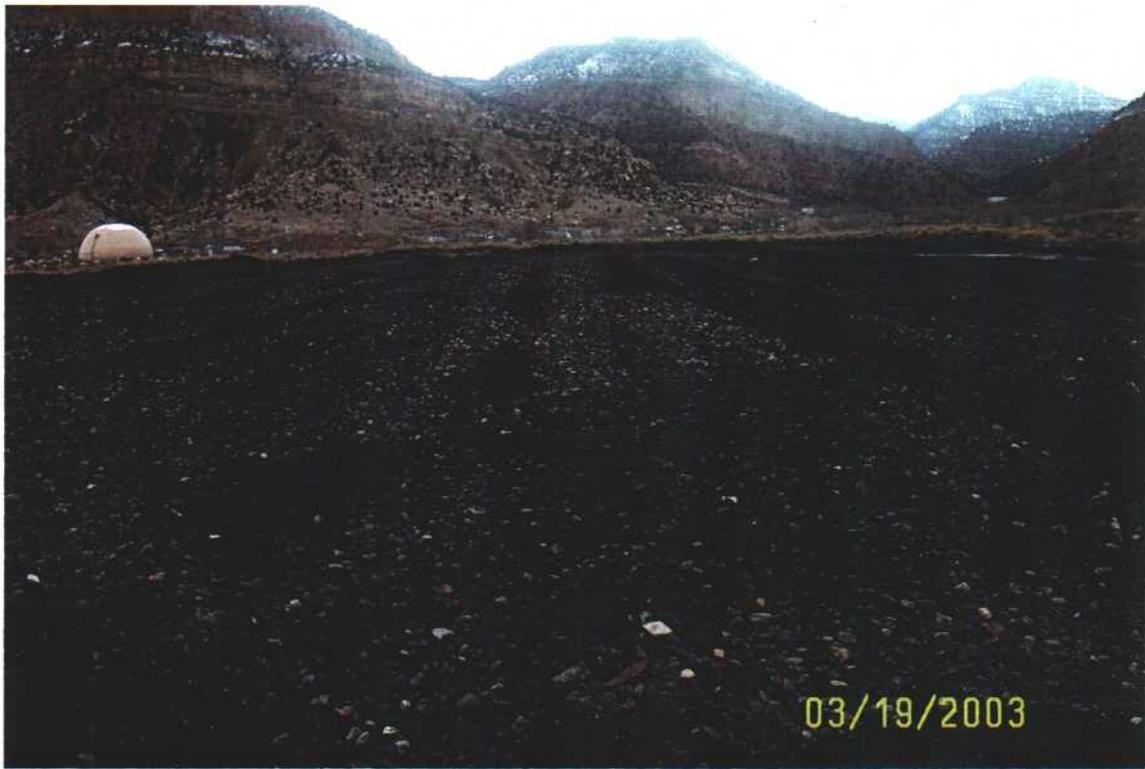
Excess Spoil Disposal Area #2 – Looking North

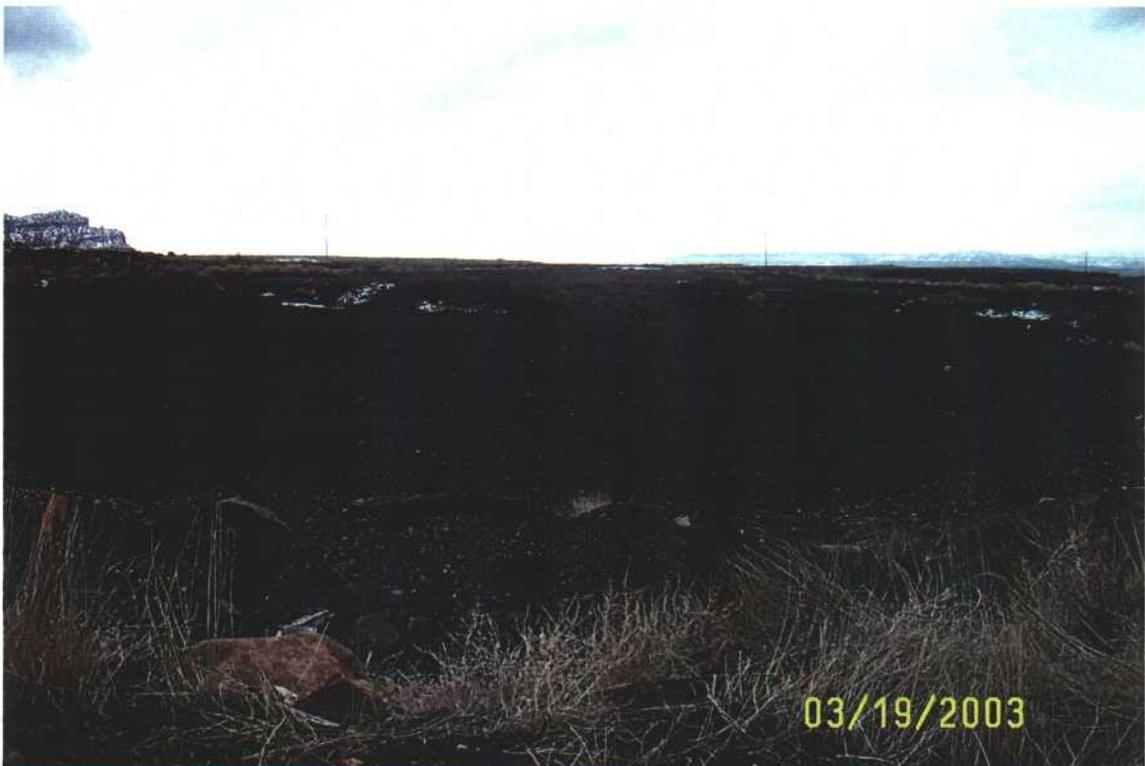
Excess Spoil Disposal Area #2 – Looking South

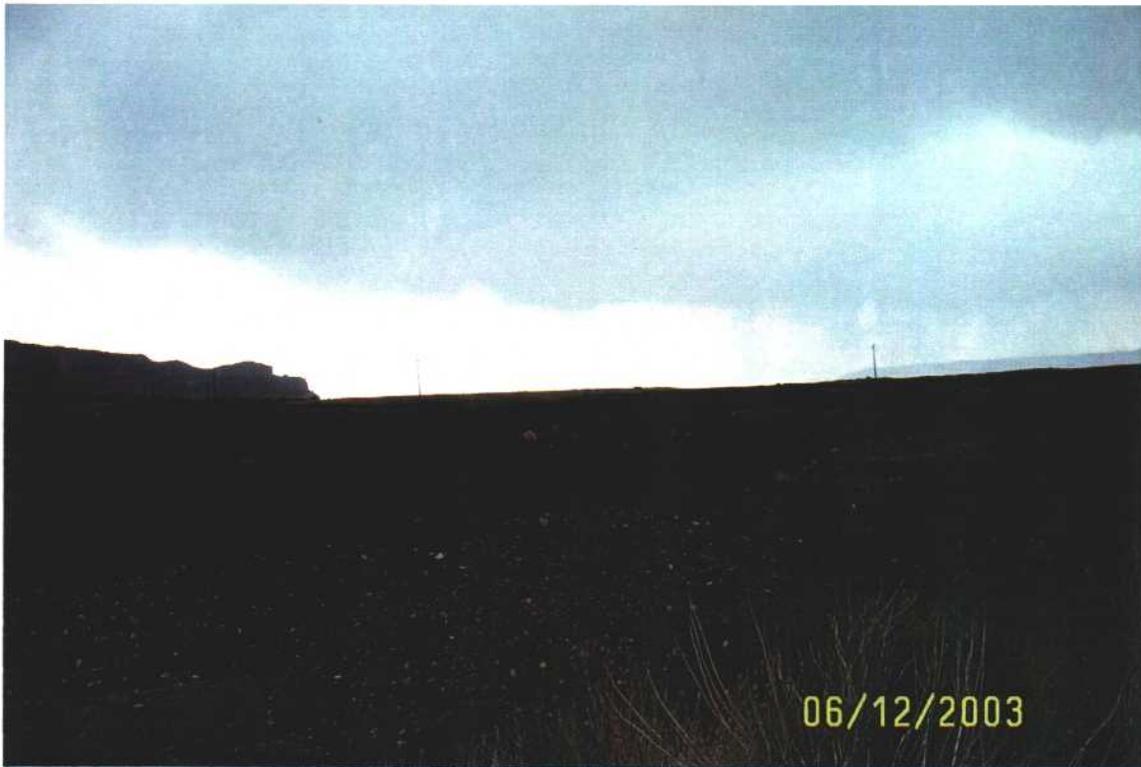
Excess Spoil Disposal Area #2 – North end looking southwesterly

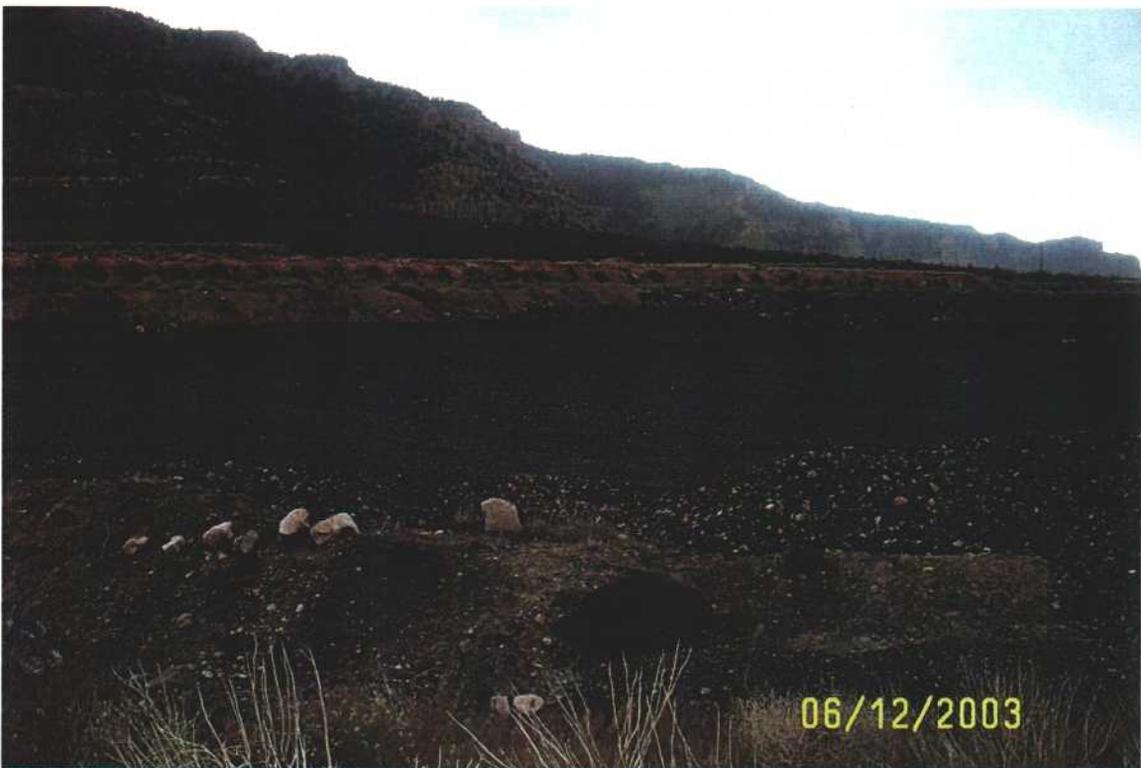
Excess Spoil Disposal Area #2 – North end looking southeasterly

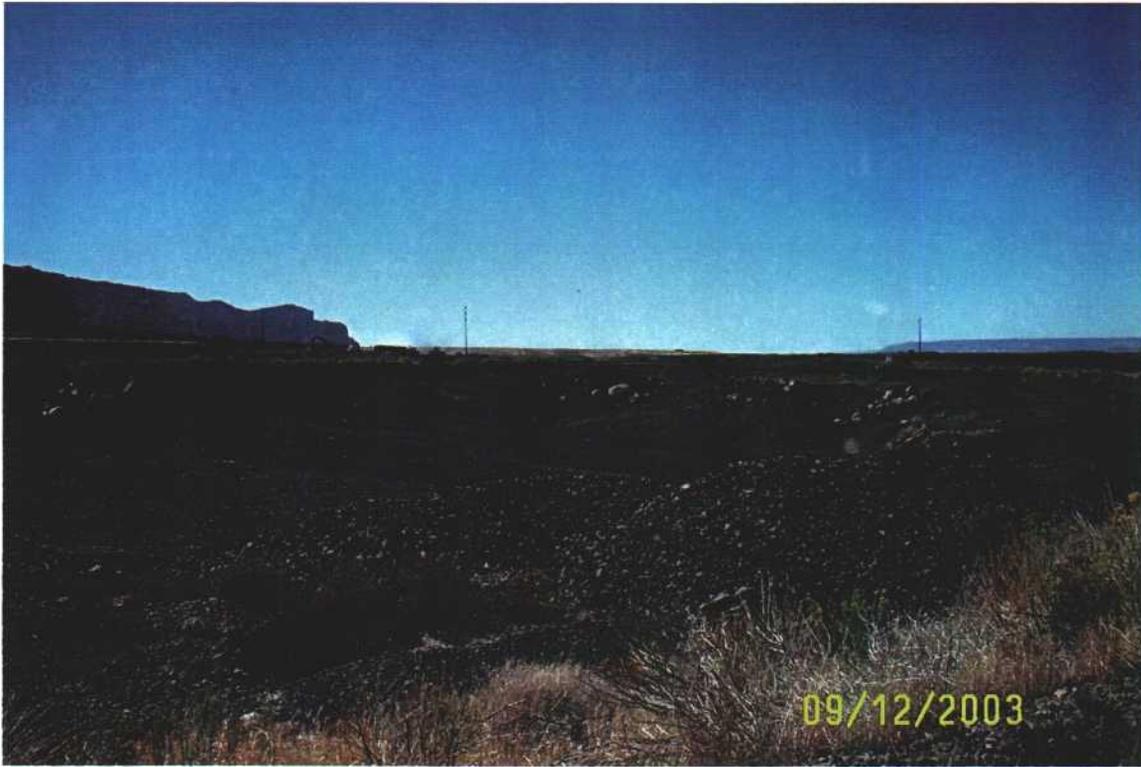
Excess Spoil Area #2, Looking Southerly

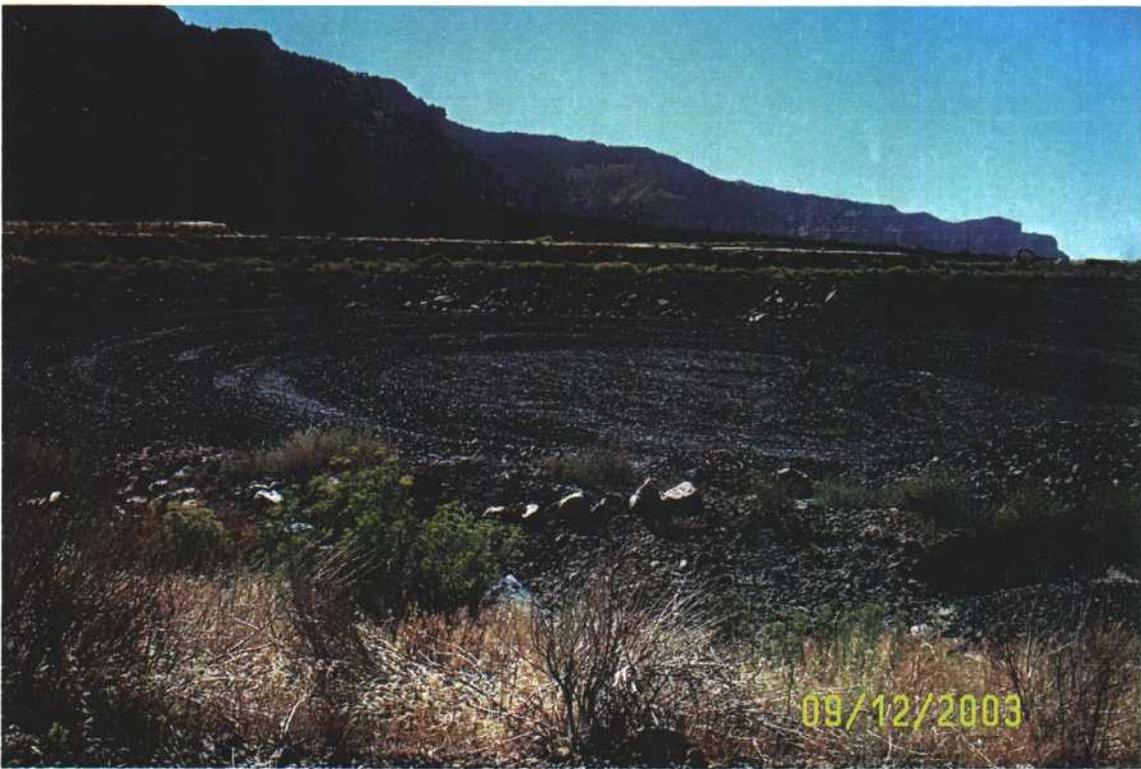
Excess Spoil Area #2, Looking Easterly

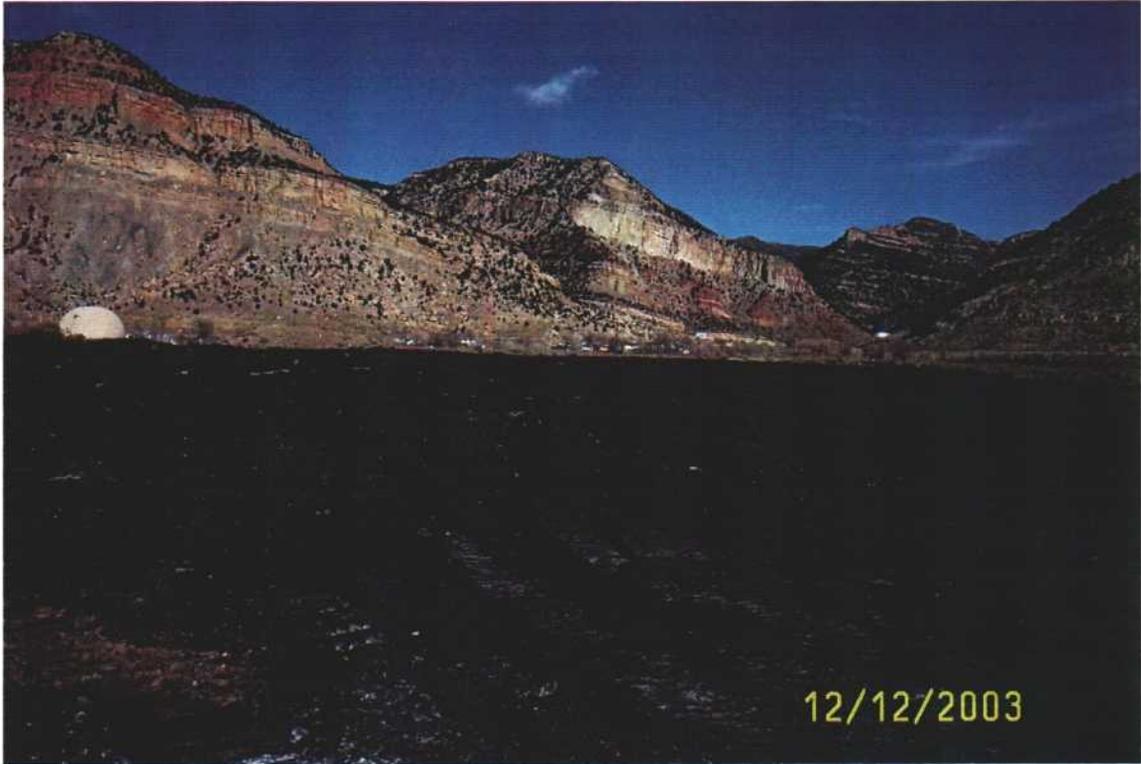
Excess Spoil Disposal Area # 2 – Looking Northerly

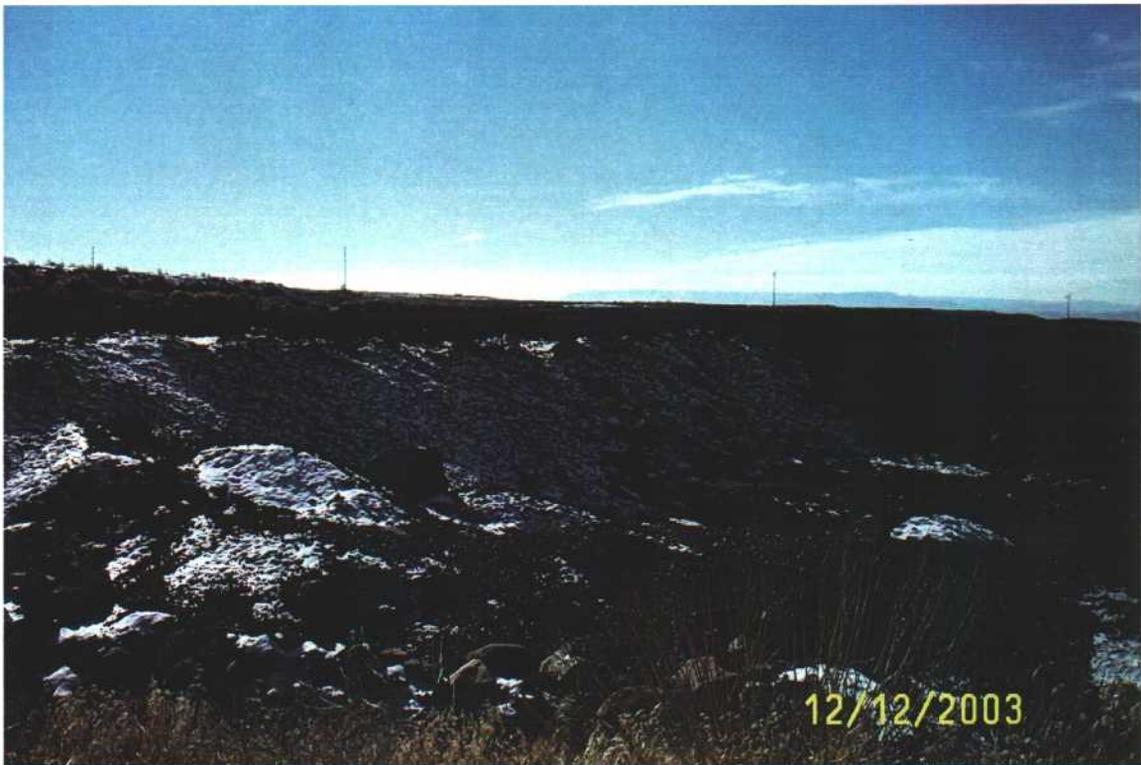
Excess Spoil Disposal Area # 2 – Looking Southerly
