IMPOUNDMENT INSPECTION AND CERTIFIED REPORT		Clear Water Pond	
Permit Number	ACT/007/035	Report Date 4/8/05	
Mine Name	SUNNYSIDE REFUSE AND SLURRY		
Company Name	SUNNYSIDE COGENERATION ASSOCIATES		
Impoundment Identification	Impoundment Name	Clear Water Pond	
	Impoundment Number	004	
	UPDES Permit Number	UT 024759	
	MSHA ID Number	N/A	
IMPOUNDMENT INSPECTION			
Inspection Date	March 25, 2005		
Inspected By	Scott Carlson		
Reason for Inspection (Annual, Quarterly or Other Periodic Inspection, Critical Installation, or Completion of Construction)		First Quarter Inspection 2005	
<p>1. Describe any appearance of any instability, structural weakness, or any other hazardous condition.</p> <p>NONE</p>			
<p>Required for an impoundment which functions as a SEDIMENTATION POND.</p>	<p>2. Sediment storage capacity, including elevation of 60% and 100% sediment storage volumes, and, estimated average elevation of existing sediment.</p> <p>Storage Capacity = 4.9 acre-feet Maximum Sediment Depth Elevation = 6527 Existing Sediment Elevation = 6523+-</p>

IMPOUNDMENT INSPECTION AND CERTIFIED REPORT

Clear Water Pond

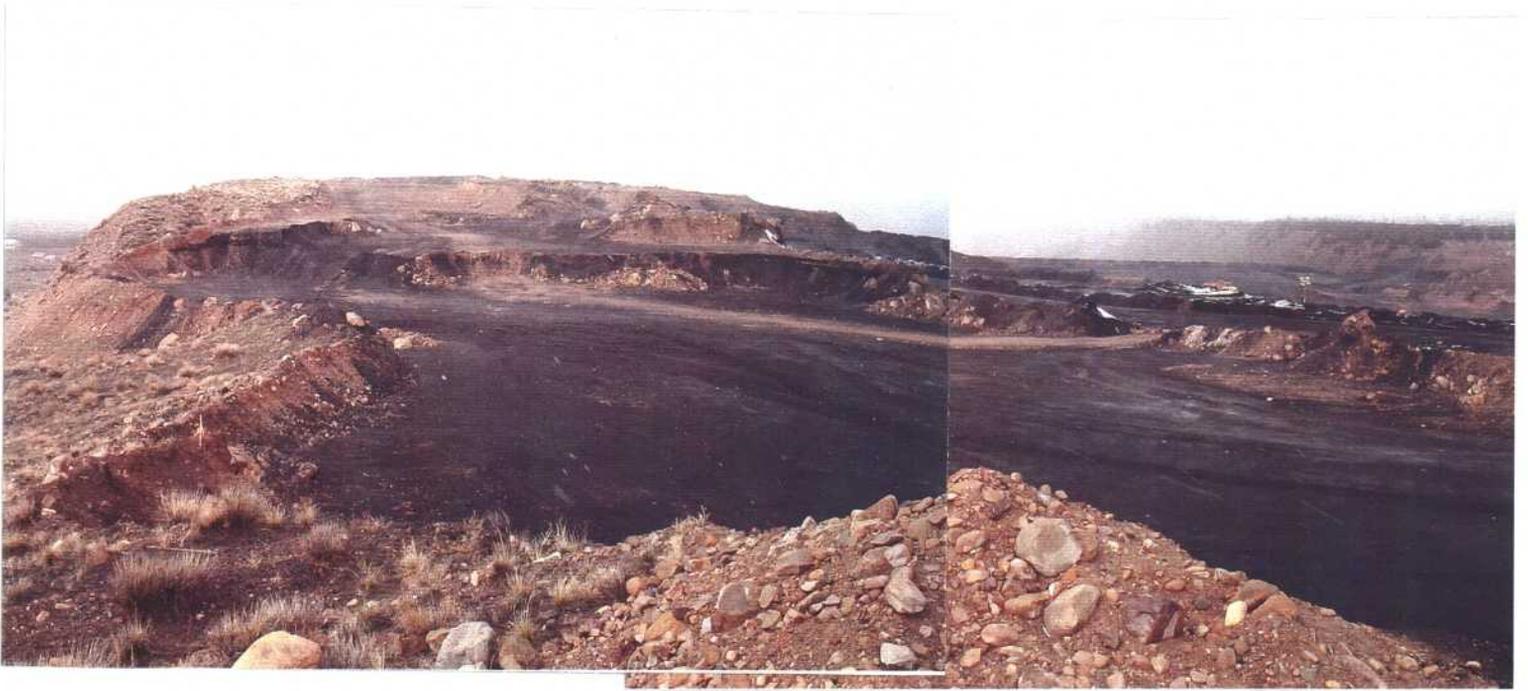
No smokers visible

Waste Coal Removal

Coarse Refuse Pile looking northwesterly

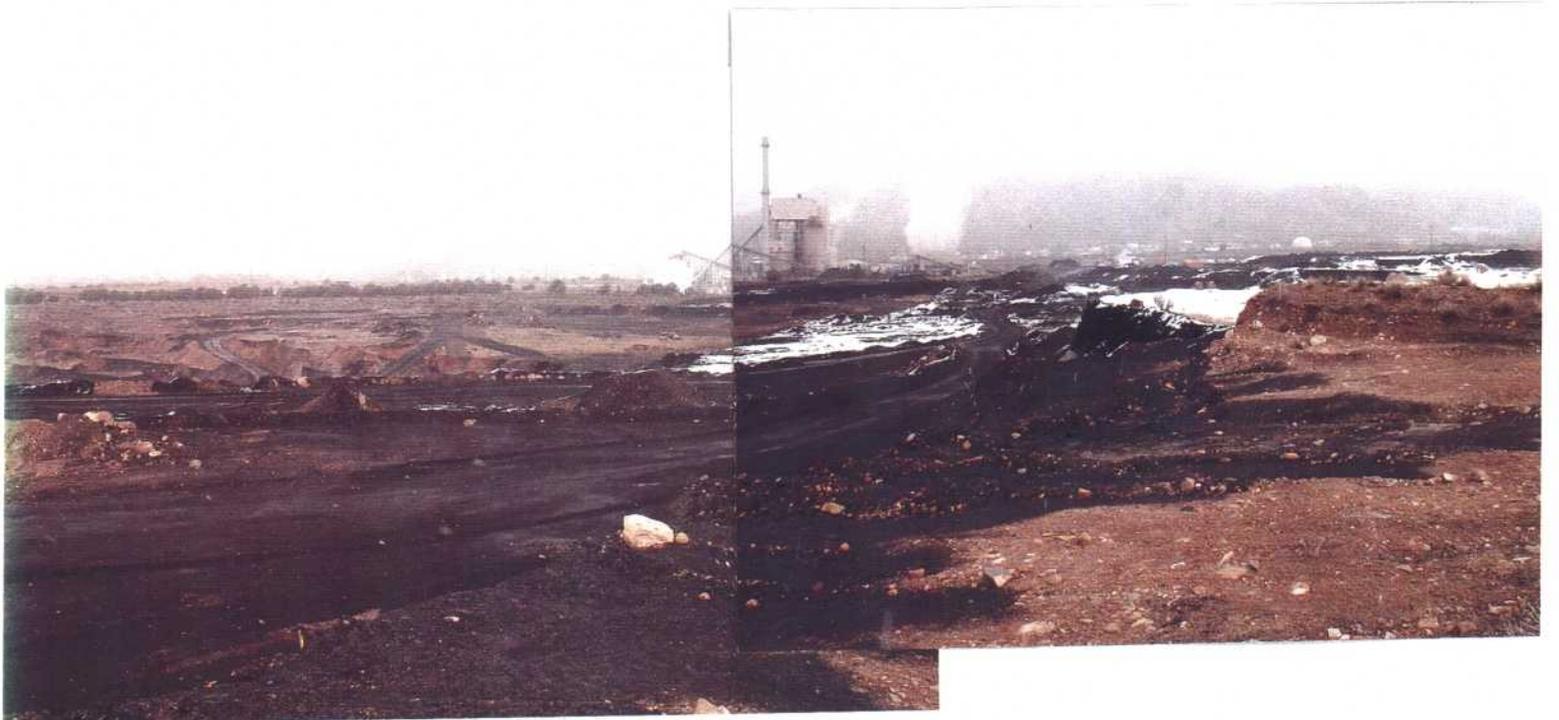
Coarse Refuse Pile Looking northeasterly

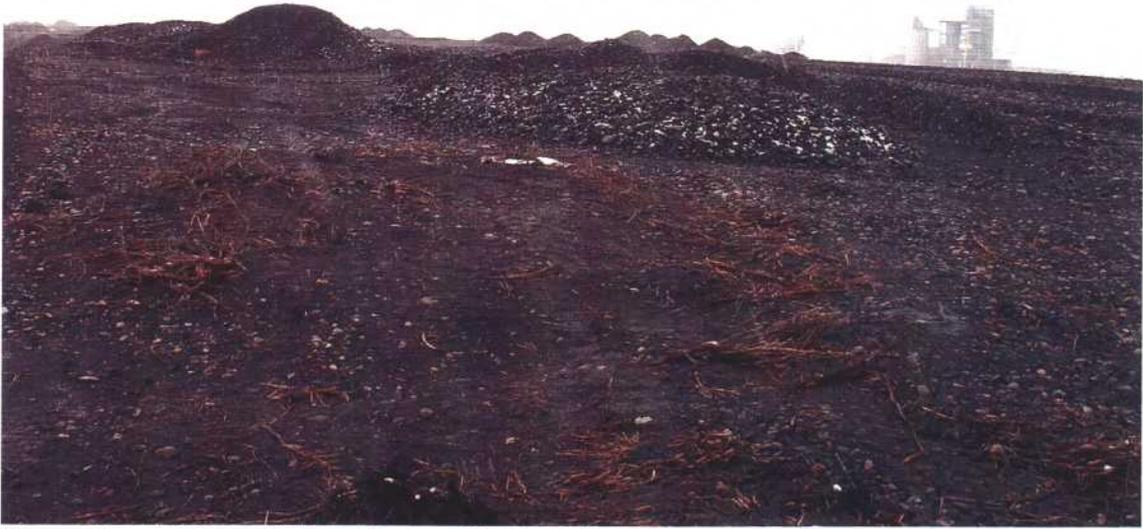
None

Both Slurry Pond #1 and Slurry Pond #2 have been approved to be and are being filled with coal mine waste and excess spoil in connection with construction of the Excess Spoil Disposal Area # 2.

Excess Spoil Disposal Area #2 Looking South

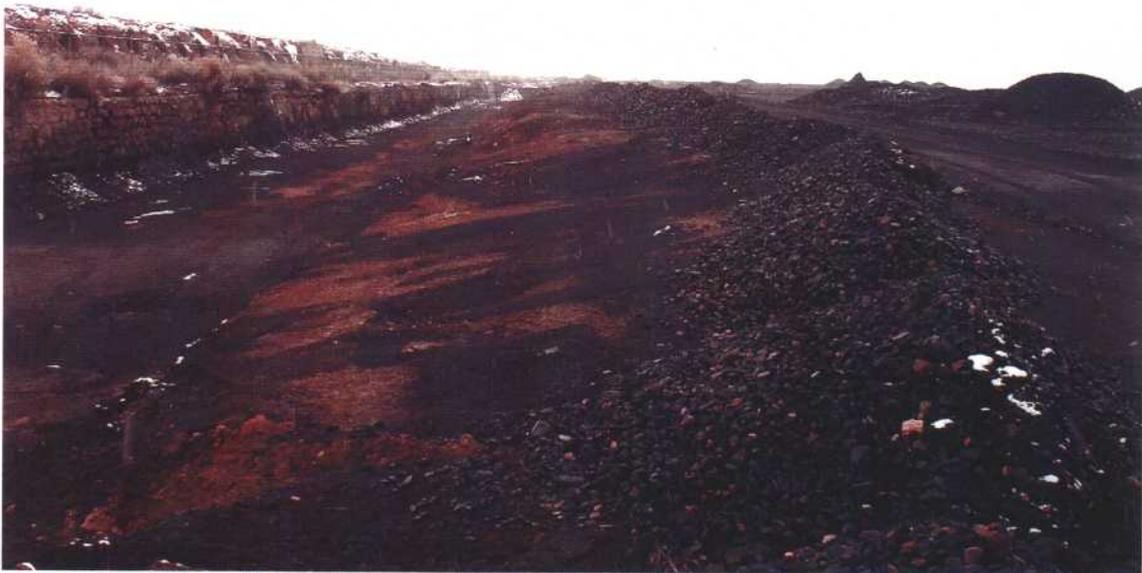
Excess Spoil Area #2 Looking south along the old slurry ditch
