IMPOUNDMENT INSPECTION AND CERTIFIED REPORT		Clear Water Pond	
Permit Number	ACT/007/035	Report Date	7/25/05
Mine Name	SUNNYSIDE REFUSE AND SLURRY		
Company Name	SUNNYSIDE COGENERATION ASSOCIATES		
Impoundment Identification	Impoundment Name	Clear Water Pond	
	Impoundment Number	004	
	UPDES Permit Number	UT 024759	
	MSHA ID Number	N/A	
IMPOUNDMENT INSPECTION			
Inspection Date	June 22, 2005		
Inspected By	Scott Carlson		
Reason for Inspection (Annual, Quarterly or Other Periodic Inspection, Critical Installation, or Completion of Construction)		Second Quarter Inspection 2005	
<p>1. Describe any appearance of any instability, structural weakness, or any other hazardous condition.</p> <p>NONE</p>			
<p>Required for an impoundment which functions as a SEDIMENTATION POND.</p>	<p>2. Sediment storage capacity, including elevation of 60% and 100% sediment storage volumes, and, estimated average elevation of existing sediment.</p> <p>Storage Capacity = 4.9 acre-feet Maximum Sediment Depth Elevation = 6527 Existing Sediment Elevation = 6523+-</p>

INSPECTION AND CERTIFIED REPORT ON EXCESS SPOIL PILE OR REFUSE PILE		Coarse Refuse Pile
Permit Number	ACT/007/035	Report Date 7/25/05
Mine Name	S

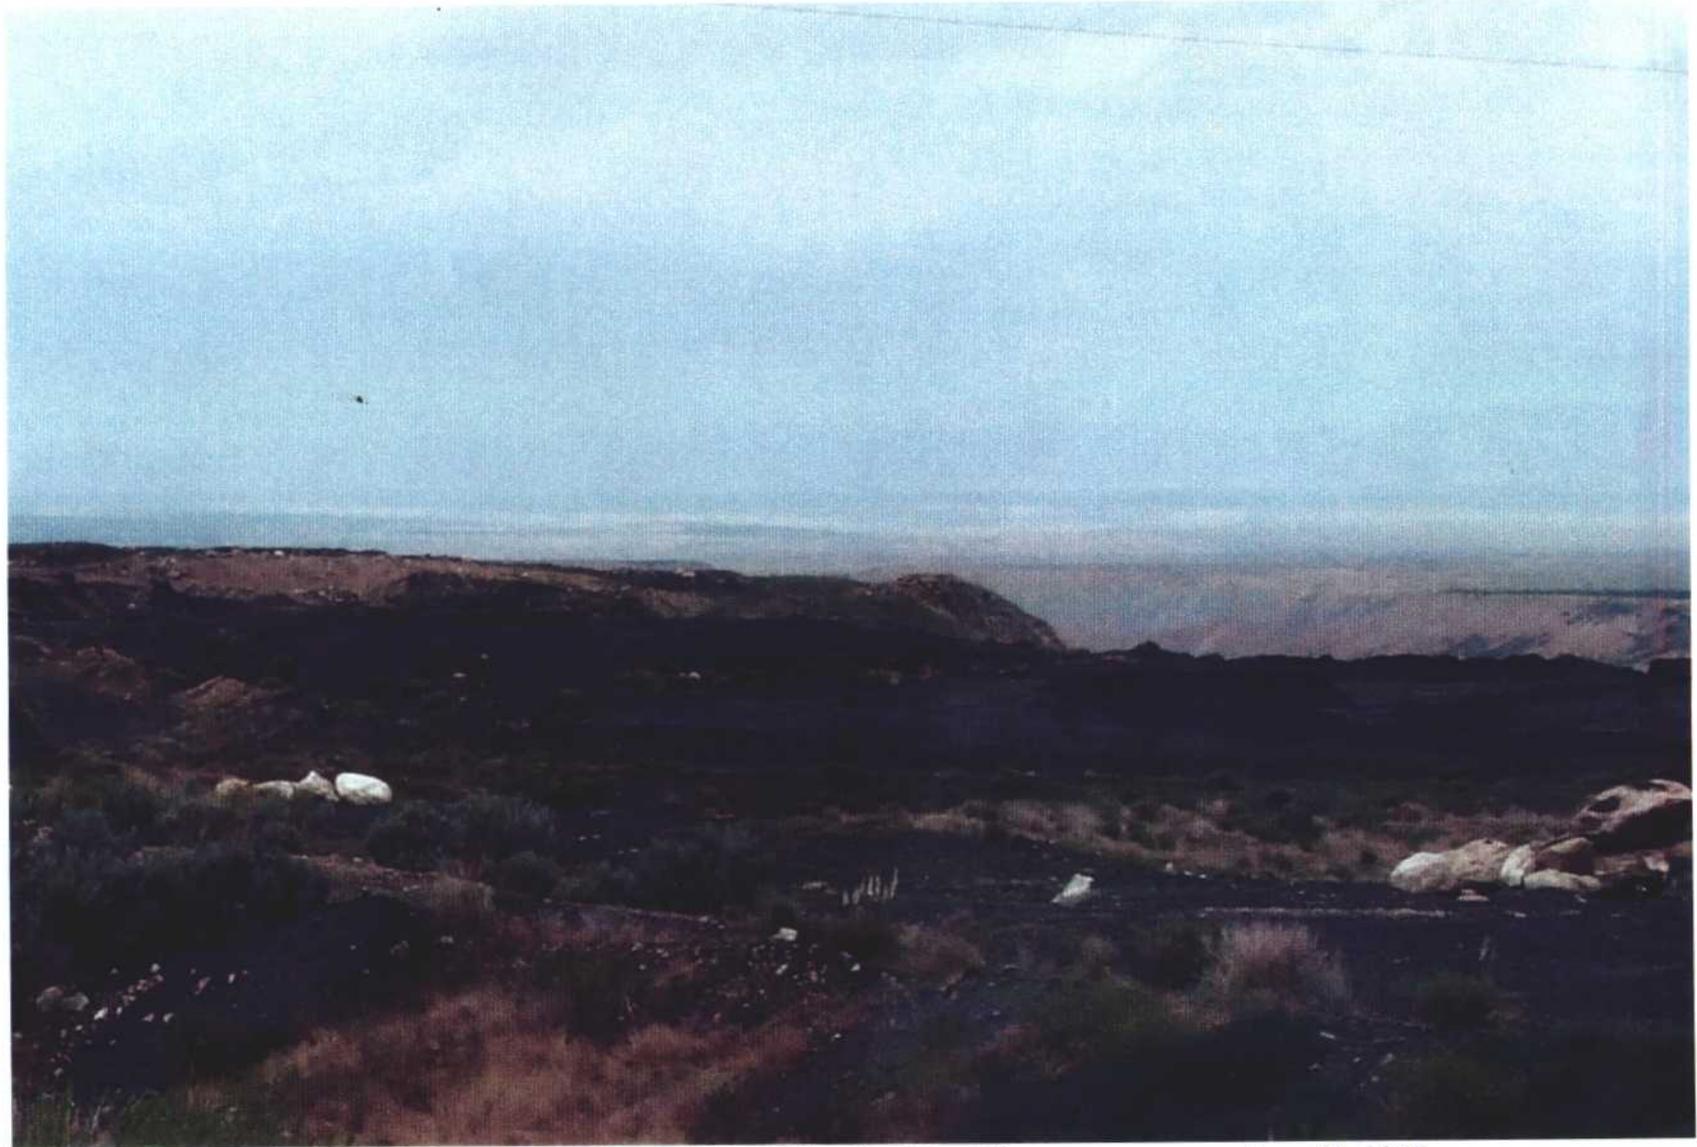
No smokers visible

Waste Coal Removal

Coarse Refuse Pile – Looking West

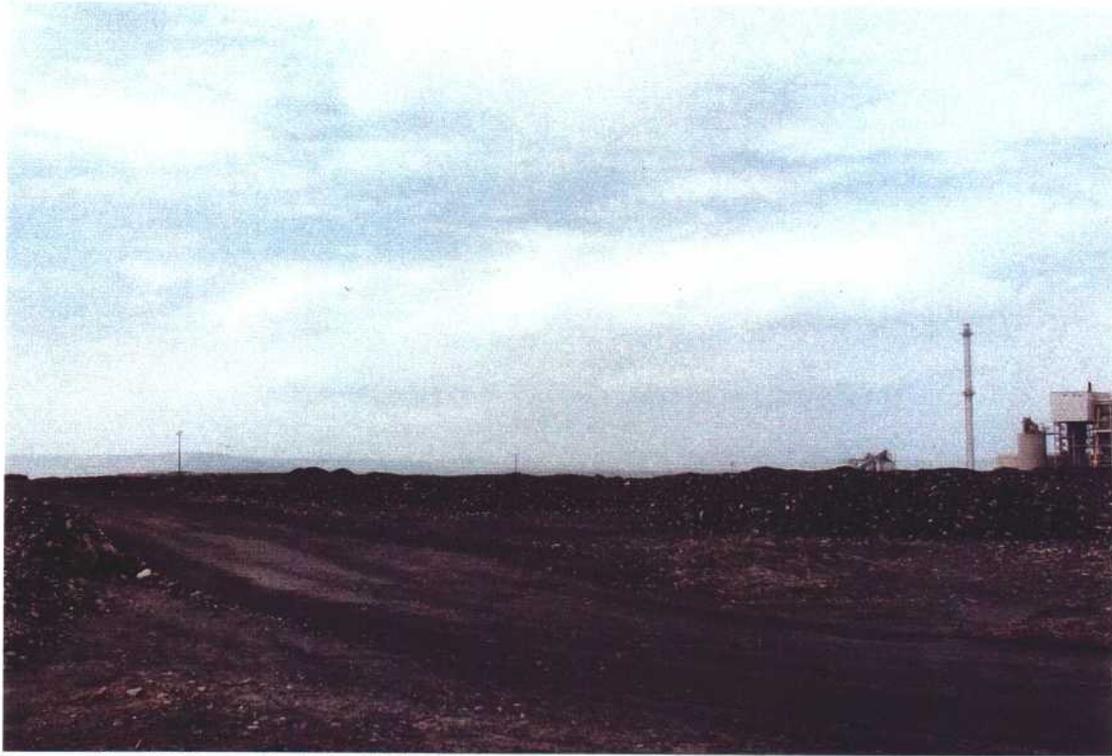
Excess Spoil Disposal Area #2 looking south

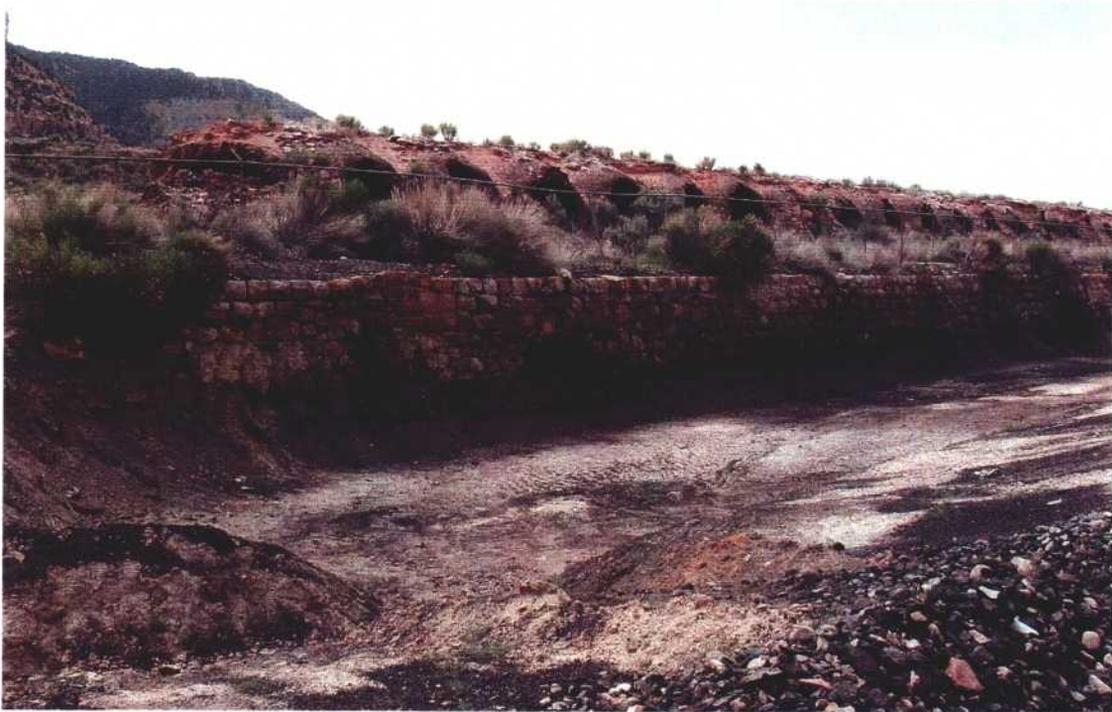
Exposed Wall along east side of Excess Spoil Disposal Area #2
