<b>IMPOUNDMENT INSPECTION AND CERTIFIED REPORT</b>		Clear Water Pond	
<b>Permit Number</b>	ACT/007/035	<b>Report Date</b>	10/14/05
<b>Mine Name</b>	SUNNYSIDE REFUSE AND SLURRY		
<b>Company Name</b>	SUNNYSIDE COGENERATION ASSOCIATES		
<b>Impoundment Identification</b>	<b>Impoundment Name</b>	Clear Water Pond	
	<b>Impoundment Number</b>	004	
	<b>UPDES Permit Number</b>	UT 024759	
	<b>MSHA ID Number</b>	N/A

**IMPOUNDMENT INSPECTION**

<b>Inspection Date</b>	September 20, 2005		
<b>Inspected By</b>	Scott Carlson		
<b>Reason for Inspection</b> (Annual, Quarterly or Other Periodic Inspection, Critical Installation, or Completion of Construction)	Third Quarter Inspection 2005

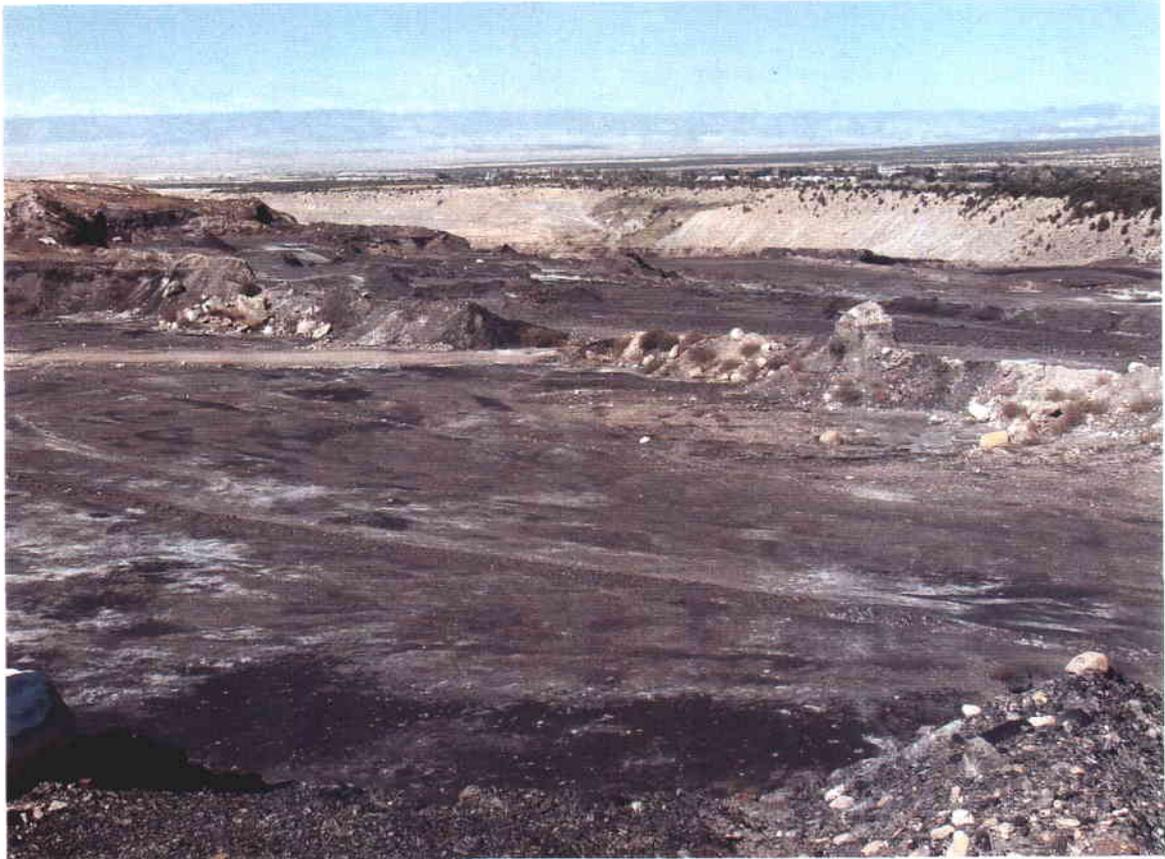
No smokers visible

Waste Coal Removal

Coarse Refuse Pile - Looking Northwesternly

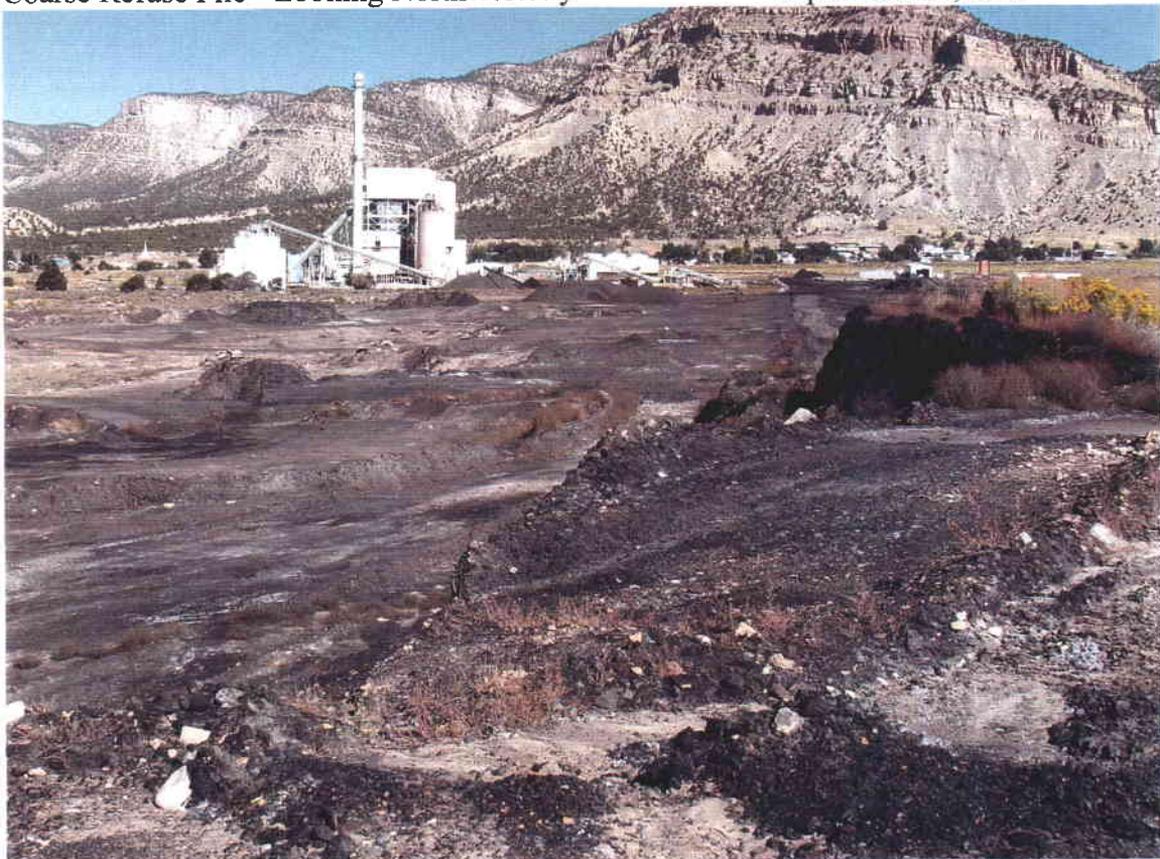
Coarse Refuse Pile - Looking Northerly

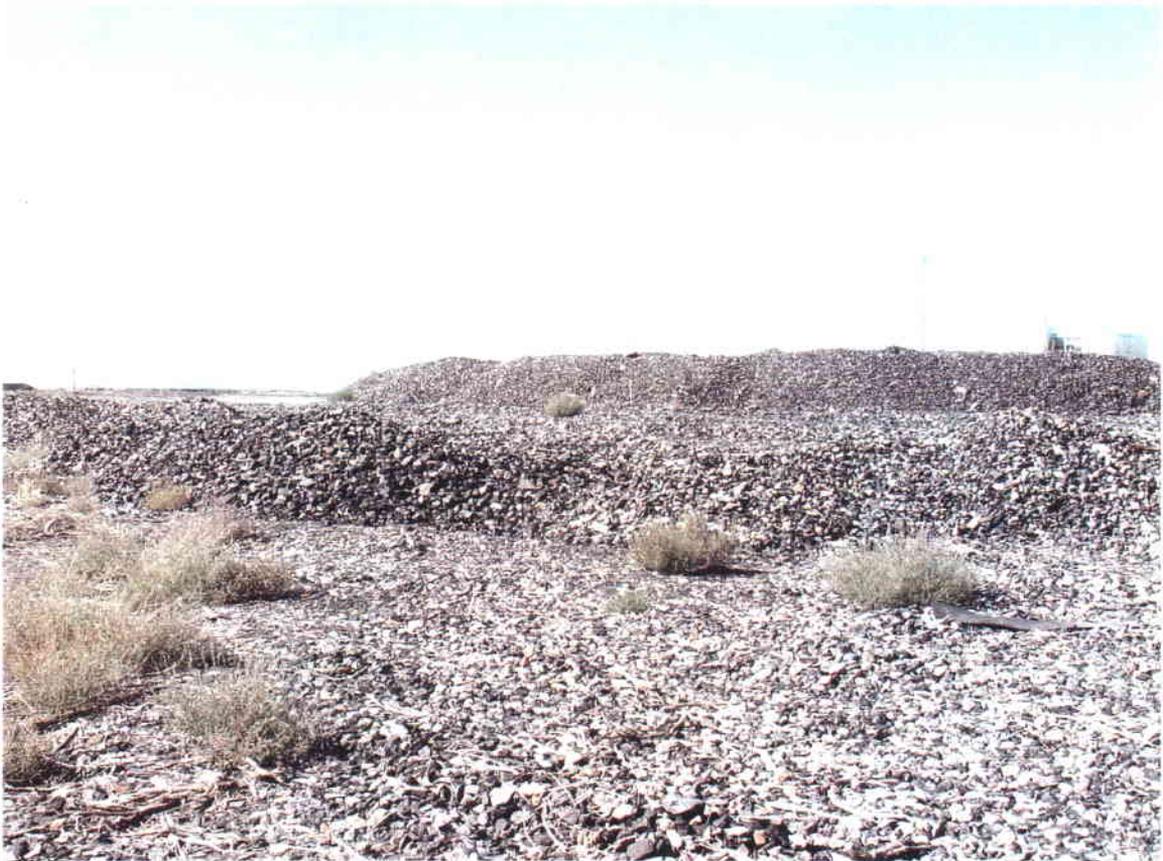
Excess Spoil Disposal Area #2 North End looking westerly
