## Sunnyside Cogeneration Associates

RE: Fourth Quarter 2005 Inspection Report  
Sunnyside Refuse Pile C/007/035

<b>IMPOUNDMENT INSPECTION AND CERTIFIED REPORT</b>		Clear Water Pond	
<b>Permit Number</b>	ACT/007/035	<b>Report Date</b> 1/20/06	
<b>Mine Name</b>	SUNNYSIDE REFUSE AND SLURRY		
<b>Company Name</b>	SUNNYSIDE COGENERATION ASSOCIATES		
<b>Impoundment Identification</b>	<b>Impoundment Name</b>	Clear Water Pond	
	<b>Impoundment Number</b>	004	
	<b>UPDES Permit Number</b>	UT 024759	
	<b>MSHA ID Number</b>	N/A	
<b>IMPOUNDMENT INSPECTION</b>			
<b>Inspection Date</b>	December 14, 2005		
<b>Inspected By</b>	Rusty Netz		
<b>Reason for Inspection</b> (Annual, Quarterly or Other Periodic Inspection, Critical Installation, or Completion of Construction)		Fourth Quarter Inspection 2005	
<p>1. Describe any appearance of any instability, structural weakness, or any other hazardous condition.</p> <p>NONE</p>			
<p>Required for an impoundment which functions as a SEDIMENTATION POND.</p>	<p>2. Sediment storage capacity, including elevation of 60% and 100% sediment storage volumes, and, estimated average elevation of existing sediment.</p> <p>Storage Capacity = 4.9 acre-feet  Maximum Sed

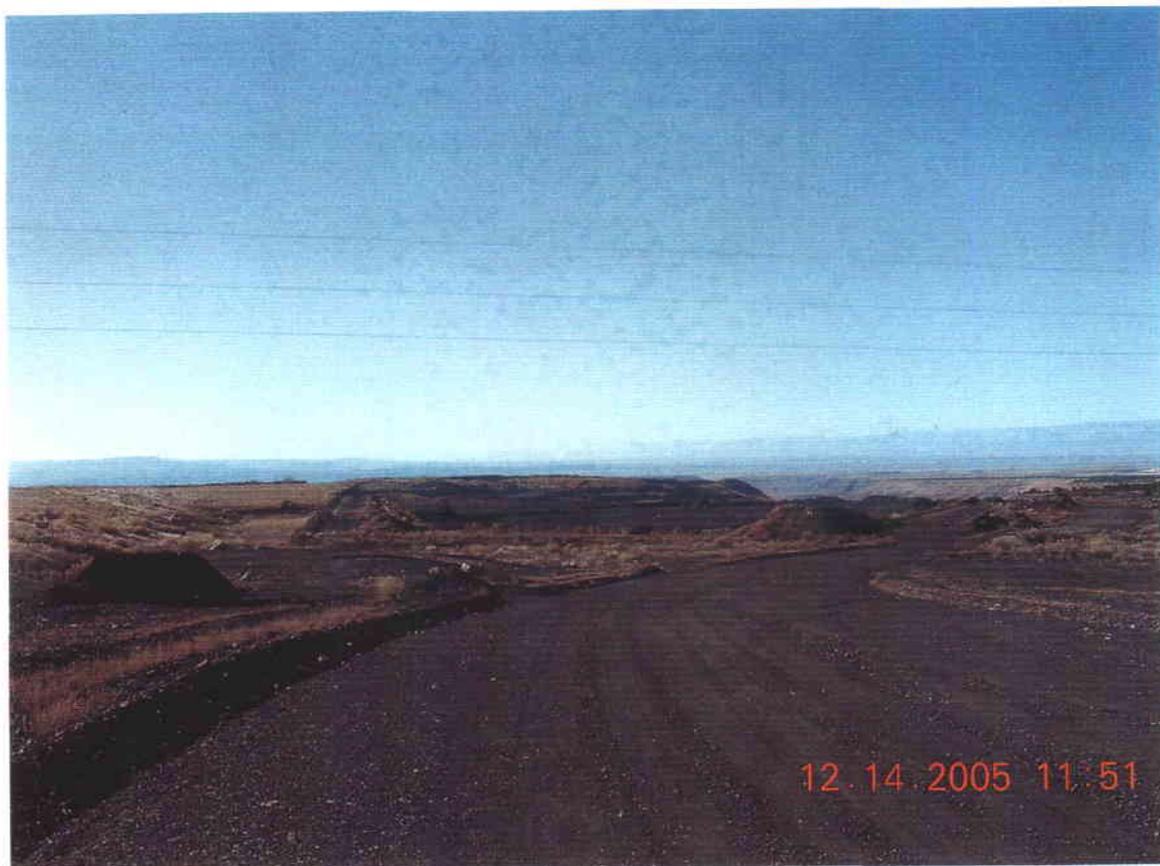
SCA Sunnyside

No smokers visible

Waste Coal Removal

Coarse Refuse Pile – Looking to the west

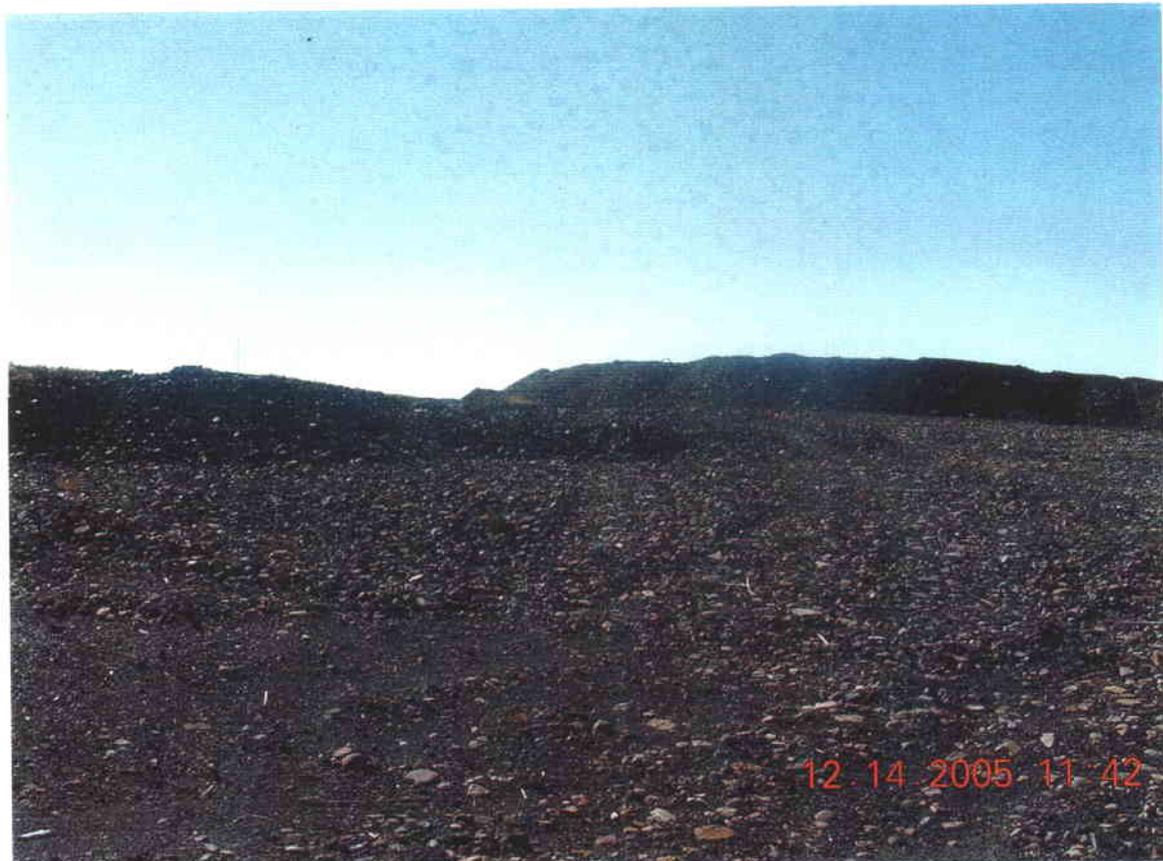
Excess Spoil Disposal Area #2 North End looking westerly
