IMPOUNDMENT INSPECTION AND CERTIFIED REPORT		Clear Water Pond	
Permit Number	ACT/007/035	Report Date	4/14/06
Mine Name	SUNNYSIDE REFUSE AND SLURRY		
Company Name	SUNNYSIDE COGENERATION ASSOCIATES		
Impoundment Identification	Impoundment Name	Clear Water Pond	
	Impoundment Number	004	
	UPDES Permit Number	UT 024759	
	MSHA ID Number	N/A

IMPOUNDMENT INSPECTION

Inspection Date	March 9, 2006		
Inspected By	Rusty Netz		
Reason for Inspection (Annual, Quarterly or Other Periodic Inspection, Critical Installation, or Completion of Construction)	First Quarter Inspection 2006

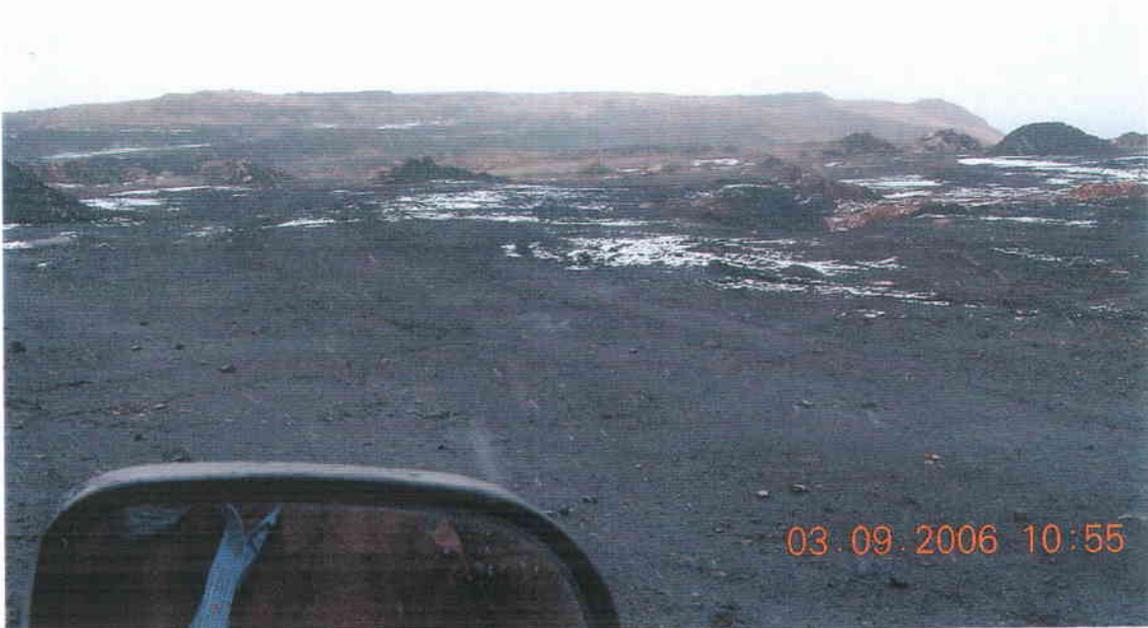
March 9, 2006

Coarse Refuse Pile looking westerly

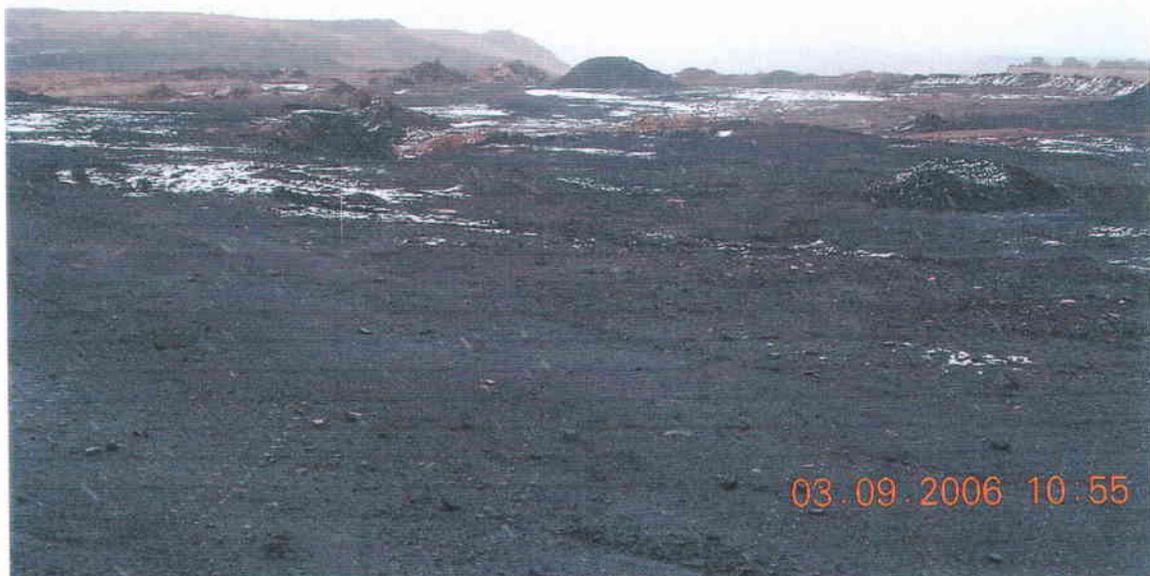
March 9, 2006

Coarse Refuse pile looking westerly / northwesterly

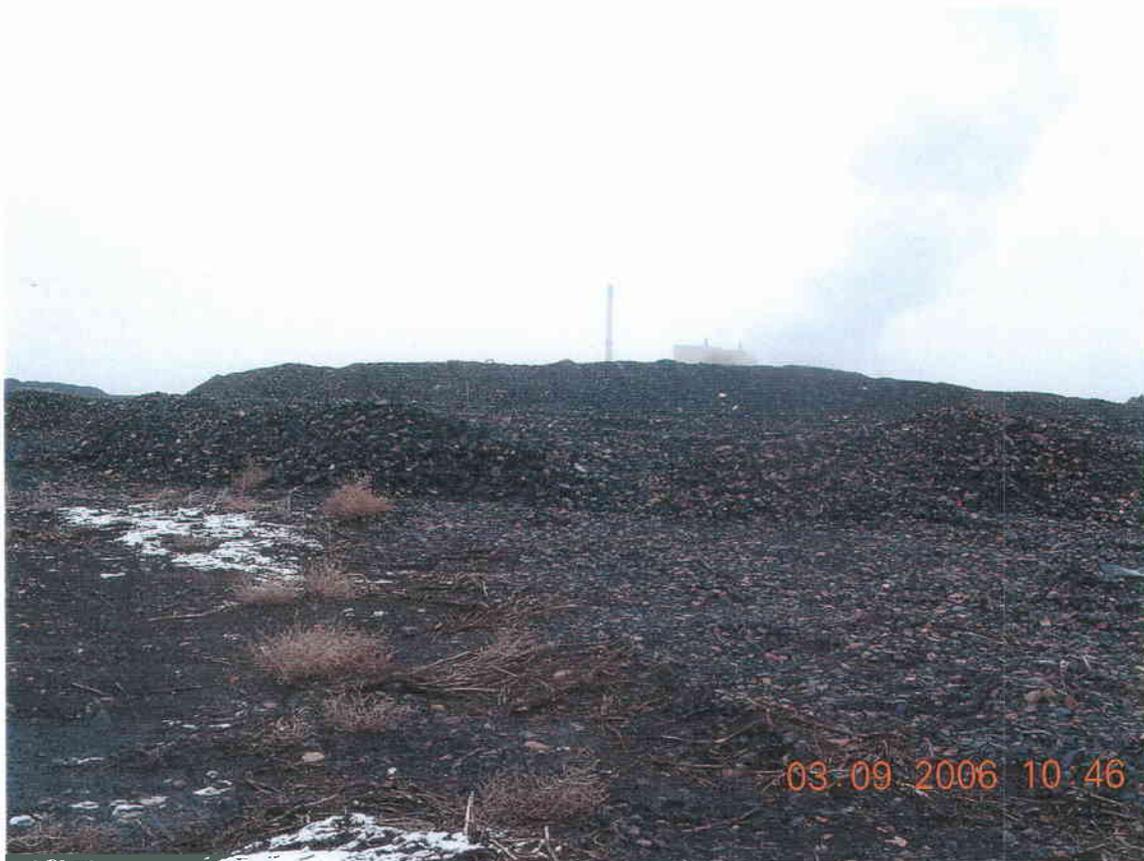
March 9, 2006

Excess Spoil Area # 2 Looking westerly

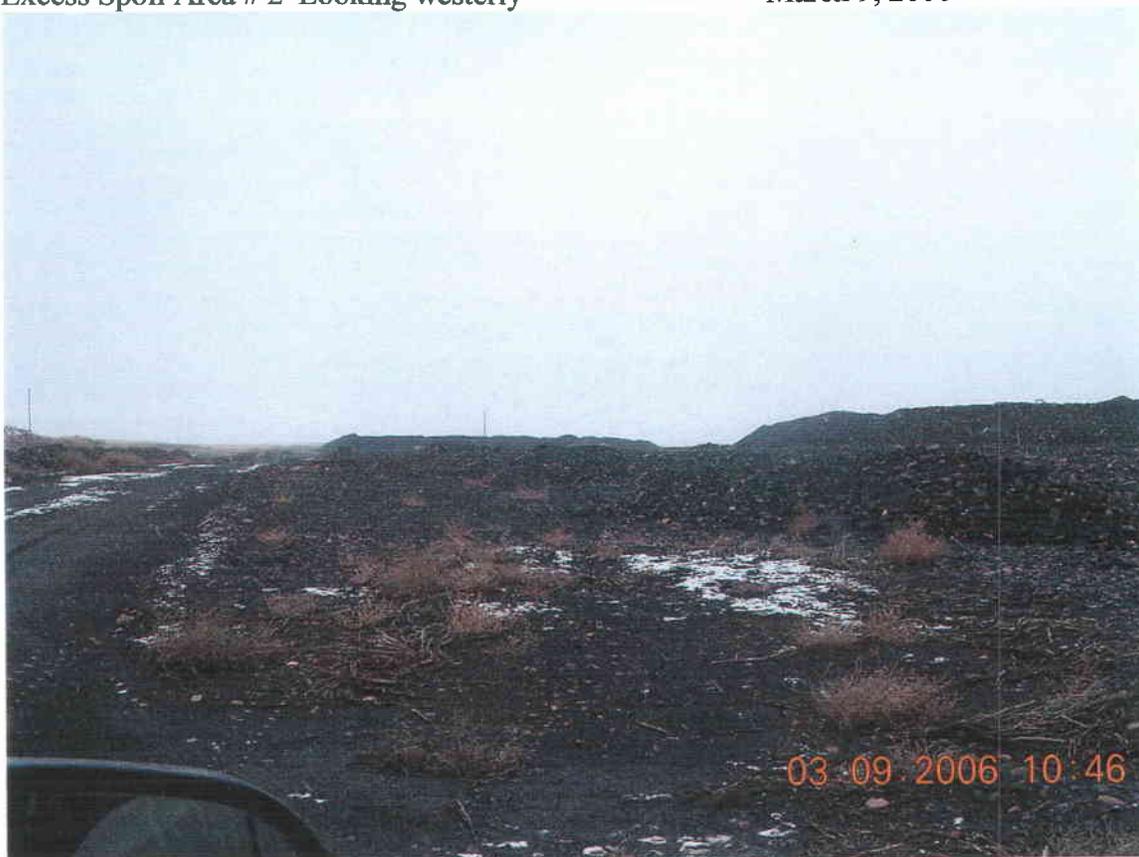
03.09.2006 10:46

Excess Spoil Disposal Area #2 Looking southerly
