IMPOUNDMENT INSPECTION AND CERTIFIED REPORT

Clear Water Sediment Pond

Report Date April 6, 2007
Permit Number C/007/035
Mine Name Sunnyside Refuse and Slurry
Company Name Sunnyside Cogeneration Associates

Inspection Date March 26, 2007
Inspected by S. Scott Carlson
Reason for Inspection First Quarter Inspection 2007

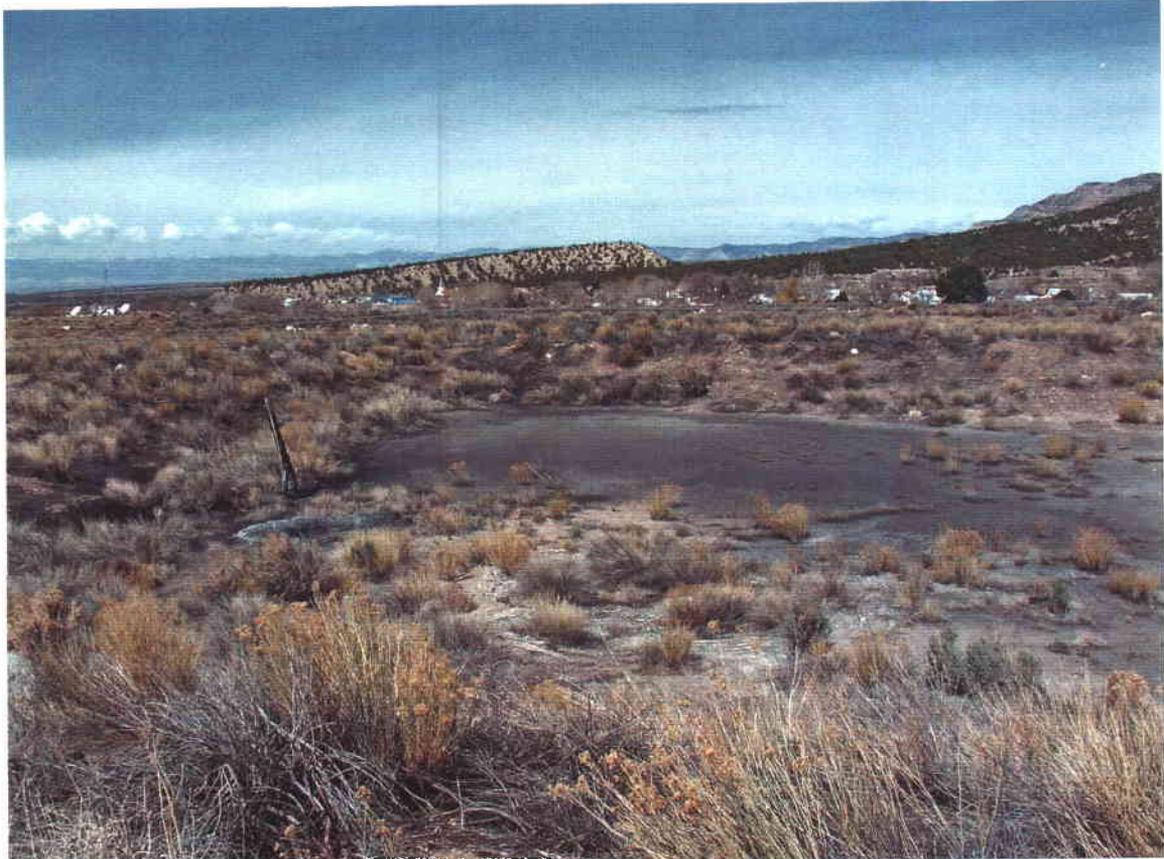
Clear Water Pond (looking northwesterly)

Pond had no water in it. No samples were taken
Sediment level was good. Pond did not require decanting.
Embankment conditions were good. Vegetation on outslopes was adequate.
Inlet / Outlet conditions were good but with some erosion present.
No structural or hazardous conditions were observed.

No recent changes in the geometry of the structure have been observed
No water was impounded
Sediment level was good.
No other aspects were observed to affect stability or functionality.

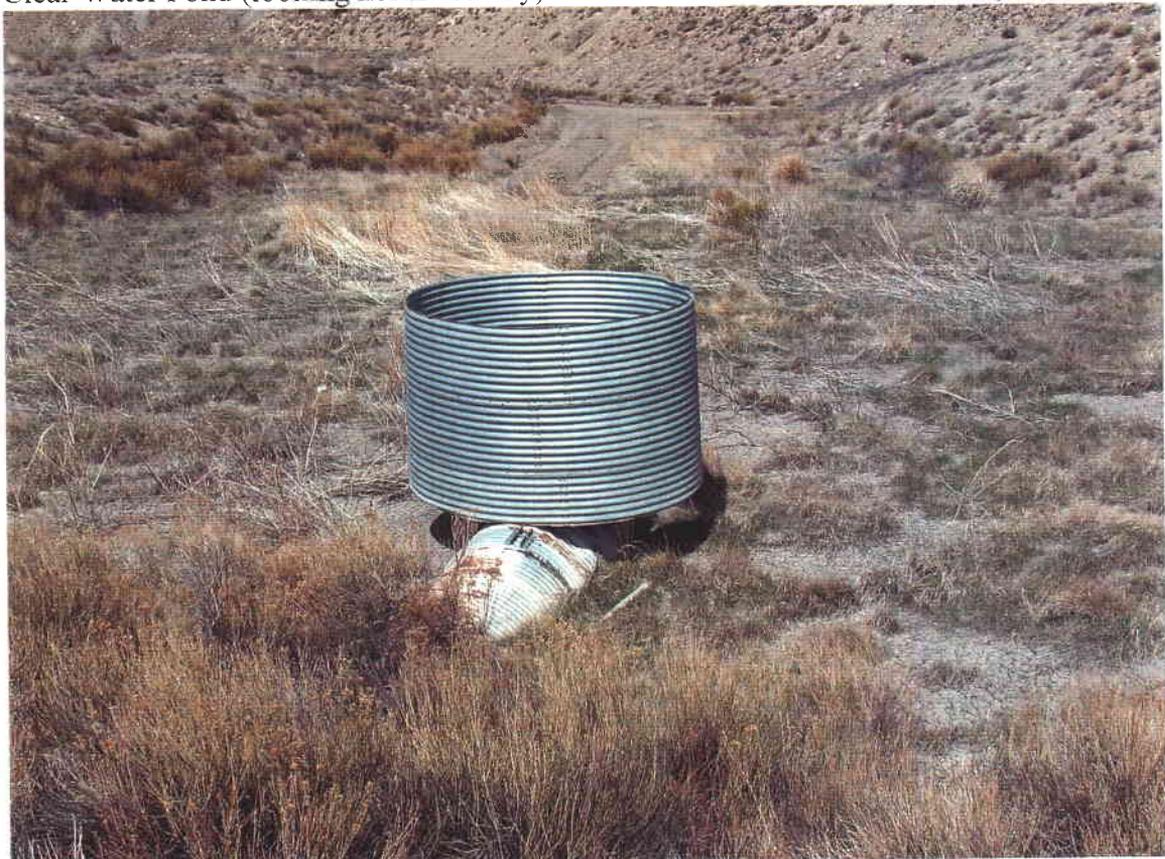
Railcut Pond (looking northerly)

Pond had no water in it. No samples were taken
SCA is in process of cleaning Sediment from pond. Pond did not require decanting.
Embankment conditions were good. Vegetation on out slopes was adequate.
Inlet / Outlet conditions were good. No structural or hazardous conditions were observed.

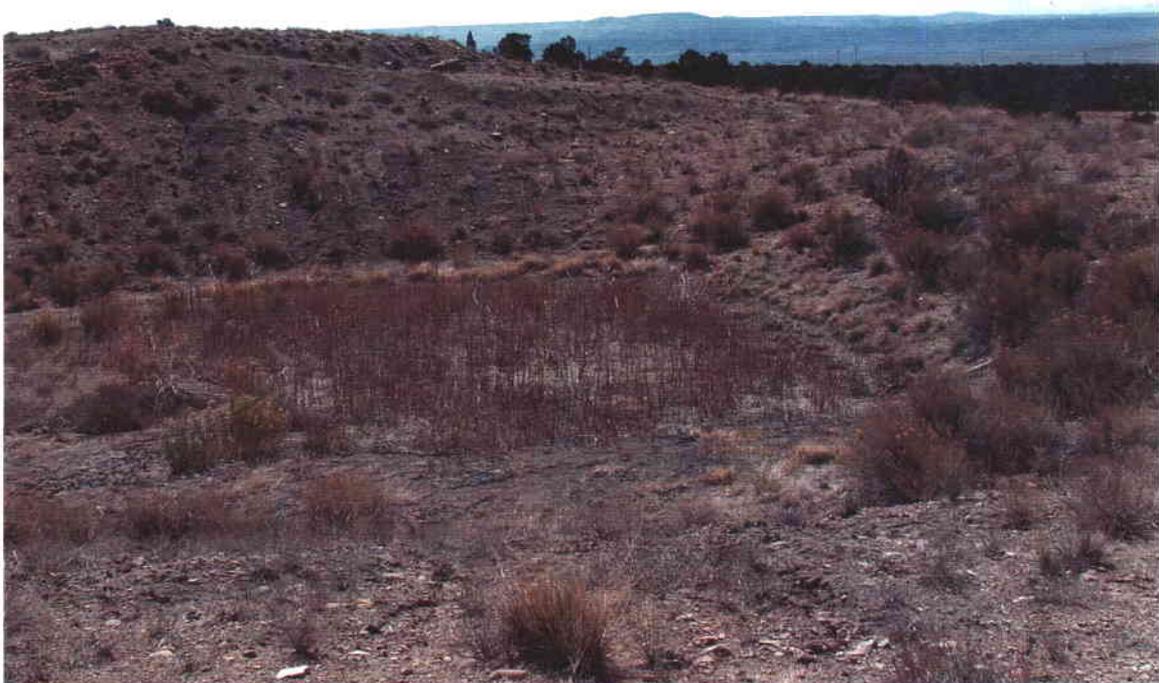
Coarse Refuse Toe Pond (looking westerly)

Pond had no water in it. No samples were taken
SCA is in process of cleaning Sediment from pond. Pond did not require decanting.
Embankment conditions were good. Vegetation on out slopes was adequate.
Inlet / Outlet conditions were good. No structural or hazardous conditions were observed.

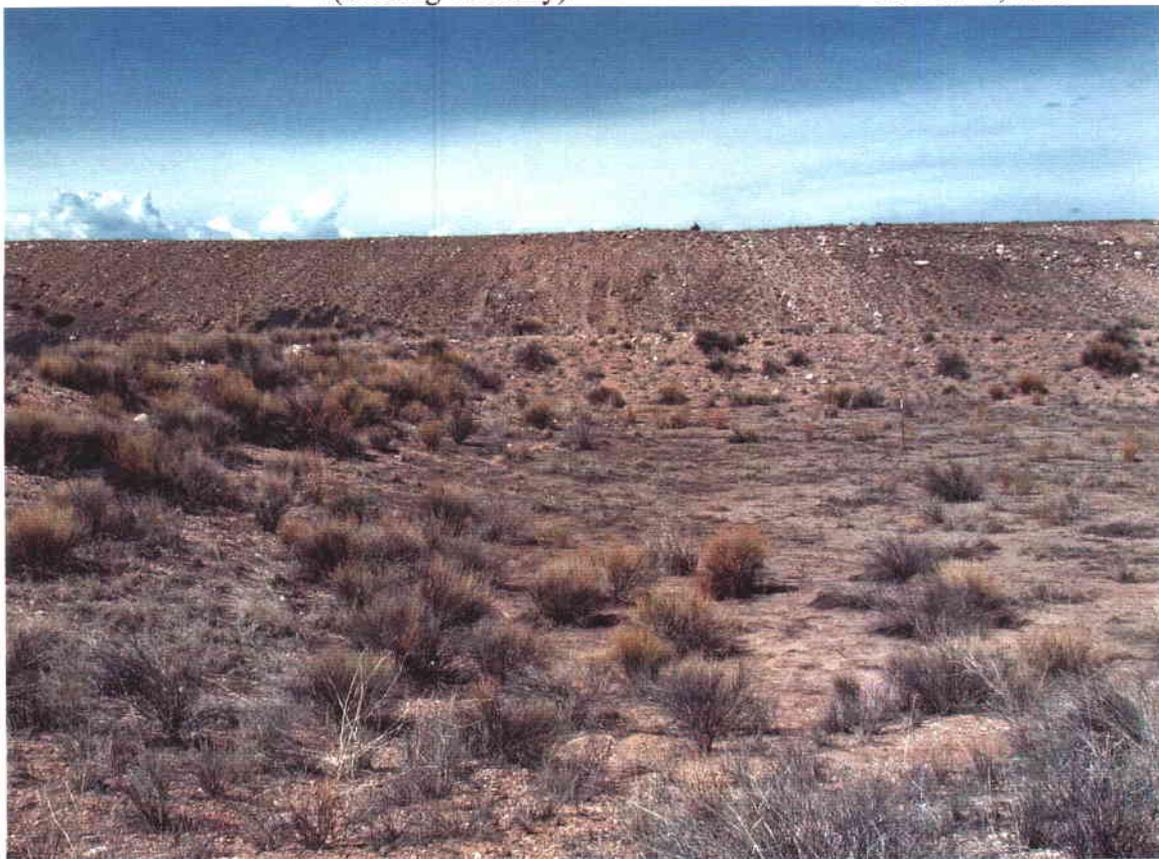
Borrow Area Pond (looking northwesterly)

Pond had no water in it. No samples were taken
Sediment level was good. Pond did not require decanting.
Embankment conditions were good. Vegetation on out slopes was adequate.
Inlet / Outlet conditions were good. No structural or hazardous conditions were observed.

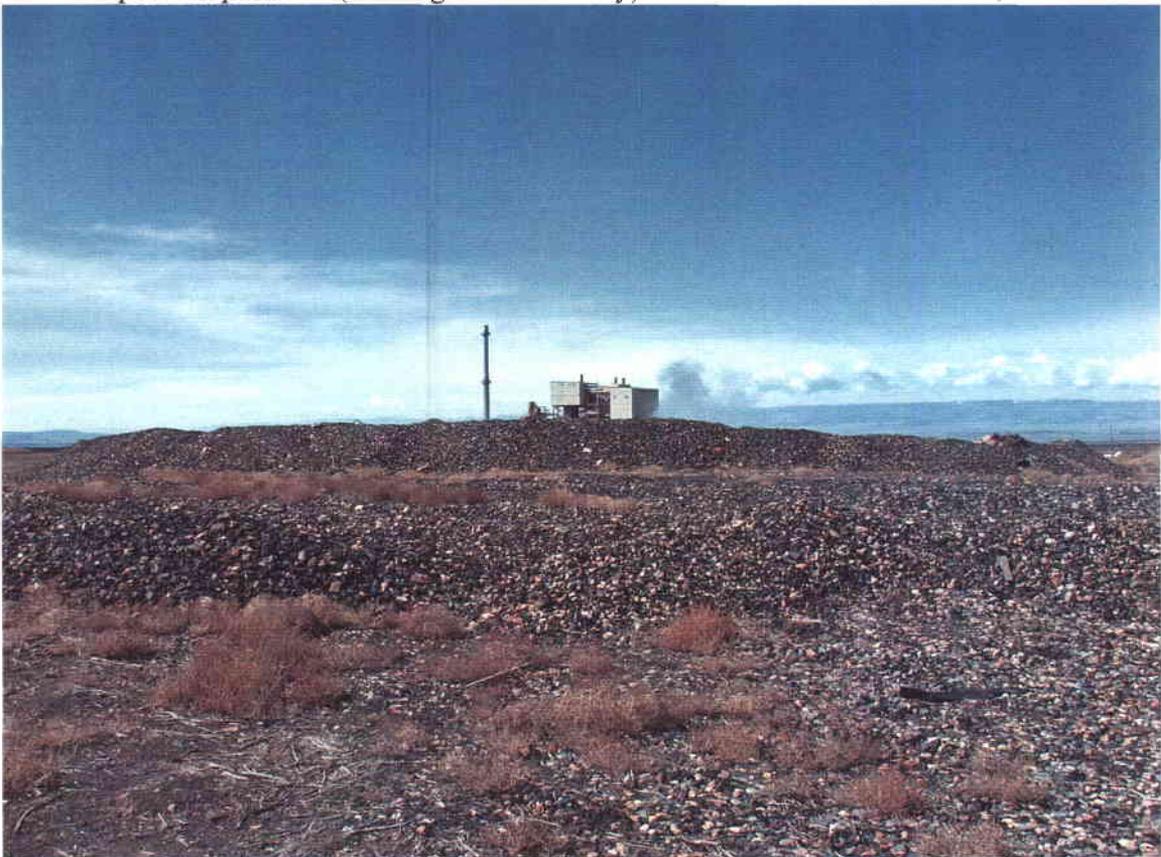
Excess Spoil Disposal #2 (looking westerly)

This pond has been approved to be filled as part of the Excess Spoil Disposal Area #2. SCA is in the process of a permit amendment to re-route all storm water drainage from this area to the Pasture Pond. Upon completion of that process, the Clear Water Pond can be de-commissioned and filled in.
