Sunnyside Cogeneration Associates

RE: Fourth Quarter 2007 Inspection Report
Sunnyside Refuse Pile C/007/035

IMPOUNDMENT INSPECTION AND CERTIFIED REPORT

Report Date January 18, 2008
Permit Number C/007/035
Mine Name Sunnyside Refuse and Slurry
Company Name Sunnyside Cogeneration Associates

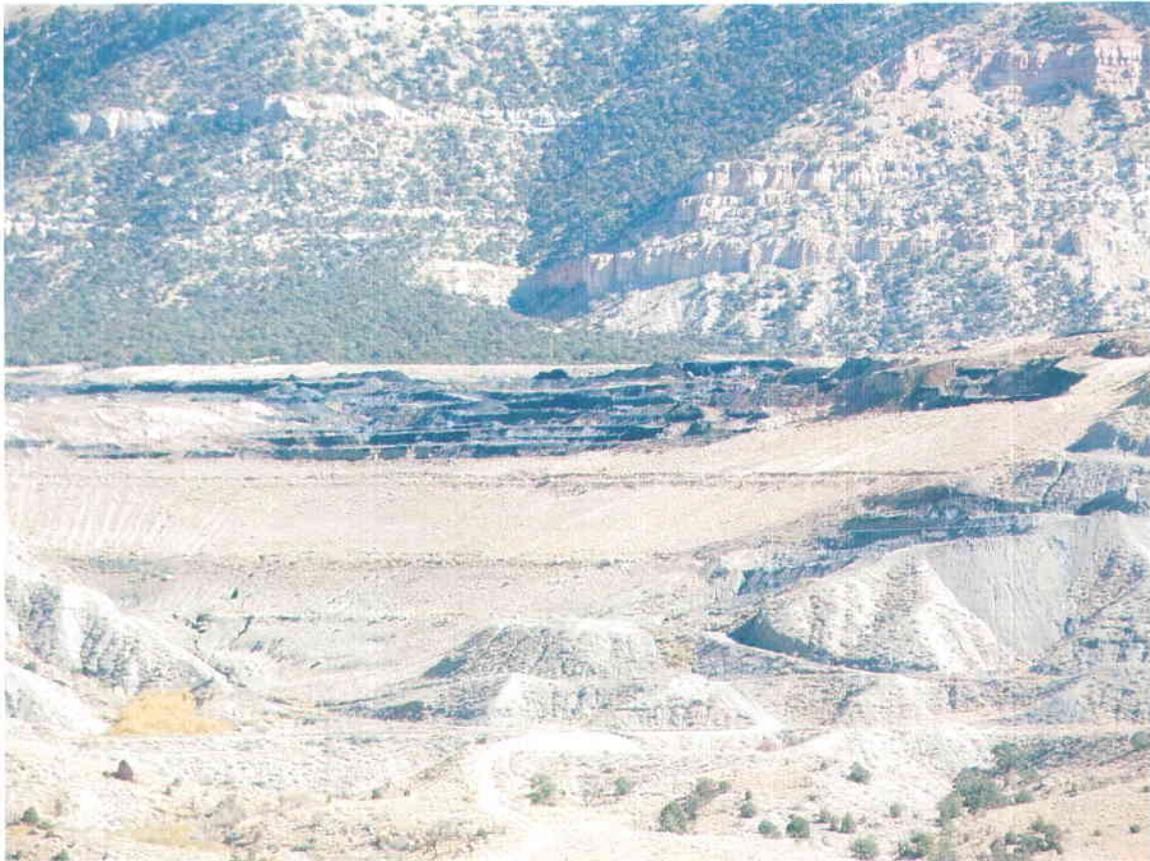
October 2007

Coarse Refuse Pile (looking southeasterly)

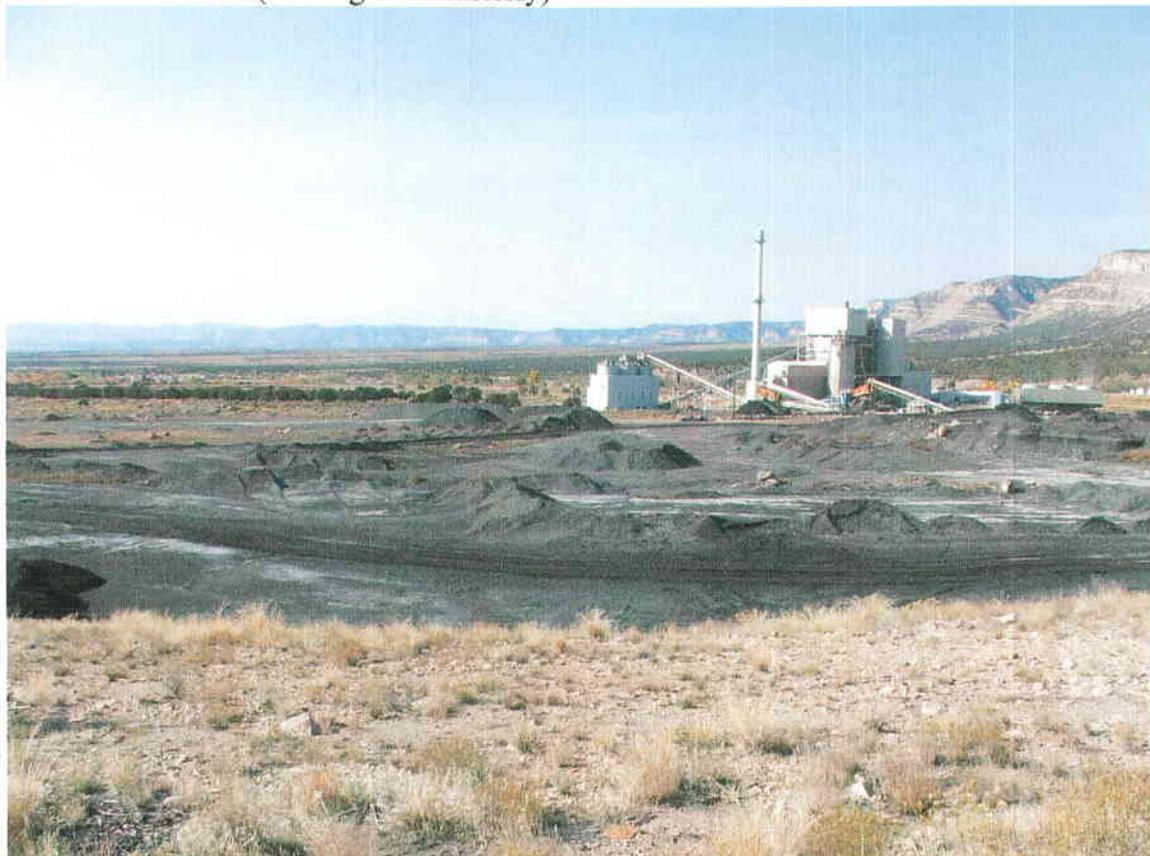
October 2007

Coarse Refuse Pile (looking northwesterly)

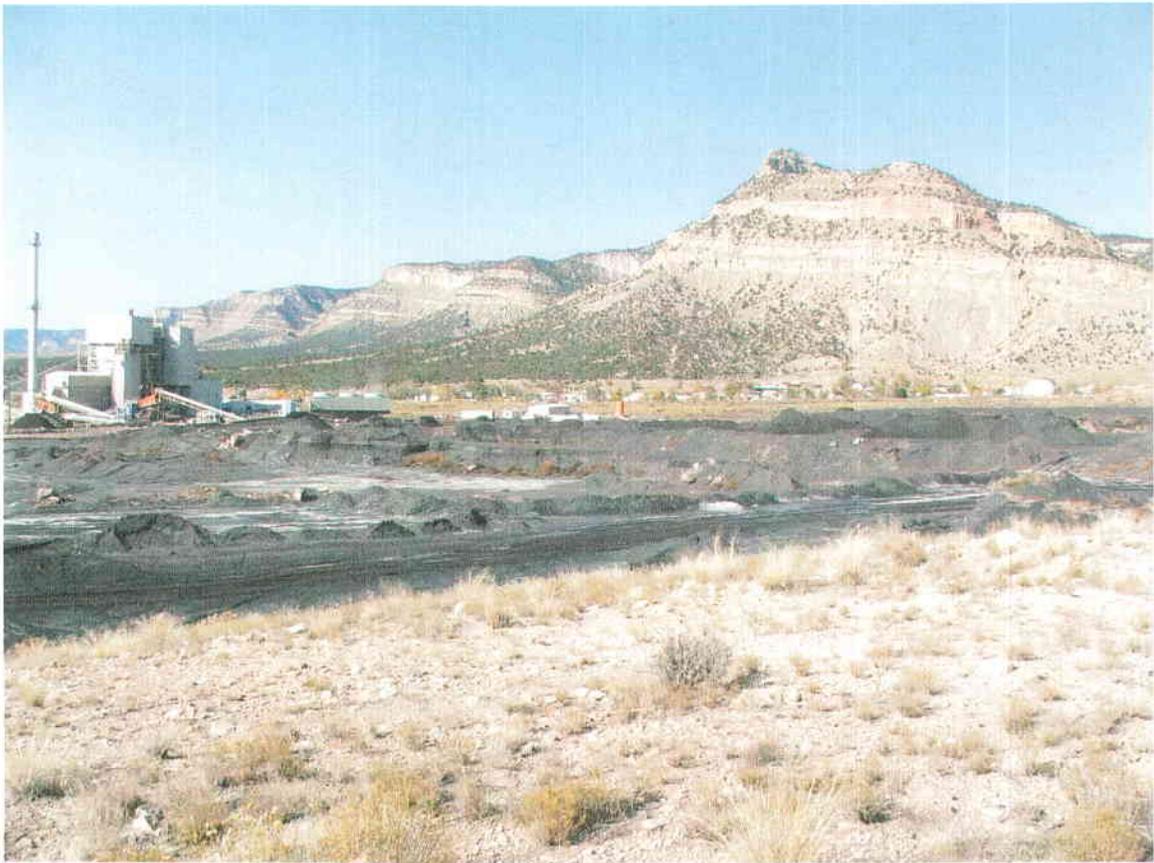
October 2007

Coarse Refuse Pile (looking northerly)

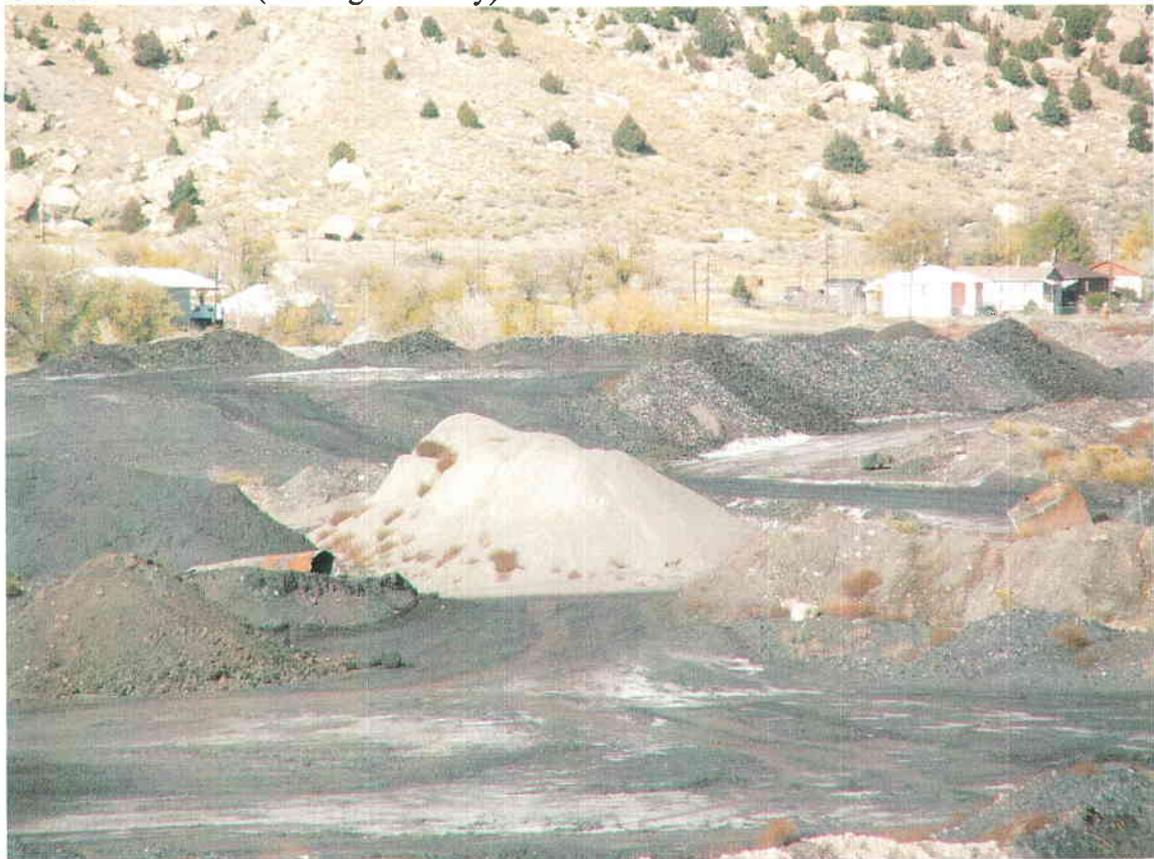
Excess Spoil Disposal Area #2 (beyond the grey pile) (looking northerly) October 2007
