Sunnyside Cogeneration Associates

RE: Annual 2010 Inspection Report
Sunnyside Refuse and Slurry C/007/035

IMPOUNDMENT INSPECTION AND CERTIFIED REPORT

Report Date January 12, 2011
Permit Number C/007/035
Mine Name Sunnyside Refuse and Slurry
Company Name Sunnyside Cogeneration Associates

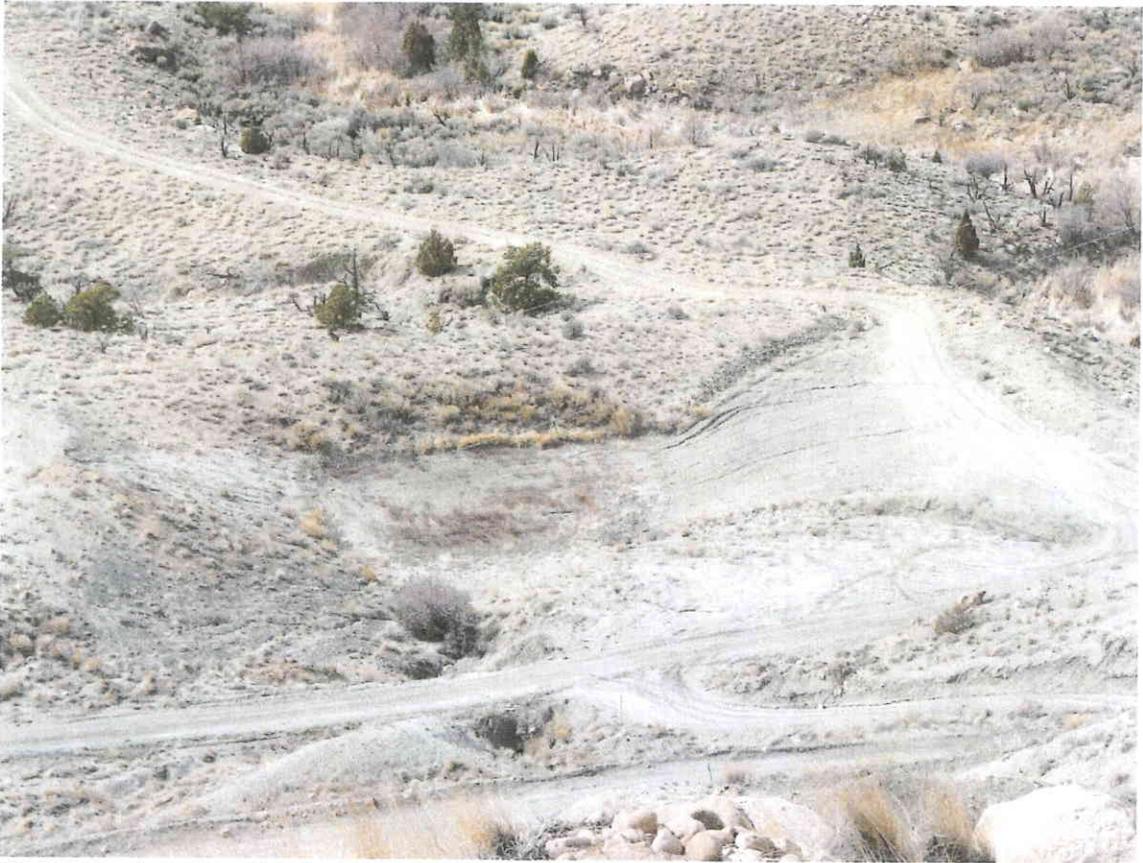
Coarse Refuse Toe Pond

Pond had some water in it. No samples were taken Pond did not require decanting
Sediment level was good
Embankment conditions were good. Vegetation on out slopes was adequate.
Inlet / Outlet conditions were good. No structural or hazardous conditions were observed.

No recent changes in the geometry of the structure have been observed
Some water was impounded
Sediment level was good.

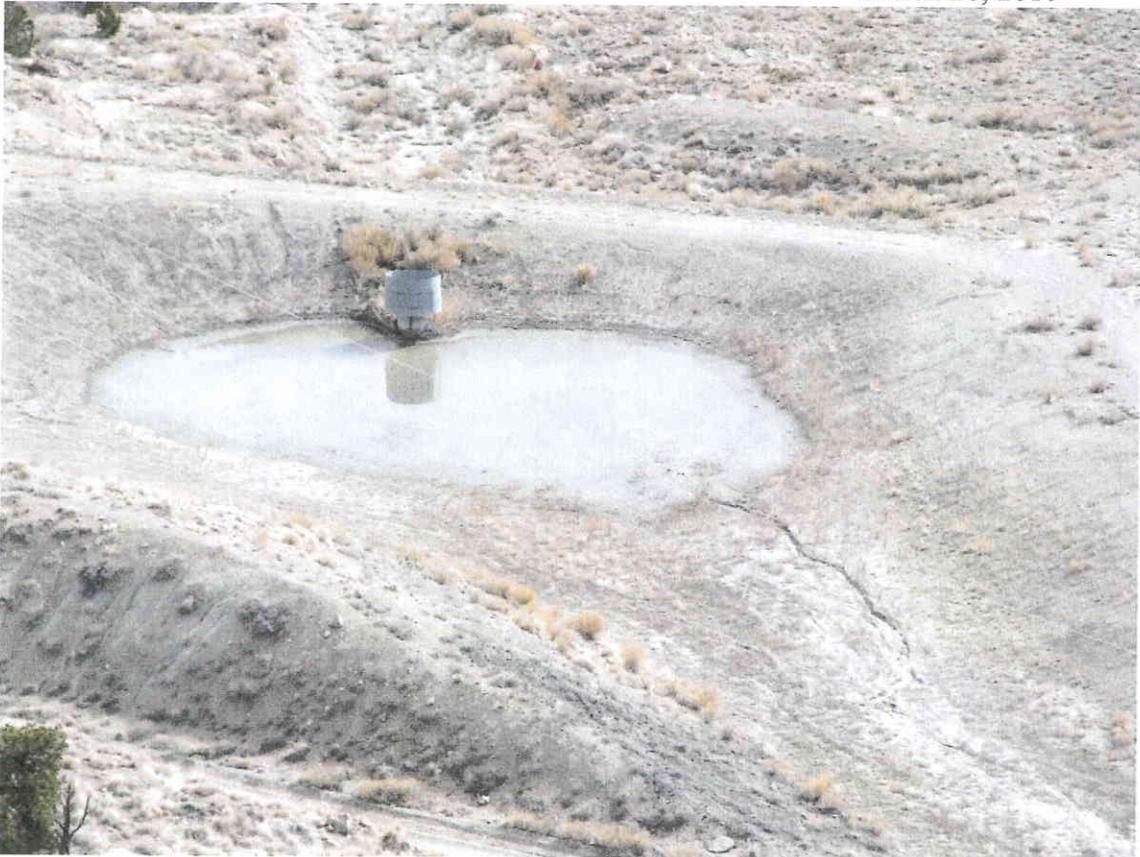
Rail Cut Pond

Pond had some water in it. No samples were taken. Pond did not require decanting.
Sediment levels were good.
Embankment conditions were good. Vegetation on outslopes was adequate.
Inlet / Outlet conditions were good. No structural or hazardous conditions were observed.

No recent changes in the geometry of the structure have been observed

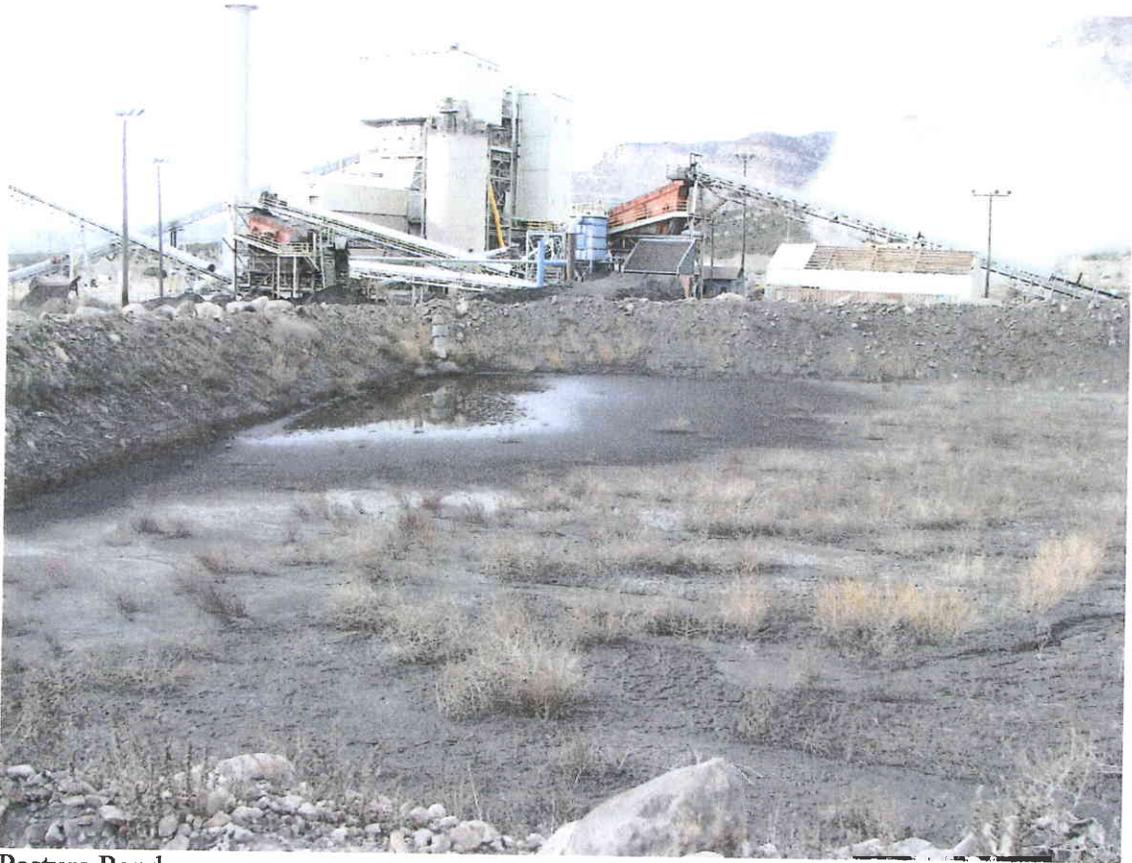
Pasture Pond

Pond had some water in it. No samples were taken Pond did not require decanting.
Sediment level was good
Embankment conditions were good. Vegetation on out slopes was adequate.
Inlet / Outlet conditions were good. No structural or hazardous conditions were observed.

No recent changes in the geometry of the structure were observed.
