Sunnyside Cogeneration Associates

RE: 2nd Quarter 2011 Inspection Report
Sunnyside Refuse Pile C/007/035

IMPOUNDMENT INSPECTION AND CERTIFIED REPORT

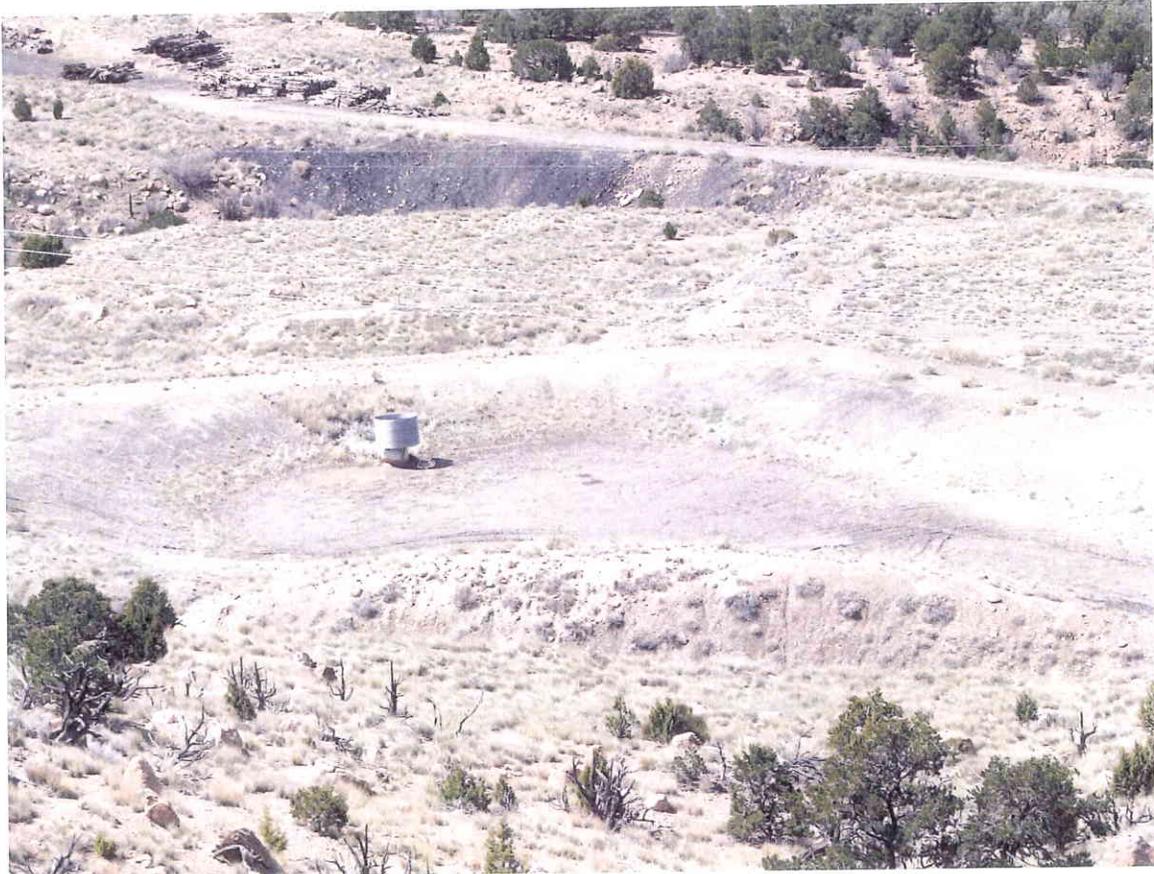
Rail Cut Sediment Pond

Pond had very little in it. No samples were taken Pond did not require decanting
Sediment levels were good
Embankment conditions were good. Vegetation on out slopes was adequate.
Inlet / Outlet conditions were good. No structural or hazardous conditions were observed.

No recent changes in the geometry of the structure have been observed
Very little water was impounded

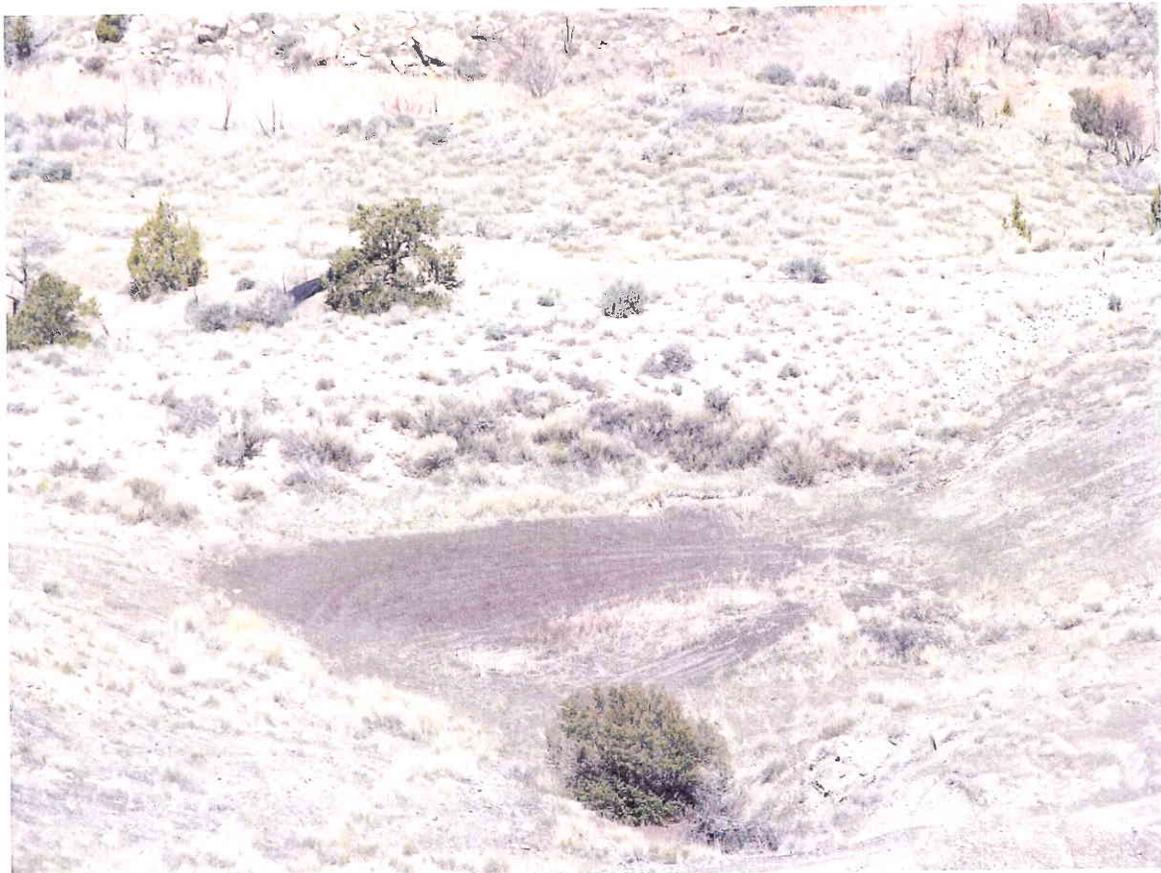
Coarse Refuse Toe Sediment Pond

Pond had some water in it. No samples were taken Pond did not require decanting
Sediment level was good
Embankment conditions were good. Vegetation on out slopes was adequate.
Inlet / Outlet conditions were good. No structural or hazardous conditions were observed.

No recent changes in the geometry of the structure have been observed
Some water was impounded
Sediment level was good.
