Sunnyside Cogeneration Associates

RE: 2nd Quarter 2012 Inspection Report
Sunnyside Refuse Pile C/007/035

IMPOUNDMENT INSPECTION AND CERTIFIED REPORT

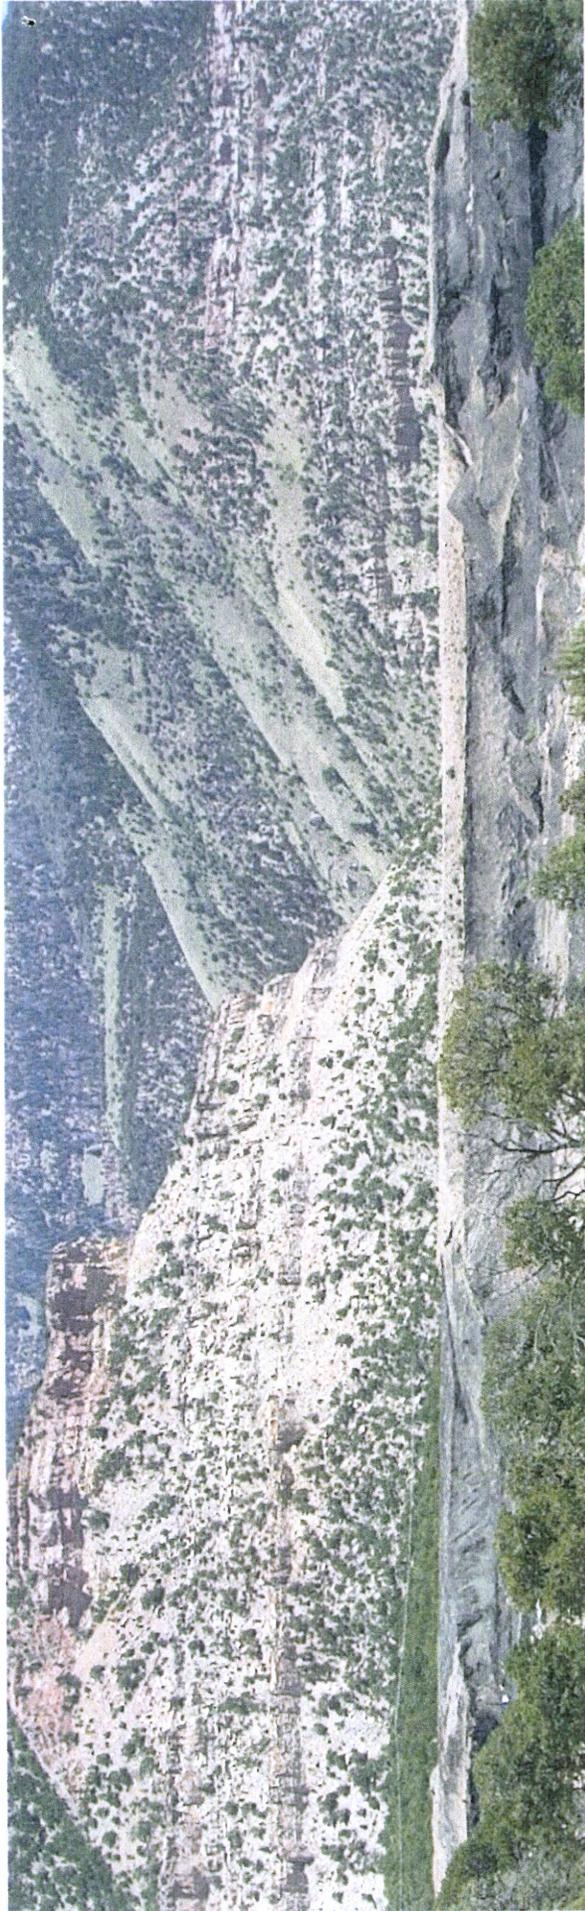
Refuse Pile – Looking southeasterly

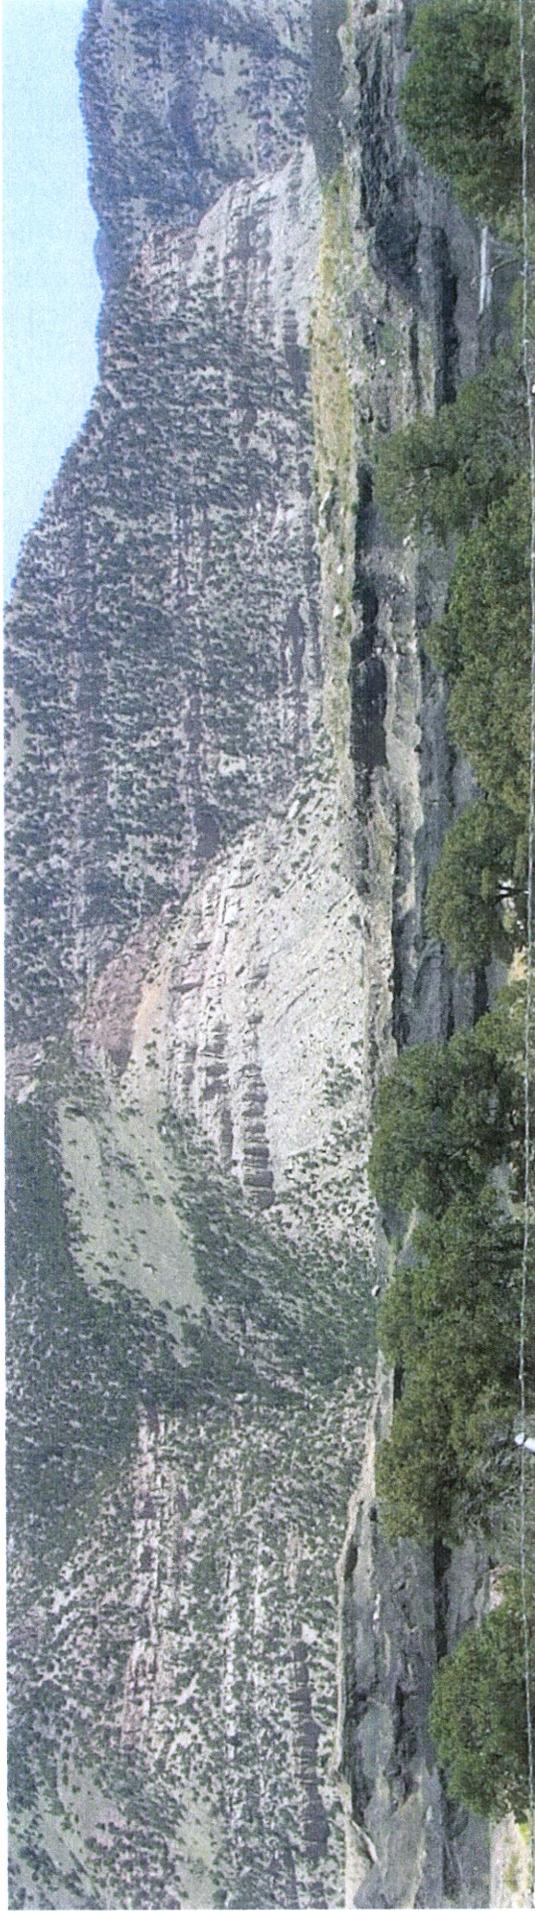
Refuse Pile – Looking southerly

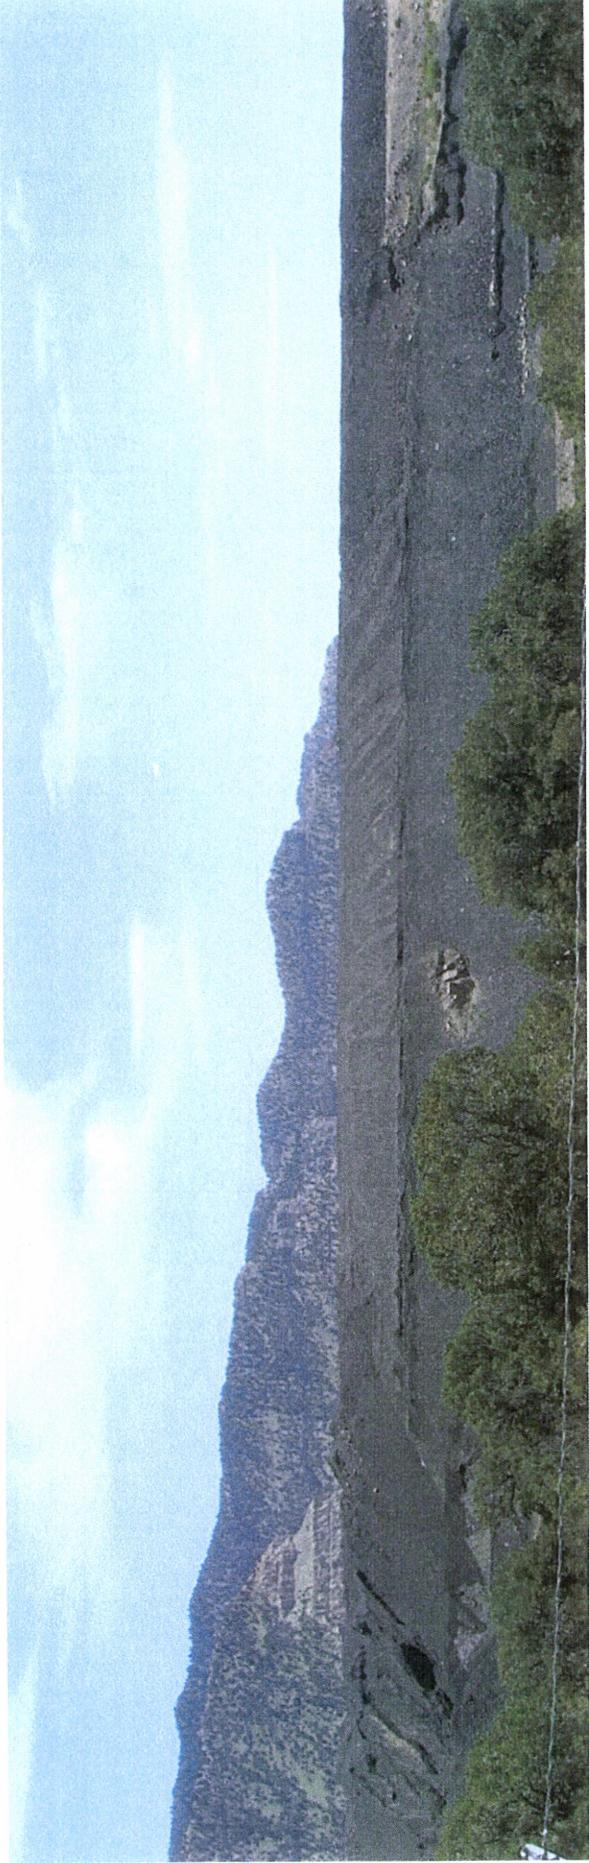
Excess Spoil Disposal Area #1 – Looking southerly

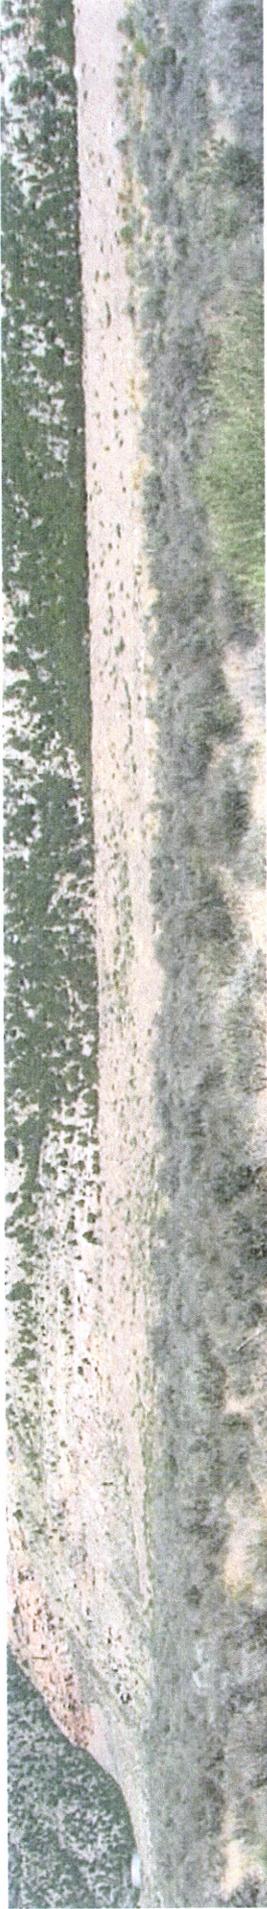
Excess Spoil Disposal Area #2 (Phase1)— Looking easterly — North half

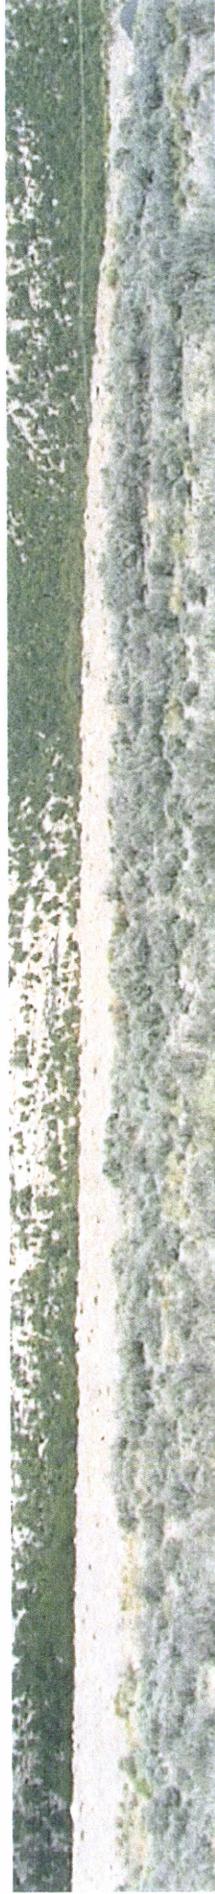
Excess Spoil Disposal Area #2 (Phase1)— Looking easterly — South half

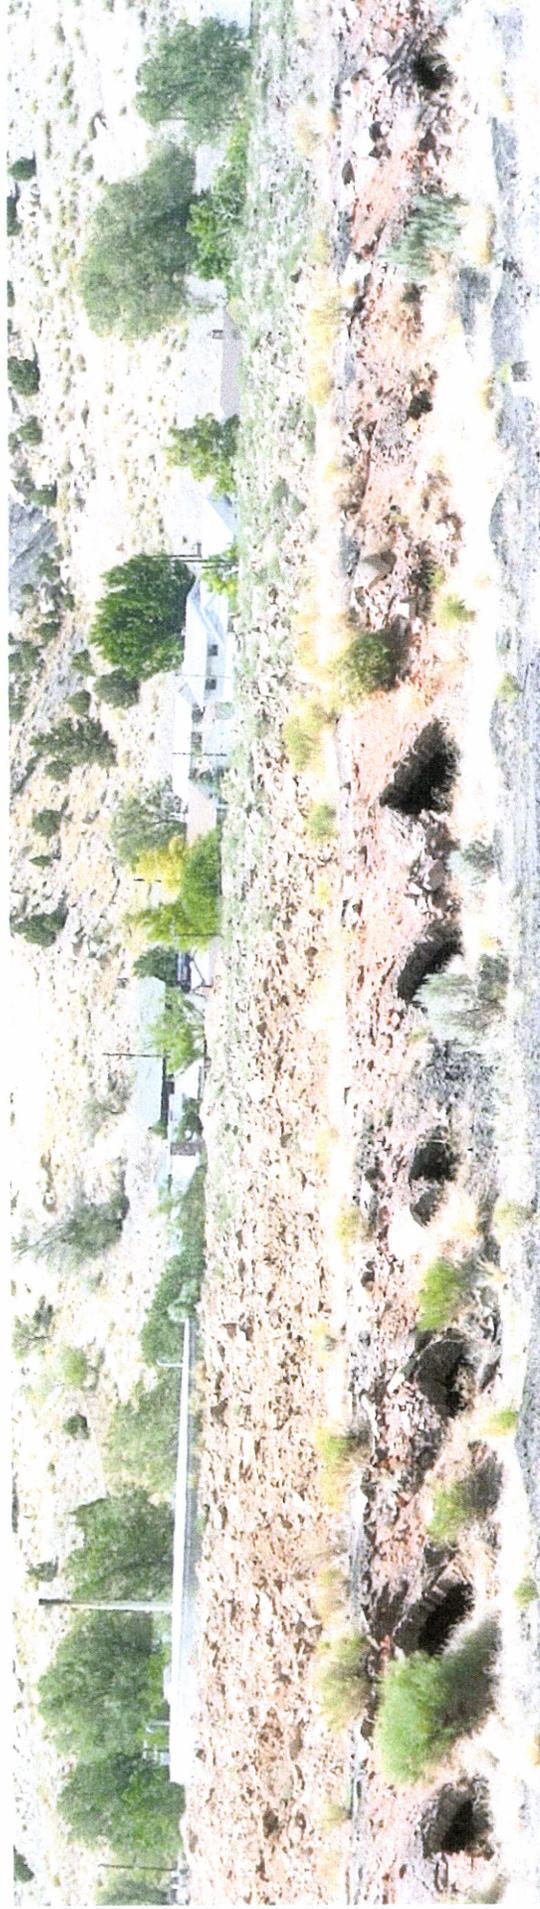
Phase 1 portion has been covered with 4ft, mulch & fertilizer incorporated and reseeded. Vegetation is proceeding slowly due to lack of rain. SCA will evaluate conditions this Fall to determine potential need for over-seeding.

Excess Spoil Disposal Area #2 (Phase1)— Looking northwesterly (coke ovens in foreground, XS#2 in background)

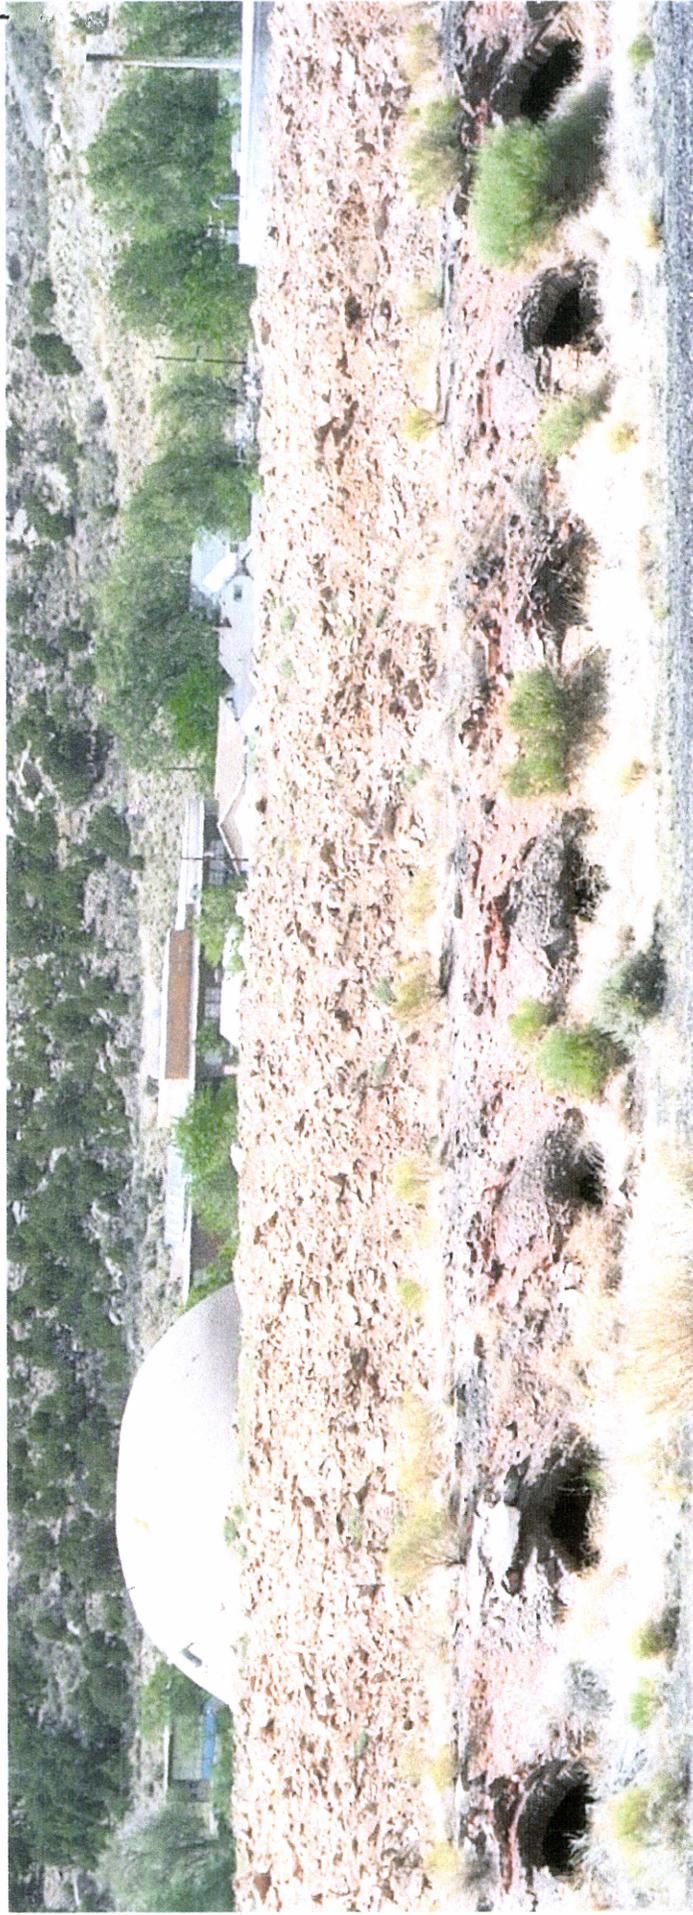
Excess Spoil Disposal Area #2 (Phase1)— Looking west/northwesterly (coke ovens in foreground, XS#2 in background)

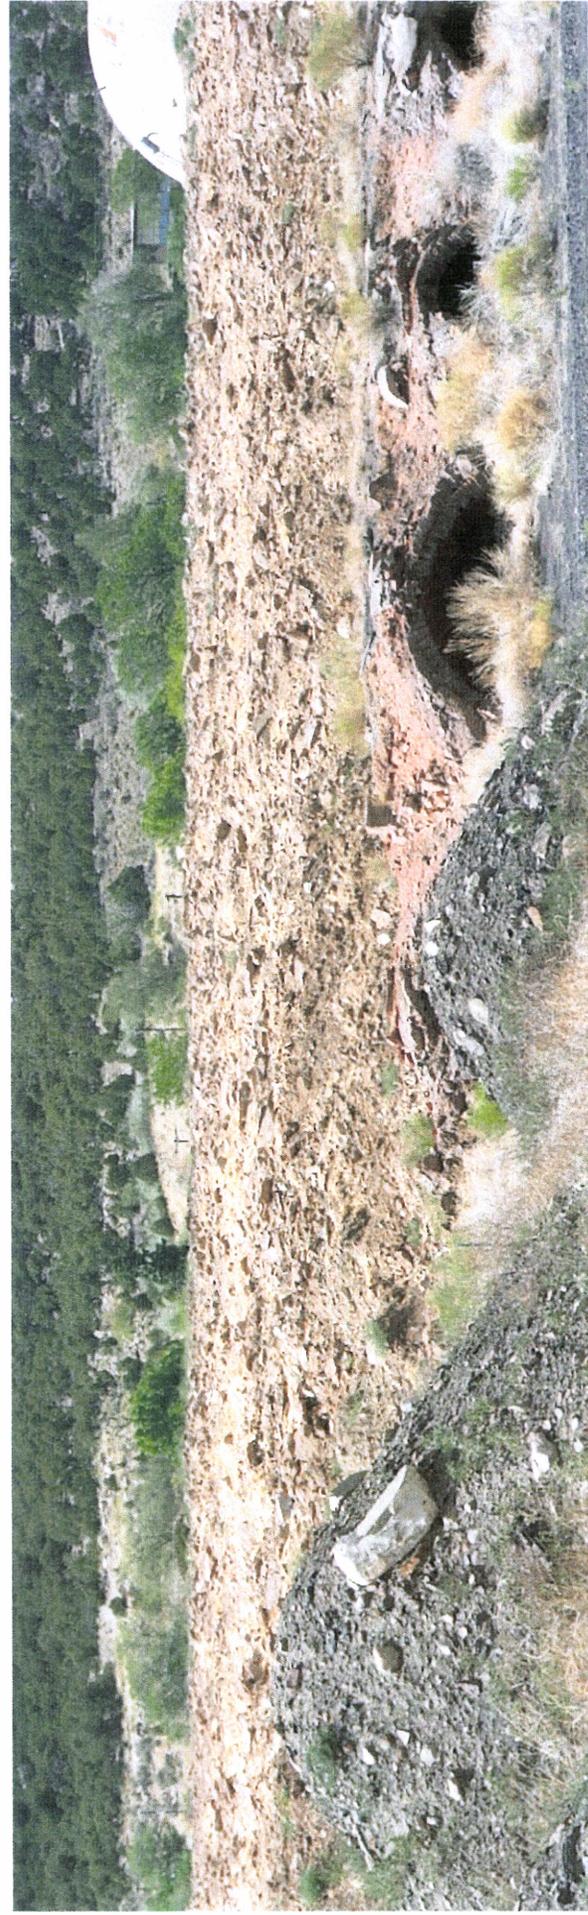
Excess Spoil Disposal Area #2 (Phase1)— Looking westerly (coke ovens in foreground, XS#2 in background)
