## Sunnyside Cogeneration Associates

RE: Annual 2015 Inspection Report  
Sunnyside Refuse and Slurry C/007/035

# ANNUAL INSPECTION FORM – IMPOUNDMENT

Permit Number: C/007/035  
Mine Name: Sunnyside Refuse and Slurry  
Mine Operator (Permittee): Sunnyside Cogeneration Associates  
MSHA ID Number: N/A  
Impoundment Name: RailCut Sediment Pond #007  
UPDES Permit Number: UT024759

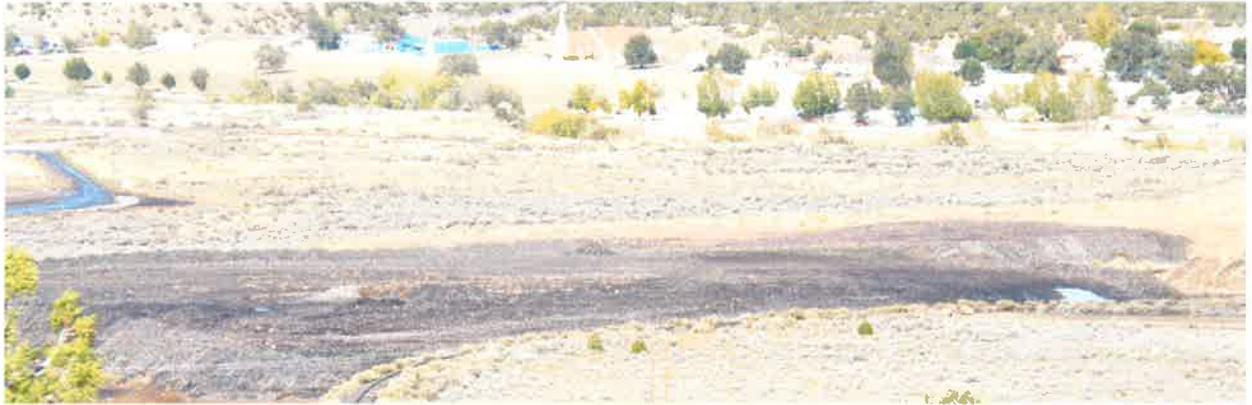
Sunnyside Excess Spoil Area #2 – Phase 2 – Looking northwesterly

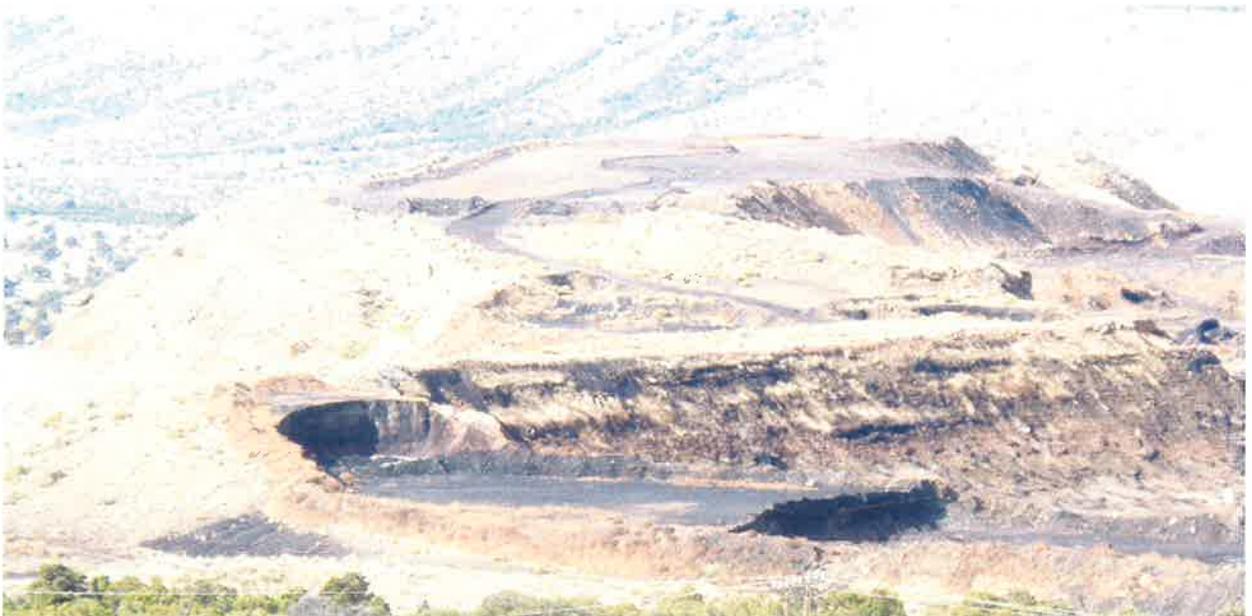
Sunnyside Excess Spoil Area #1 – Looking northwesterly

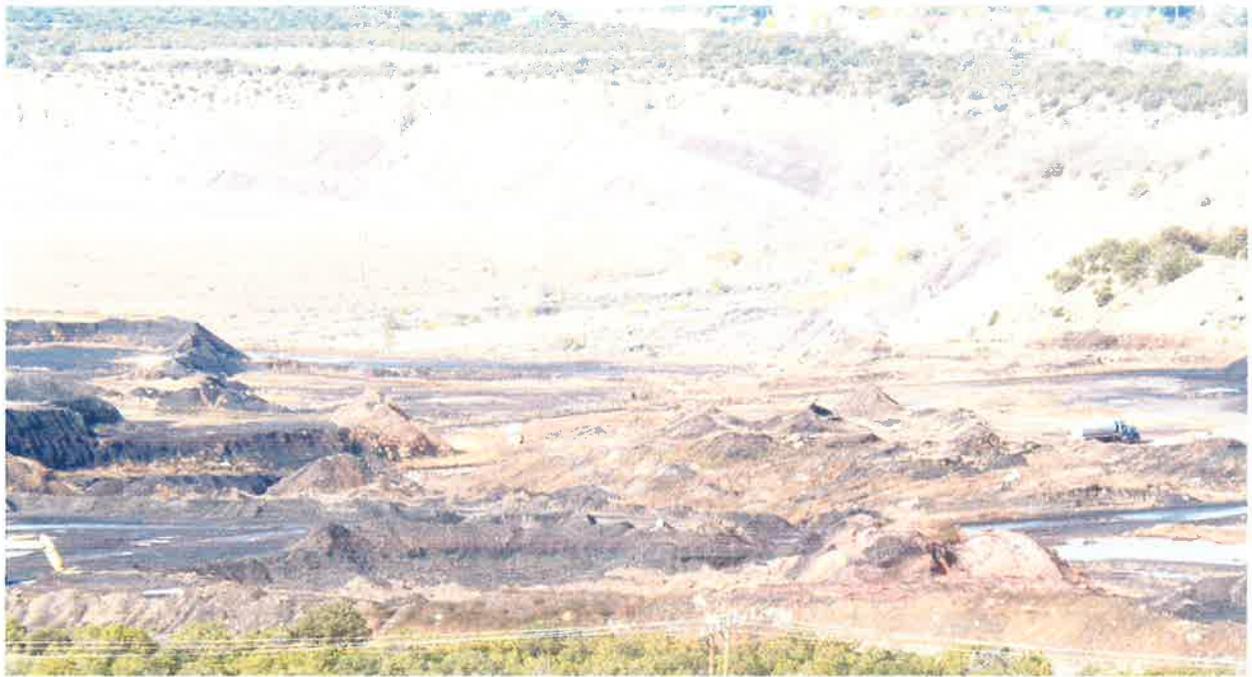
Sunnyside Refuse Pile – West end – Looking northwesterly

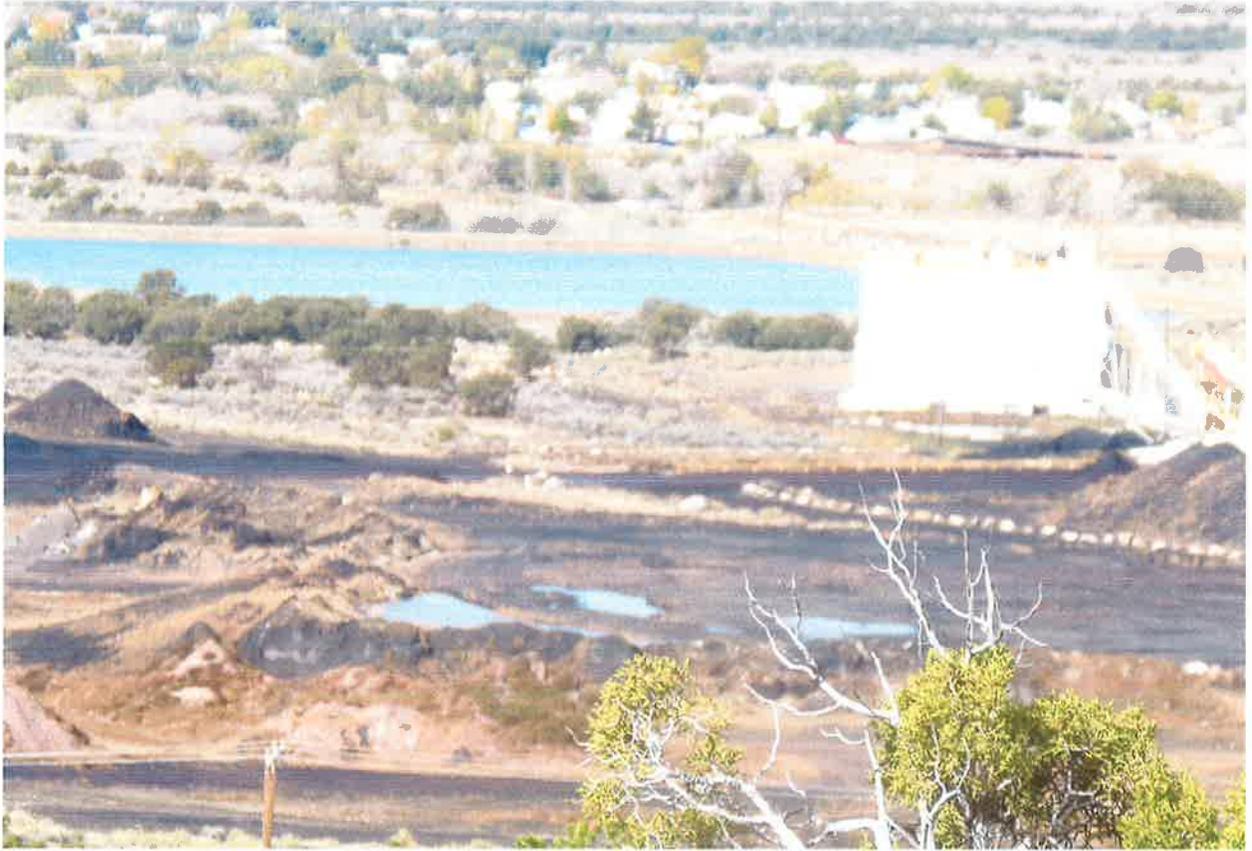
Sunnyside Refuse Pile – Center portion – Looking northwesterly

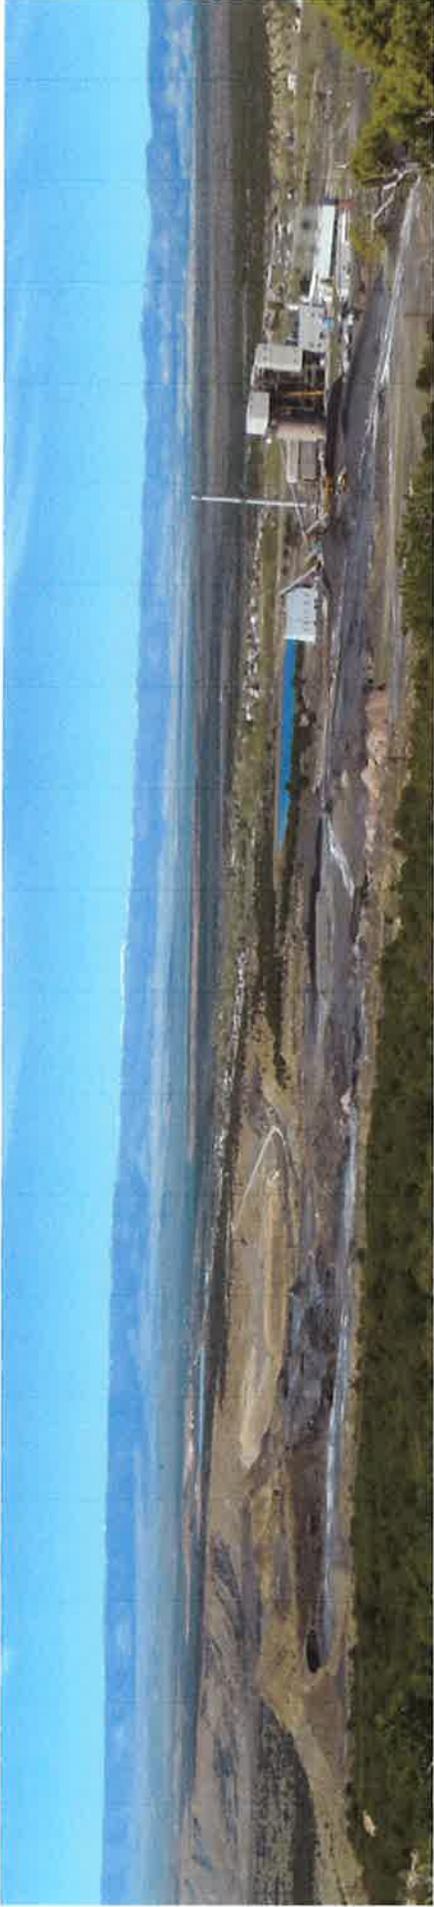
Sunnyside – Refuse Pile looking west

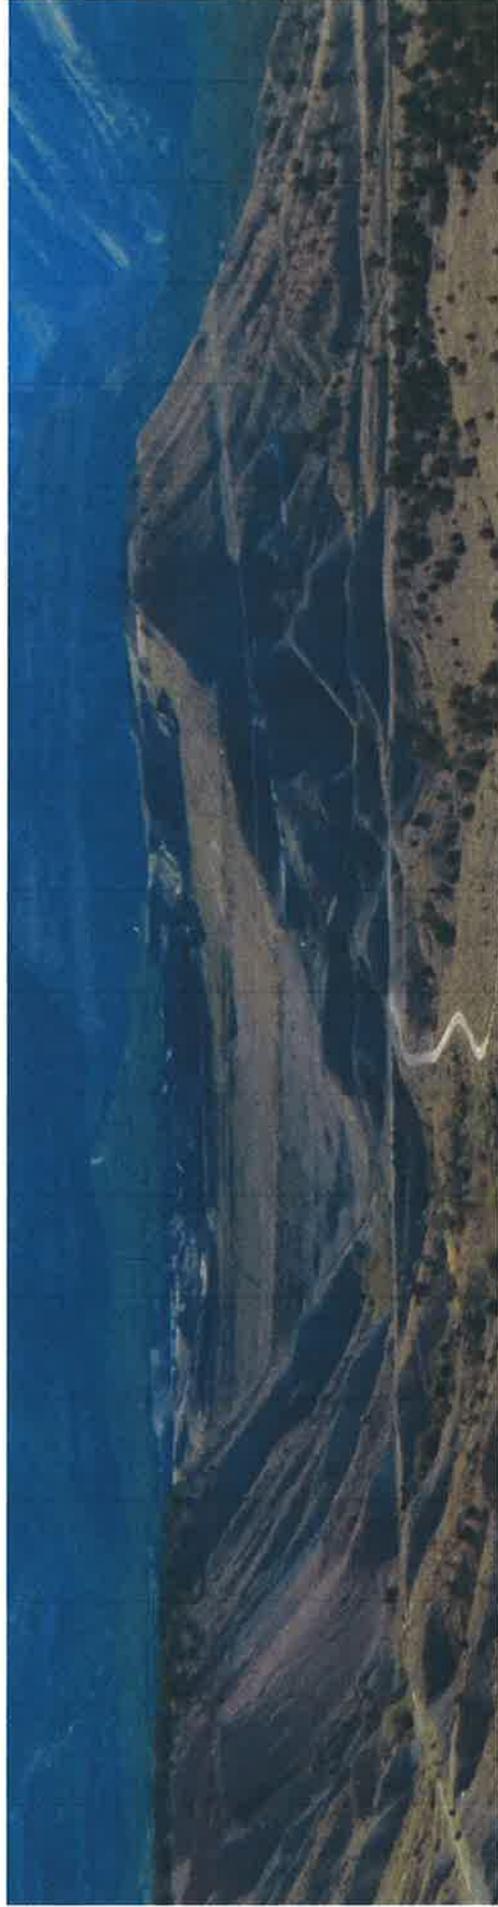
Sunnyside – Refuse Pile looking east

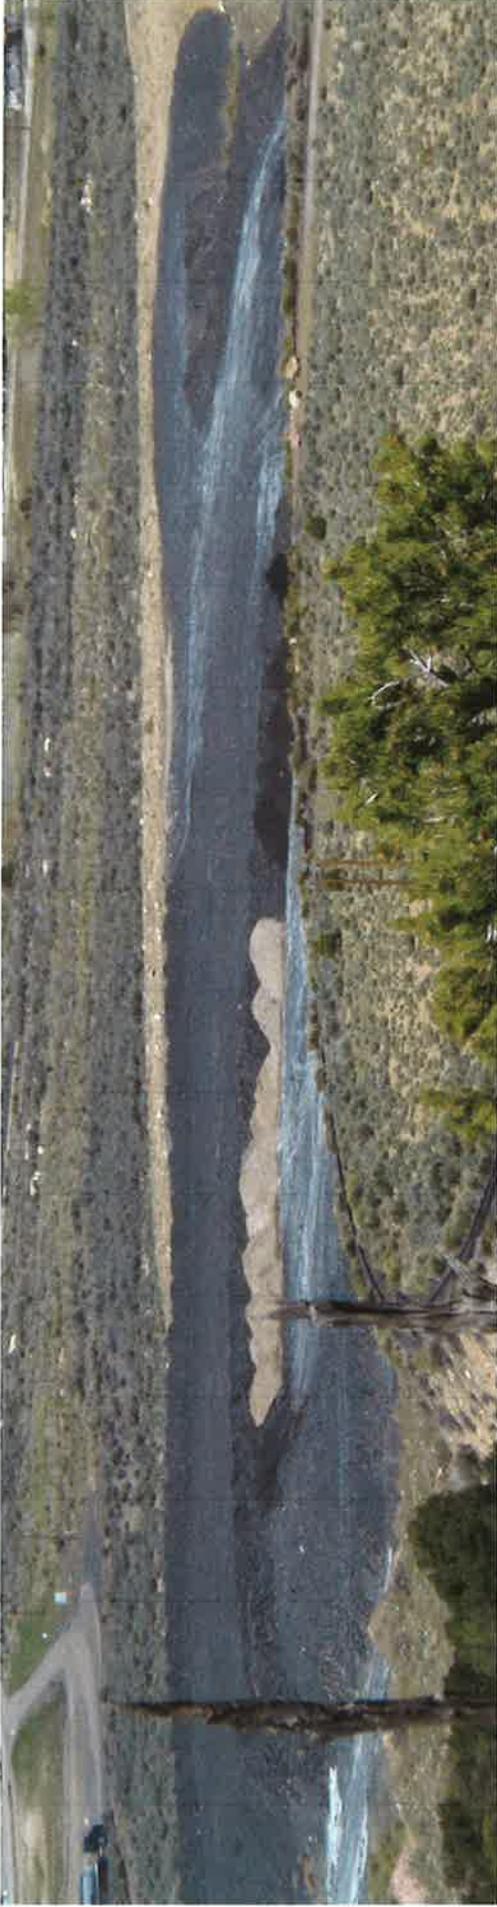
Sunnyside Excess Spoil Area #2 – Phase 2 – Looking northwesterly

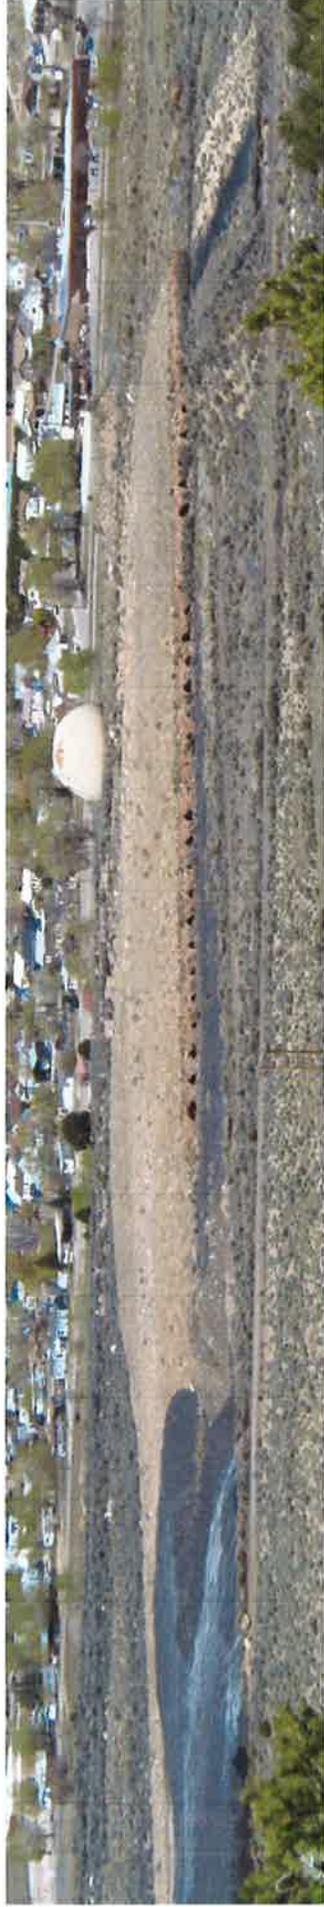
Sunnyside Excess Spoil Area #2 – Phase 1 – Looking northwesterly
