## Sunnyside Cogeneration Associates

RE: 3rd Quarter 2016 Inspection Report  
Sunnyside Refuse Pile C/007/035

# QUARTERLY INSPECTION FORM – IMPOUNDMENT

Permit Number: C/007/035  
Mine Name: Sunnyside Refuse and Slurry  
Mine Operator (Permittee): Sunnyside Cogeneration Associates  
MSHA ID Number: N/A  
Impoundment Name: RailCut Sediment Pond #007  
UPDES Permit Number: UT024759

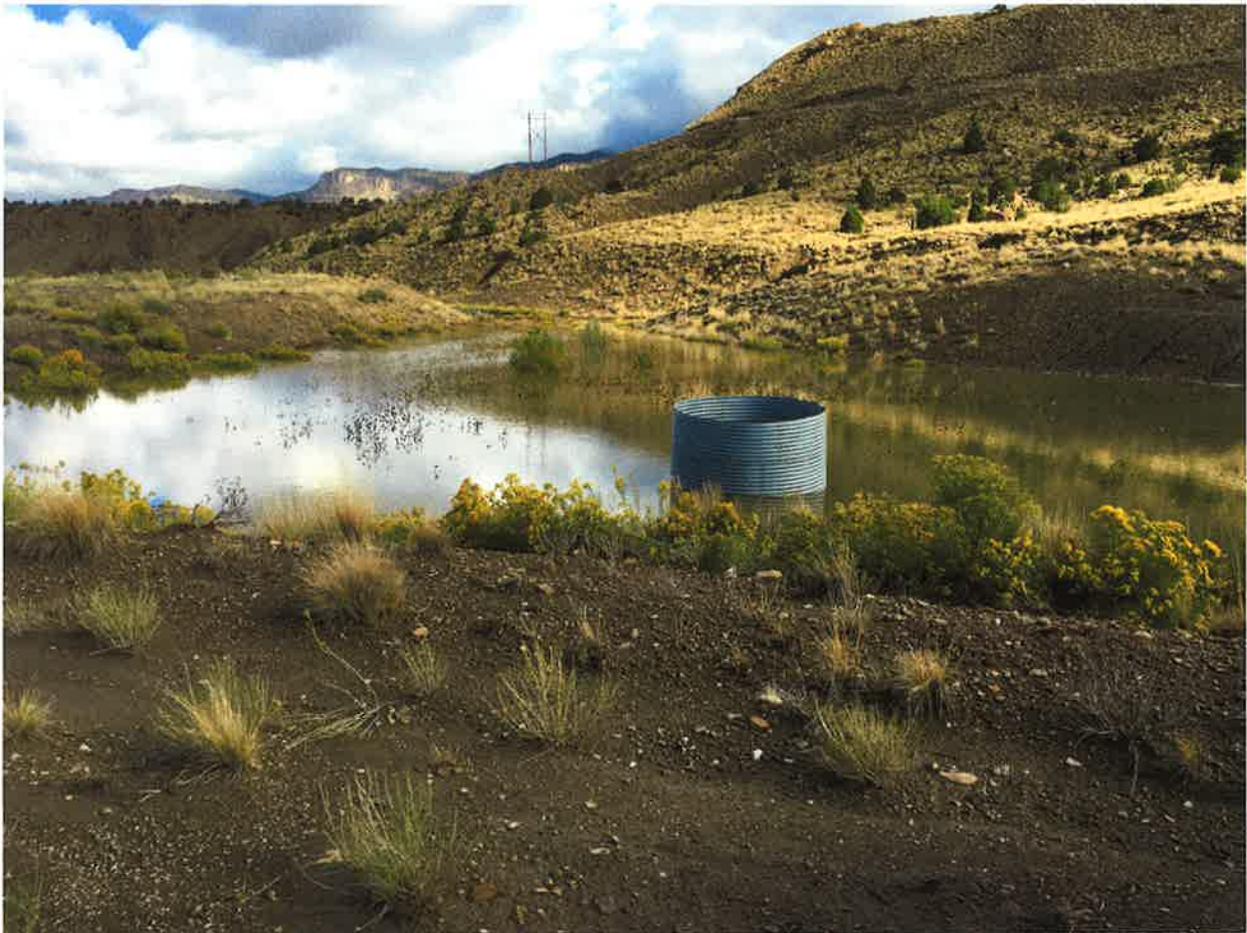
Rail Cut Pond – 007 - Looking northerly

Pond was full and discharging due to storms which brought approximately 6-inches of rain in about 24 hours. Samples were taken. Visual observation indicates expectation that discharge water quality should be within UPDES requirements.

Pond was full to discharge spillway elevation

A major storm brought approximately 6 inches of rain in about 24 hours to the Sunnyside area on September 22, 2016. Sediment ponds at the SCA Sunnyside facilities handled the runoff well. Discharges occurred at Rail Cut Pond -007, Old Coarse Refuse Road Pons -008, Pasture Pond -009, and Coal Pile Sediment Pond -014. Other sediment ponds filled nearly full but did not discharge.

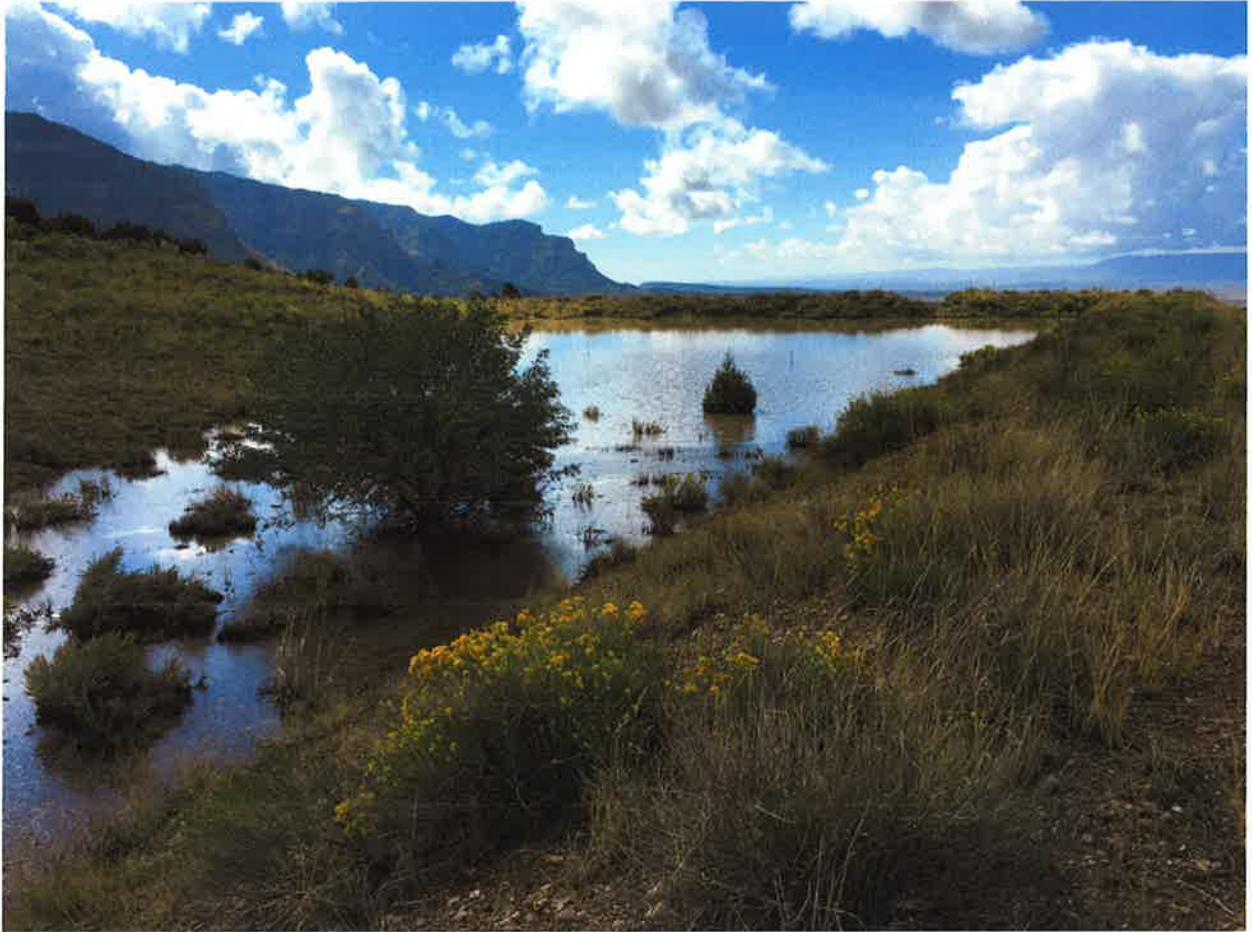
Borrow Area Pond – 016 – Looking southerly

Pond was nearly full, but no discharge occurred. No samples were taken  
Sediment level was good. Pond did not require decanting.  
Embankment conditions were good. Vegetation on out slopes was adequate.  
Inlet / Outlet conditions were good. No structural or hazardous conditions were observed.

No recent changes in the geometry of the structure have been observed  
Pond was nearly full, but no discharge occurred. Sediment level was good.  
No other aspects of the impounding structure were observed that could affect its stability or functionality.
