United States Department of the Interior

BUREAU OF LAND MANAGEMENT

Re: Inspection of shafts that are temporarily abandoned on Federal Coal Lease SL-071737 (Crandall Canyon).

Subject: Shaft Inspection at Crandall Canyon on Federal Coal Lease UTU-071737

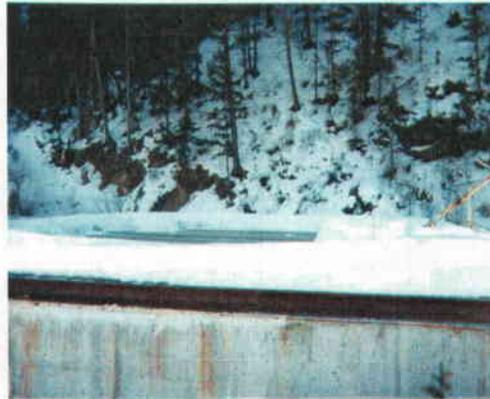
Exhaust Shaft Cap

Exhaust Shaft: We then went down the canyon to the exhaust shaft. This cap has had a hole drilled through the cap in the past. No methane readings were taken because the wind was blowing so hard up the canyon. The center of the cap had the snow melted away from it. This could be from the sun or from warm air inside the shaft.

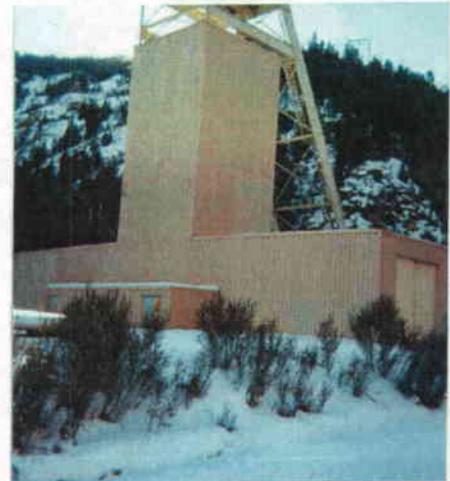
Intake Shaft Head Frame

Intake Shaft: We then went to the intake shaft. Access was easily obtained by pushing the door to the head frame enclosure open. Methane measurements were taken and no gas was detected. The seal over the shaft looked to be in good shape. The cage guide rails were protruding through the cap and the cage was blocked up on top of the cap. We then went outside and looked at the caps on where the fans had been located on the intake shaft. There apparently were slopes driven from the

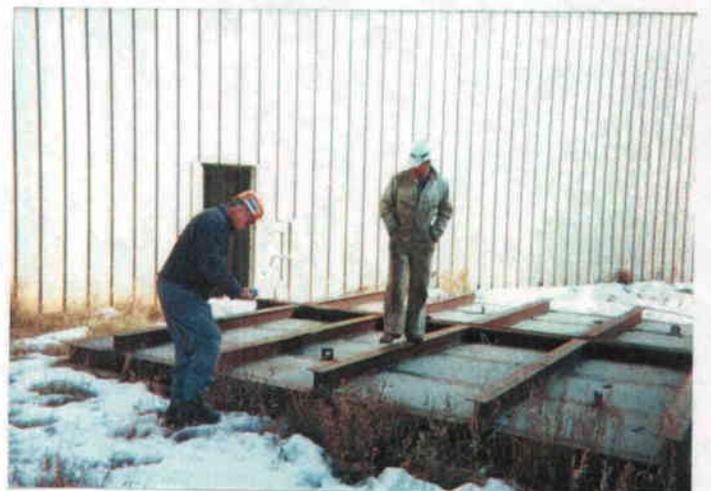
North Fan Slope Methane Measurement

fan foundations down into the shaft. The temporary caps did not seal the slopes well. On the north slope methane was checked from a gap in the shaft cap and 0.5% methane was recorded. The wind was blowing very hard so it is unknown what the true reading was from the air going from the shaft to the atmosphere. It is also unknown what the methane concentration is inside the shaft. At the cap over the south slope we could not detect methane coming out. It was interesting that the in-take shaft was exhausting at the north slope. It is unknown why this is the case. No barometric pressures were recorded nor was any data analyzed. The return shaft was in the sun light at the time of the measurements.

1. There is easy access to these shafts. The caps are temporary and are not solid. There was methane gas coming out of the north slope entry of the intake shaft. We are not sure of the concentration because of outside conditions at the time the measurements were taken. We are also unsure why the north slope of the intake shaft was exhausting. The concrete caps appear to be adequately designed and constructed to support personnel. However, they are accessible to vehicles and it is not known if they would support such a live load. We feel that there should be a fence with a locked gate around each of the shafts and the slopes. This would limit access, danger to the public and liability from potential problems from the shaft. **This should be done immediately.**
