Subject: Inspection of Willow Creek Preparation Plant Coal Refuse Pile

Report Date 30 Sep 2010
Permit Number C/007/038
Company Name Plateau Mining Corporation

Pile Name Willow Creek Preparation Plant (Schoolhouse Canyon) Refuse Pile
Pile Number 1211-UT-09-02113-01
MSHA ID Number 42-02113

Subject: Willow Creek Preparation Plant Refuse Pile
Verification of Reclamation Channel Adequacy at Rock Fall

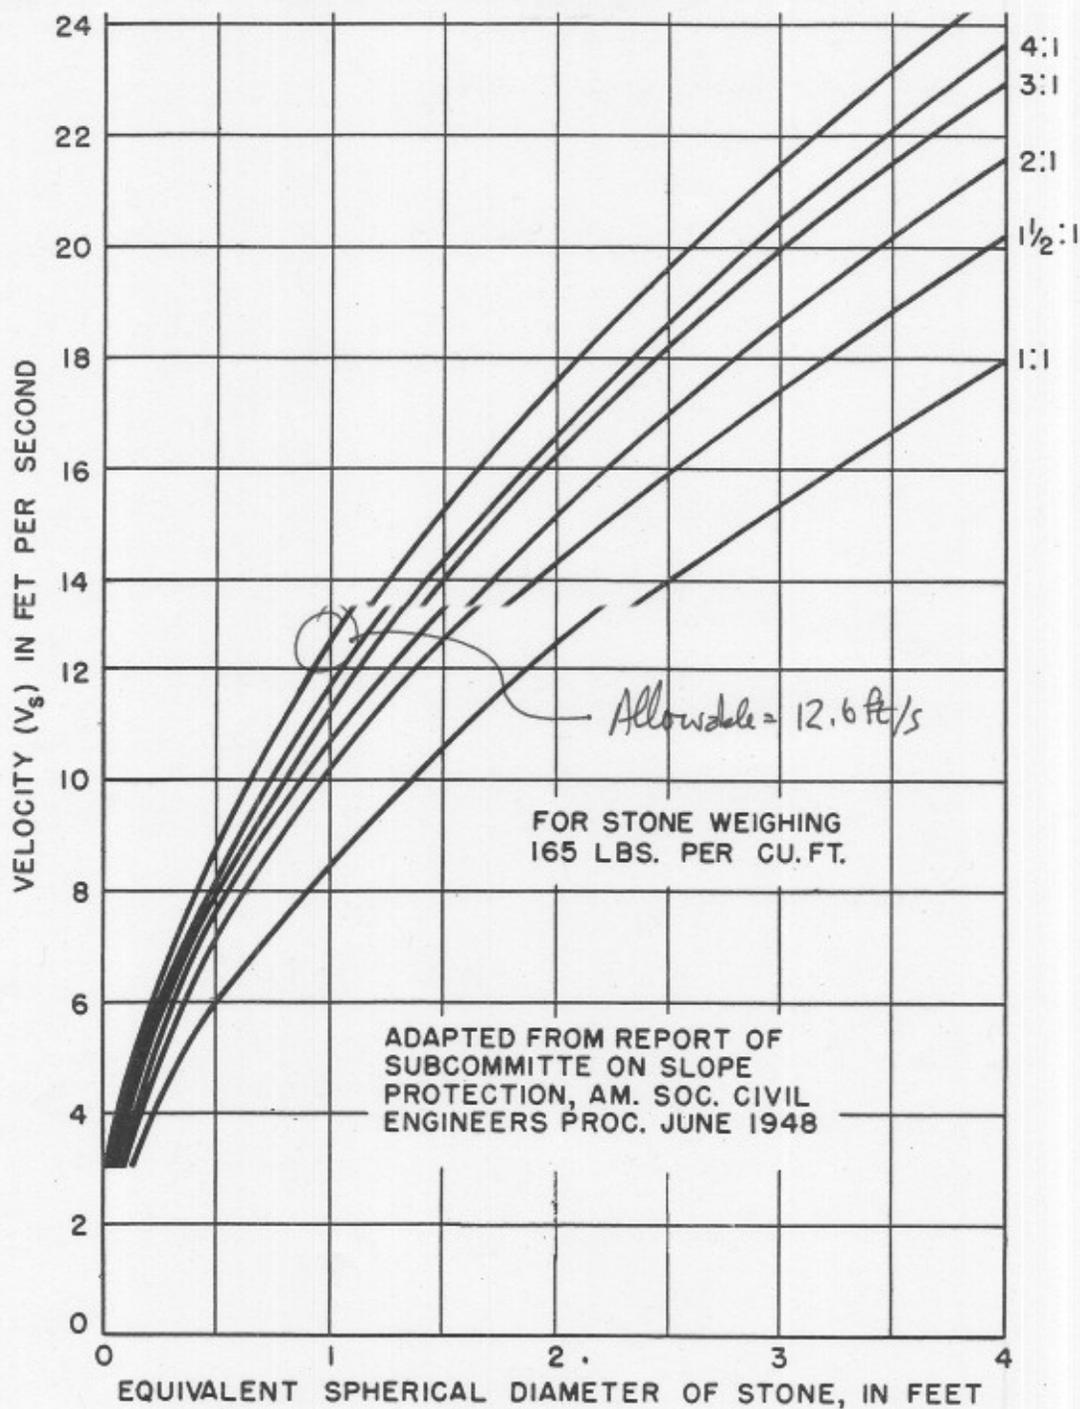
FIG. 2-SIZE OF STONE THAT WILL RESIST DISPLACEMENT FOR VARIOUS VELOCITIES AND SIDE SLOPES

At your request, I evaluated the adequacy of CGRD-1 to convey runoff through the constricted point under non-erosive conditions. Based on my measurements collected on 1 Jun 2006, the reclaimed at the constriction has a minimum bottom width of 4 feet with side slopes that are approximately vertical. The channel slope through the area of constriction is 0.032 ft/ft. The channel bottom is underlain throughout CGRD-1 by riprap with a median diameter of 12 inches.

Attachment 1 of Exhibit 19, Appendix 3.4N of the Willow Creek Preparation Plant Mining and Reclamation Plan indicates that the peak flow resulting from the 100-year, 6-hour storm for the entire watershed draining watershed CGRWS-1 is 31.19 cubic feet per second. Since the point of constriction is more than 2,000 feet upstream from the mouth of CGRWS-1, this peak flow is conservatively high for the current evaluation. Nonetheless, using this peak flow with a channel width of 4 feet, bottom slope of 0.032 ft/ft, and vertical side slopes, the velocity at peak flow was calculated to be 5.81 ft/s (based on a Manning's roughness coefficient of 0.0395 for riprap with a median diameter of 12 inches), with a flow depth of 1.34 feet (see the attached printout). The allowable velocity for riprap with a median diameter of 12 inches on the channel bottom is 12.6 ft/s (see the attached calculation sheet). Hence, the channel capacity is adequate, even with the constriction.
