Inspection Report

Permit Number:	C0070038
Inspection Type:	PARTIAL
Inspection Date:	Monday, December 08, 2014
Start Date/Time:	12/8/2014 1:00:00 PM
End Date/Time:	12/8/2014 3:00:00 PM
Last Inspection:	Friday, November 14, 2014

Permitee: **PLATEAU MINING CORP**
Operator: **PLATEAU MINING CORP**
Site: **WILLOW CREEK MINE**
Address: **PO BOX 30, HELPER UT 84526-0030**
County: **CARBON**
Permit Type: **PERMANENT COAL PROGRAM**
Permit Status: **INACTIVE**

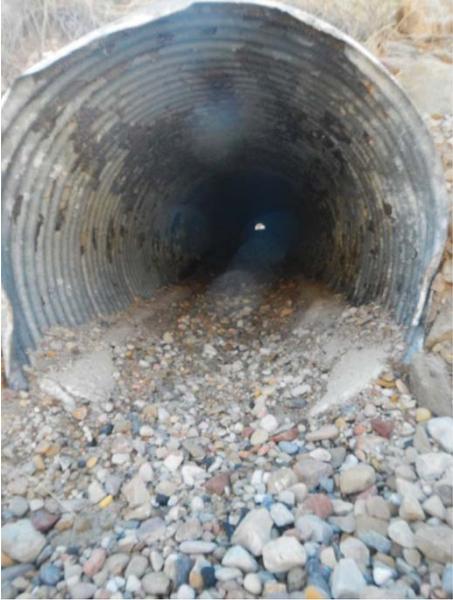
A large rain event occurred in September of 2014 causing extensive runoff throughout the Price area. At the reclaimed School House Refuse Pile, the runoff deposited sediment which filled the main culvert. The culvert was partial open in the November inspection and during this December inspection it was completely cleaned out. Photo 1 shows the cleared out culvert completely open.

Photo 1 Culvert under Frontage road of Hwy6

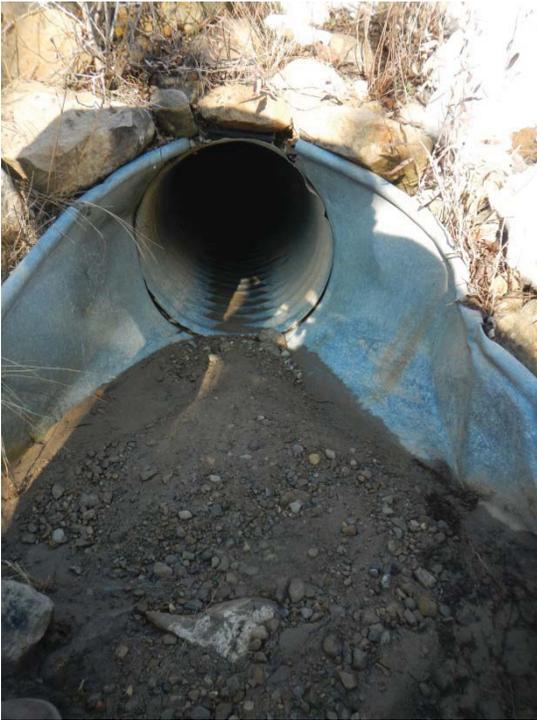
Roads appeared to be in good maintained along Crandall Canyon and School House Refuse pile with no rills or headcuts along the road or shoulders. Photo 2 shows the cleaned out culverts along the road up Crandall Canyon.

Photo2 Looking along cleared out culvert to other side

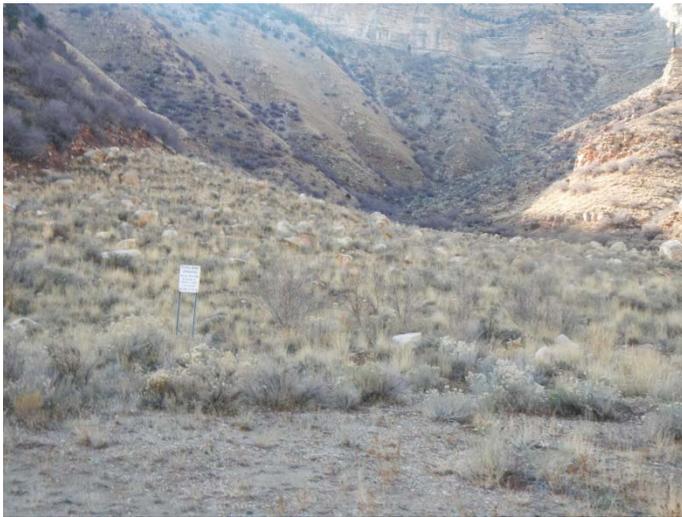
Photo 3 Gravel Canyon

No slides or subsidence were witnessed during the inspection of the four sites. See Photo 3 of Gravel Canyon and Photo 4 of School House Refuse Pile.

The site appears to have a healthy established vegetation population with no or few invasive or noxious weeds seen at any of the areas. See Photo 3 of the vegetation at Gravel Canyon.

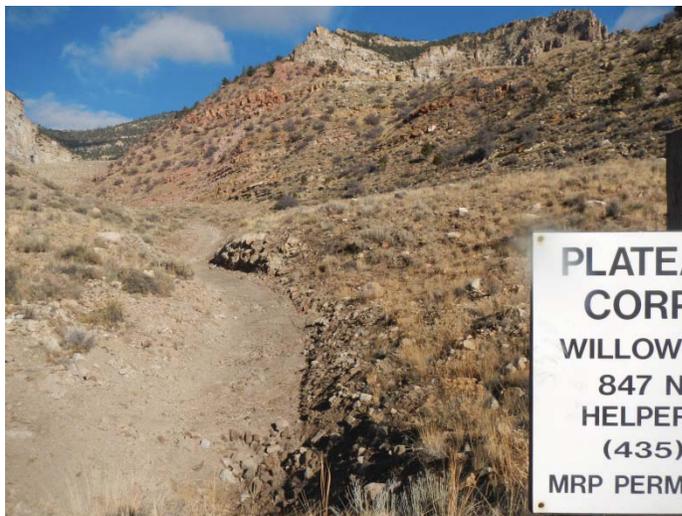
Photo 4 School House Refuse Pile

The Mine and Permit identification signs were inspected at all four locations (School House Refuse pile, Gravel Canyon, Crandall Canyon, and west of the former Facilities) and found to be in working order. All the information on the signs was current and meets the minimum requirements of R645.521.200-.244 Coal Rules. See Photo 4.

Vegetation has grown in and stabilized all reclaimed areas. No noticeable riling or gulying occurred since the previous inspection in November along the length of the slope at the School House Refuse Pile. See Photo 4.
