Re: Midterm Review, Canyon Fuel Company, LLC, Dugout Canyon Mine, ACT/ [REDACTED]
MT00, O [REDACTED]

Dugout Canyon Mine
Midterm Review
C/007/039-MT00
Technical Analysis
December 7, 2000

To: Internal File
From: Daron R. Haddock, Permit Supervisor *DRH*
Re: Technical Field Visit as part of Midterm Review, Canyon Fuel Company, LLC,
Dugout Canyon Mine, C/007/039

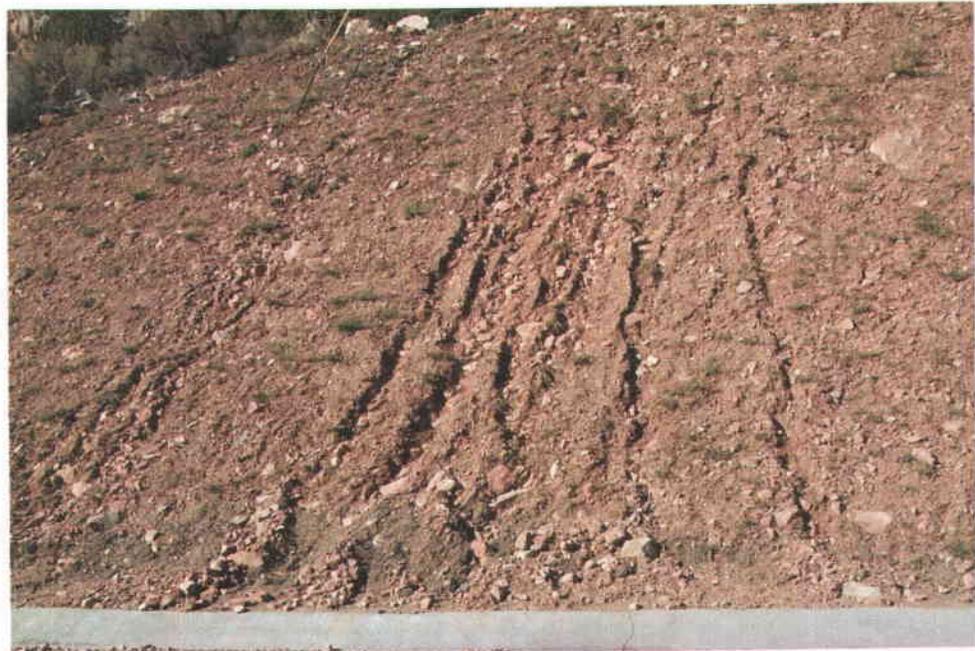
Between the pond and the office buildings (adjacent to the truck loadout), there is an area where a slope was cut to build some of the pad area. There appears to be a small amount of rilling on this slope(see Figure 2 page 4). The area has been seeded, but since this is new construction, vegetation has not completely stabilized the slope. It is felt that the slope will become stable as the vegetation grows in. The area should be watched during the next growing season to ensure it stabilizes. The substation, powder magazine, and water storage tank areas were also inspected. No concerns were identified.

1. Canyon Fuel should provide the detail necessary in a revised reclamation cost estimate to more accurately reflect the cost of reclamation.
2. The cost estimate identified a concrete non-coal waste storage area, but there is none on the maps or on the ground. This discrepancy needs to be resolved
3. The mine is encouraged to capture a sample of the bubbles coming up in the sedimentation pond and have them analyzed in order to better understand this phenomenon
4. There appears to be a small amount of rilling on the cut slope between the sediment pond and the office building (adjacent to the truck loadout). The area should be watched during the next growing season to ensure it stabilizes.
