Canyon Fuel Company, LLC
Dugout Canyon Mine
P.O. Box 1029
Wellington, Utah 84542

RE: Subsidence Crack Repair – Proposed Scope of Work
Dugout Canyon Mine, Canyon Fuel Company, LLC, C/007/039, Carbon County, Utah

SUBSIDENCE CRACK REPAIR PROJECT, PACE CANYON AREA

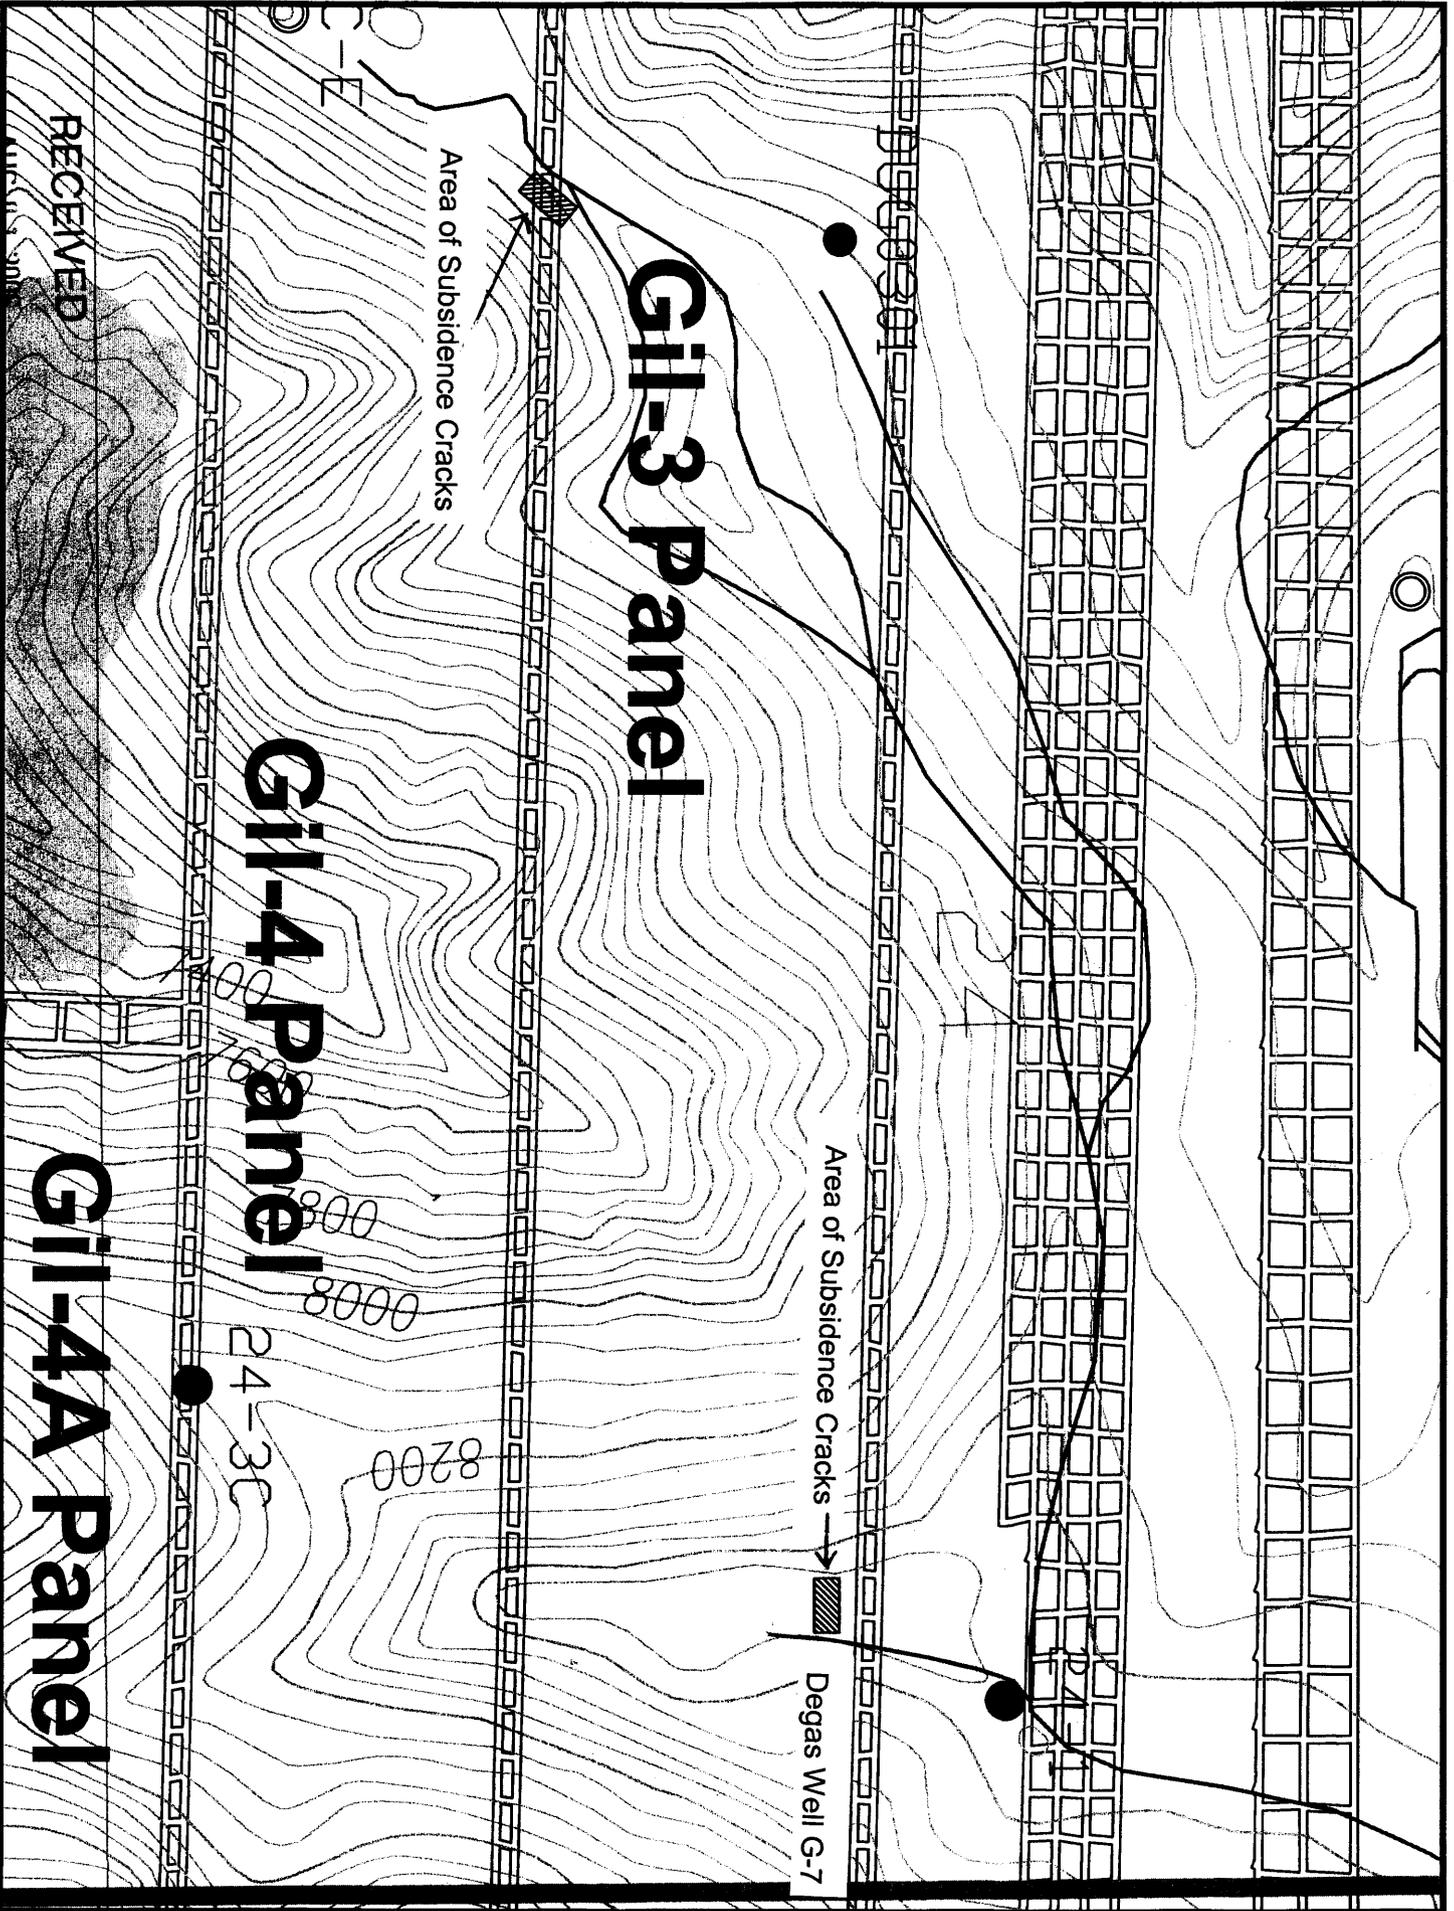
Only one crack is open enough to be considered hazardous to humans, wildlife or livestock (N1/2NE1/4SE1/4). This crack is across an existing road and immediately adjacent to the fence around the drill pad for degas well G-7. The crack is approximately 200' long, however only approximately 20 feet of the crack is open enough to be considered hazardous. A second crack has formed within the fenced area of the G-7 pad and another crack runs horizontal to this crack just outside the fenced pad. Canyon Fuel Company, LLC, Dugout Canyon Mine proposes to repair these open cracks using the methods described below.

There are additional cracks (N1/2SW1/4SW1/4), however they are not as deep or wide as described above. The cracks range in size from three feet to 30 feet in length and are five to fifteen inches deep. When necessary, smaller cracks will be filled with hand tools.

Area of Subsidence Cracks

Degas Well G-7

The site work will be accomplished using, hand tools a trackhoe, rubber tired backhoe, pickup truck, trailer and dump truck. The approximate twenty-foot crack will be filled with soil and rock and compacted when possible. The placed soil will be left in a roughened state and seeded using the reclamation seed mix specified for reclamation of well site G-7. When necessary, smaller cracks will be filled with hand tools and seeded.
