FROM: DUGOUT CANYON MINE, CANYON FUEL COMPANY, LLC, C007/039

RE: STORM EXCEEDENCE

Pace Canyon – Sections 17, 18, 19 & 20, Township 13S Range 13E

Precipitation Event: August 14, 2007

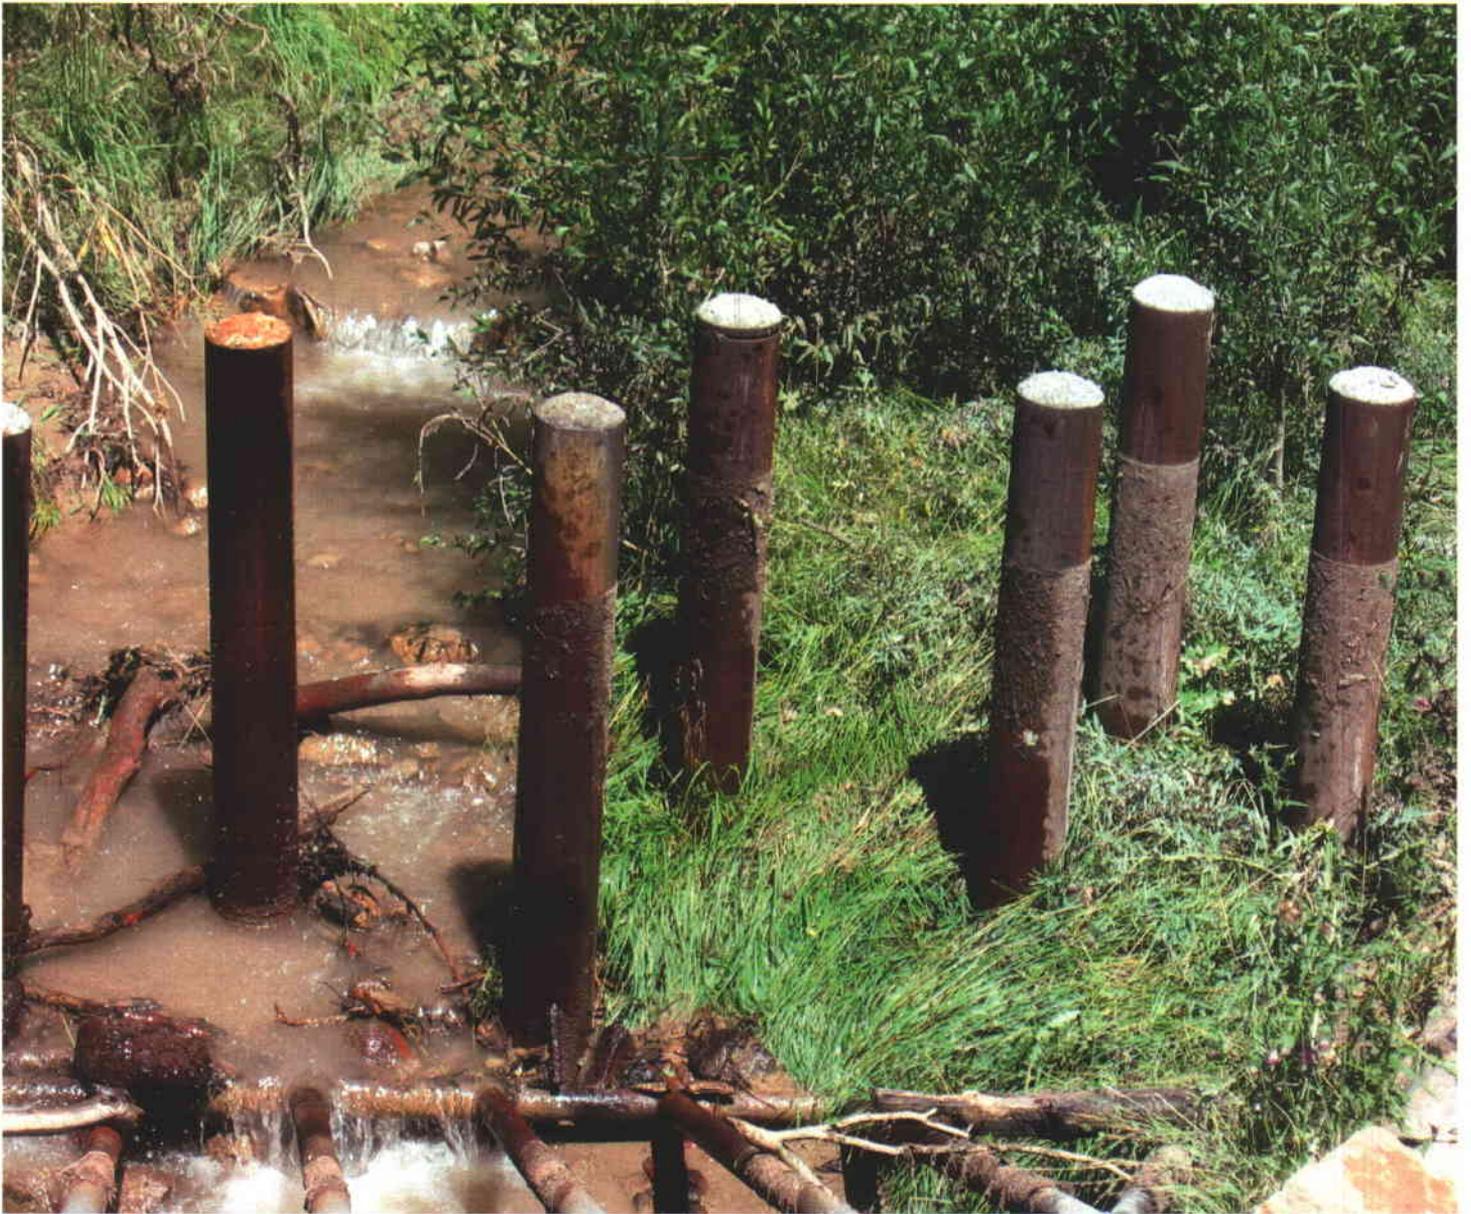
The inlet of Culvert UC-6 (Plate 7-5) on Dugout Creek was not breached, however the water was 4 feet 3 inches in the channel per markings on the inlet's trash racks.

Inlet Culvert UC-6  
note water line mark

Following Storm

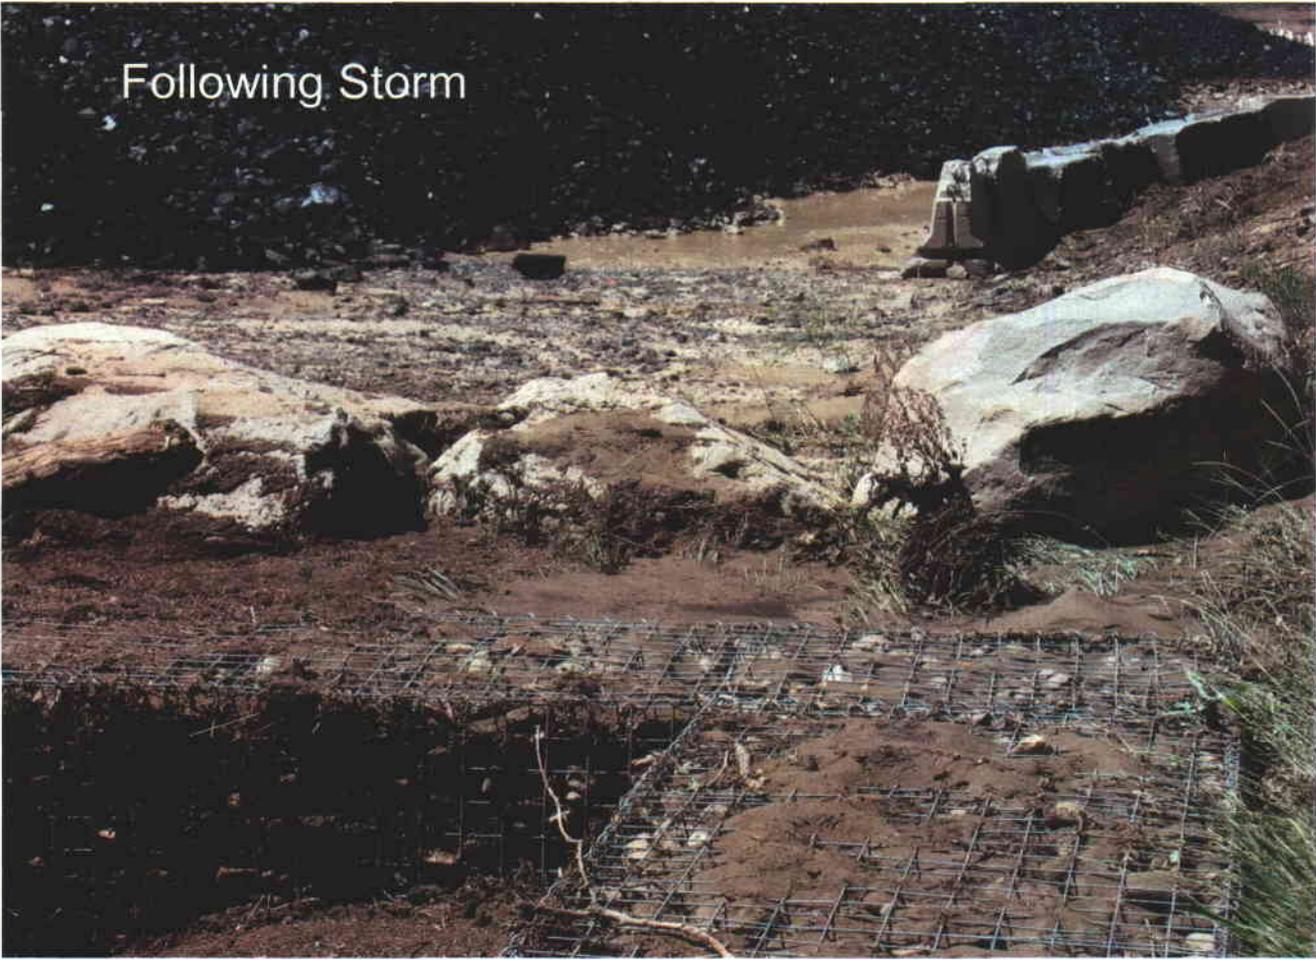
Around 7:25 pm the inlet to Culvert UC-5 (Plate 7-5) of Dugout Creek became blocked. The inlet was blocked due to logging debris from upstream. Water topped the gabion baskets and flooded the area behind the coal pile. The trash racks kept the debris from entering the culvert. The mine sites drainage system collected the overflow and directed it into the sediment pond. The sediment pond did not discharge.

Inlet Culvert UC-5

Debris Removed

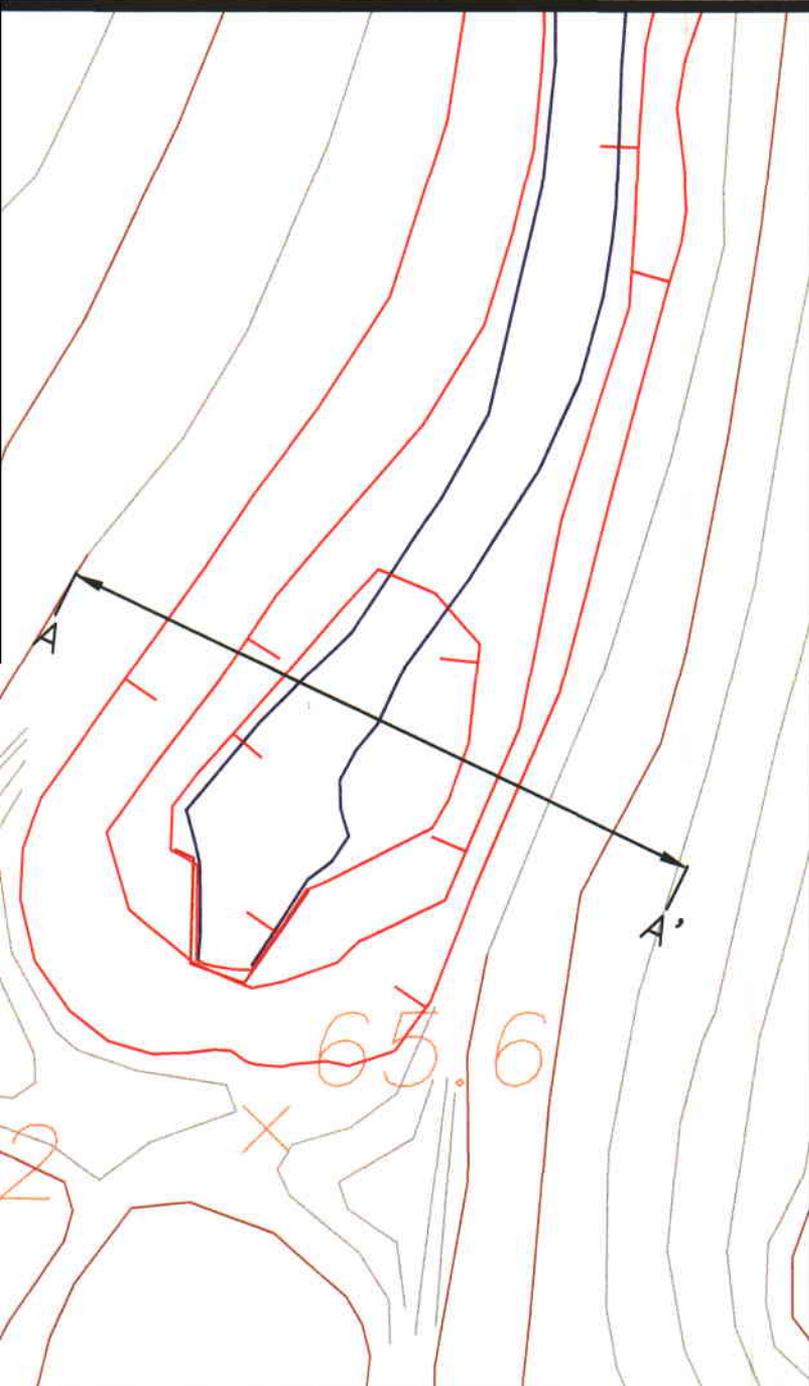
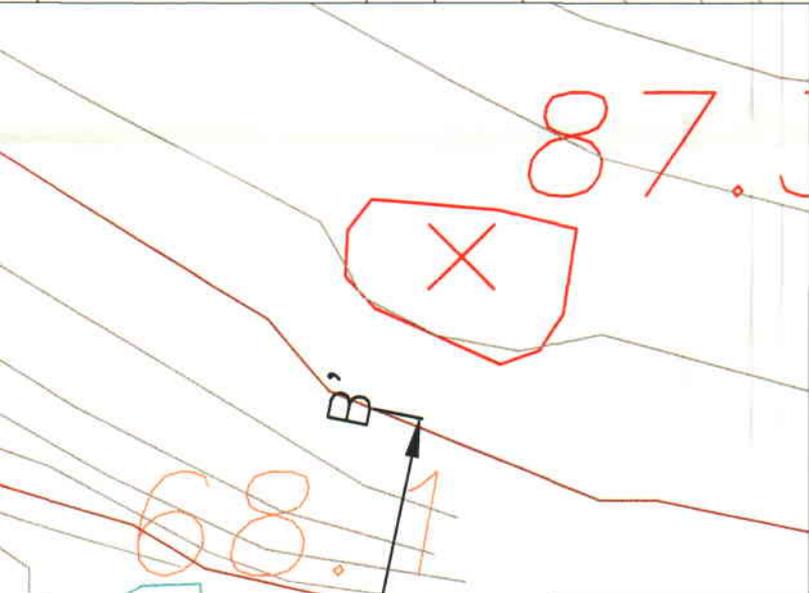
UC-6 (PLATE 7-5)

Cross-sections of the inlets are attached, blue line represents depth of water at its highest observed and recorded level. High watermark photographs are attached.
