**From:** Pete Hess  
**To:** Daron Haddock; Pam Grubaugh-Littig; Steve Christensen  
**Date:** 9/12/2007 2:02 PM  
**Subject:** Storm Event of August 14, 2007 @ Dugout Canyon and Pace Canyon / C/007/039  
**Attachments:** 20070912141005.pdf

TO: COAL STAFF  
FROM: DUGOUT CANYON MINE, CANYON FUEL COMPANY, LLC, C007/039

RE: STORM EXCEEDENCE

Dugout Canyon Mine Site – Sections 14 & 23, Township 13S Range 12E

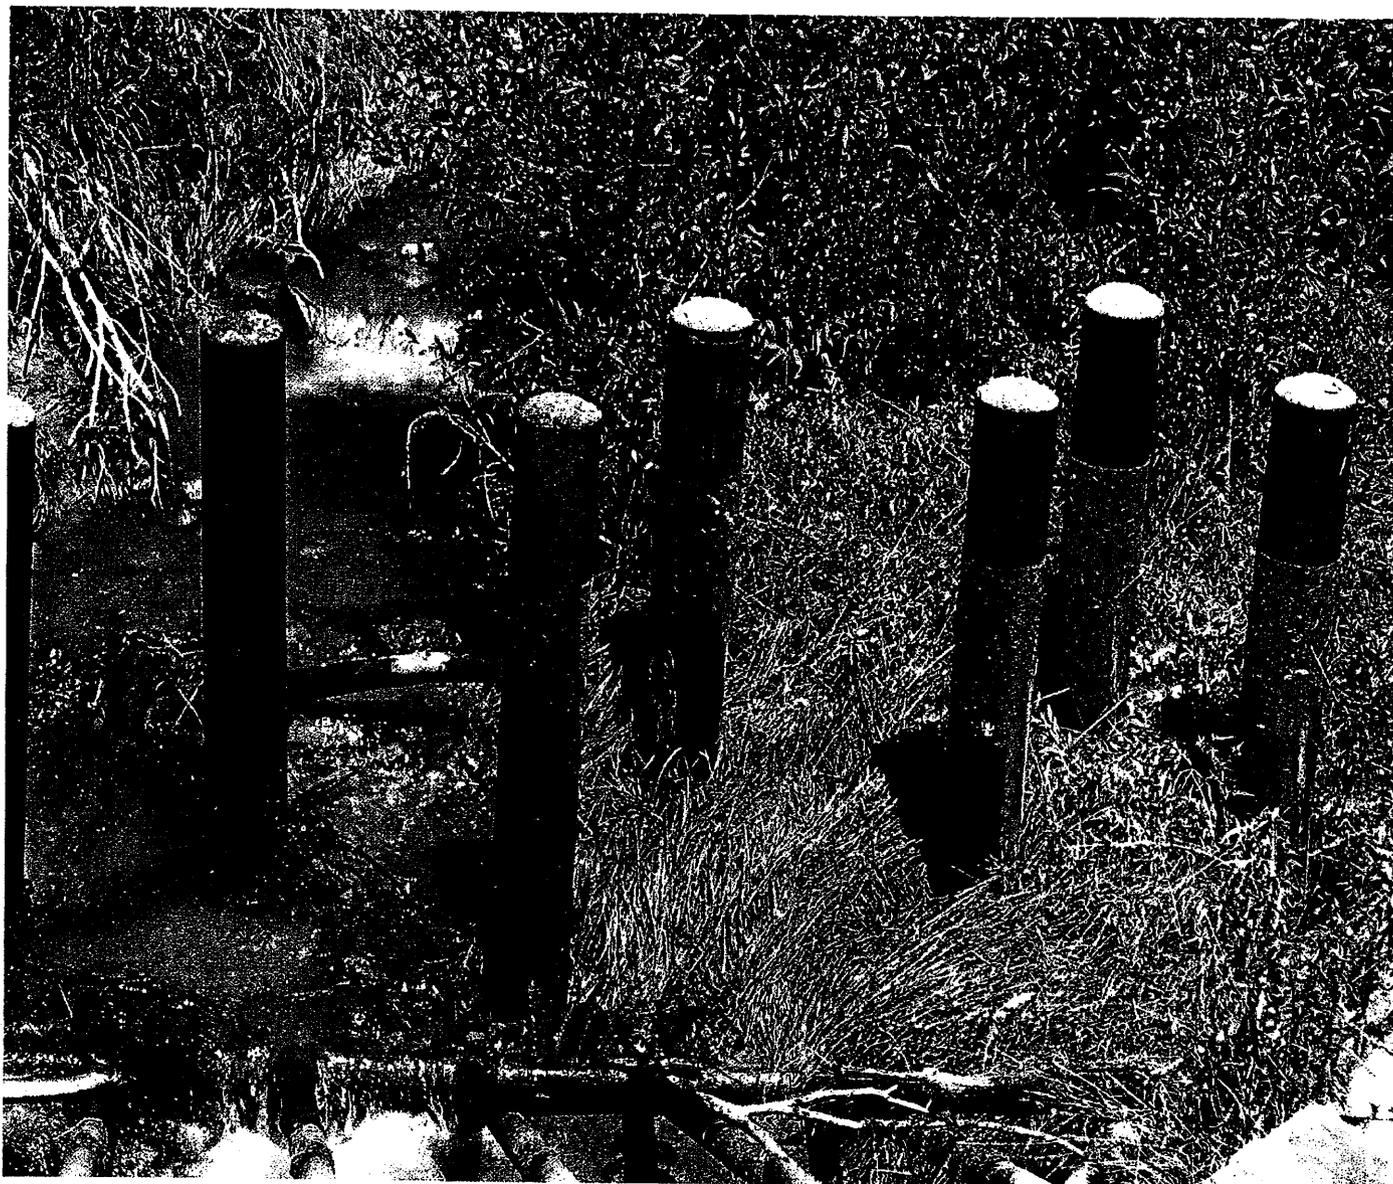
The inlet of Culvert UC-6 (Plate 7-5) on Dugout Creek was not breached, however the water was 4 feet 3 inches in the channel per markings on the inlet's trash racks.

Inlet Culvert UC-6  
note water line mark

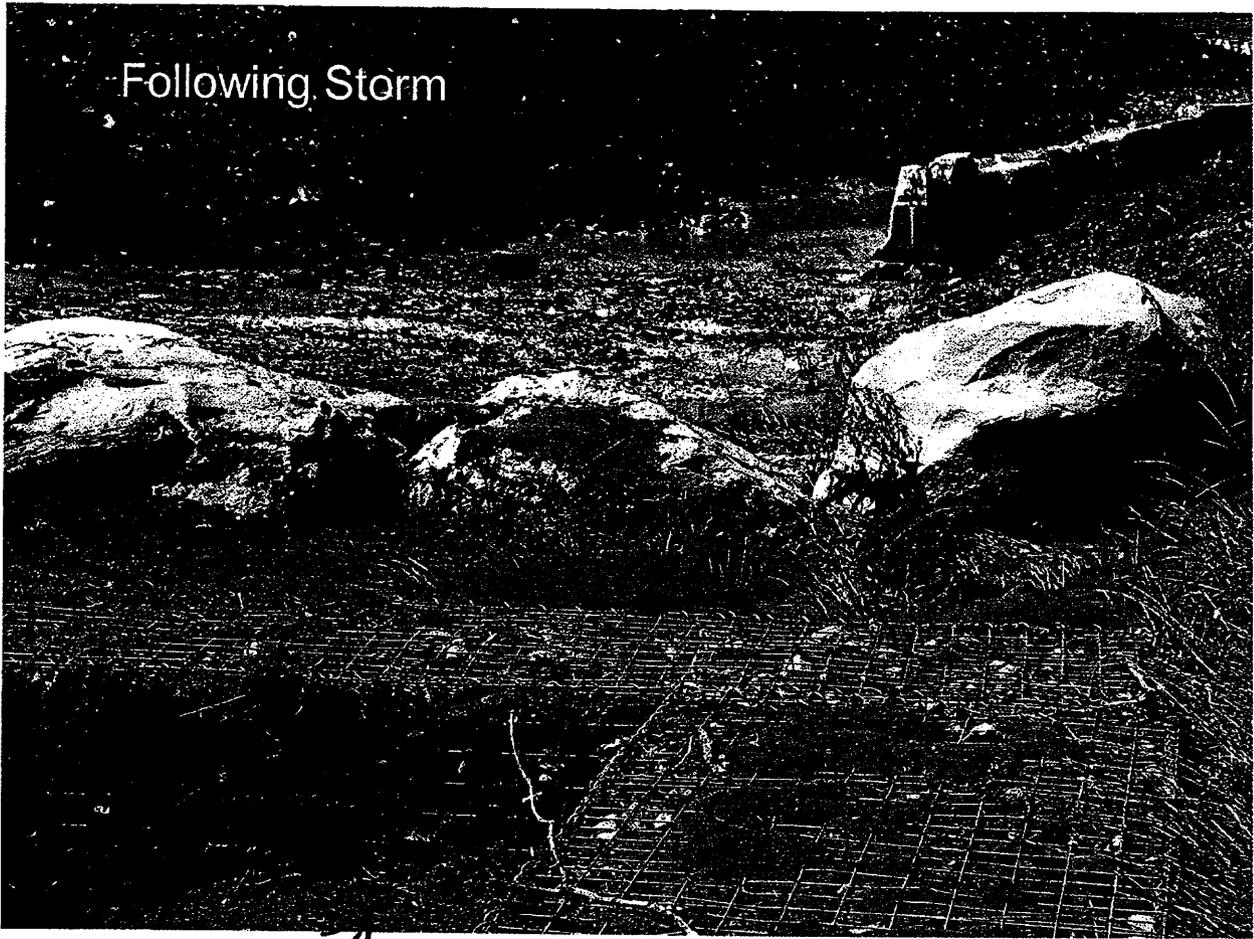
Around 7:25 pm the inlet to Culvert UC-5 (Plate 7-5) of Dugout Creek became blocked. The inlet was blocked due to logging debris from upstream. Water topped the gabion baskets and flooded the area behind the coal pile. The trash racks kept the debris from entering the culvert. The mine sites drainage system collected the overflow and directed it into the sediment pond. The sediment pond did not discharge.

*Note Debris Level* Inlet Culvert UC-5

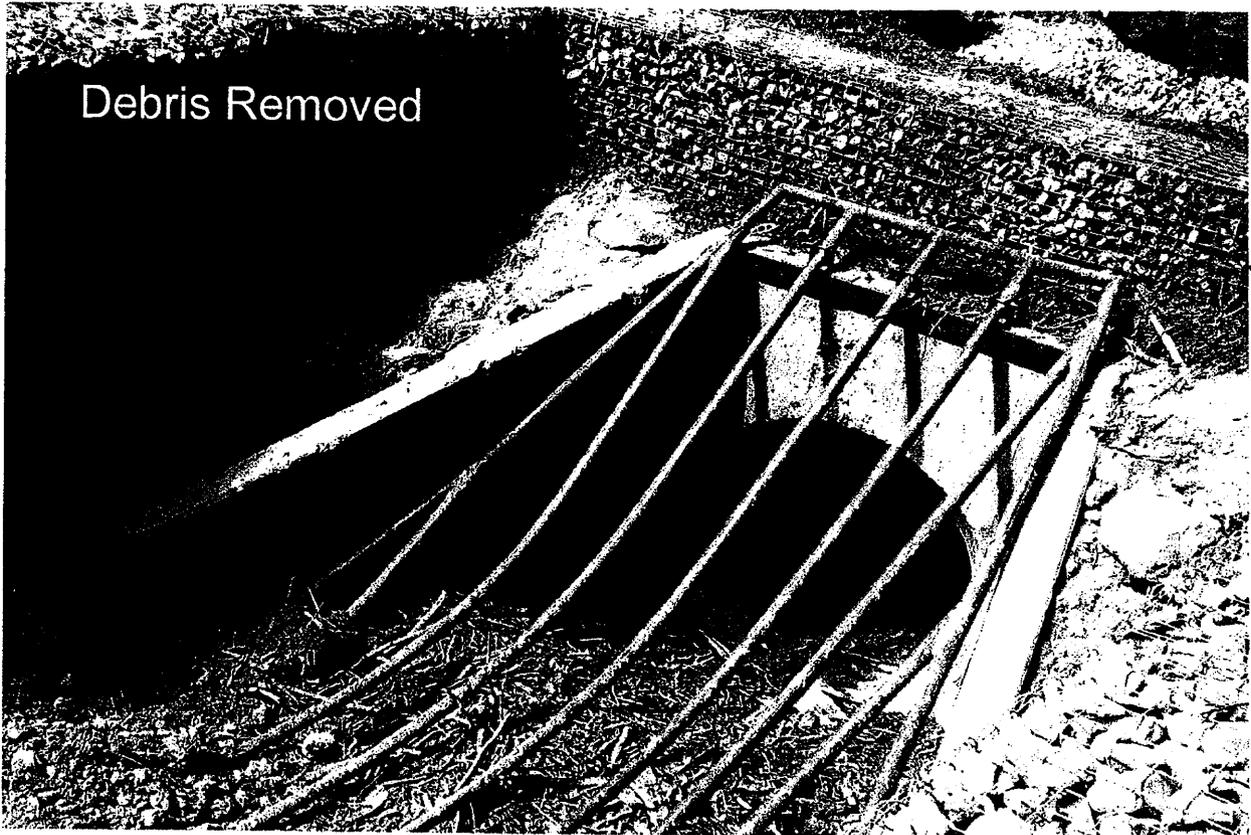
*Debris Level*

Path of Overflow from Pace Creek at Gate

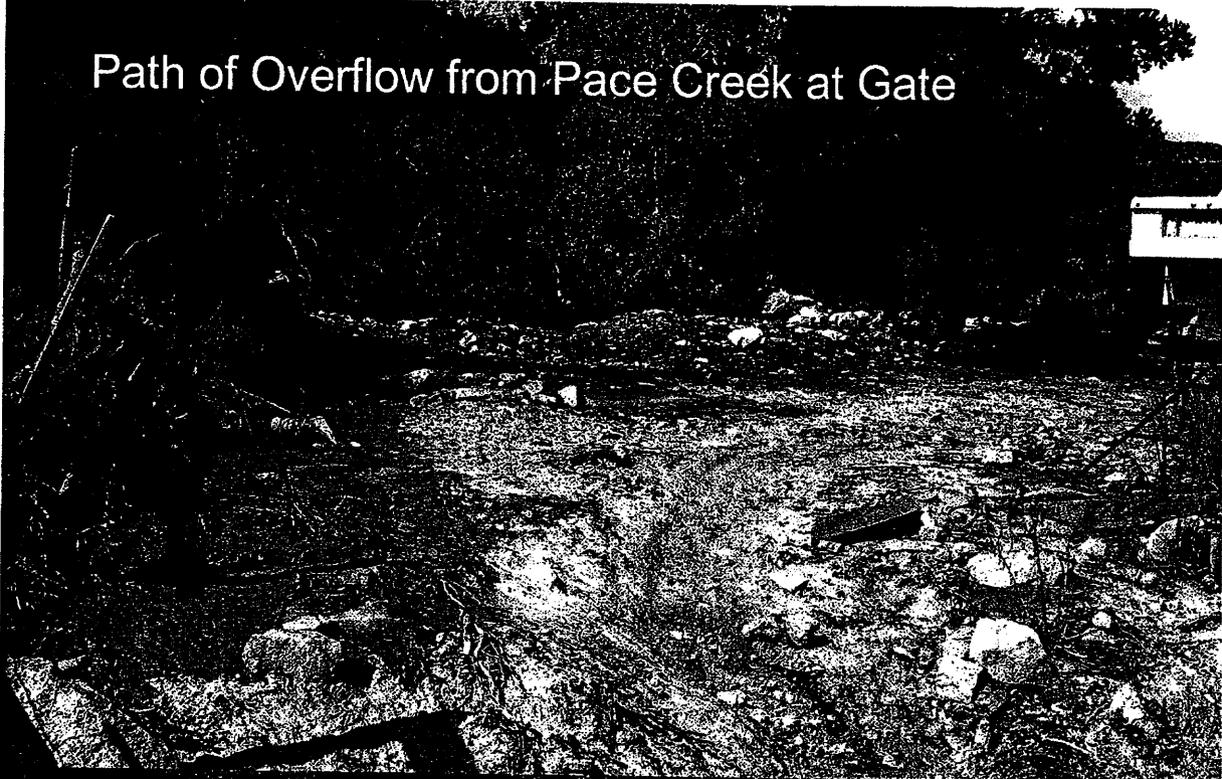
Pace Creek Channel

Hand drawn diagram of Pace Creek channel immediately above access gate from Clarks Valley. The creek topped the bank and ran over the ground for approximately 450' before rejoining the creek channel below the access gate. Pete Hess took picture of this location on Thursday, August 16<sup>th</sup>, high watermarks are visible in the picture.

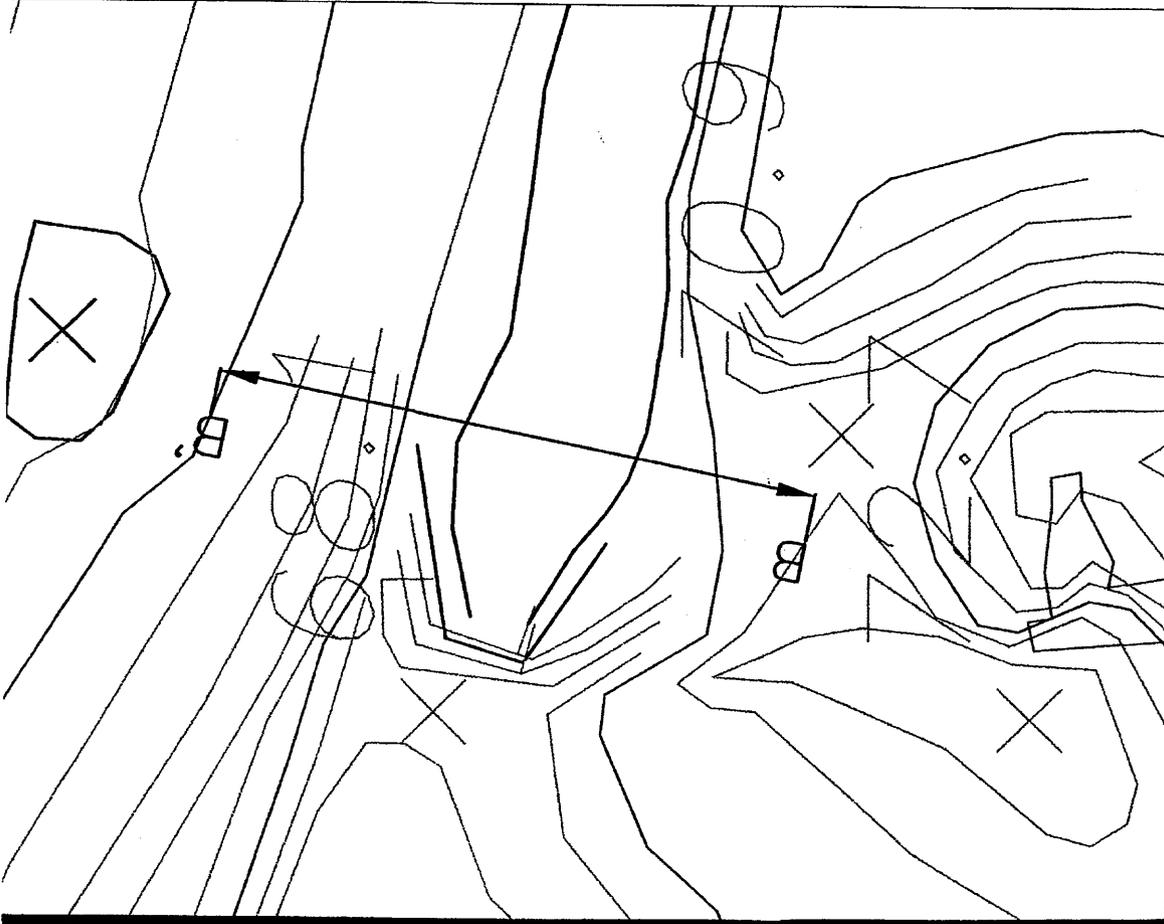
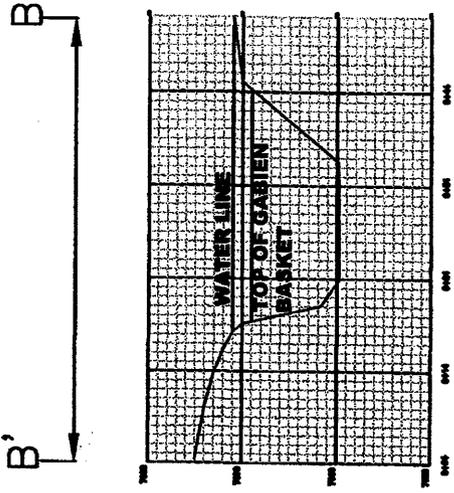
UC-5 (PLATE 7-5)

Cross-sections of the inlets are attached, blue line represents depth of water at its highest observed and recorded level. High watermark photographs are attached.
