Division of
Oil, Gas & Mining

Inspection Report

Permit Number:	C0070039
Inspection Type:	PARTIAL
Inspection Date:	Wednesday, September 24, 2008
Start Date/Time:	9/24/2008 12:00:00 PM
End Date/Time:	9/24/2008 4:00:00 PM
Last Inspection:	Tuesday, August 26, 2008

Permittee: **CANYON FUEL COMPANY LLC**
Operator: **CANYON FUEL COMPANY LLC**
Site: **DUGOUT CANYON MINE**
Address: **PO BOX 1029, WELLINGTON UT 84542**
County: **CARBON**
Permit Type: **PERMANENT COAL PROGRAM**
Permit Status: **ACTIVE**

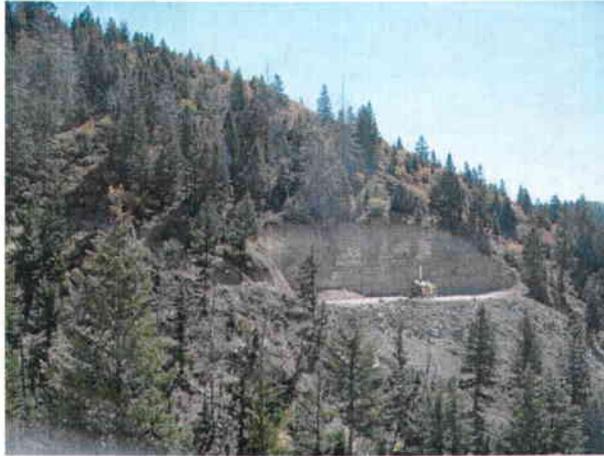
Gas Wells GW-18, GW-19 and GW-31 were photographed. GW-19 is east of the AMV road as shown on Attachment 5-4, Plate 1. GW-31 is no longer active and may be reclaimed next season. Two mudpits at GW-31 still contain water.

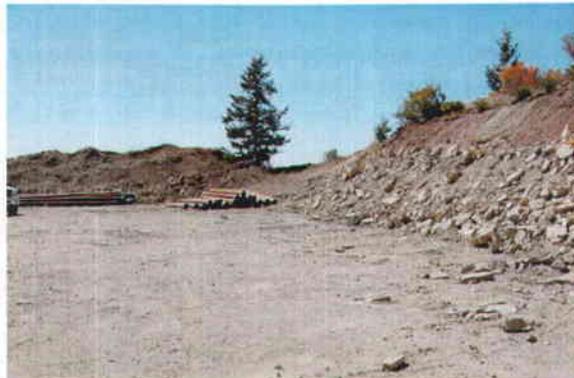
The total disturbed acreage for degas wells #18, #31 and AMV road is 19.29 acres. The AMV road is 6,705 ft. long. An average of one foot of topsoil was removed from all disturbed areas (Attach. 5-4, As-Built Areas and Cut/Fill Volumetrics). Visual characteristics of the topsoil confirms topsoil texture analysis and rockiness detailed in Attachment 2-1 of the Methane Degas Volume. Along the AMV road, salvage of soil to the one foot depth included both topsoil and the whitish subsoil. Topsoil stockpiles at the pads is reddish clay loam. Extremely rocky topsoil and subsoil was noted at degas pad G-18.

GW-18
(topsoil pile T-10 in background)

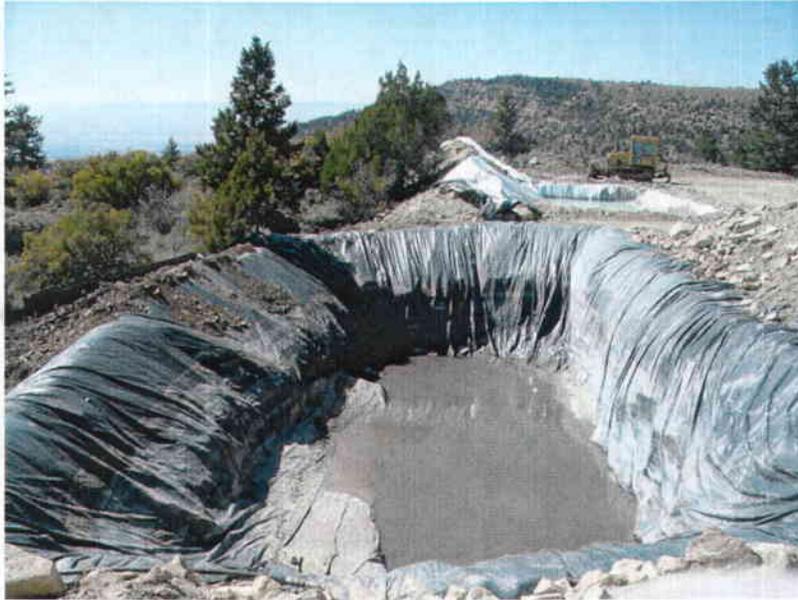
mud pits at GW-31

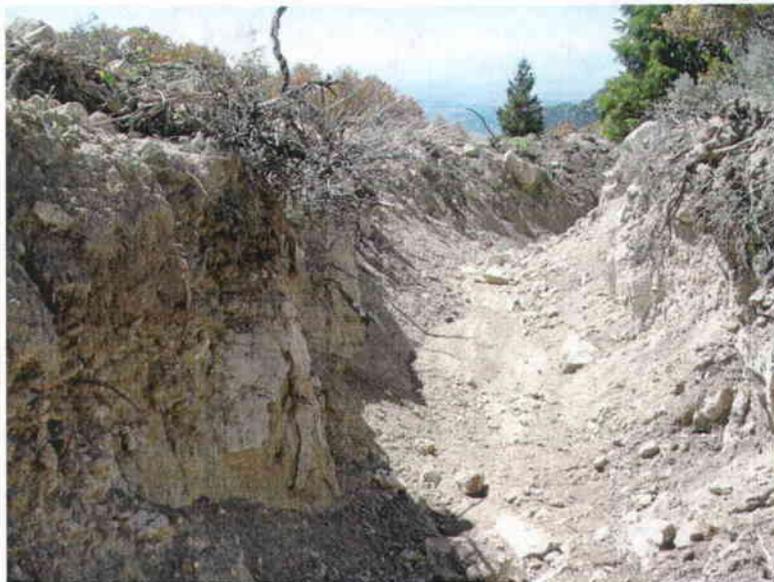
The berm around stockpile T-6 is made of topsoil, not subsoil. Berms around several topsoil piles were excavated from around the topsoil pile, so that the piles have moats (T-7, T-10, T-5). As discussed with Ms. Miller, this approach should be avoided in the future.

excavated "moat" around T-7

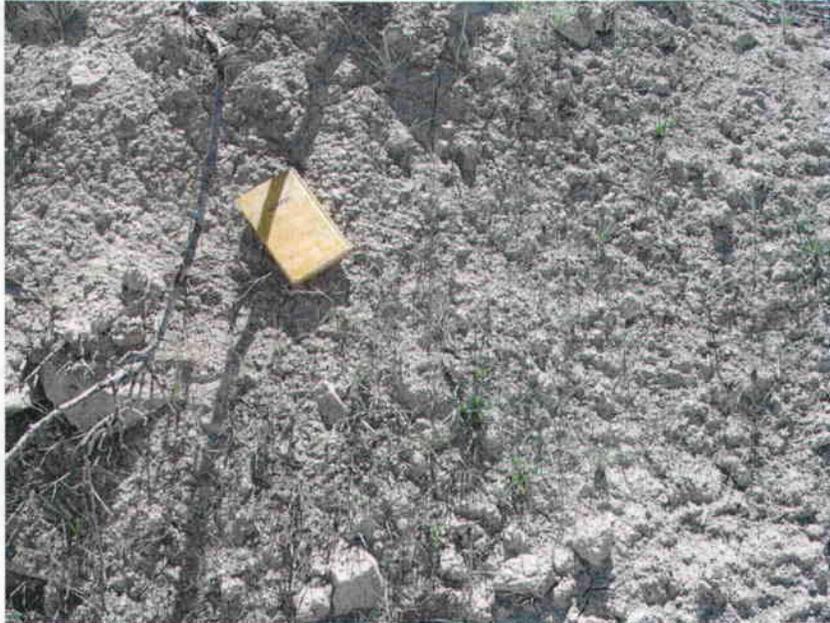
Eight topsoil stockpiles were constructed along the road and at well pads in the late fall 2007. Table 2-2 provides stockpile dimensions derived from aerial photography. Stockpiles were roughened and seeded immediately after construction. Some grass seedlings and several snowberry seedlings have emerged on most stockpiles.

Emerging grasses on T-7

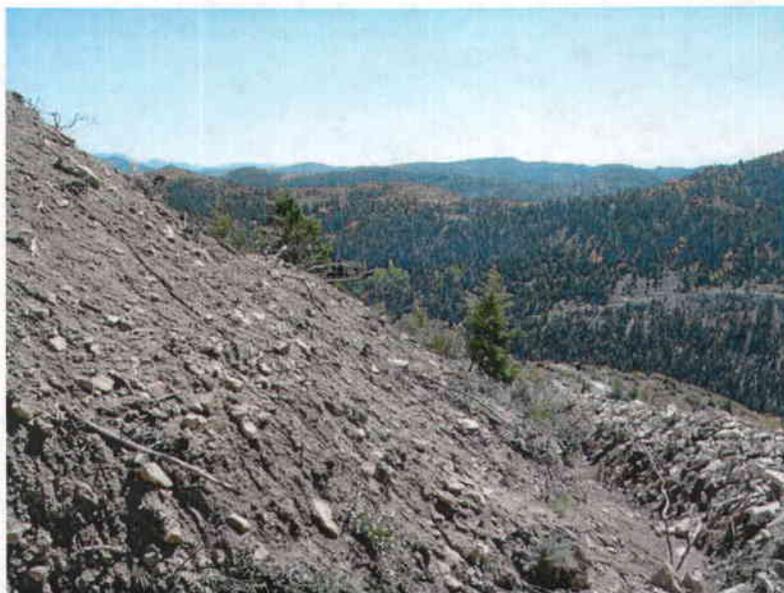
Topsoil stockpiles appear to be at the angle of repose, and steep outslopes have lost their surface roughening through slope movement on the following piles: T-5, T-6, T-7, T-9, and T-10. After the site visit, topsoil pile slope angles were calculated from information provided in Attach. 5-4 Plate 3 as follows: T-5, T-6, and T-7 are quite steep (1.5h:1v, 1.6h:1v, and 1.8h:1v, respectively). Stockpiles T-2, T-3, and T-10 have lesser slopes of 2h:1v or less.

Gouges "melted" on slope of T-9

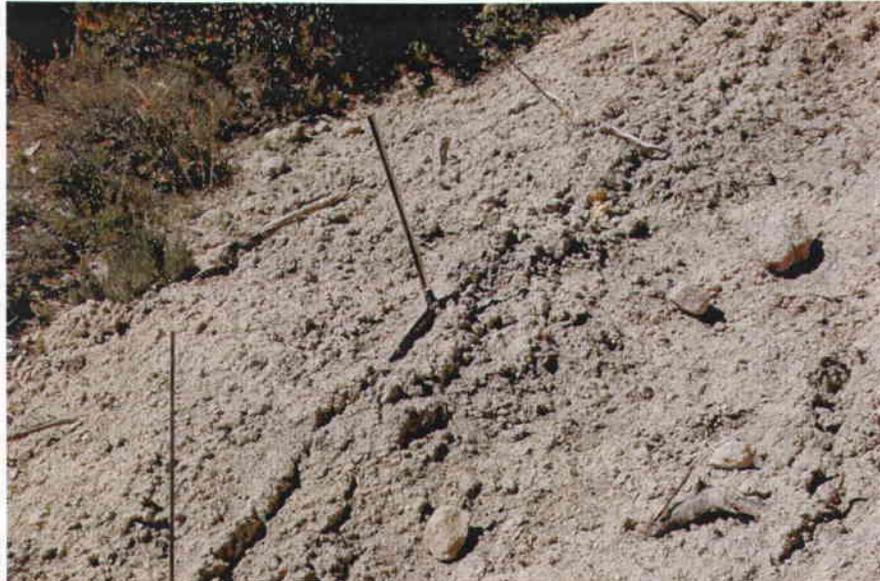
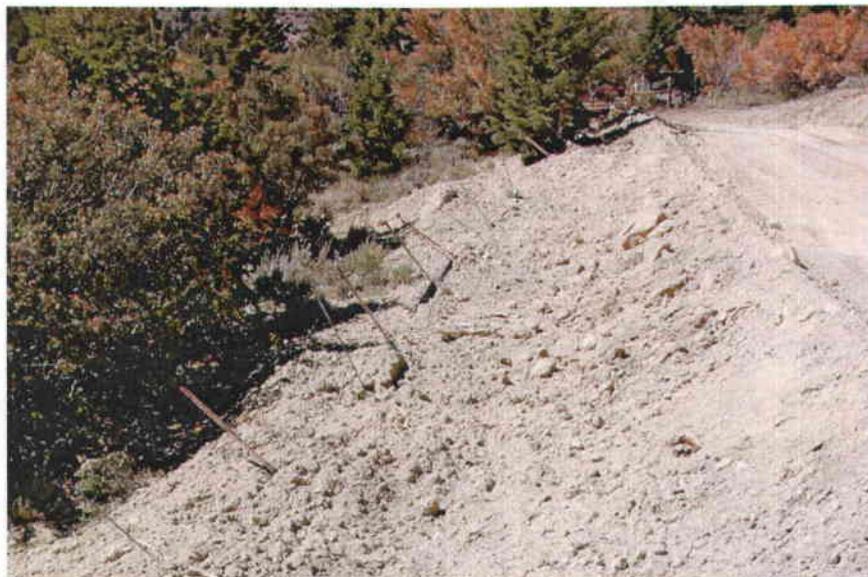
On page 7-16 of the approved methane degas well amendment to the MRP, the Permittee states that additional contributions of sediment or runoff outside the wellsite areas, as well as the access roads, will be prevented to the extent possible by utilizing silt fences, berms and straw bale dikes. Upon inspection of the AMV access road, the Permittee opted to use silt fences at the out slopes of the access road, as well as along the perimeter of the pads for degas wells G-18 and G-31. Although large segments of the access road's silt fence was functioning as designed and was observed to have additional sediment holding capacity, there were several areas observed during the field inspection where the constructed silt fence was either entirely buried or had already failed allowing sediment to be transported off the disturbed area (See Attached Photos).

Areas where the silt fence was noticeably impacted and failing was observed in numerous areas: 1) Directly adjacent to degas pad G-31 on the east side. 2) Up and down gradient of culvert C5. 3) Up and down gradient of culvert C4 and 4) The approximately 900' of AMV access road between culvert C4 and topsoil pile T-3. The aforementioned locations are general examples of where the sediment controls require maintenance. It is not intended as a comprehensive list.

Silt Fence Failure Example (Adjacent to G-31)

On September 30th, 2008, Ms. Miller and Mr. Christensen discussed the approved sediment control language within the approved methane degas amendment to the MRP. Mr. Christensen pointed out that according Section 742.200 on page 7-16, "Additional contributions of suspended solids and sediment or runoff outside the well site area, including access roads, will be prevented to the extent possible using silt fences, berms and straw bale dikes." Due to the observed failure of the silt fence in numerous locations adjacent to the AMV access road and degas pads, Ms. Miller indicated that additional silt fence would be installed in order to provide adequate sediment control. Ms. Miller indicated that the additional sediment controls would be installed prior to the onset of winter and inaccessible conditions due to snowfall.

On October 14, 2008, Ms. Miller indicated to Mr. Christensen via a phone conversation that additional silt fence had been ordered and that the additional silt fence would be installed prior to be driven off the mountain due to weather conditions.

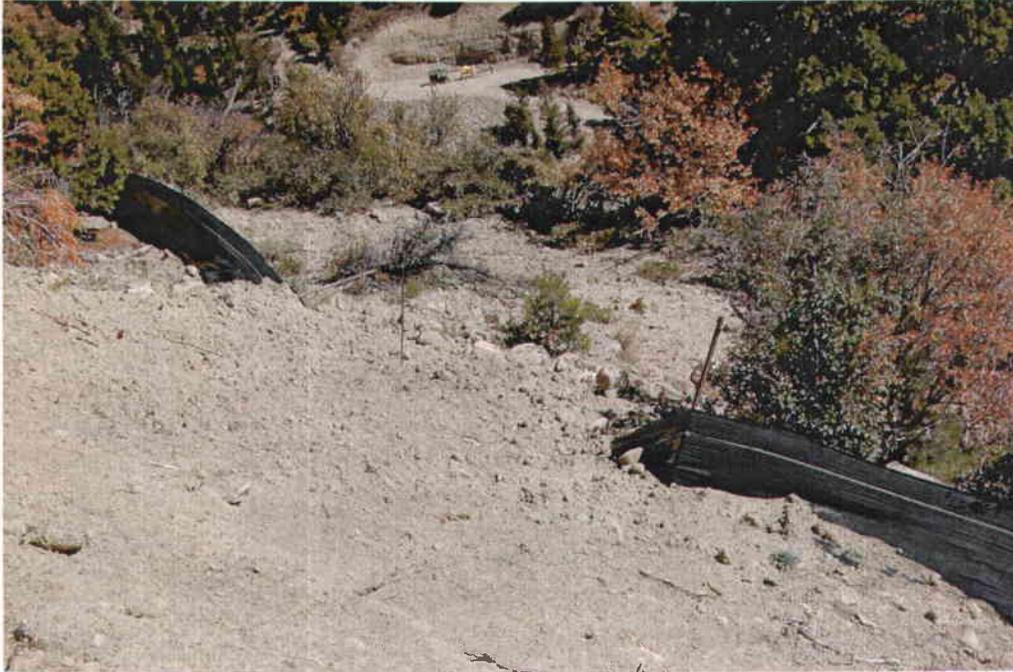
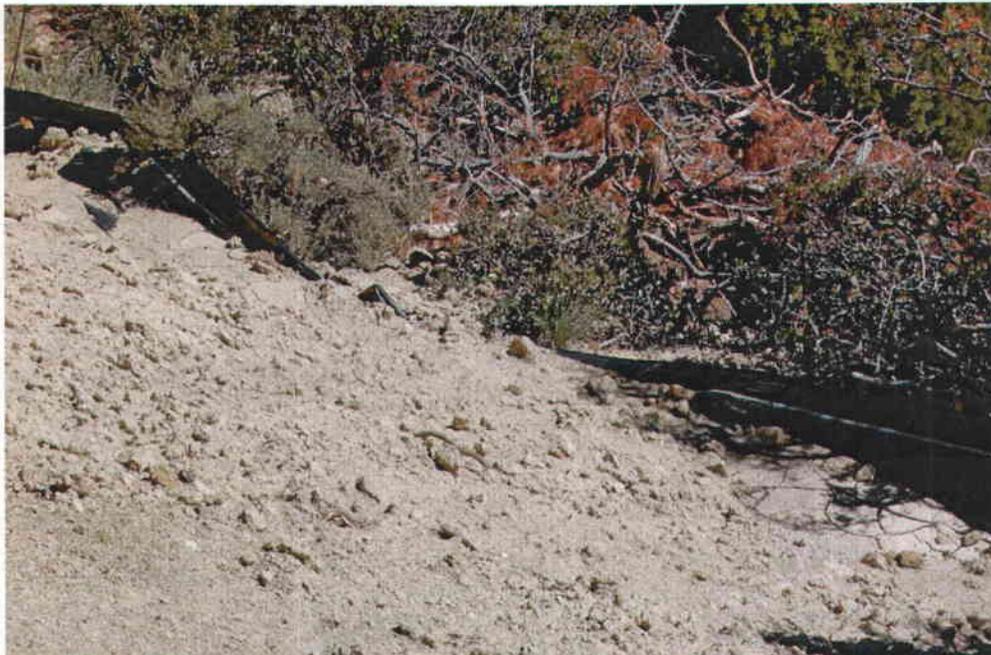
Silt Fence Failure Example
