# WATER QUALITY MEMORANDUM Utah Coal Regulatory Program

April 15, 2010

TO: Internal File  
THRU: James D. Smith, Permit Supervisor *JDS 20 Apr 10*  
FROM: Steve Christensen, Environmental Scientist *SKC*  
RE: 2009, 1<sup>st</sup> Quarter Water Monitoring, Canyon Fuel Company (CFC), LLC, Dugout Mine, C/007/0039-WQ09-1, Task ID #3240

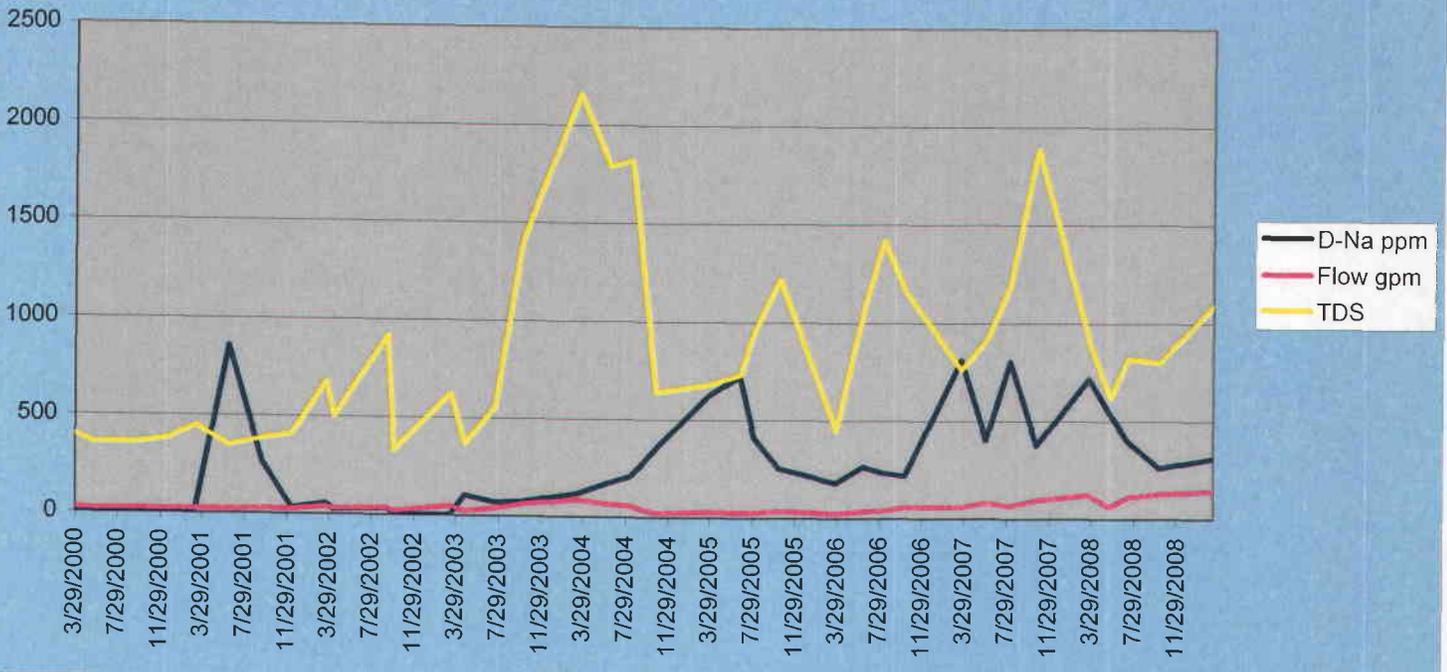
### DC-1: D-Na, TDS and Flow vs. Time

DC-1 reported a value of dissolved sodium (D-Na) that was outside of two standard deviations. This stream monitoring point has historically produced erratic D-Na values. Based upon the data set, it appears that the D-Na concentrations tend to spike during the spring and early summer, presumably as a result of snowmelt. (See Chart Below).

Continued monitoring of elevated concentrations at sites that were inaccessible due to snow conditions or where no observable flow was reported.

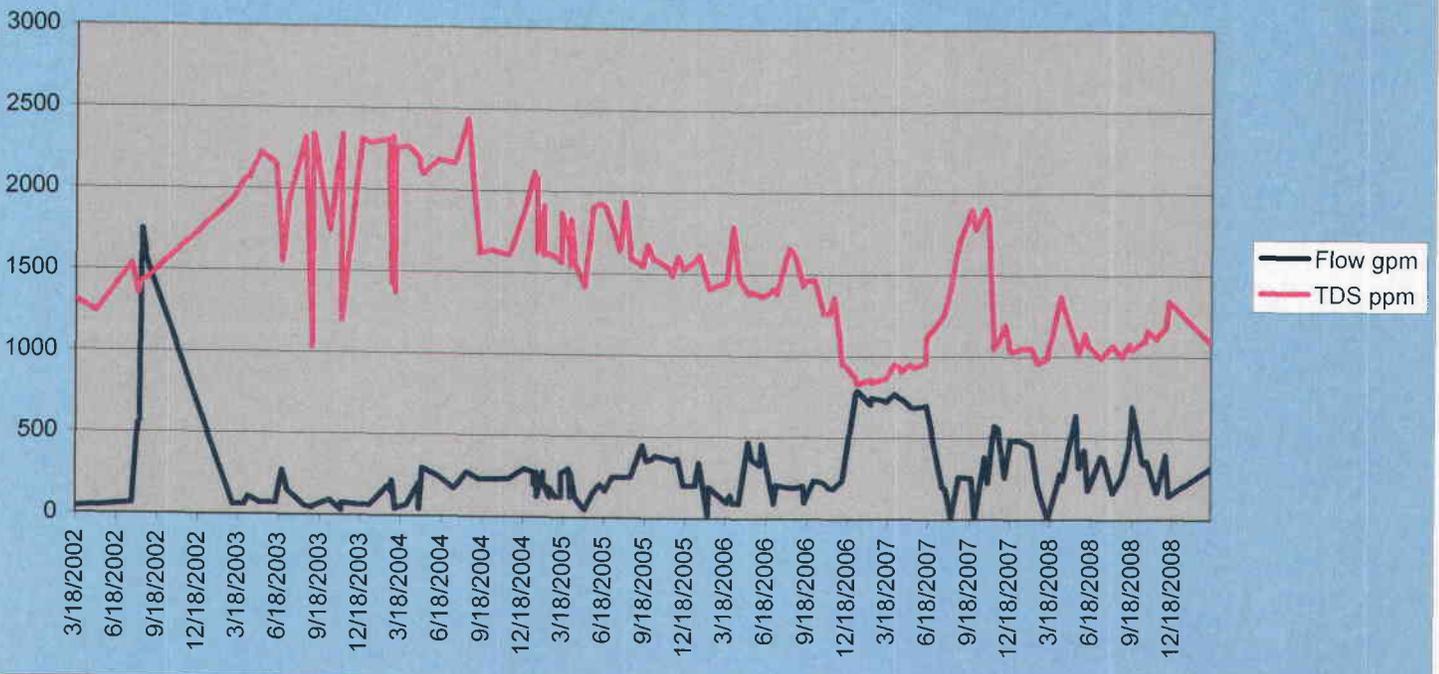
### UPDES Outfall 001

Of the six monitored UPDES outfalls, site 001 was the only one to produce a measurable flow. The average flow for the quarter was 306 gpm. The reported water quality parameters were within two standard deviations from the mean. Additionally, the reported concentrations were compliant with the standards outlined in the Permittee's UPDES discharge permit.
