# WATER QUALITY MEMORANDUM

## Utah Coal Regulatory Program

RE: 2009 4<sup>th</sup> Quarter Water Monitoring, Canyon Fuel Company (CFC), LLC, Dugout Mine, C/007/0039-WQ09-4, Task ID #3431

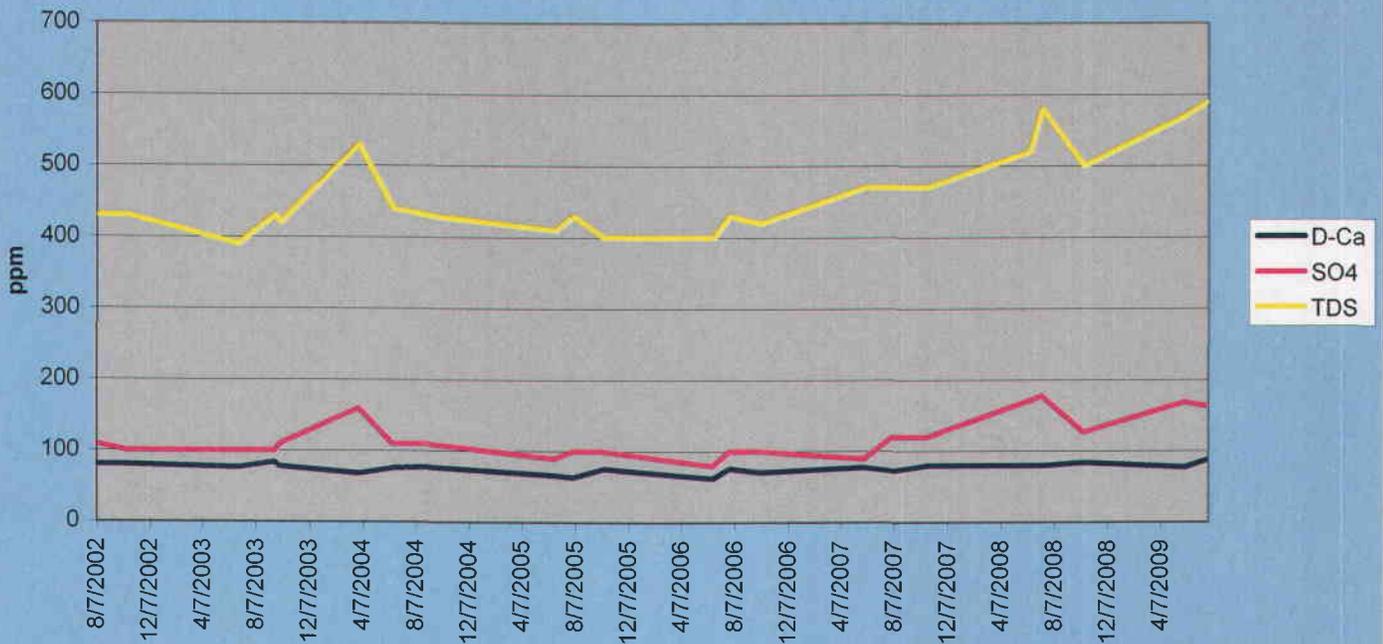
Spring SC-116: D-Ca, SO4, TDS vs. Time

**SC-116** The previous two quarters (WQ09-2 and WQ09-3), SO<sub>4</sub>, TDS and T-Cats were reported outside of two standard deviations. Additionally, dissolved calcium (D-Ca) was

reported outside of two standard deviations the previous quarter (WQ09-3). This quarter, all required parameters were reported within two standard deviations of the mean. (See Chart Below)

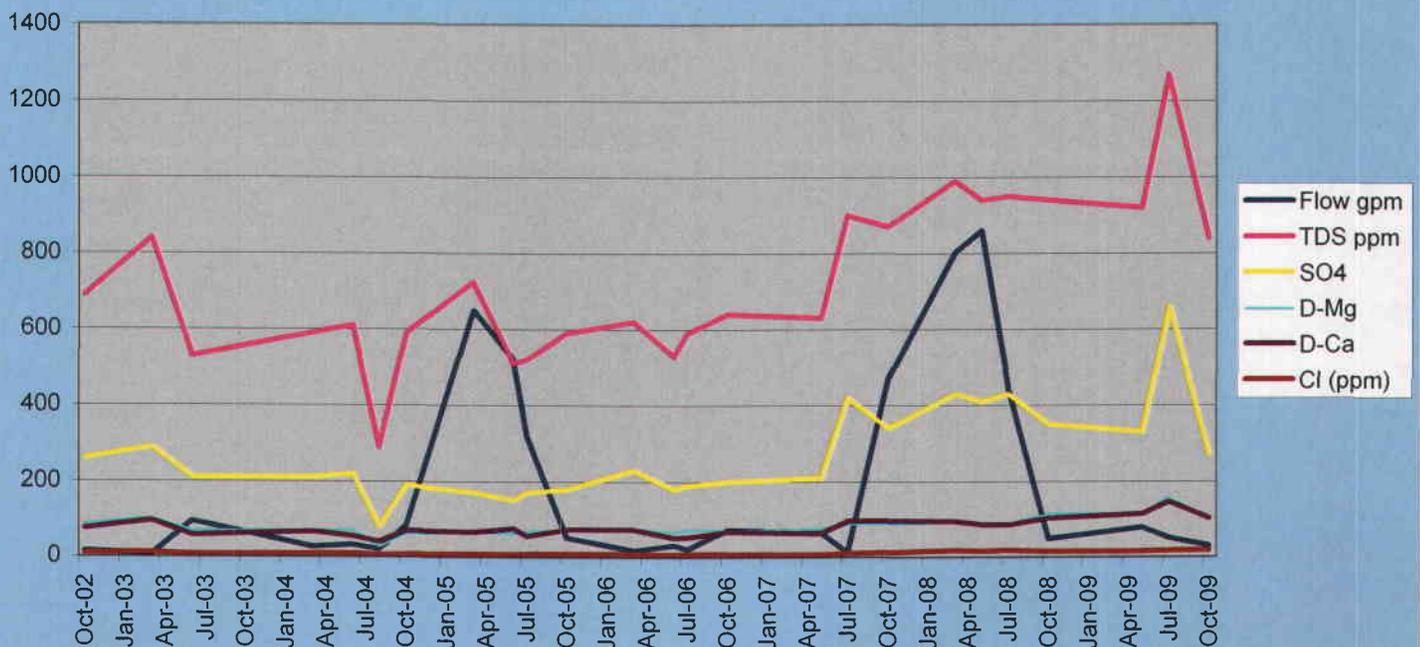
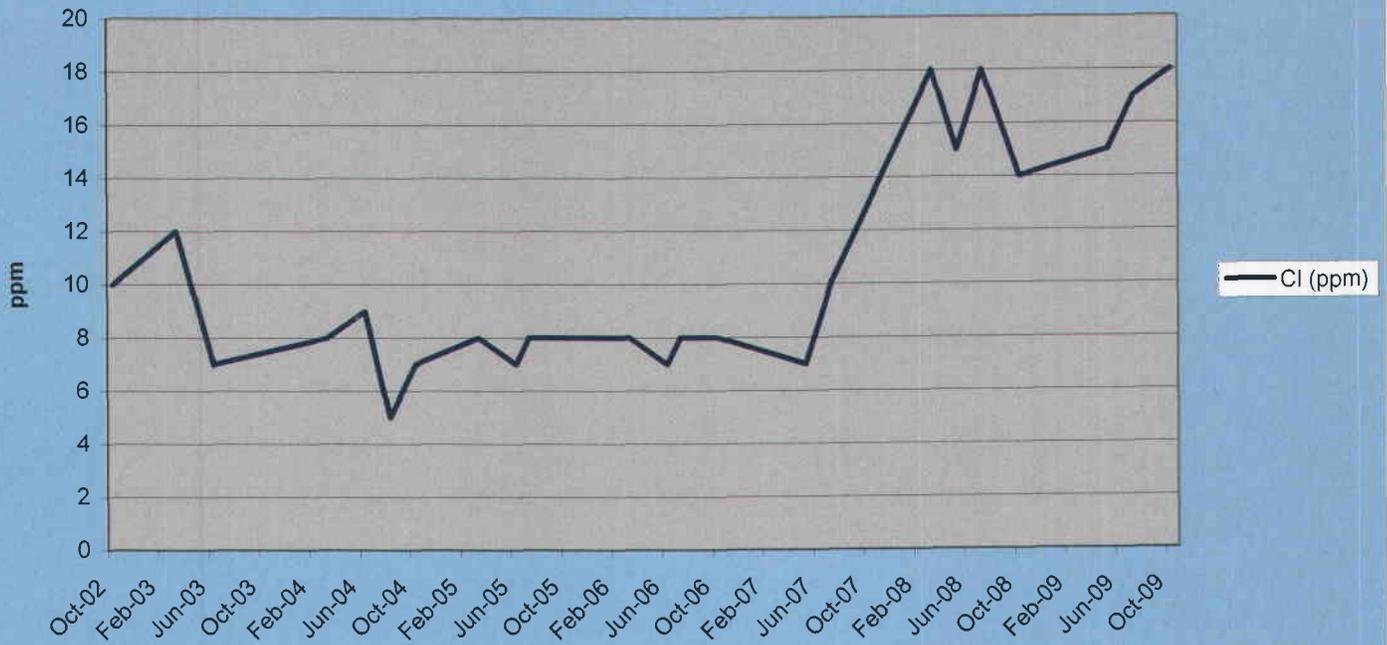
Stream Monitoring Site PC-2

During the previous two quarters (WQ09-2 and WQ09-3), site PC-2 has reported several parameters outside of two standard deviations (D-Ca, D-Mg, total alkalinity, bicarbonate, field conductivity, Cl, total cations, total anions, SO<sub>4</sub> and TDS). This quarter, Cl, total alkalinity and bicarbonate were again reported outside of two standard deviations. (See Chart Below)

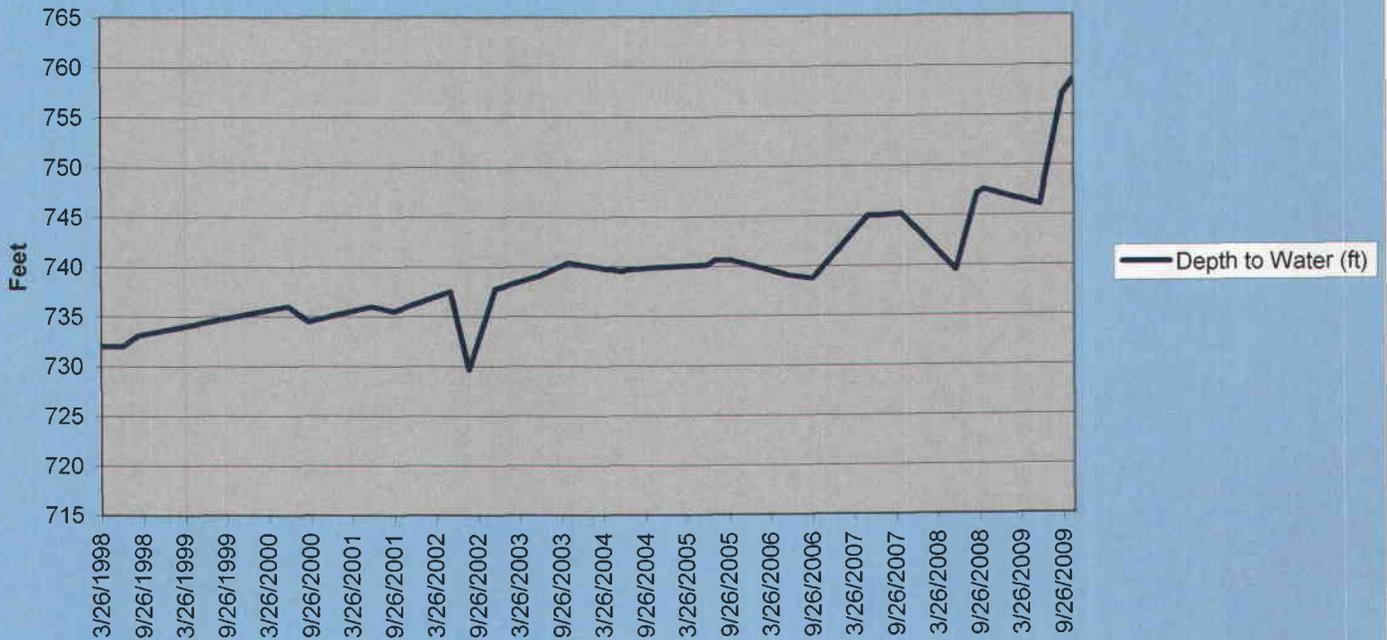
### Monitoring Well GW-10-2

For the second consecutive quarter, monitoring well GW-10-2 reported a depth to water outside of two standard deviations from the mean. Continued monitoring of water levels in well GW-10-2 will be conducted to ascertain if a downward trend is emerging. (See Chart Below)

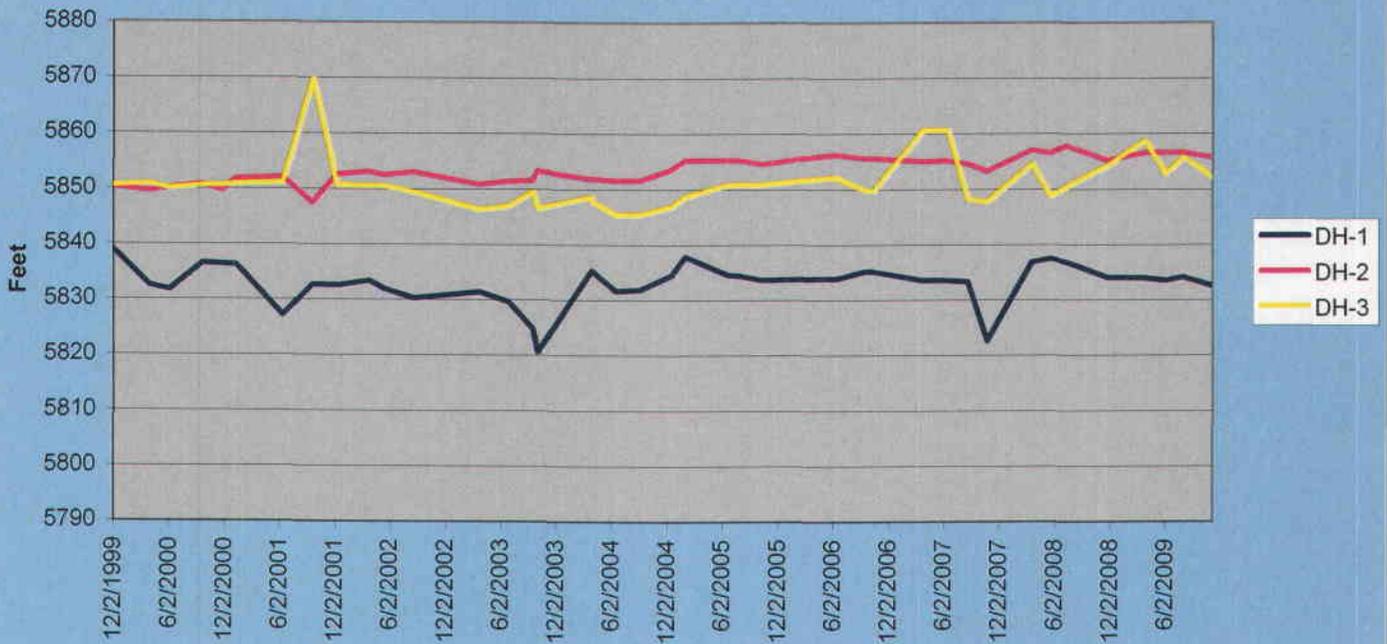
### Monitoring Wells DH-1, DH-2 and DH-3: Water Level vs. Time

Water levels reported for wells DH-1, DH-2 and DH-3 were all within two standard deviations of the mean. (See Chart Below)

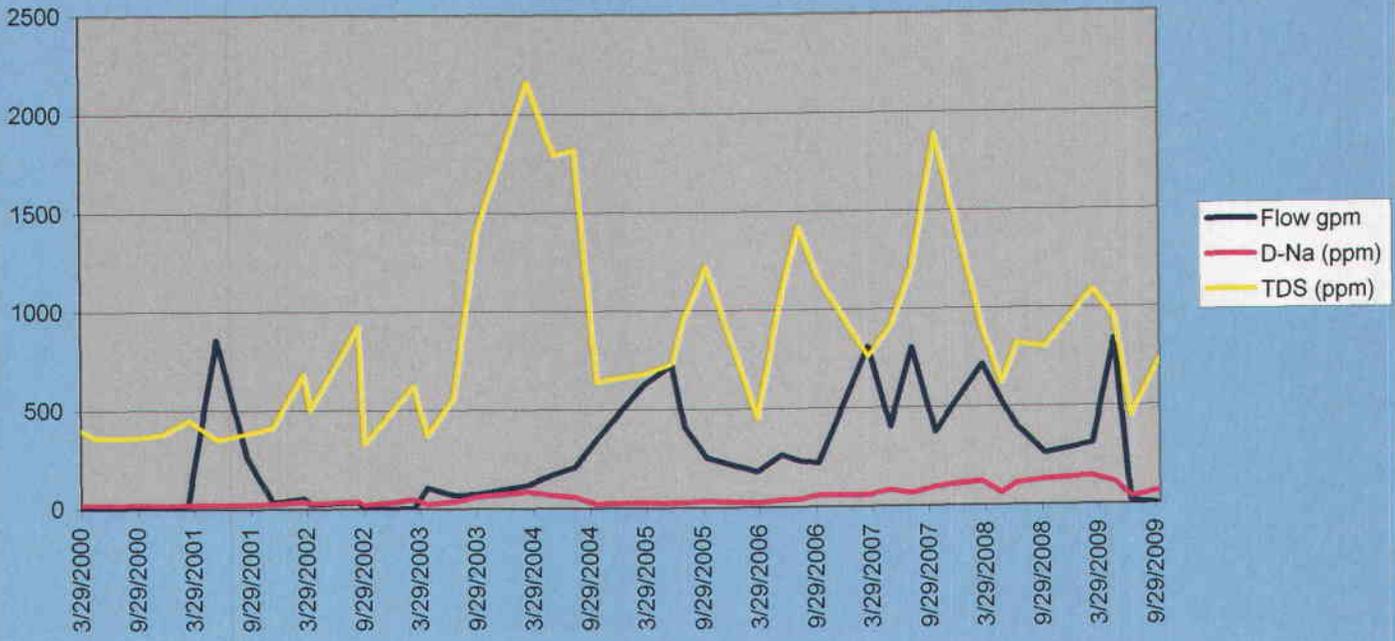
### DC-1: D-Na, TDS and Flow vs. Time

DC-1 reported a D-Na concentration within two standard deviations of the data set for the second consecutive quarter. Historically, this site has produced erratic D-Na trends typified by spikes in the late spring/early summer. (See Chart Below)

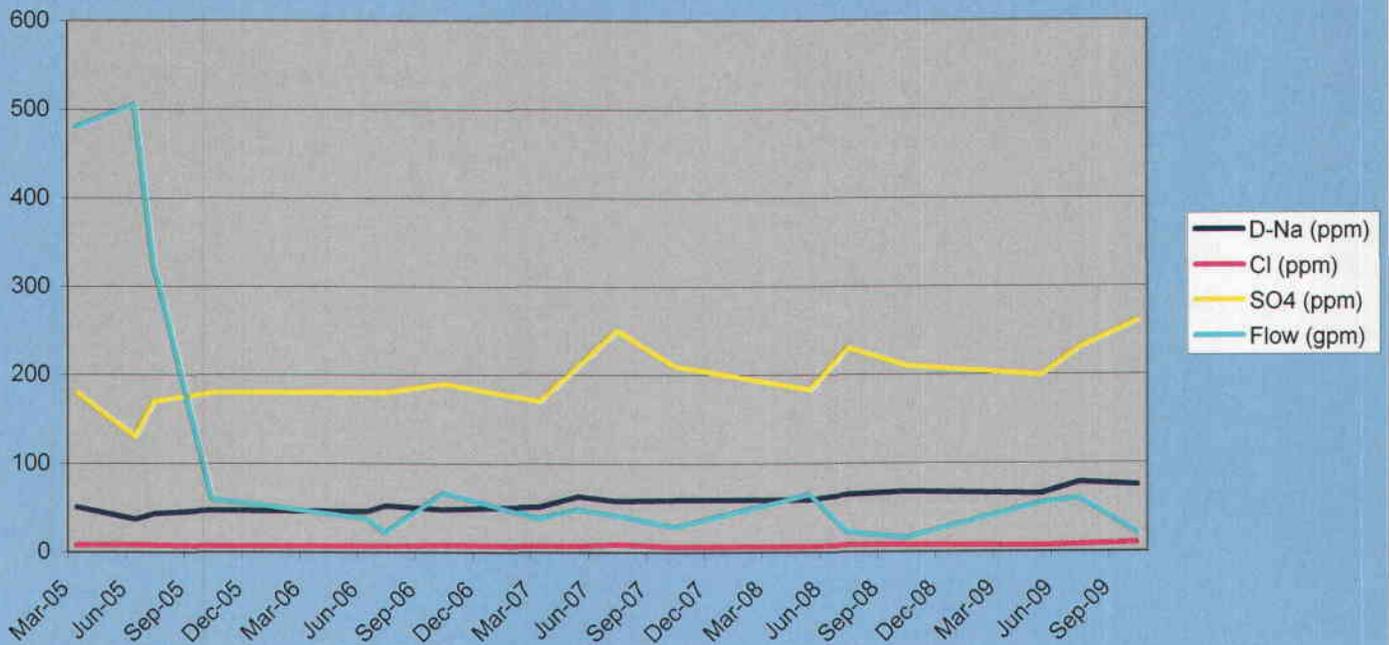
### FAN Monitoring site: D-Na, Cl, SO4 and Flow vs. Time

The FAN surface water-monitoring site below the Pace Canyon Fan portals reported an elevated D-Na value the previous quarter (WQ09-3). D-Na, Cl, SO<sub>4</sub>, total alkalinity and total cations were reported outside of two standard deviations for this quarter. Continued monitoring will be conducted in order to ascertain if a trend is emerging. (See Chart Below)
