# WATER QUALITY MEMORANDUM

Utah Coal Regulatory Program

TO: Internal File  
THRU: James D. Smith, Permit Supervisor *DS 7 Dec 2010*  
FROM: Steve Christensen, Environmental Scientist *SKC*  
RE: 2010 2<sup>nd</sup> Quarter Water Monitoring, Canyon Fuel Company (CFC), LLC, Dugout Mine, C/007/0039-WQ10-2, Task ID #3560

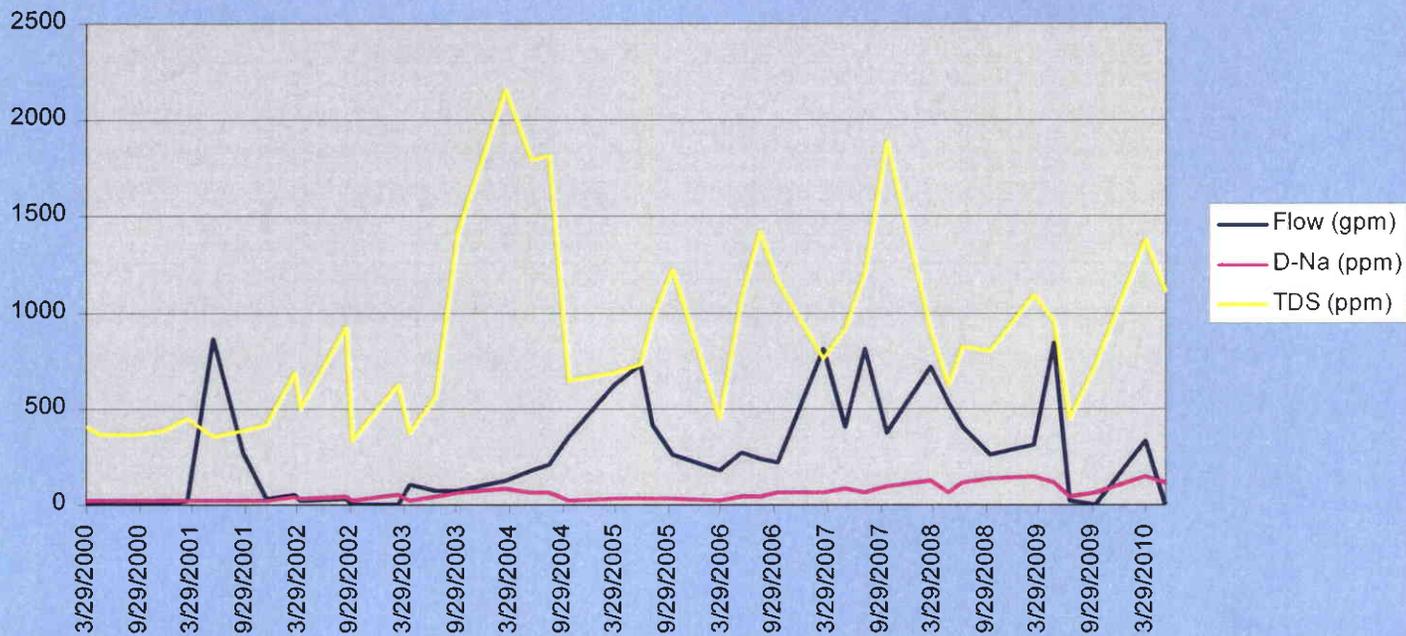
### DC-1: D-Na, TDS and Flow vs. Time

Stream monitoring site DC-1 had reported elevated dissolved sodium (D-Na), chloride (Cl) and bicarbonate (Bcrb) the previous quarter. However; all of the previously elevated concentrations were back to within two standard deviations of the data set this quarter. Continued monitoring will be conducted at monitoring site DC-1 in order to determine if a trend is emerging.

Continued monitoring of stream monitoring sites DC-1, DC-2, FAN and PC-2 for upward trends in TDS and its chemical constituents.

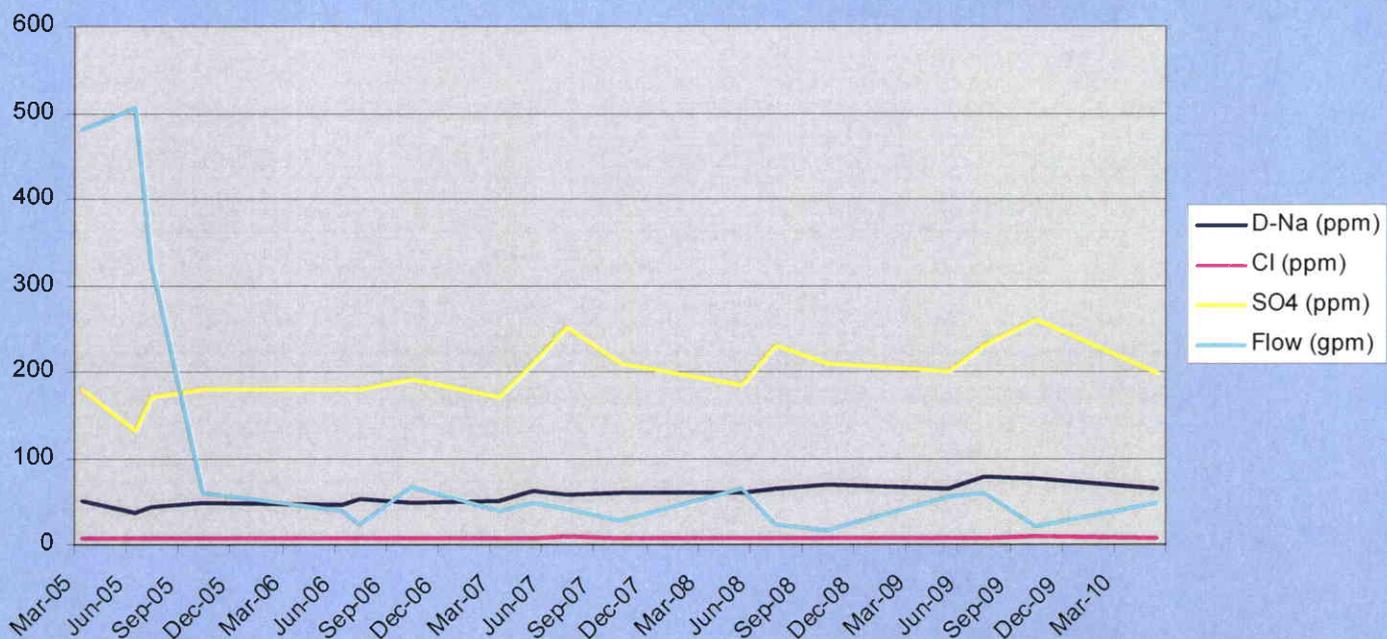
### FAN Monitoring site: D-Na, Cl, SO4 and Flow vs. Time

The FAN monitoring site below the Pace Canyon Fan portal reported elevated levels of D-Na, CL SO4 and total alkalinity during the 3<sup>rd</sup> and 4<sup>th</sup> quarters of 2009. The site was inaccessible due to snow conditions the first quarter of 2010. An elevated D-Na concentration was reported this quarter.
