Inspection Report

Permit Number:	C0070039
Inspection Type:	PARTIAL
Inspection Date:	Wednesday, August 01, 2012
Start Date/Time:	8/1/2012 6:30:00 AM
End Date/Time:	8/1/2012 4:00:00 PM
Last Inspection:	Thursday, July 12, 2012

Permitee: **CANYON FUEL COMPANY**
 Operator: **CANYON FUEL COMPANY**
 Site: **DUGOUT CANYON MINE**
 Address: **PO BOX 1029, WELLINGTON UT 84542**
 County: **CARBON**
 Permit Type: **PERMANENT COAL PROGRAM**
 Permit Status: **ACTIVE**

On August 1st, 2012, Division of Oil, Gas and Mining (the Division) staff conducted a field inspection of the gob gas vent hole sites at the Dugout Canyon Mine. The purpose of the field inspection was to document the condition of the gob gas vent hole sites and associated access roads. All but three of the 25 gob gas vent hole sites depicted on Figure 1-1, Methane Degas Bore Hole Locations, were constructed. Sites G-1, G-8 and G-29 were permitted but never drilled/constructed. Of the remaining 22 gob gas vent hole sites, 11 have been reclaimed. Based upon information provided by the Operator, the underground mine workings below 8 of the 11 un-reclaimed sites have been sealed and no longer require active ventilation in order to ma

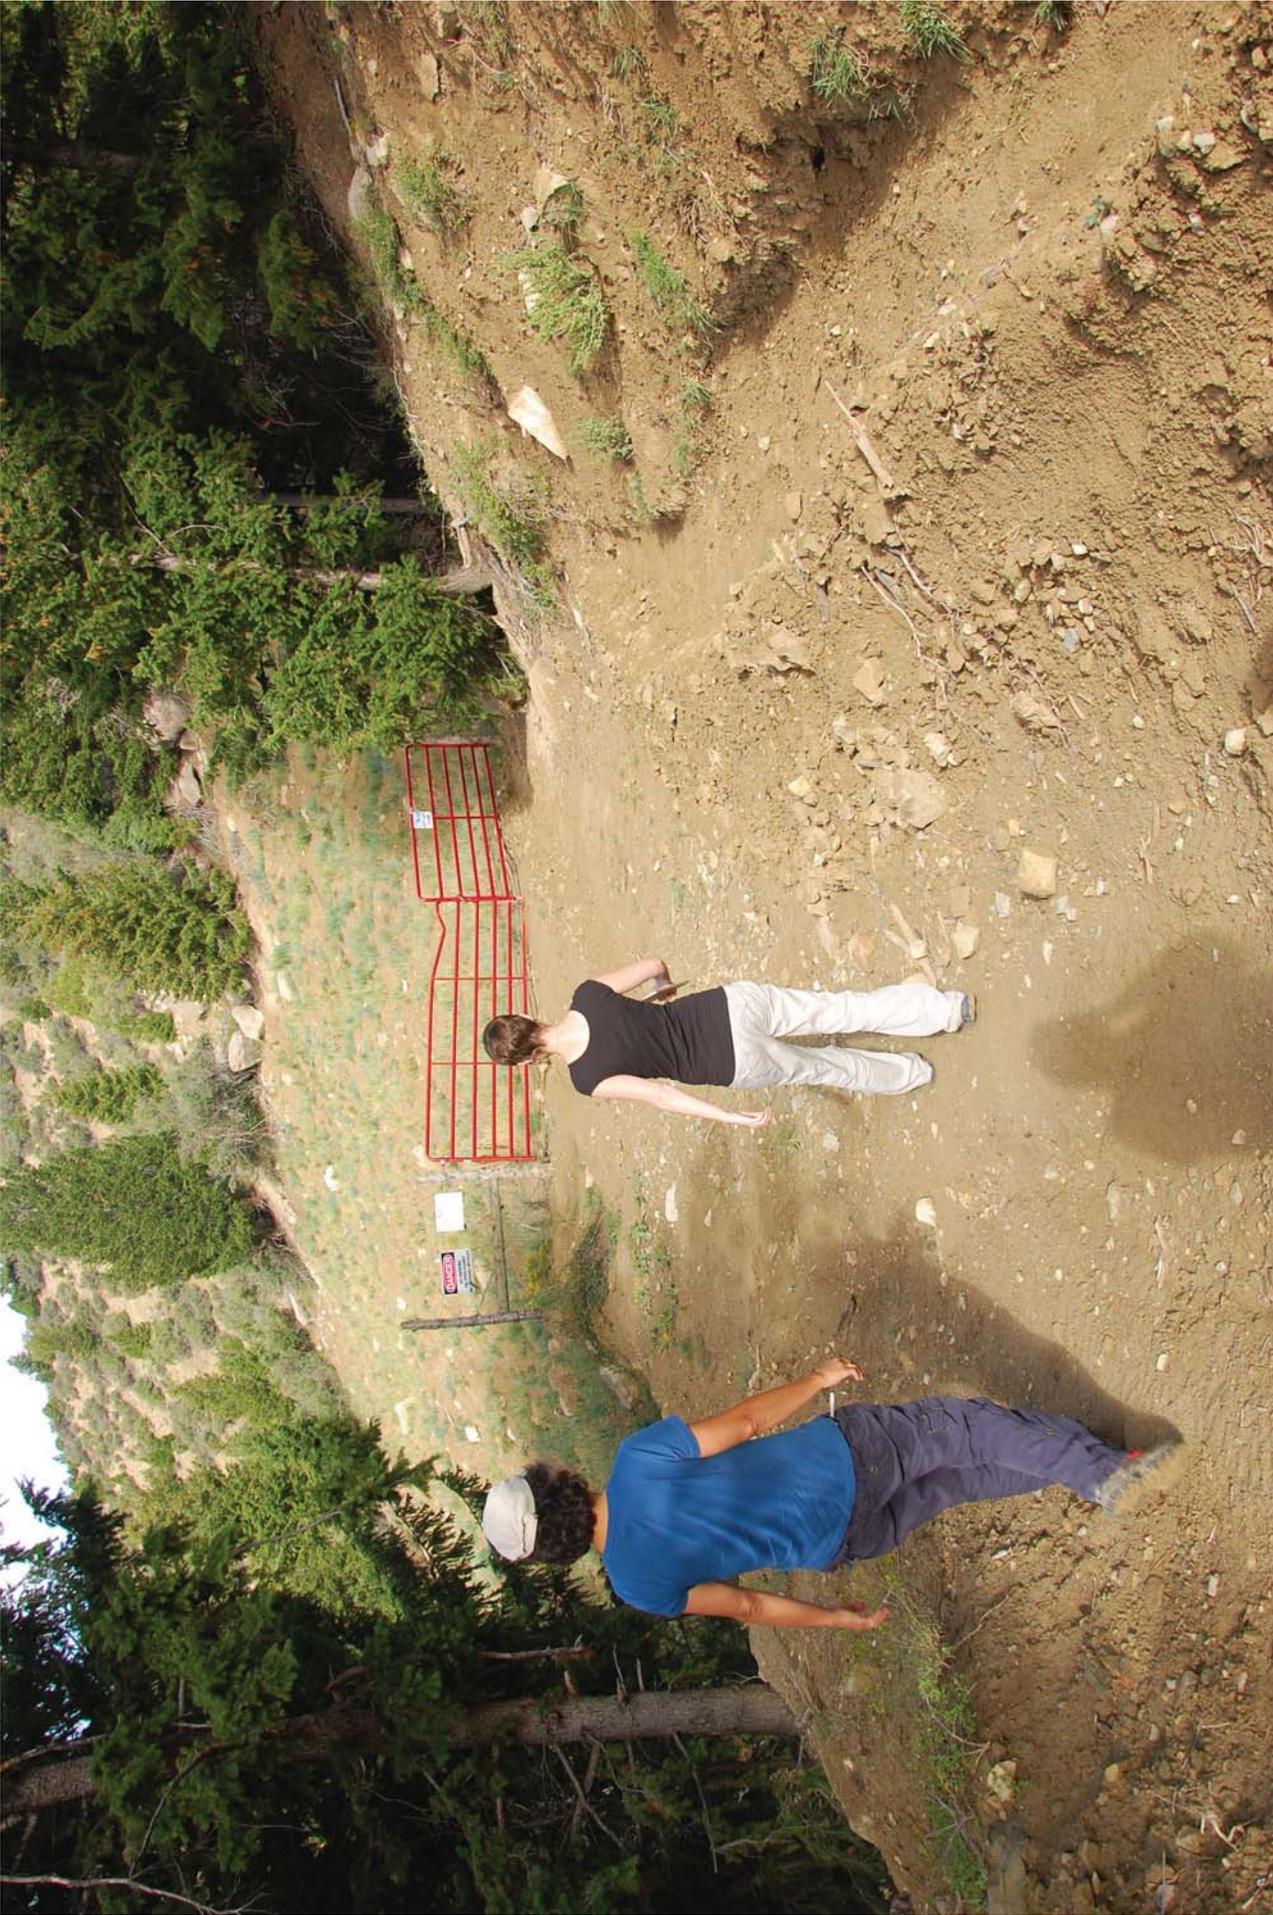
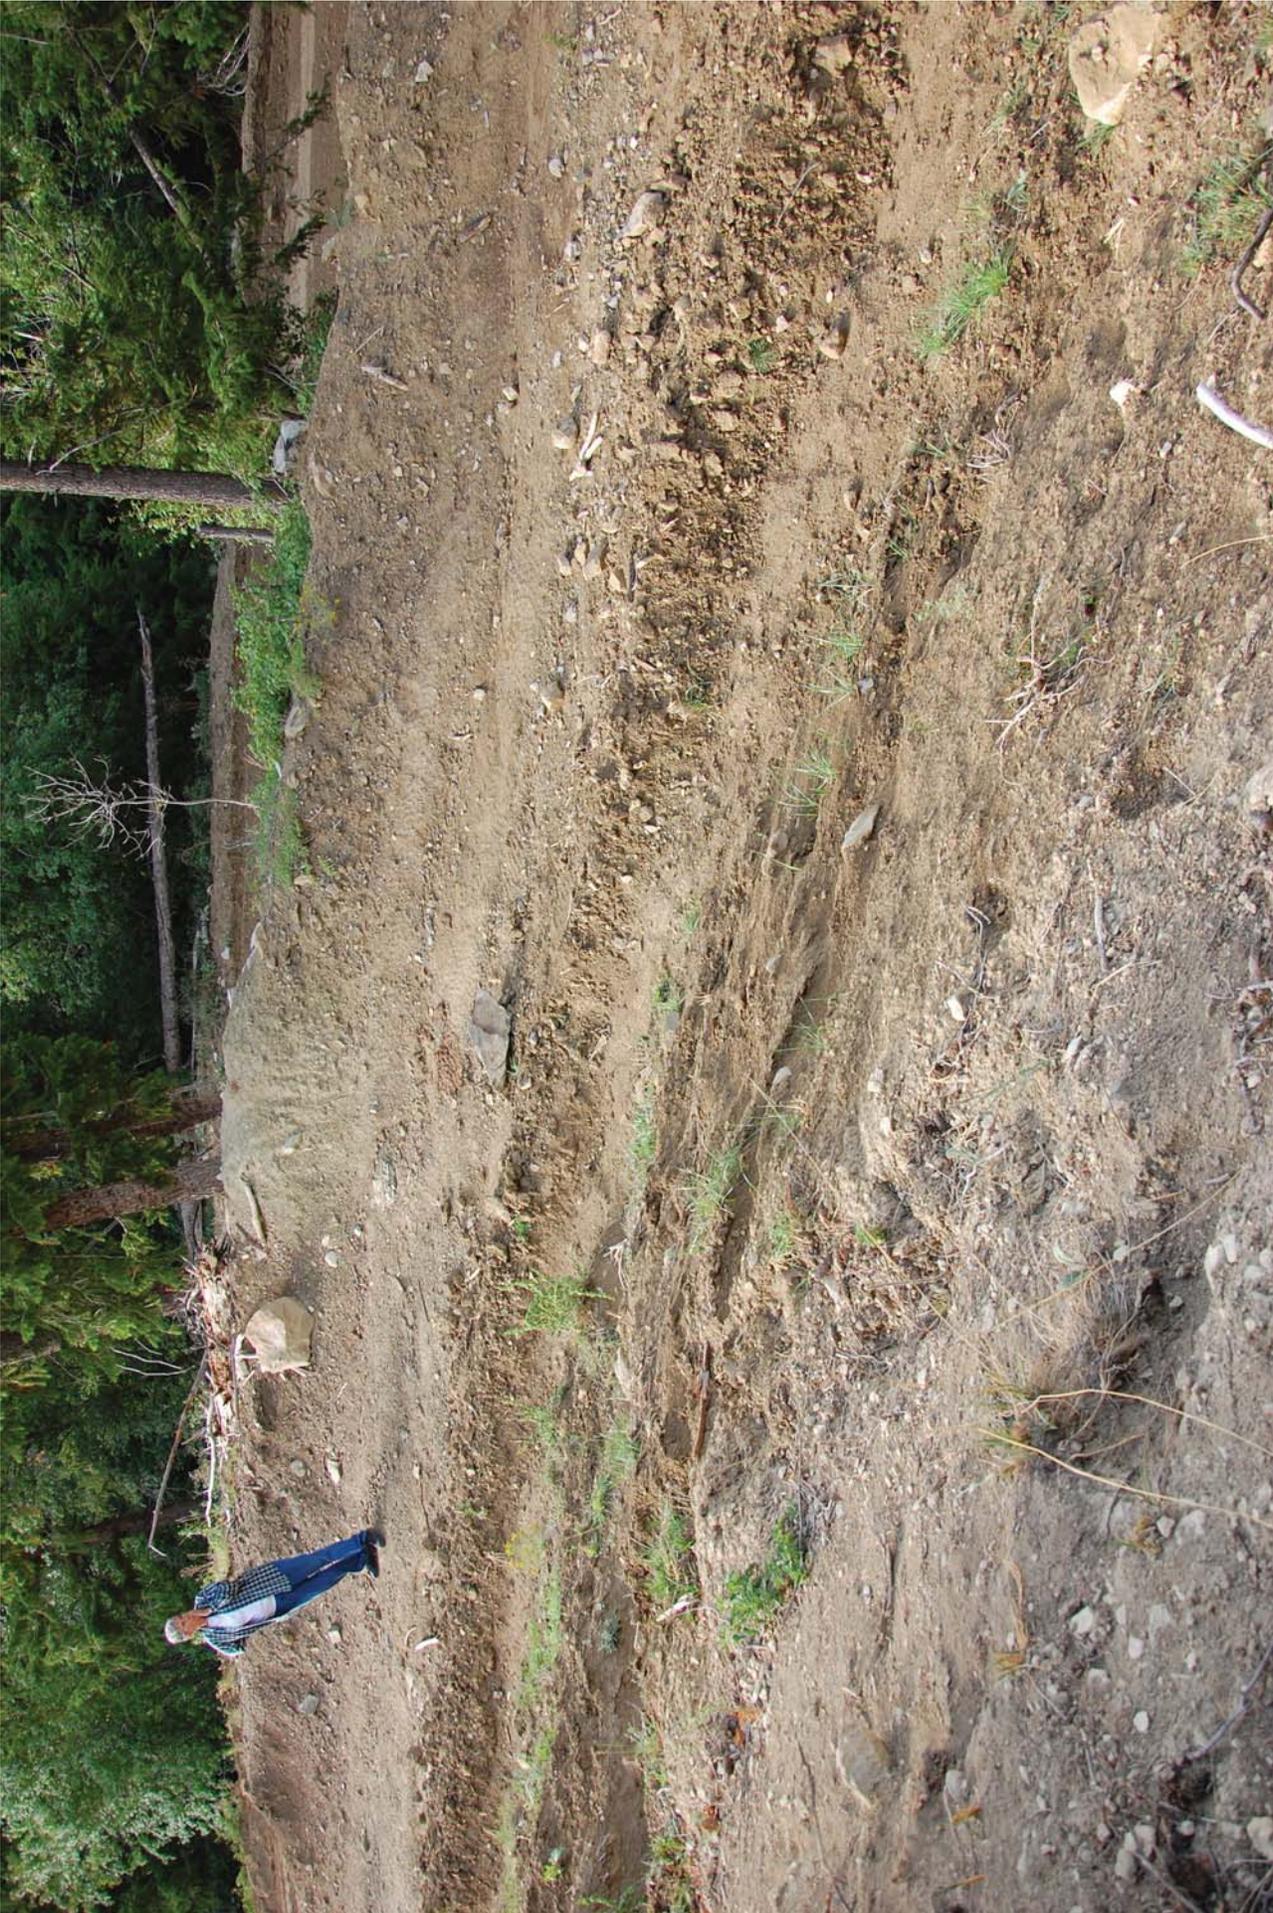
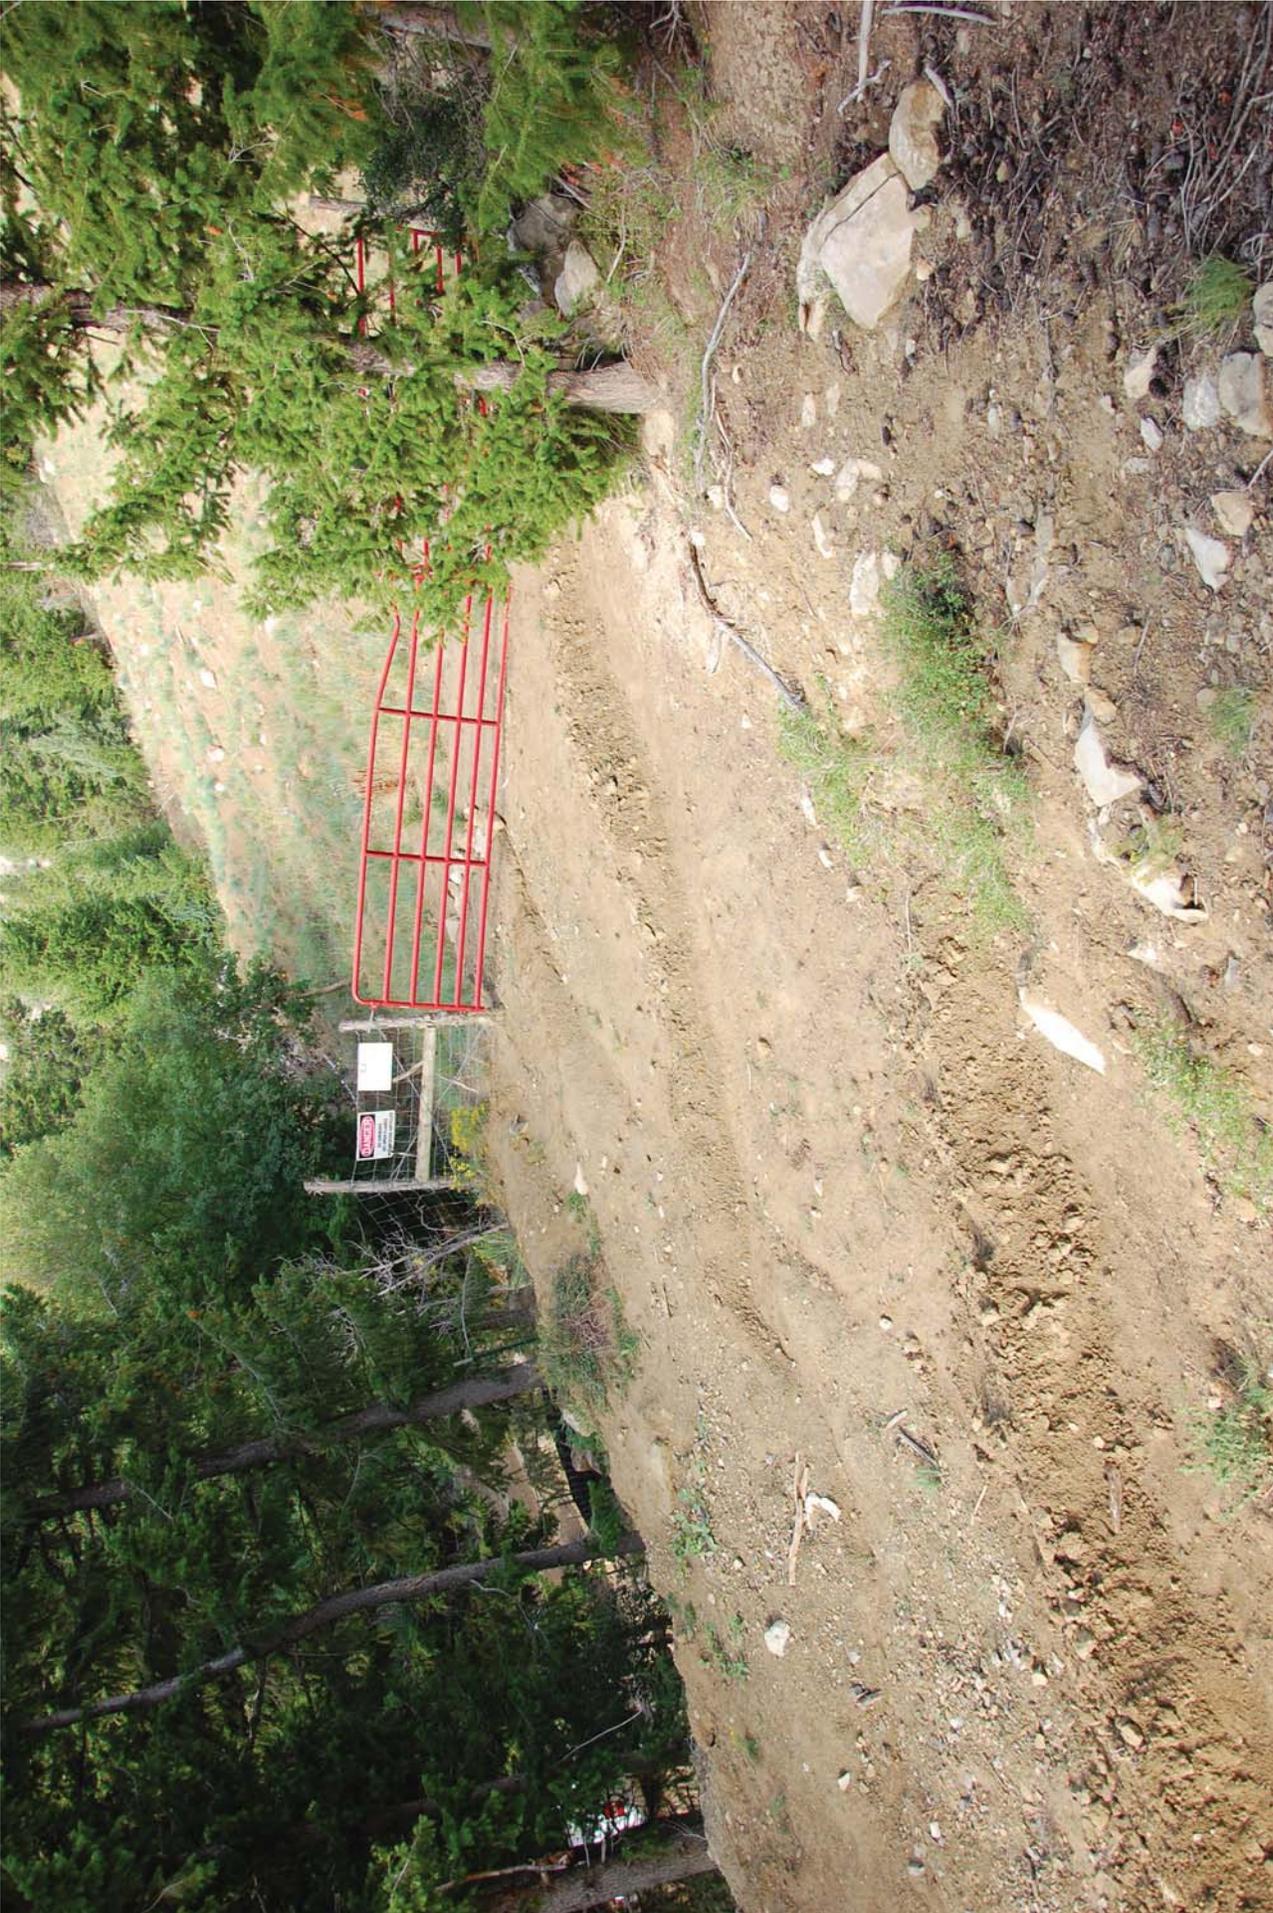
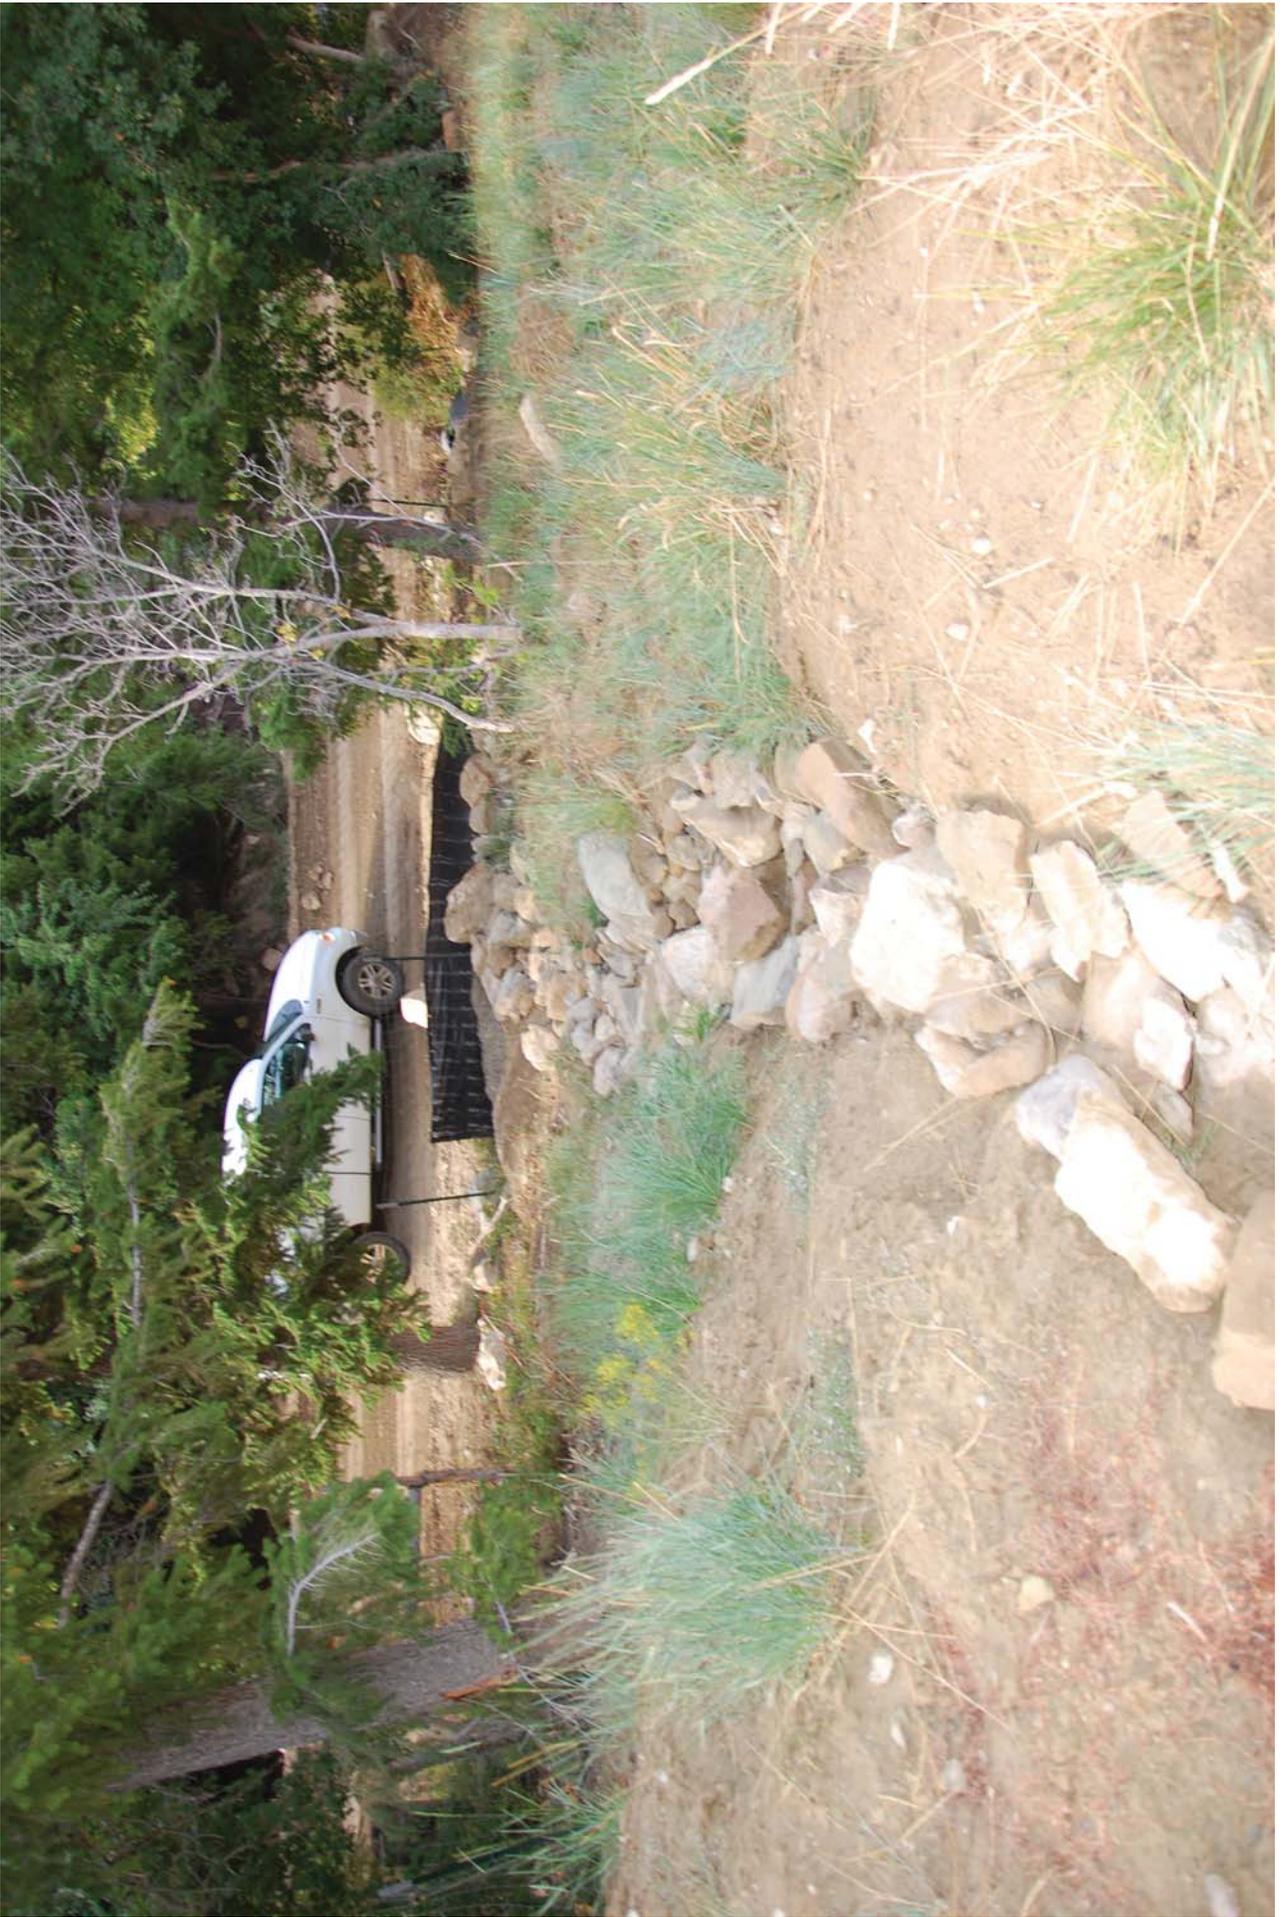
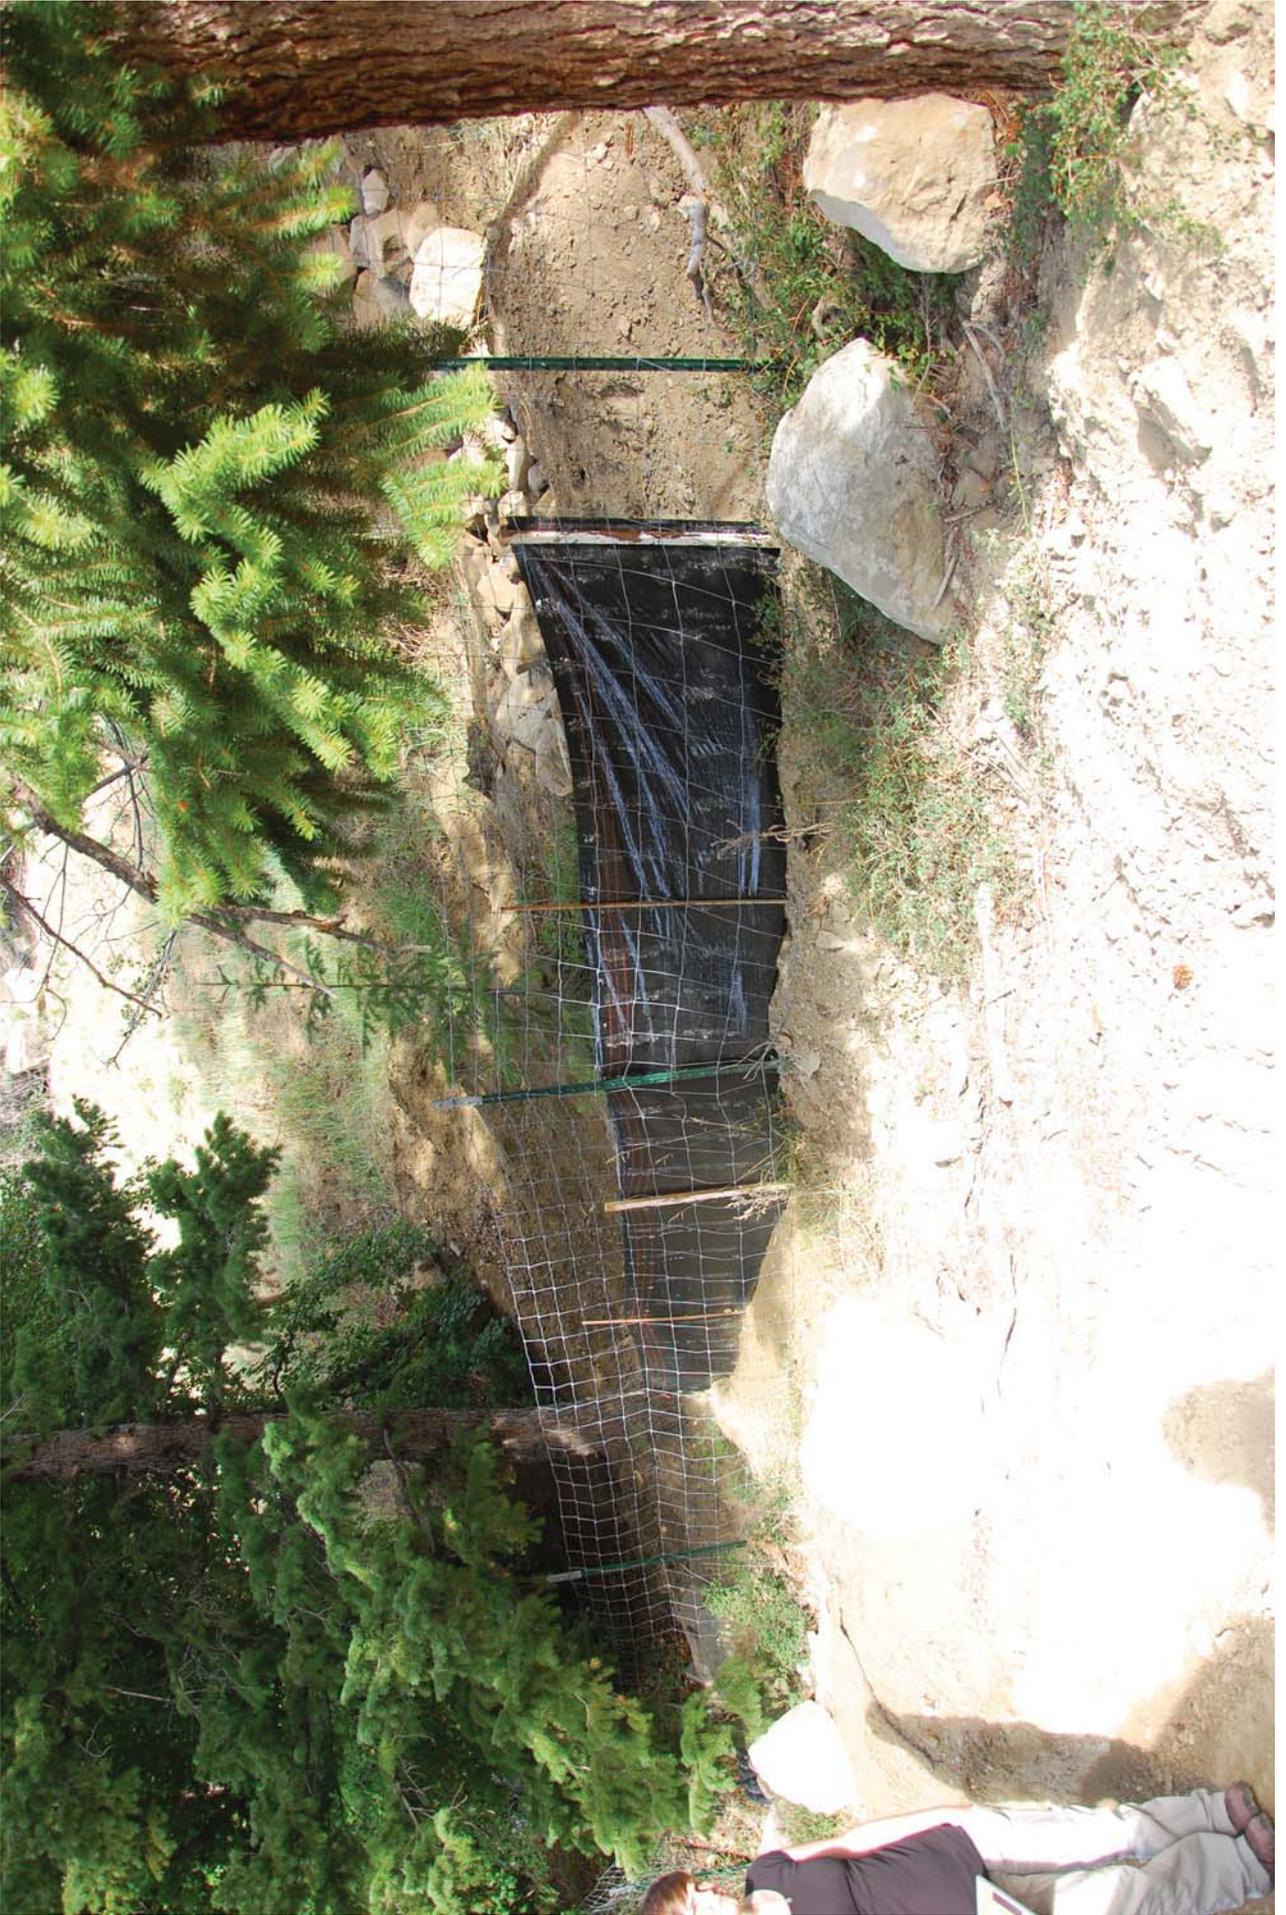
Site G-10: The site has been reclaimed. As with Site G-30, a rip rapped diversion channel routing drainage from the pad area to the access road below (approximately 50-75') has been installed. Vicky Miller indicated that a gully began to form and in order to minimize additional erosion and off-site sedimentation, the gully was rip rapped and a silt fence installed at the outlet of the diversion located directly adjacent to the access road. The approved design did not include the installation of a diversion ditch for this site. See Figure 1, Contour Map for G-10 and Figure 3, Approximate Drilling Layout for G-10 of Attachment 5-4. Two berms were recently constructed in order to control the drainage coming off the reclaimed portion of the site as it enters into the spur/access road segment. As with the diversion, the berms are not included in the approved design for the site.

According to Vicky Miller, the spur road that connects the pad to the main canyon road was pre-existing and as such, will remain in place. Attachment 5-4, Plate 4, Pace Canyon Road System does depict the spur to G-10 as a pre-existing road. As a result, reclamation will not be required for this section of road. However; design details/calculations should be submitted to the Division for review and incorporation into the MRP if the recently rip rapped diversion is to remain a drainage feature for the site. (See R645-301-740, -742.300 and -742.323)

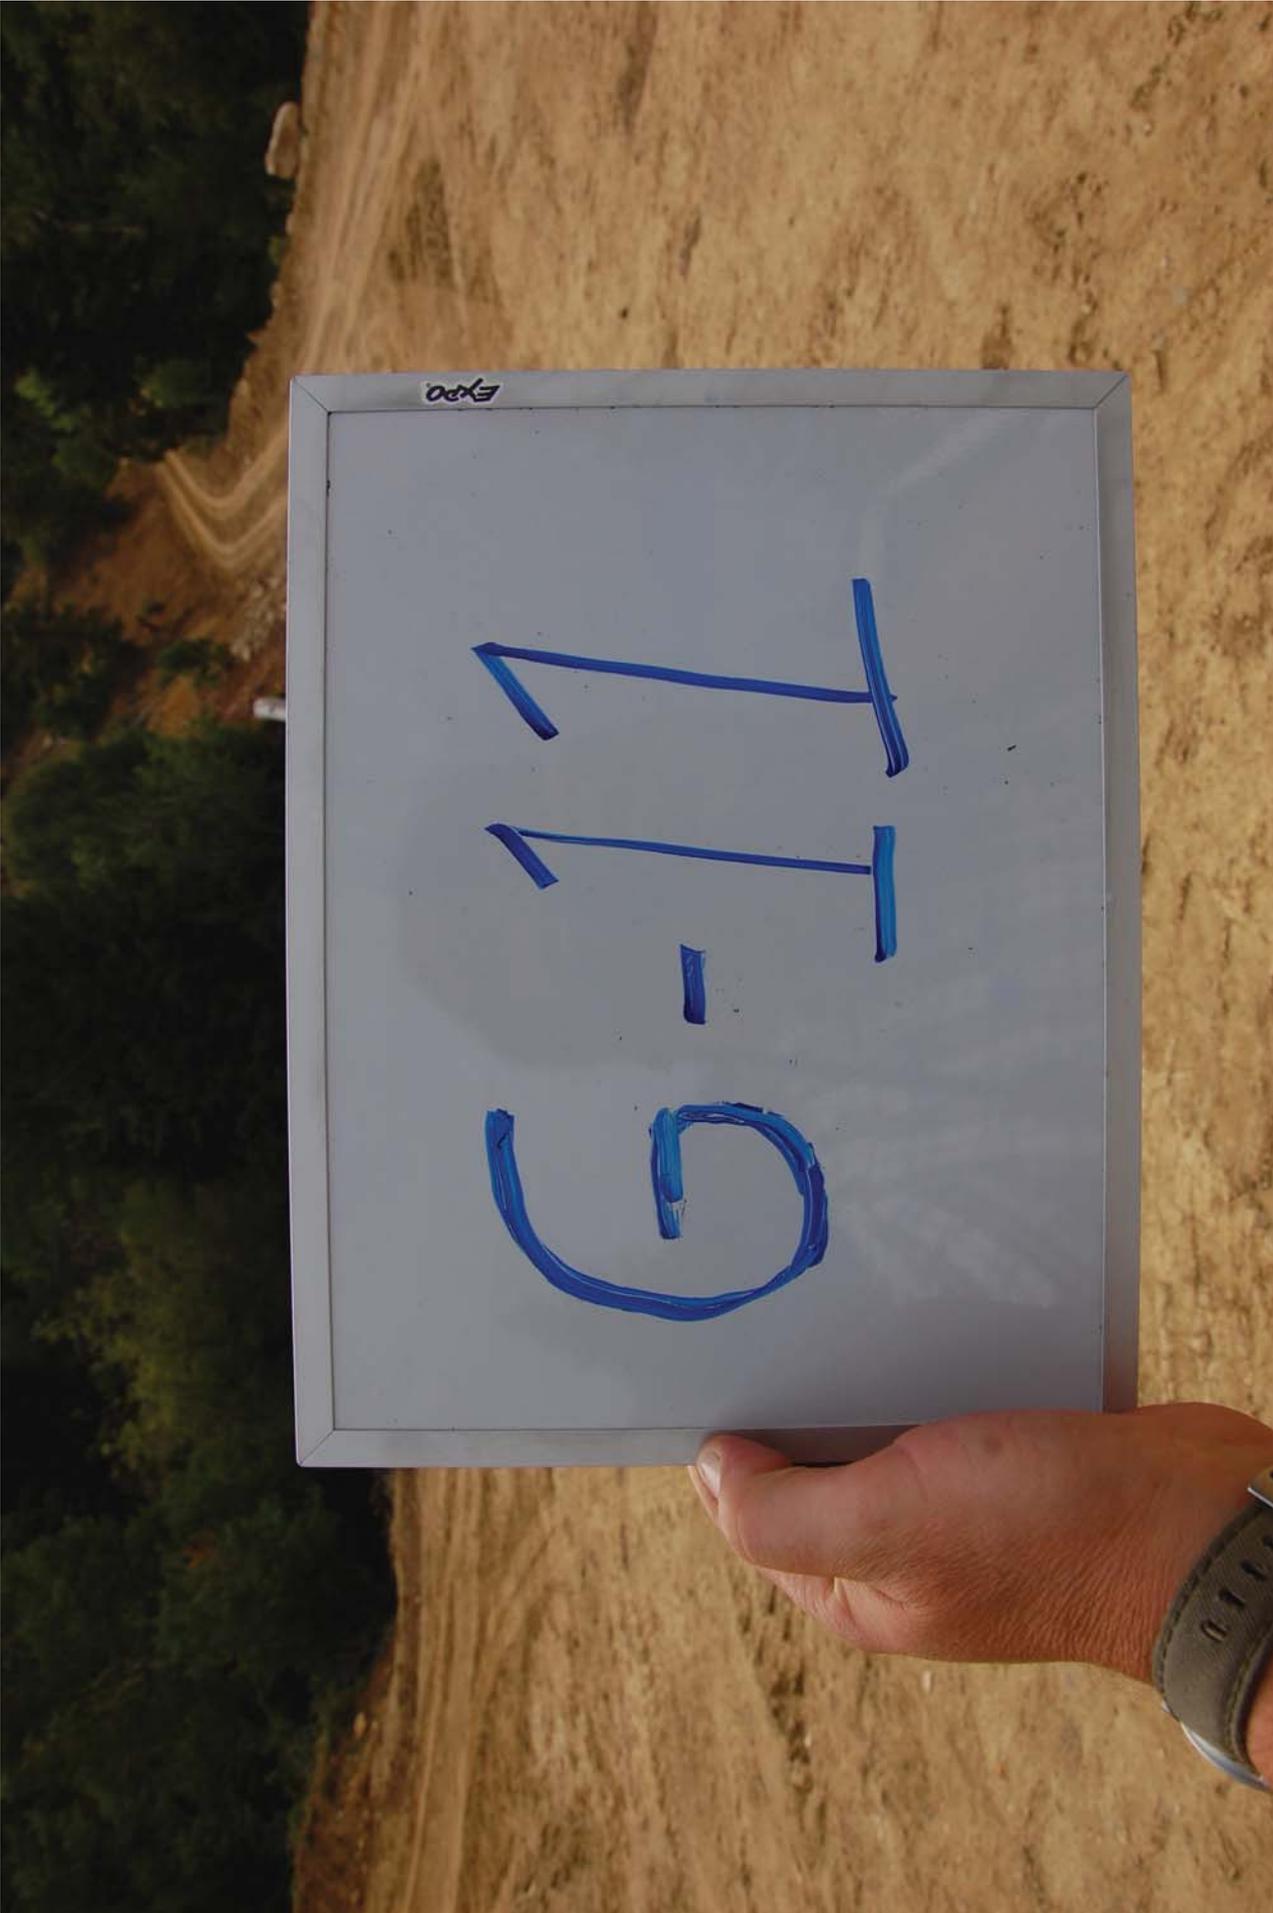
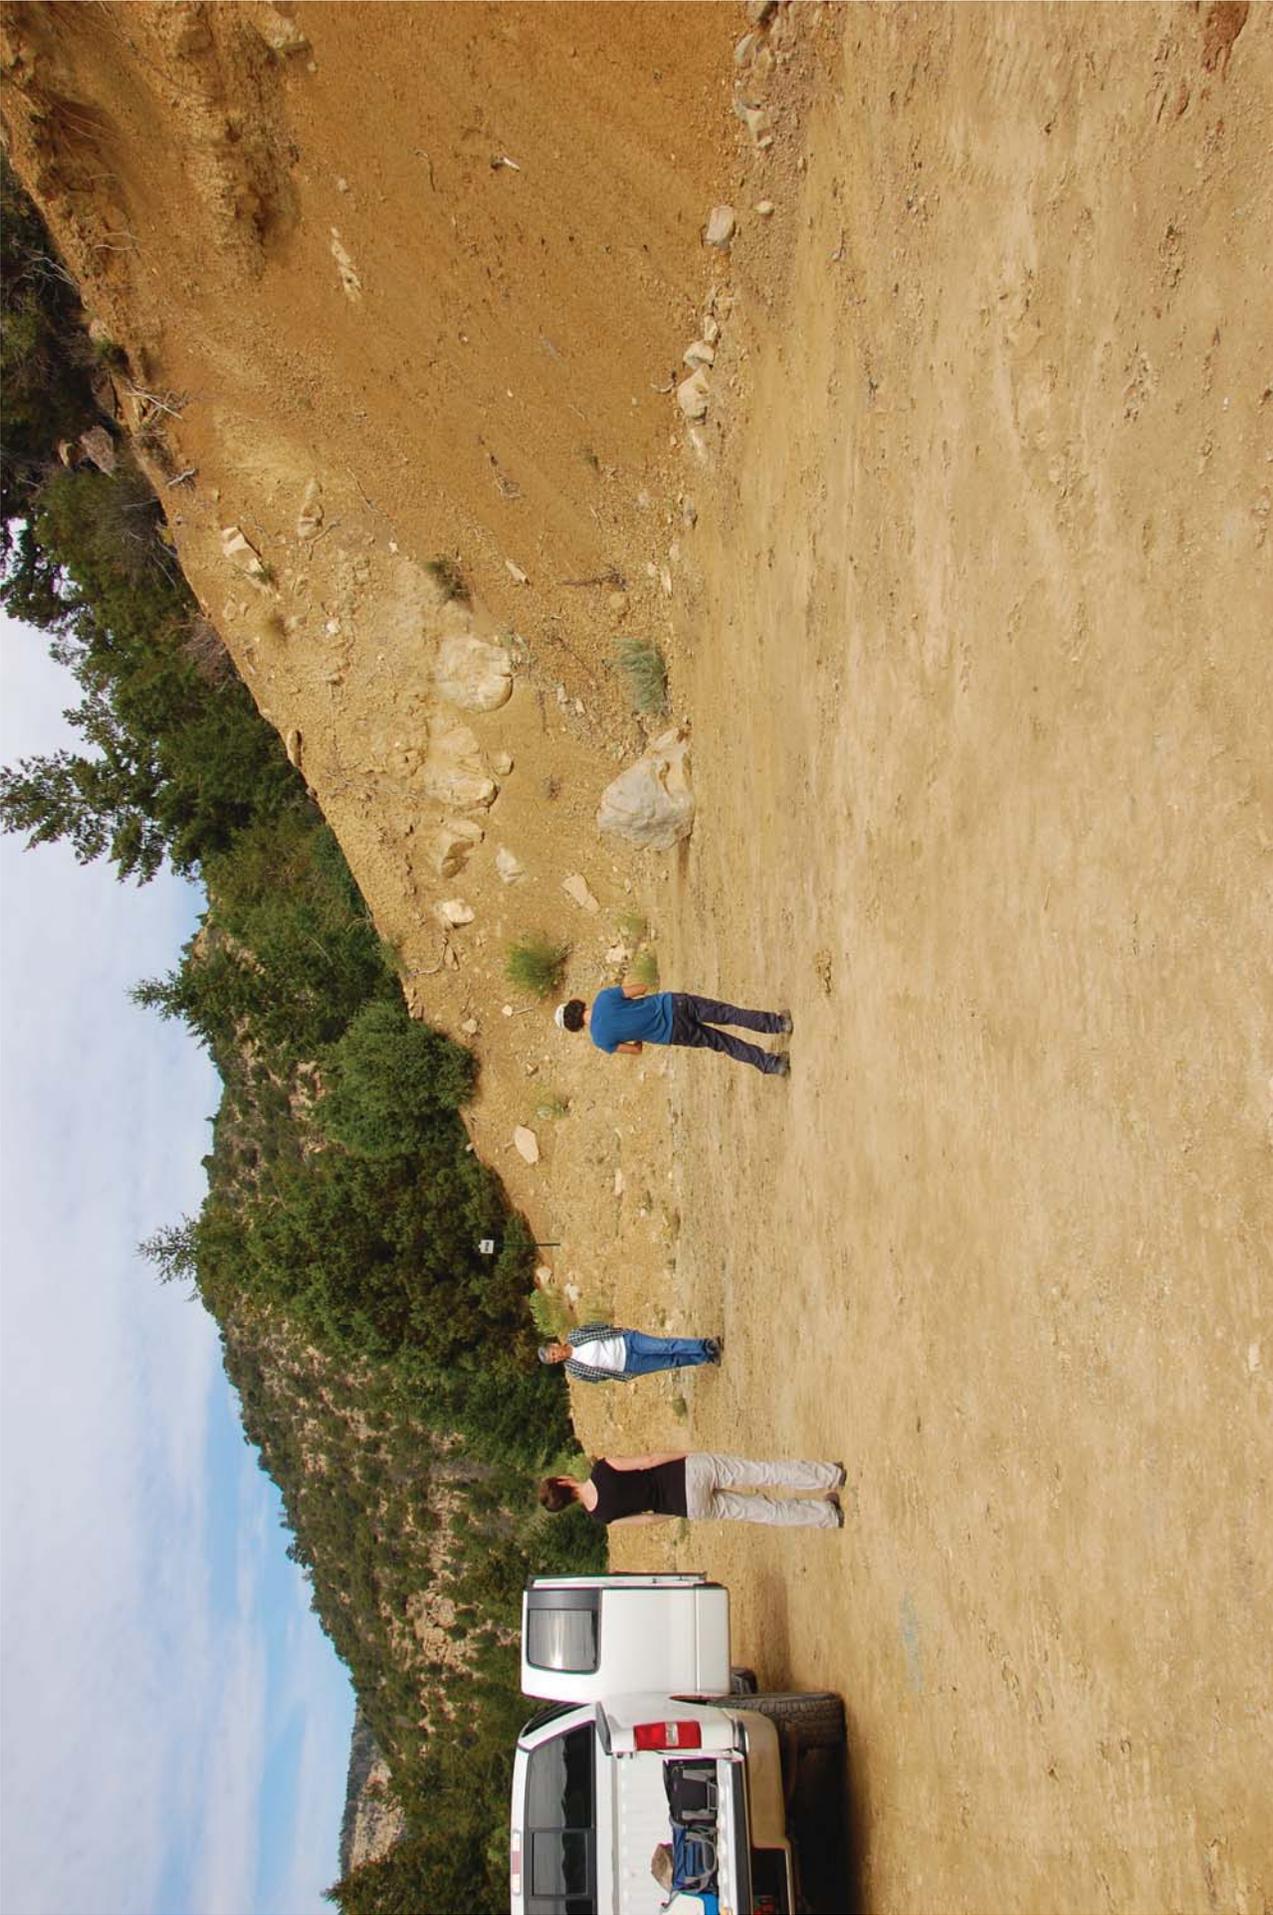
Site G-11: The site is un-reclaimed. The site cannot be reclaimed until Sites G-18, G-31 and the AMV road have been reclaimed as it will be utilized as a staging area. The site appeared stable during the field inspection. No evidence of erosion or cutting was observed during the site visit. The site is located directly adjacent to the pre-existing canyon road. The site should be reclaimed as soon as possible following the completion of reclamation work on G-18, G-31 and the AMV Road.

There is a 40 ft. cut slope at site G-11. Fill to partially reclaim site G 11 is in the road embankment. Site G-12 is completely occupied by topsoil. Fill to reclaim G-11 and G-12 was noted as being elsewhere on the property. The storage location for this fill material should be noted in the narrative or on a map within the MRP.
