Inspection Report

Permit Number:	C0070039
Inspection Type:	PARTIAL
Inspection Date:	Wednesday, August 01, 2012
Start Date/Time:	8/1/2012 6:30:00 AM
End Date/Time:	8/1/2012 4:00:00 PM
Last Inspection:	Thursday, July 12, 2012

Permitee: **CANYON FUEL COMPANY**
 Operator: **CANYON FUEL COMPANY**
 Site: **DUGOUT CANYON MINE**
 Address: **PO BOX 1029, WELLINGTON UT 84542**
 County: **CARBON**
 Permit Type: **PERMANENT COAL PROGRAM**
 Permit Status: **ACTIVE**

On August 1st, 2012, Division of Oil, Gas and Mining (the Division) staff conducted a field inspection of the gob gas vent hole sites at the Dugout Canyon Mine. The purpose of the field inspection was to document the condition of the gob gas vent hole sites and associated access roads. All but three of the 25 gob gas vent hole sites depicted on Figure 1-1, Methane Degas Bore Hole Locations, were constructed. Sites G-1, G-8 and G-29 were permitted but never drilled/constructed. Of the remaining 22 gob gas vent hole sites, 11 have been reclaimed. Based upon information provided by the Operator, the underground mine workings below 8 of the 11 un-reclaimed sites have been sealed and no longer require active ventilation in order to ma

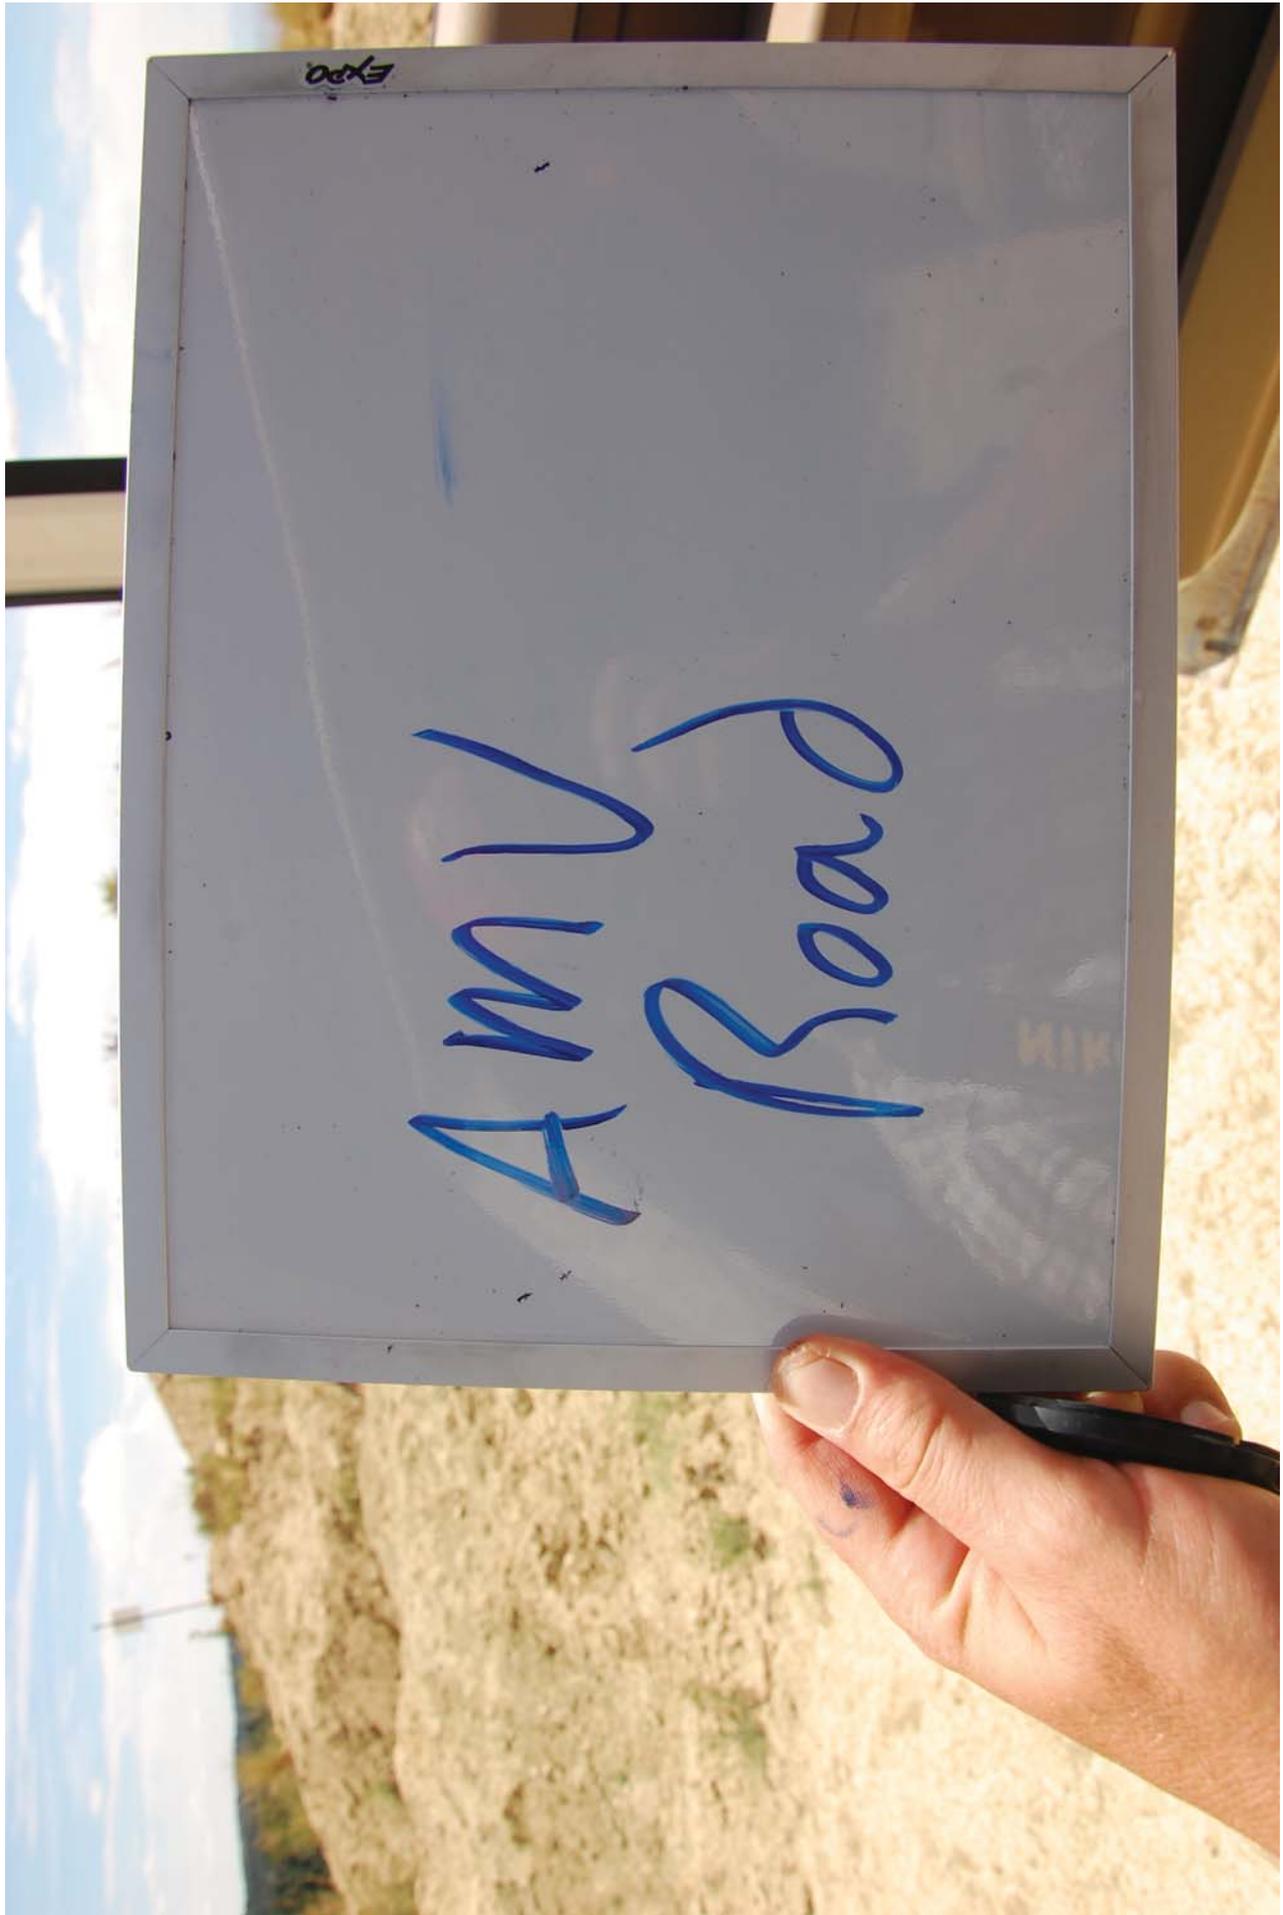
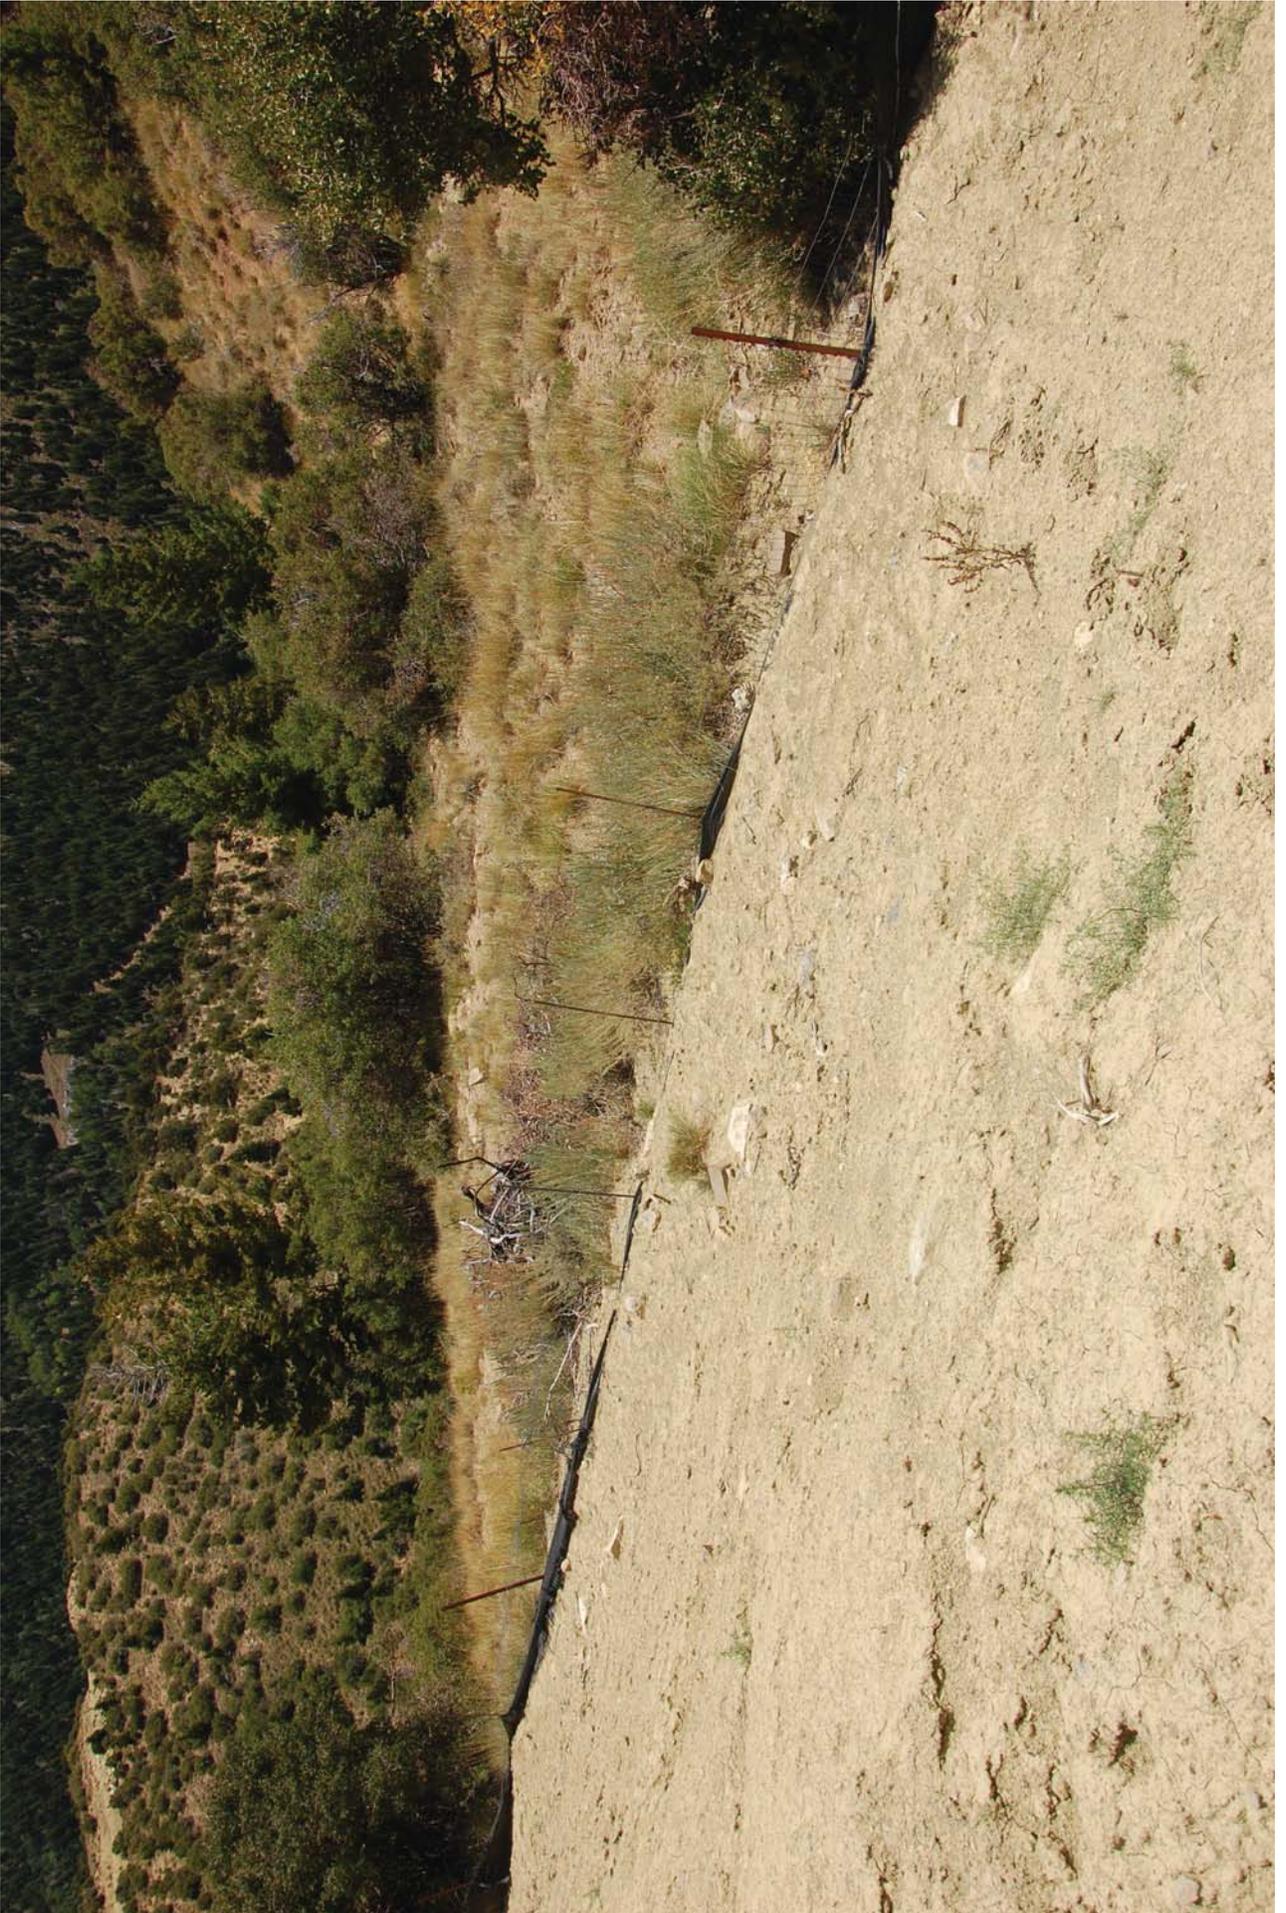
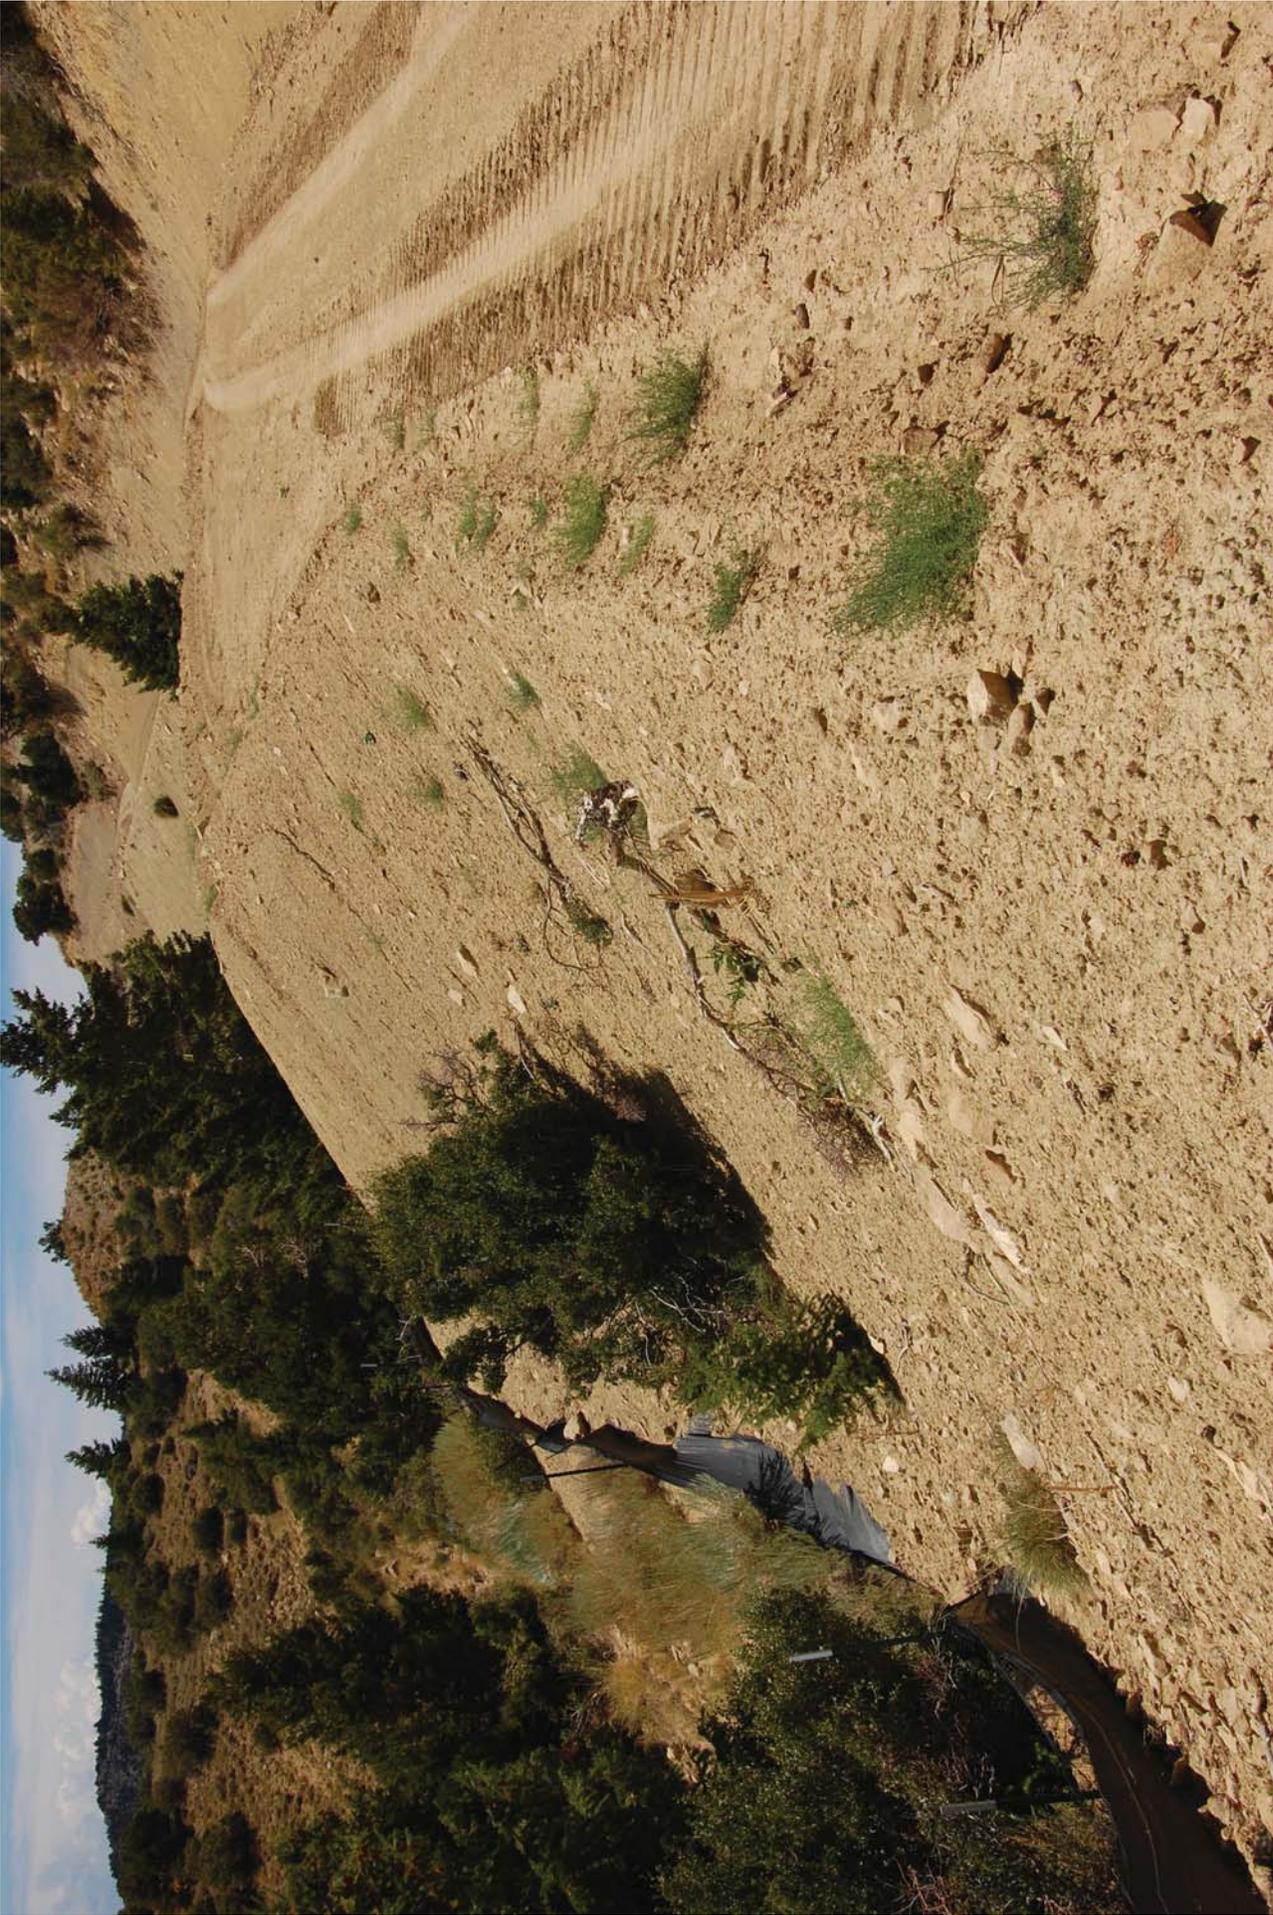
AmV
Road

AMV Access Road: Division staff walked the entire length of the AMV Access Road during the field inspection. The Permittee was unable to establish vegetation on the outslope of the road due to the poor quality of the soil. As a result, the primary sediment control measure employed for the road is silt fence. The silt fence has performed well during the utilization of this access road. However; in numerous locations the silt fence has either been destroyed or has been filled to capacity thus limiting its effectiveness. Prior to the onset of winter, the Permittee must provide additional sediment control along the AMV Access Road. Failure to do so could lead to a loss of the fill material. If the fill material is lost, successful reclamation of the road could prove more challenging as well as more expensive. Additionally, the lost fill material would result in additional suspended solids and sediment being deposited into the receiving watershed resulting in enforcement action. At present, the fill material is contained with the disturbed area boundary (See Attachment 5-4, Plate 1, Degas Well G-31, G-18 and Access Road). Based upon the observed condition of

the AMV Road during the field inspection, more rigorous and frequent maintenance/repair of the road will be required going forward.

The AMV Road needs to be reclaimed as soon as possible. As G-18 and G-31 are being reclaimed during the 2012 construction season, the AMV road must either be reclaimed this year or reclaimed during the 2013 construction season. If the road is not reclaimed this year, then additional sediment control measures must be put in place prior to the onset of winter. Failure to do so may result in enforcement action.
