Inspection Report

Permit Number:	C0070039
Inspection Type:	PARTIAL
Inspection Date:	Thursday, November 29, 2012
Start Date/Time:	11/29/2012 7:00:00 AM
End Date/Time:	11/29/2012 12:30:00 PM
Last Inspection:	Thursday, November 15, 2012

Permitee: **CANYON FUEL COMPANY**
 Operator: **CANYON FUEL COMPANY**
 Site: **DUGOUT CANYON MINE**
 Address: **PO BOX 1029, WELLINGTON UT 84542**
 County: **CARBON**
 Permit Type: **PERMANENT COAL PROGRAM**
 Permit Status: **ACTIVE**

On November 29th, 2012, Division of Oil, Gas and Mining (the Division) staff conducted a field inspection of recently conducted reclamation work on gob gas vent holes and associated access roads at the Dugout Canyon Mine.

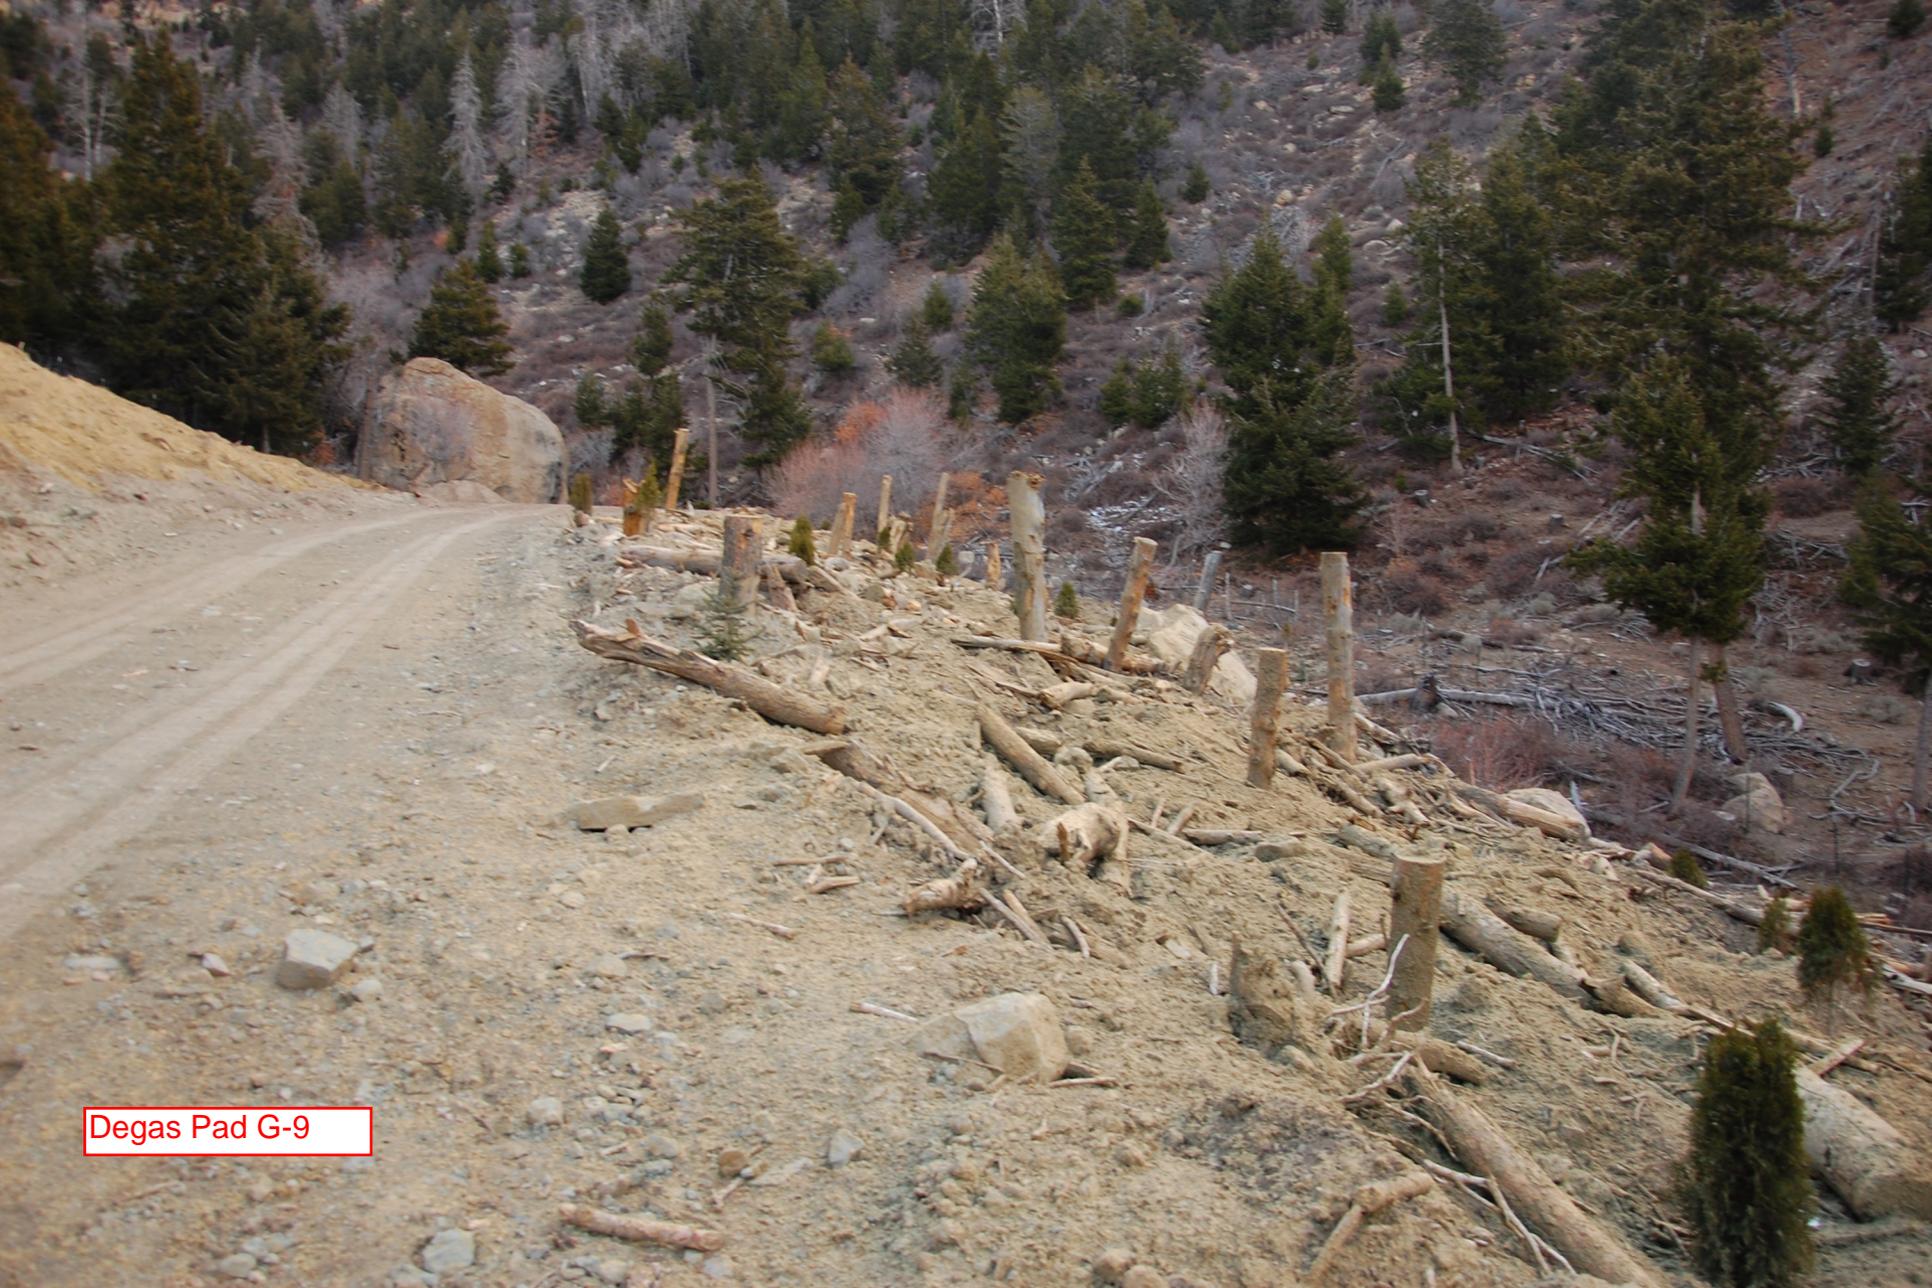
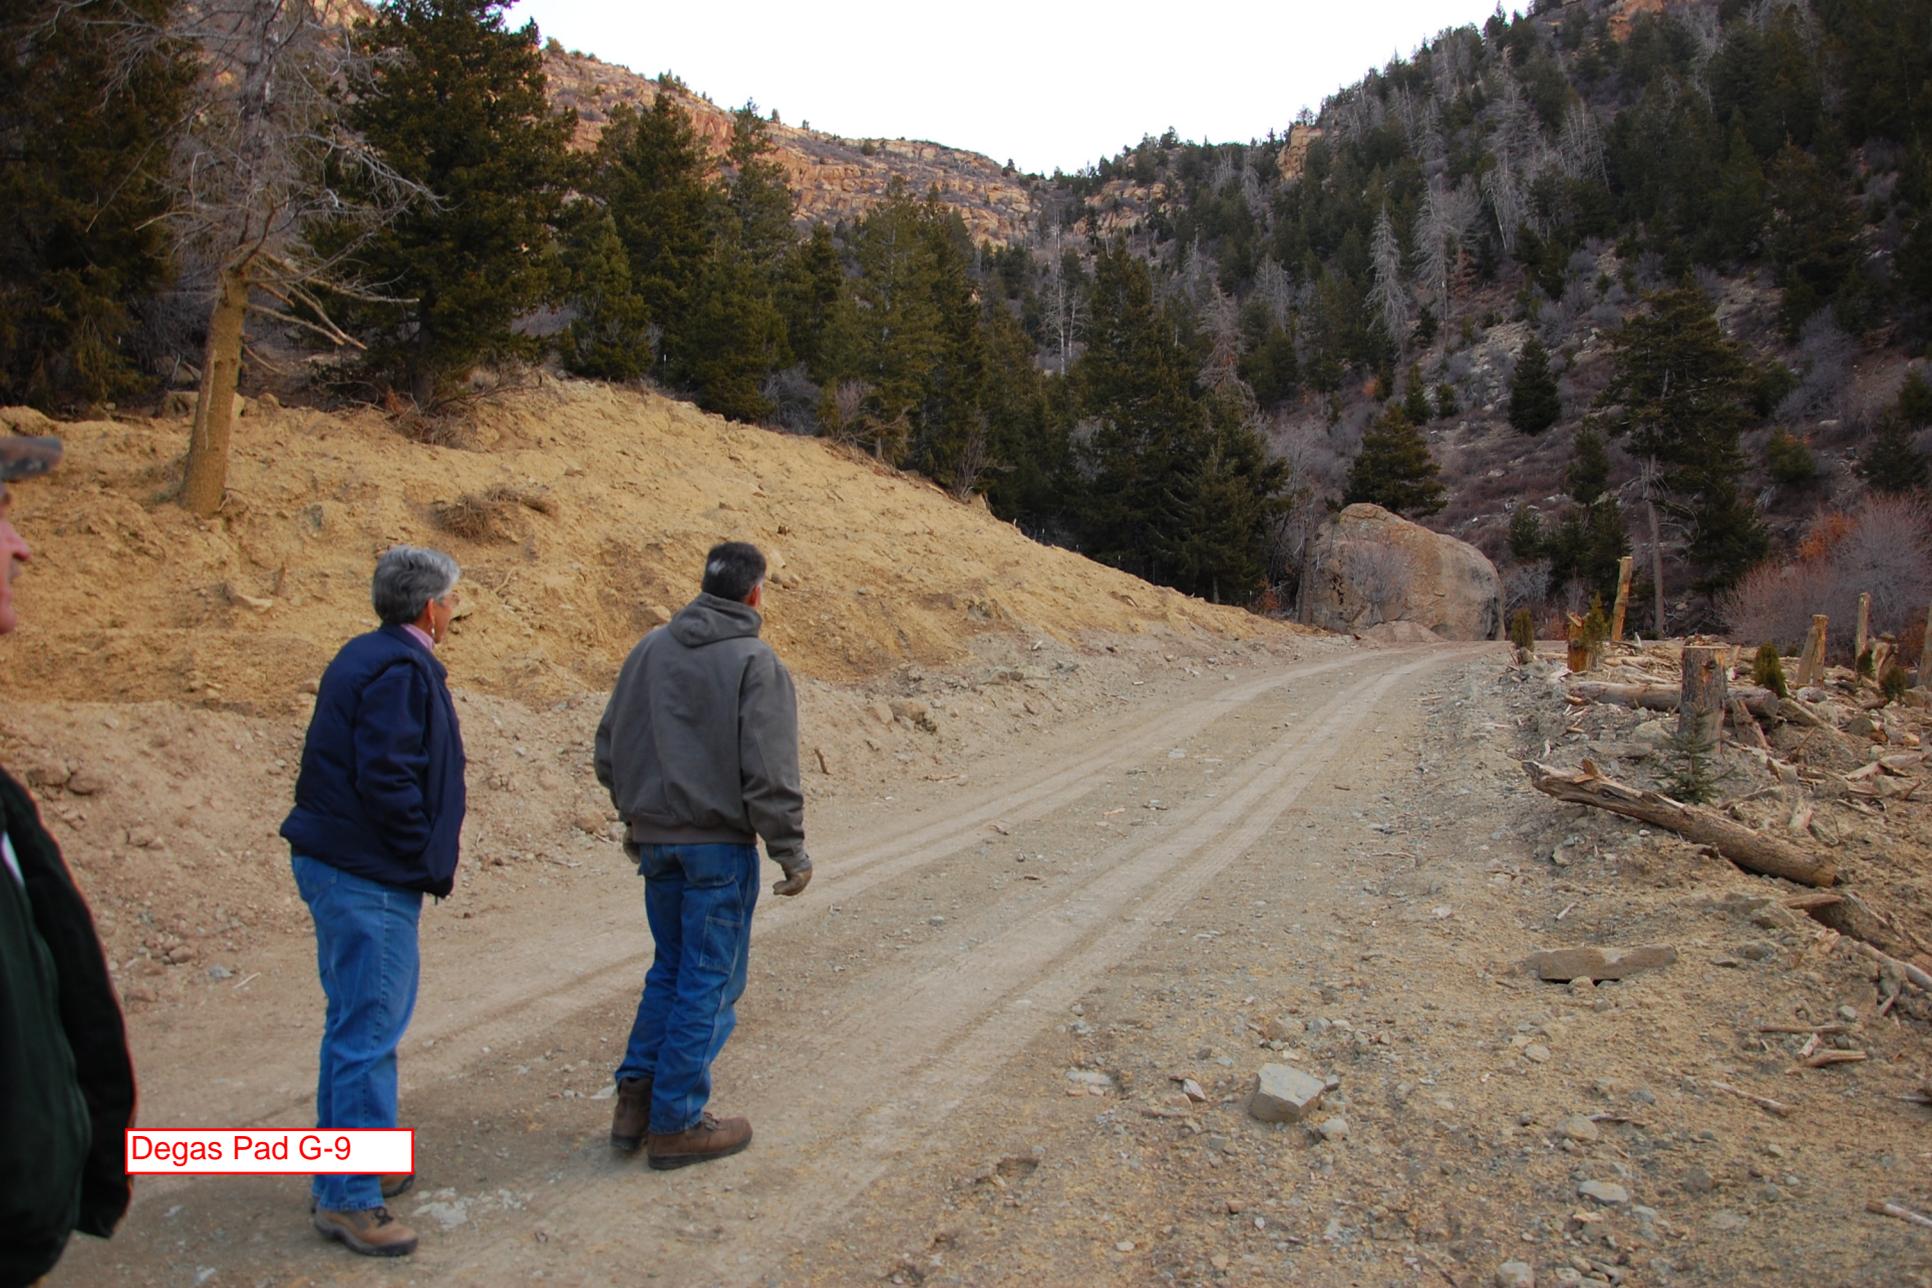
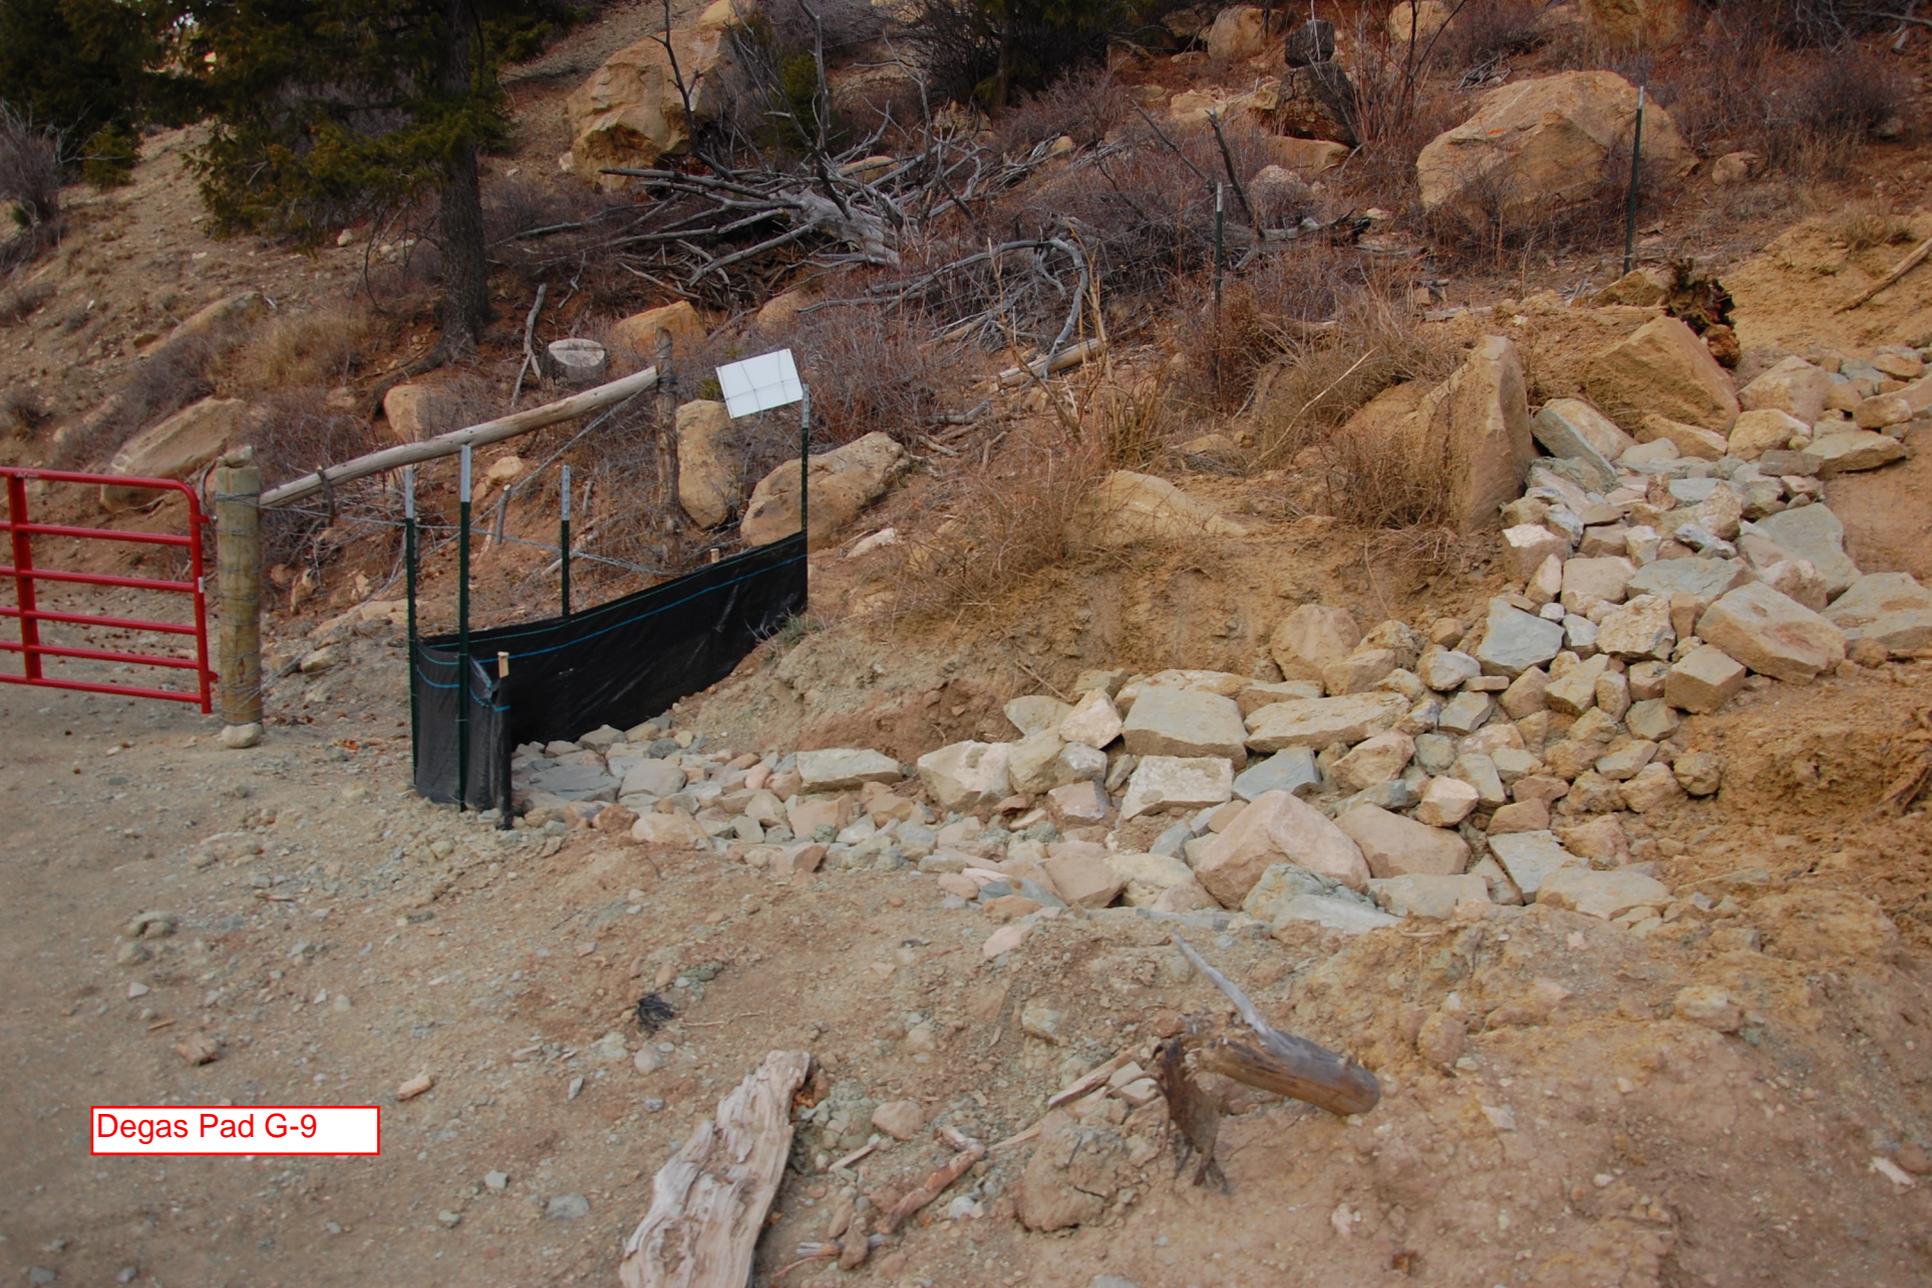
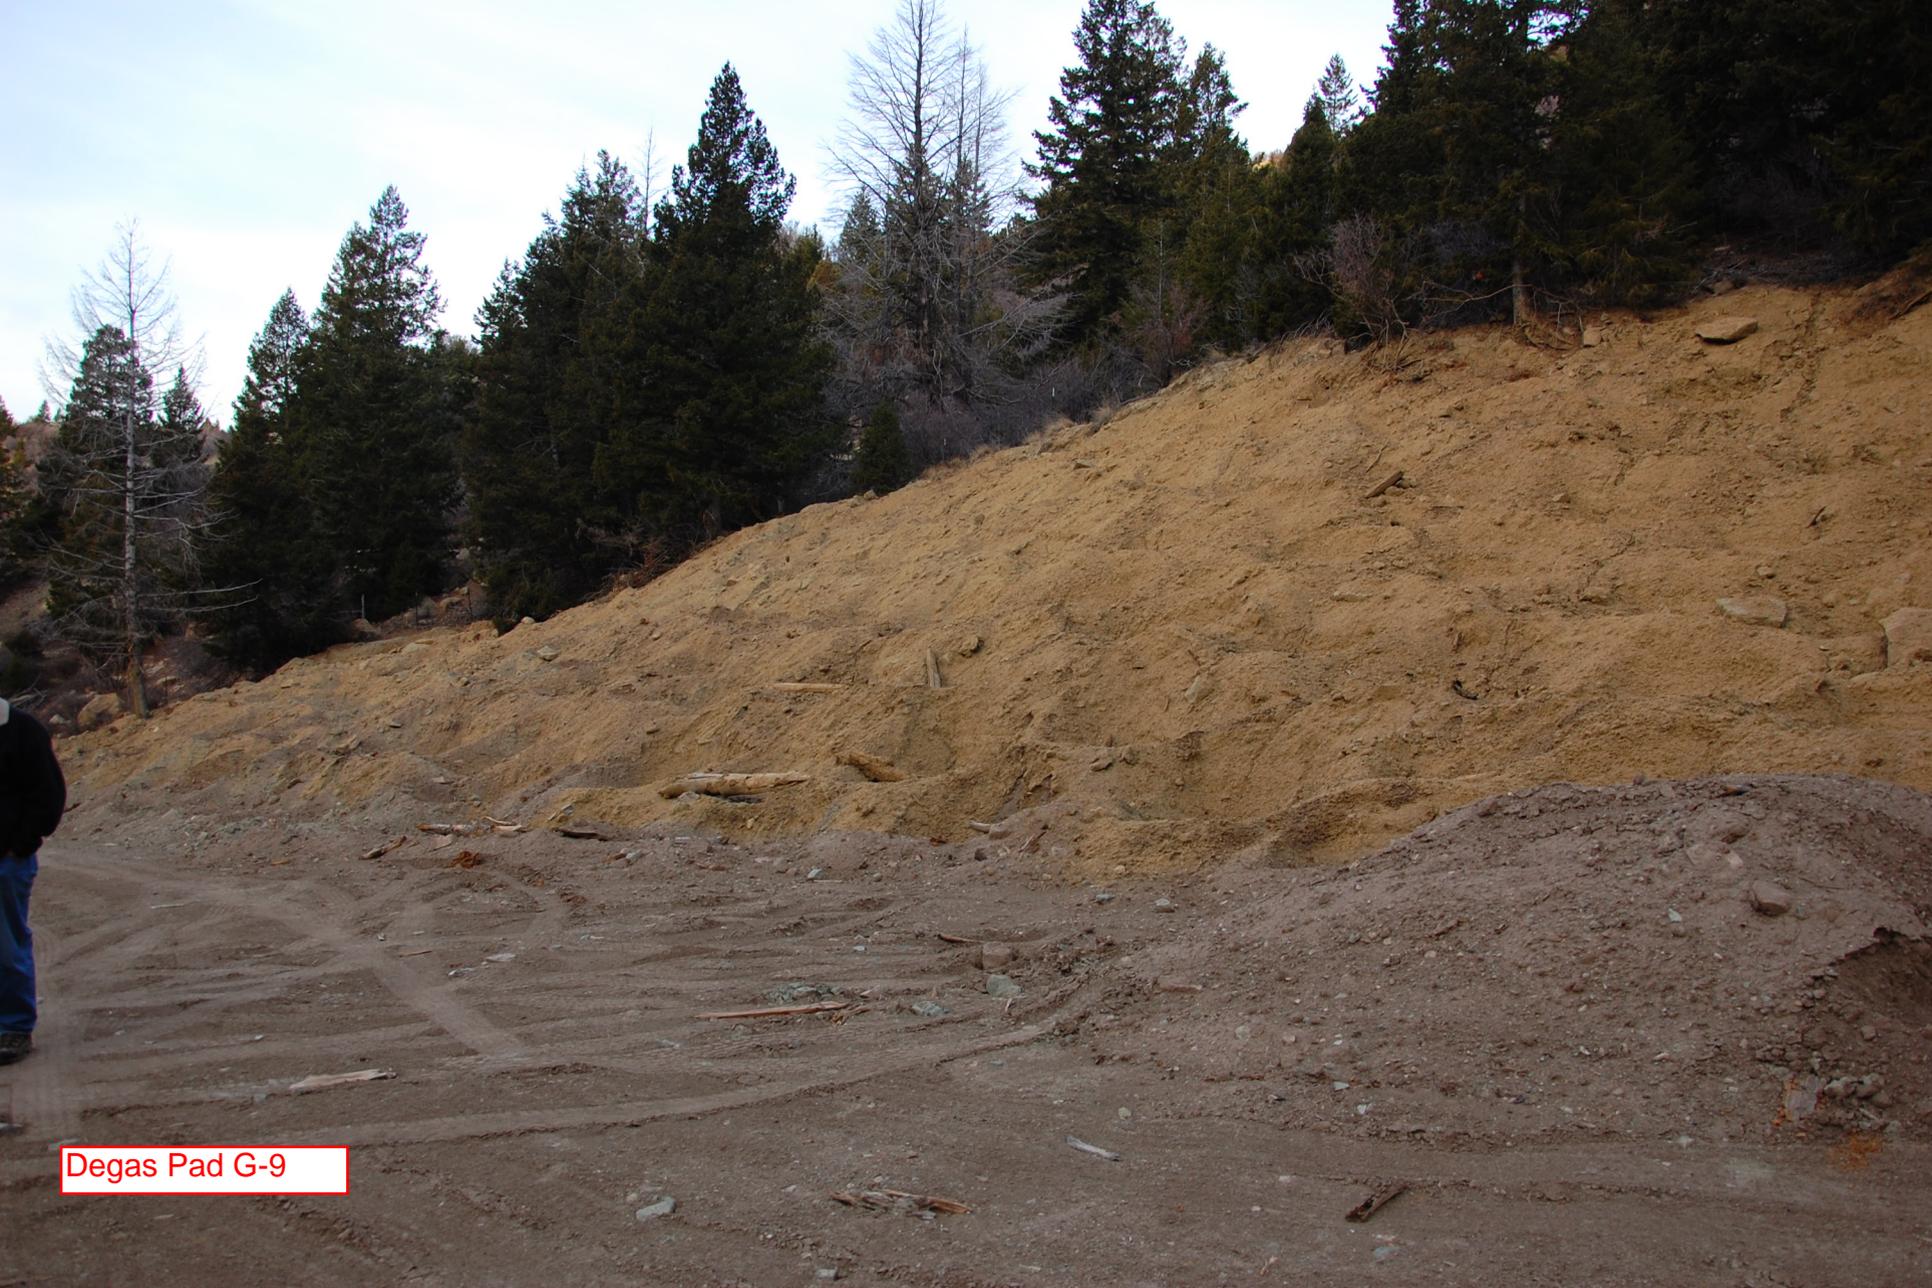
Degas Pad G-9

DG-9, 1,574 cu yds. stored in two stockpiles was replaced over the 2.2 graded site, with the exception of the road. The replacement depth over the entire site calculates to approximately 6 inches (less than the twelve inches expected in Table 2-3). The replacement looks thin on the north side of the road (see attached images). Approximately one cubic yard of topsoil remains to be scattered and should be placed on the slope on the north side of the road. This was brought to the operator's attention and Vicky Miller and David Thayn will see that this is accomplished this season.

Site G-9: Reclamation work was being conducted the last time this site was inspected (08/01/2012) At the time of this inspection, reclamation work had been completed. The site has been pocked, seeded and mulched. A disturbed drainage ditch located directly adjacent to the main access road has been fitted with silt fence and excelsior log sediment controls to prevent sediment from leaving the site.

Site DG-9, 2.2 acres, fenced. The site was pocked, hand seeded and hydromulched. The road was retained through the site and ends in a pad. The pad is supported by a constructed rock wall. Below the road, the slope was planted with a dozen or more evergreens and numerous tree stumps were placed vertically to serve as bird roosts.

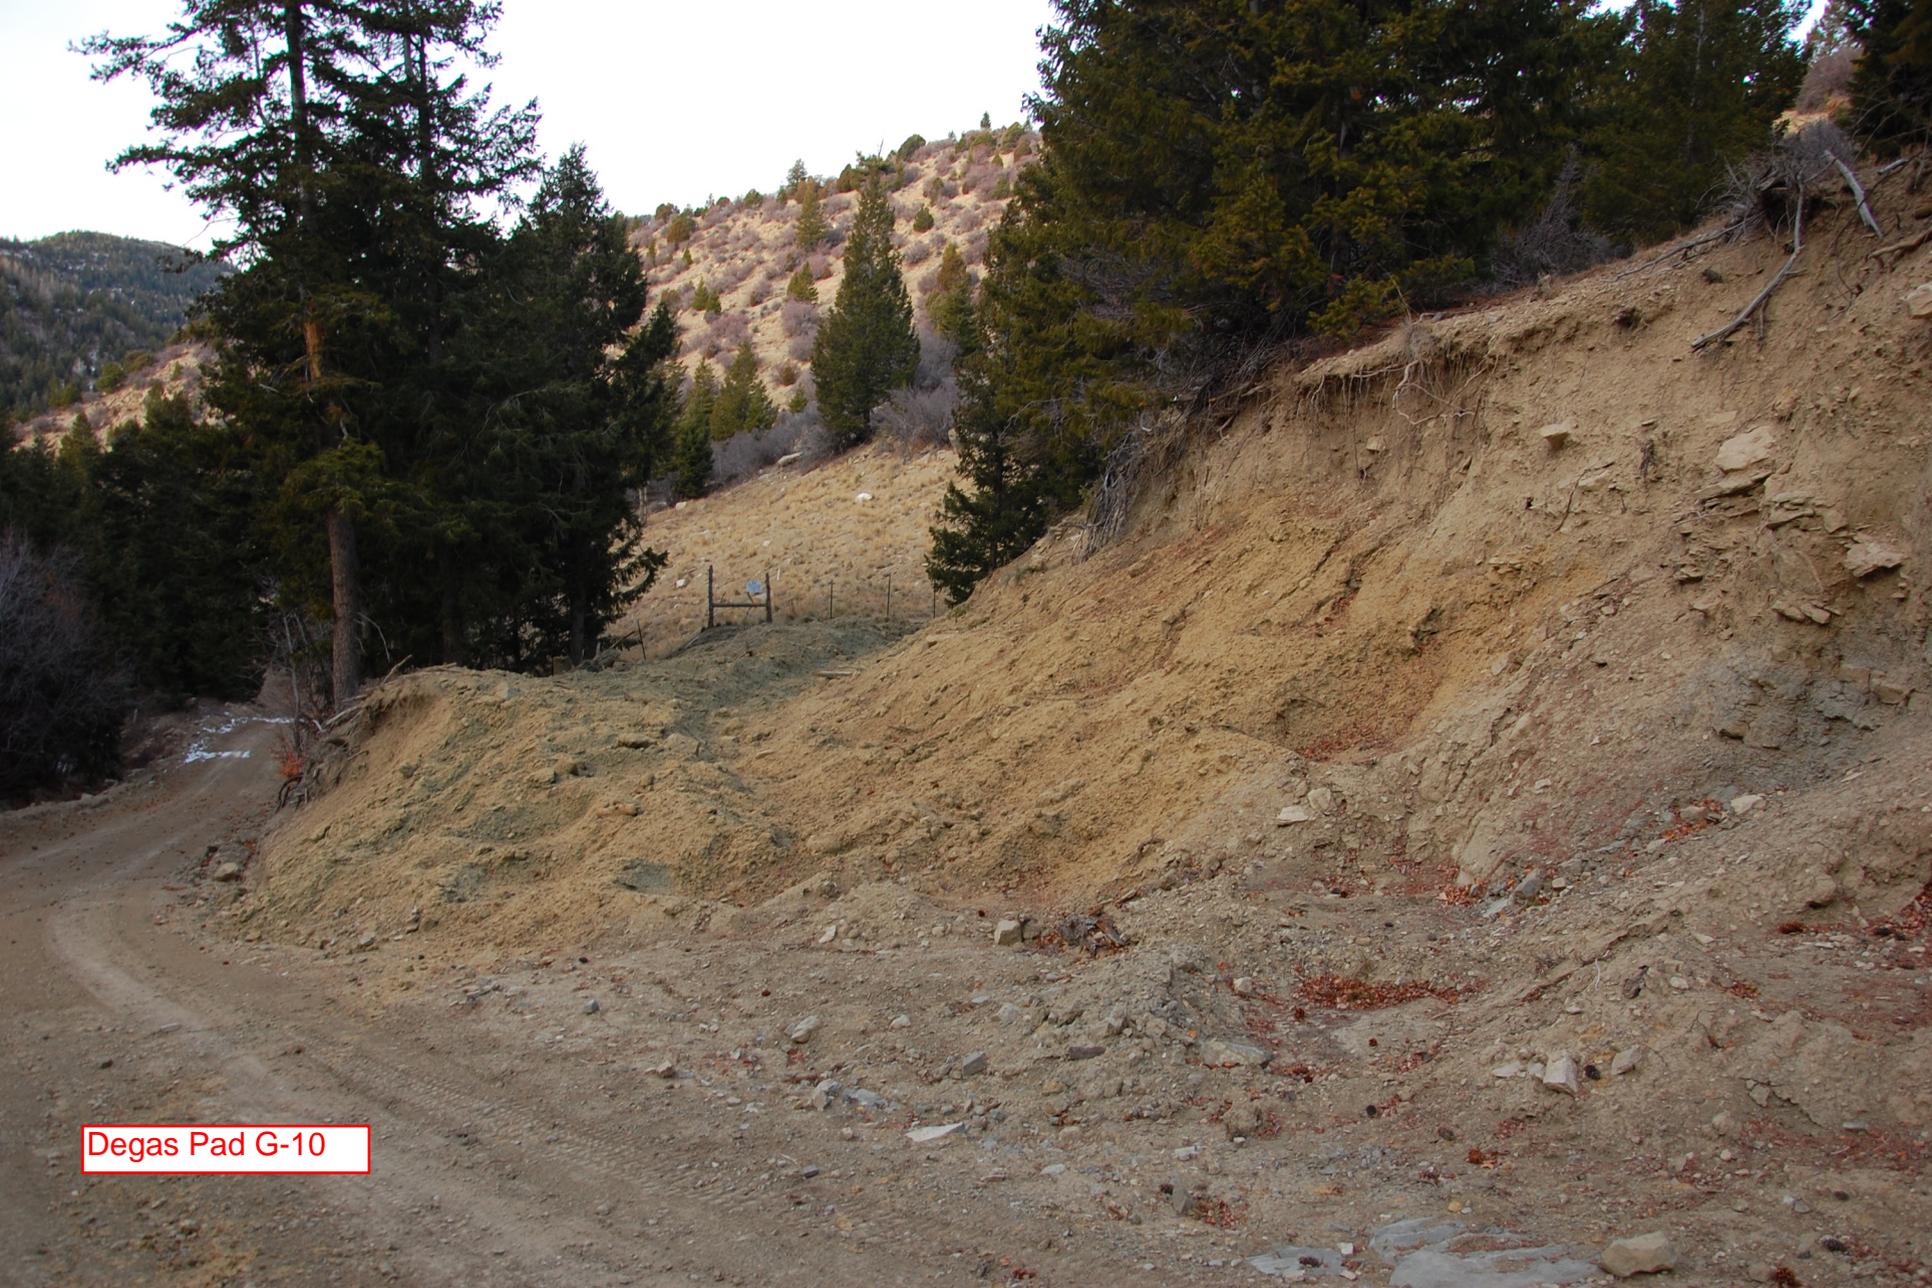
Degas Pad G-10

DG - 10. Most of the 2,344 cu yds stored for this site was replaced in 2011 during reclamation of the 1.7 acre pad. In the fall 2012, Thayn dispersed the small topsoil stockpile that remained on the former access road to DG 10. The topsoil was poked and seeded.

Site G-10: The site has been reclaimed. The approximate original contour has been re-established. In addition, the site has been seeded and pocked. A short diversion ditch (approximately 50' in length) is located adjacent to the site. The diversion conveys runoff from the pad site to the main access road ditch. The diversion has been lined with rip rap with a silt-fence installed at the outlet. The short access/spur road to the site has been reclaimed.

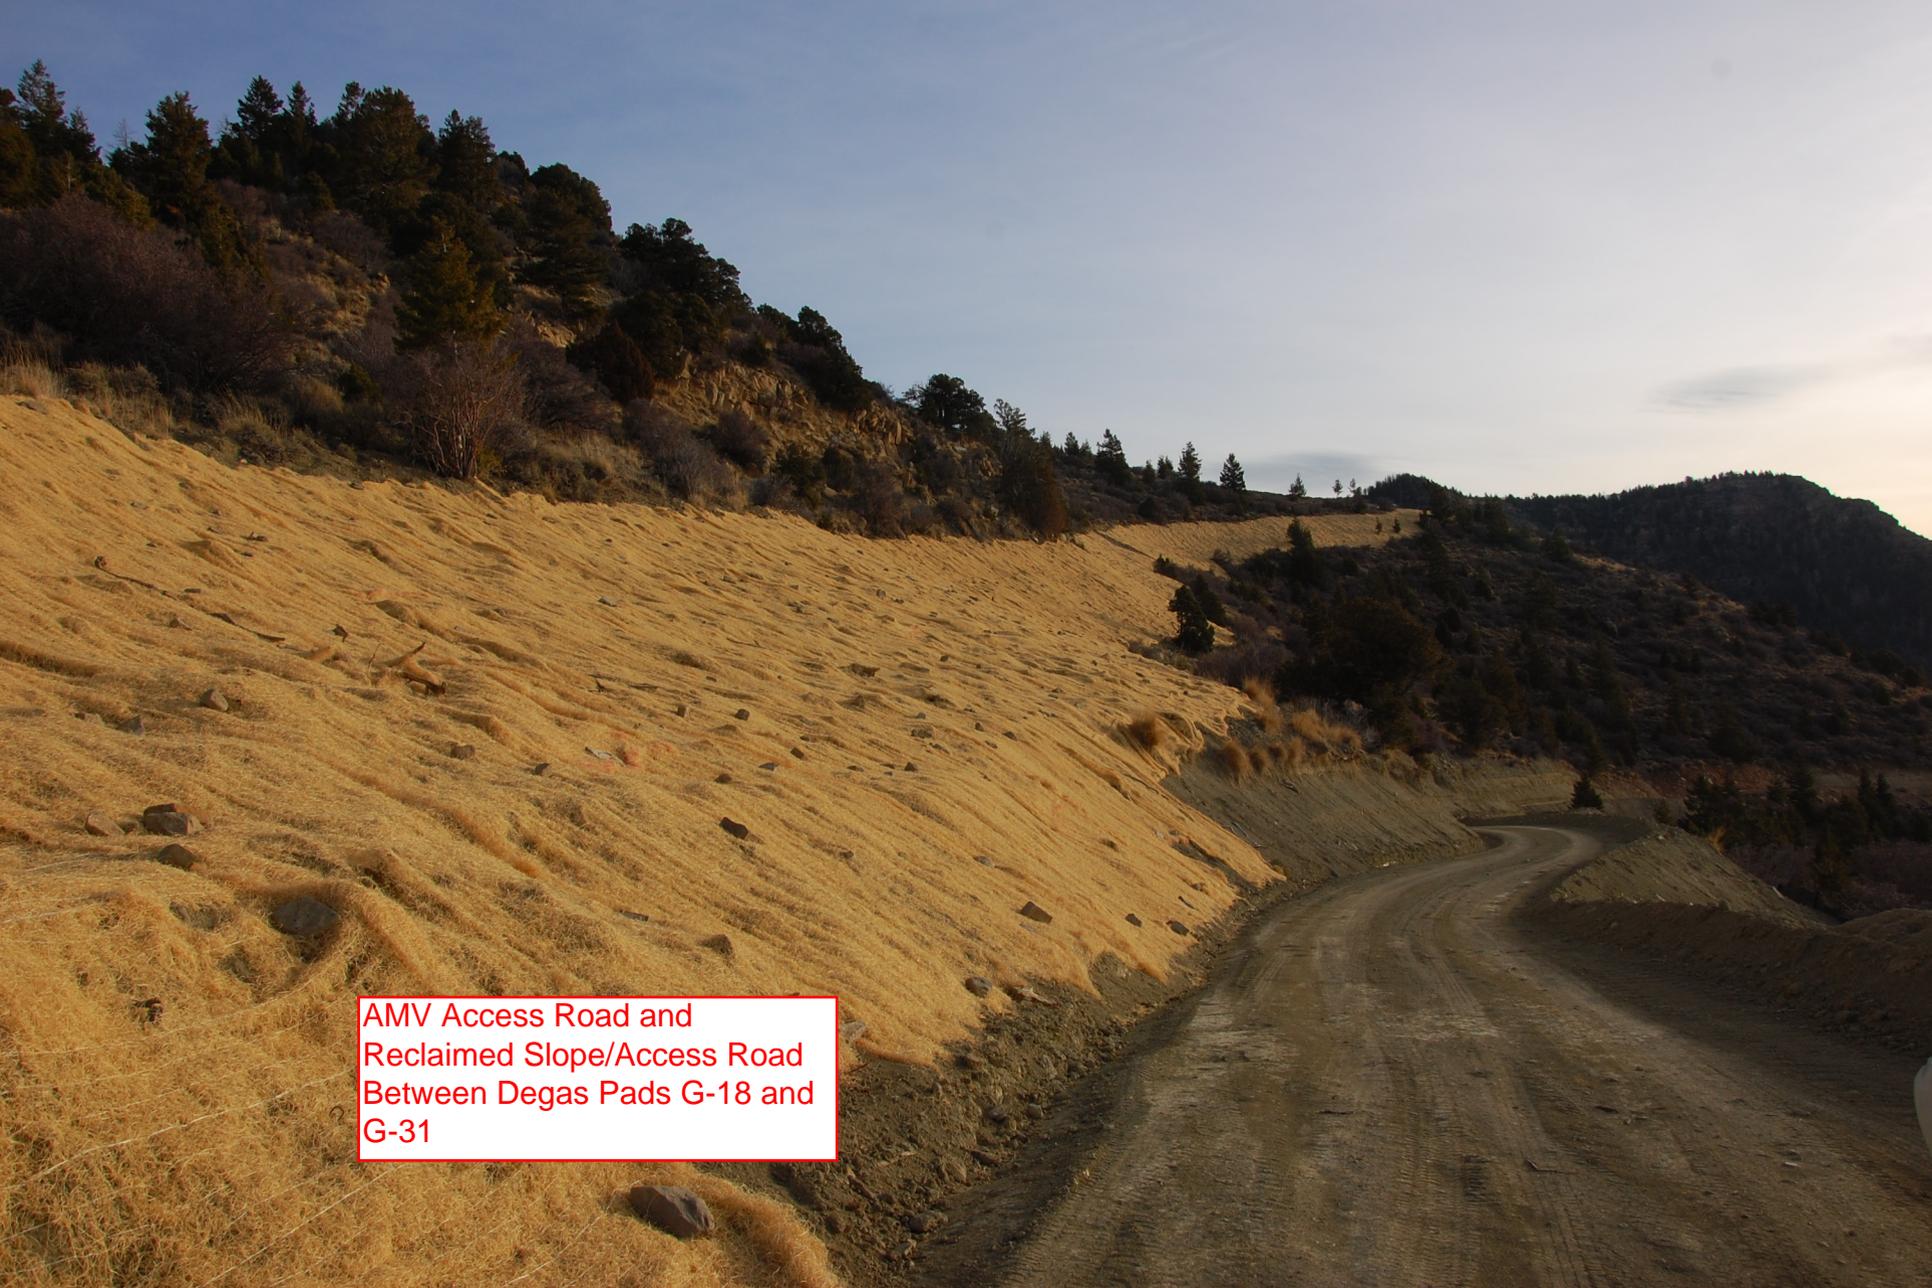
AMV Access Road and
Reclaimed Slope/Access Road
Between Degas Pads G-18 and
G-31

AMV access road between DG 31 and DG-18, 1300 ft. (0.24 miles), has been reclaimed to approximate original contour. An elevation change of 70 ft. v./100 ft h. (70% or 1.5v:1h) is illustrated for cross section 5+00. An elevation change of 50 ft vertical /100 ft horizontal (50% or 2v:1h) is illustrated for cross section 7+00. The slope length narrows to 30 ft. at each end of the reclaimed roadway. The reclaimed surface was not pocked, but was left smooth. The reclaimed road was hand seeded and covered with an excelsior blanket. The excelsior blanket was held down with stakes and rocks. One small 3 ft. section near G 18 had blown off from the surface. Other sections near G 18 were seen to be anchored to shrubs and so elevated will likely catch wind. Three drainages were constructed approximately 300 ft apart along the 1300 ft. length (see images) An as-built for the drainages and surface treatments on the reclaimed AMV road will be provided to the Division.

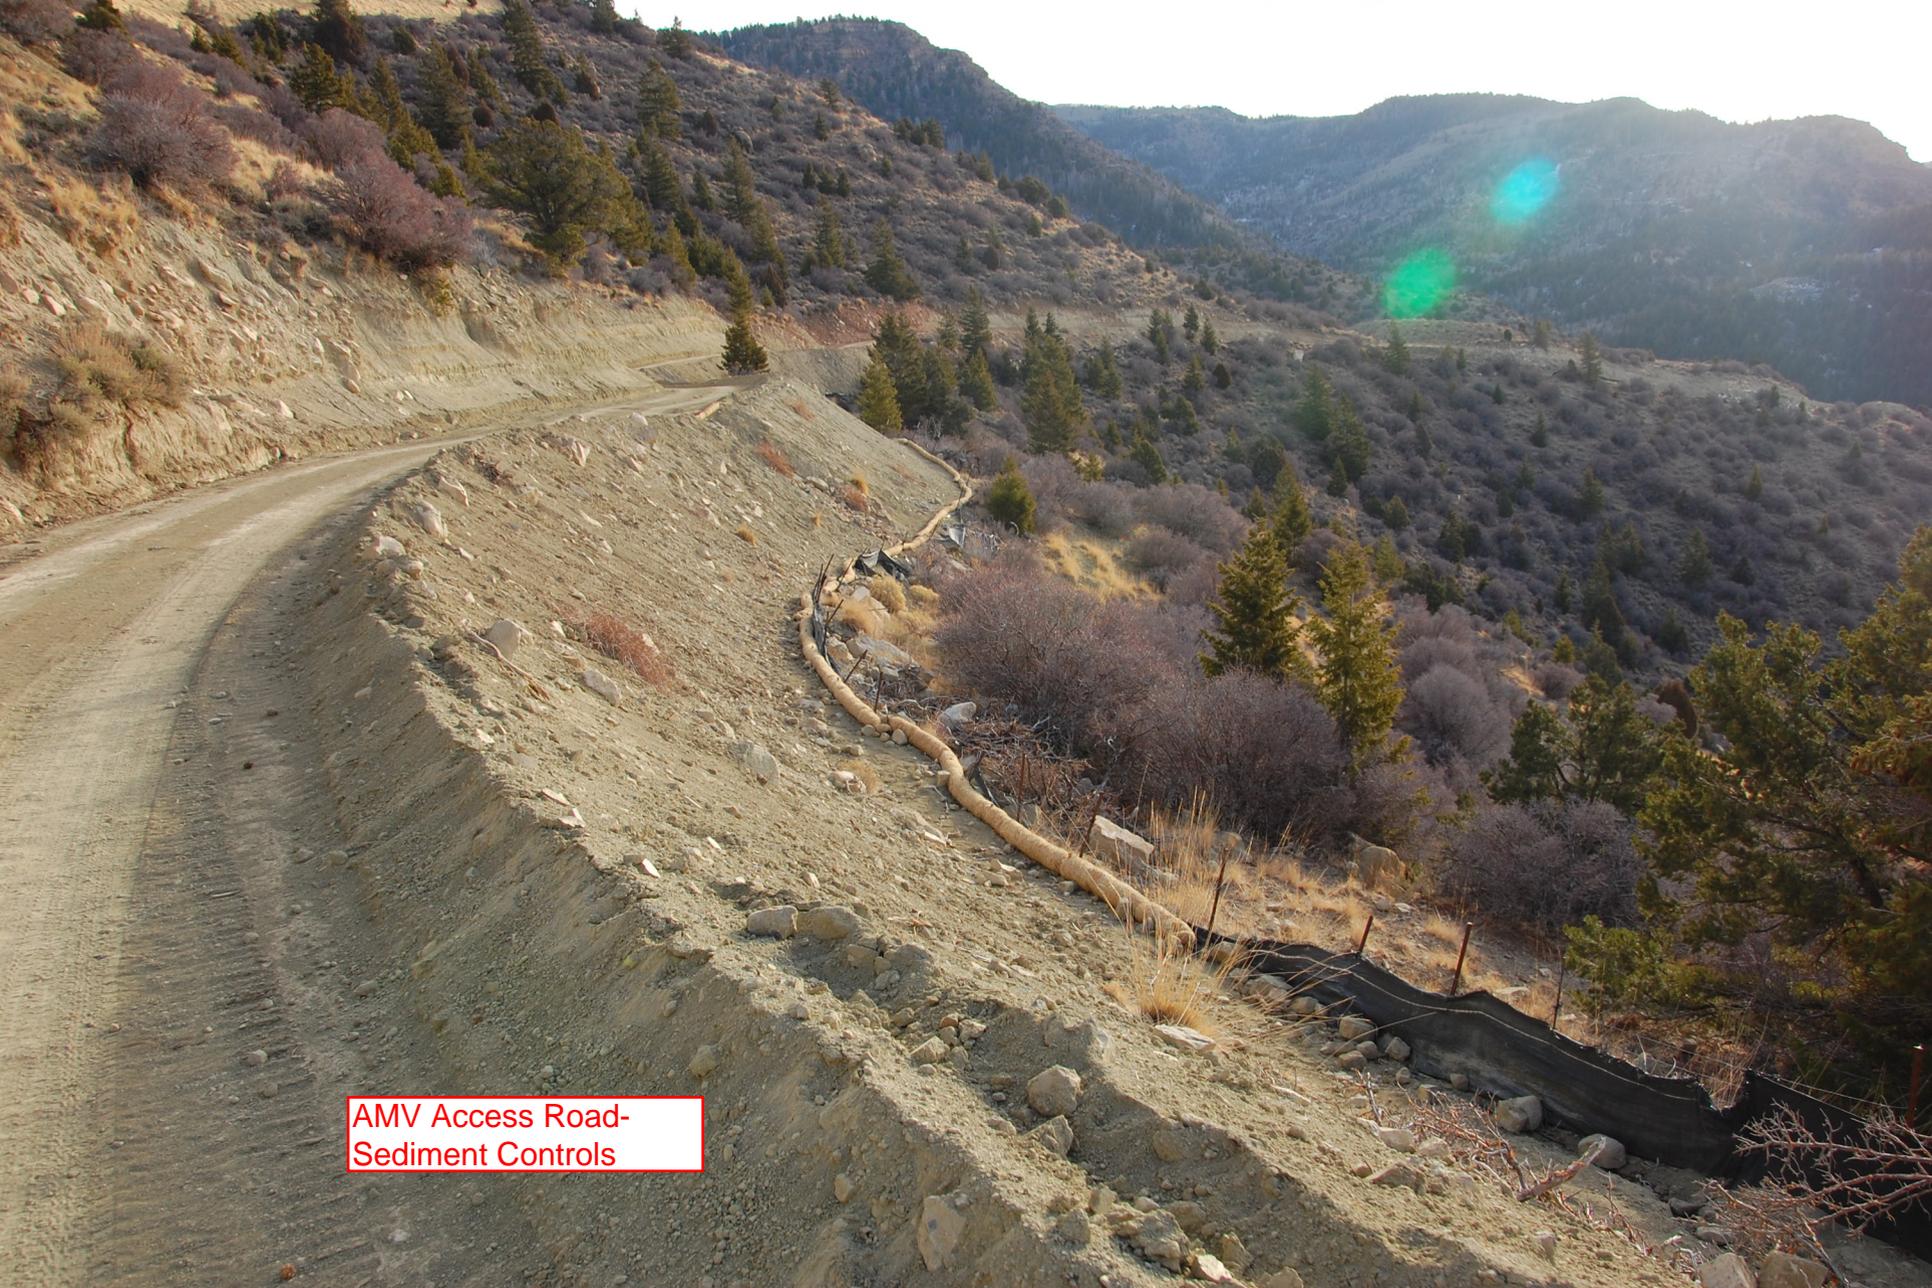
AMV Access Road-
Sediment Controls

The entire length of the remaining AMV access road was inspected. In order to prevent additional contributions of sediment outside the disturbed area, the Permittee utilizes silt fence and excelsior logs installed at the toe of the out-slope. A berm is located on the outside edge of the road. In addition, the road is graded towards the in-slope of the road prism at an approximately 2% grade in order to prevent storm water runoff from running over the out-slope. Water bars have been installed at increments along the entire length of the AMV access road.

During the last inspection of the road (08/01/2012), numerous areas were noted where the sediment control was in need of repair. The Permittee was directed to perform mandatory maintenance on the AMV road prior to the onset of winter. At the time of this inspection, sediment control had been re-established at the toe of the out-slope along the entire length of the road. In areas where the previously installed silt-fence had blown out, rows of excelsior logs have been installed. In addition, the road has been re-graded, the in-slope ditch cleaned out and the water-bars had been re-established with excelsior logs installed at both the inlets and outlets. The Division finds that the sediment controls have been adequately repaired on the AMV access road.

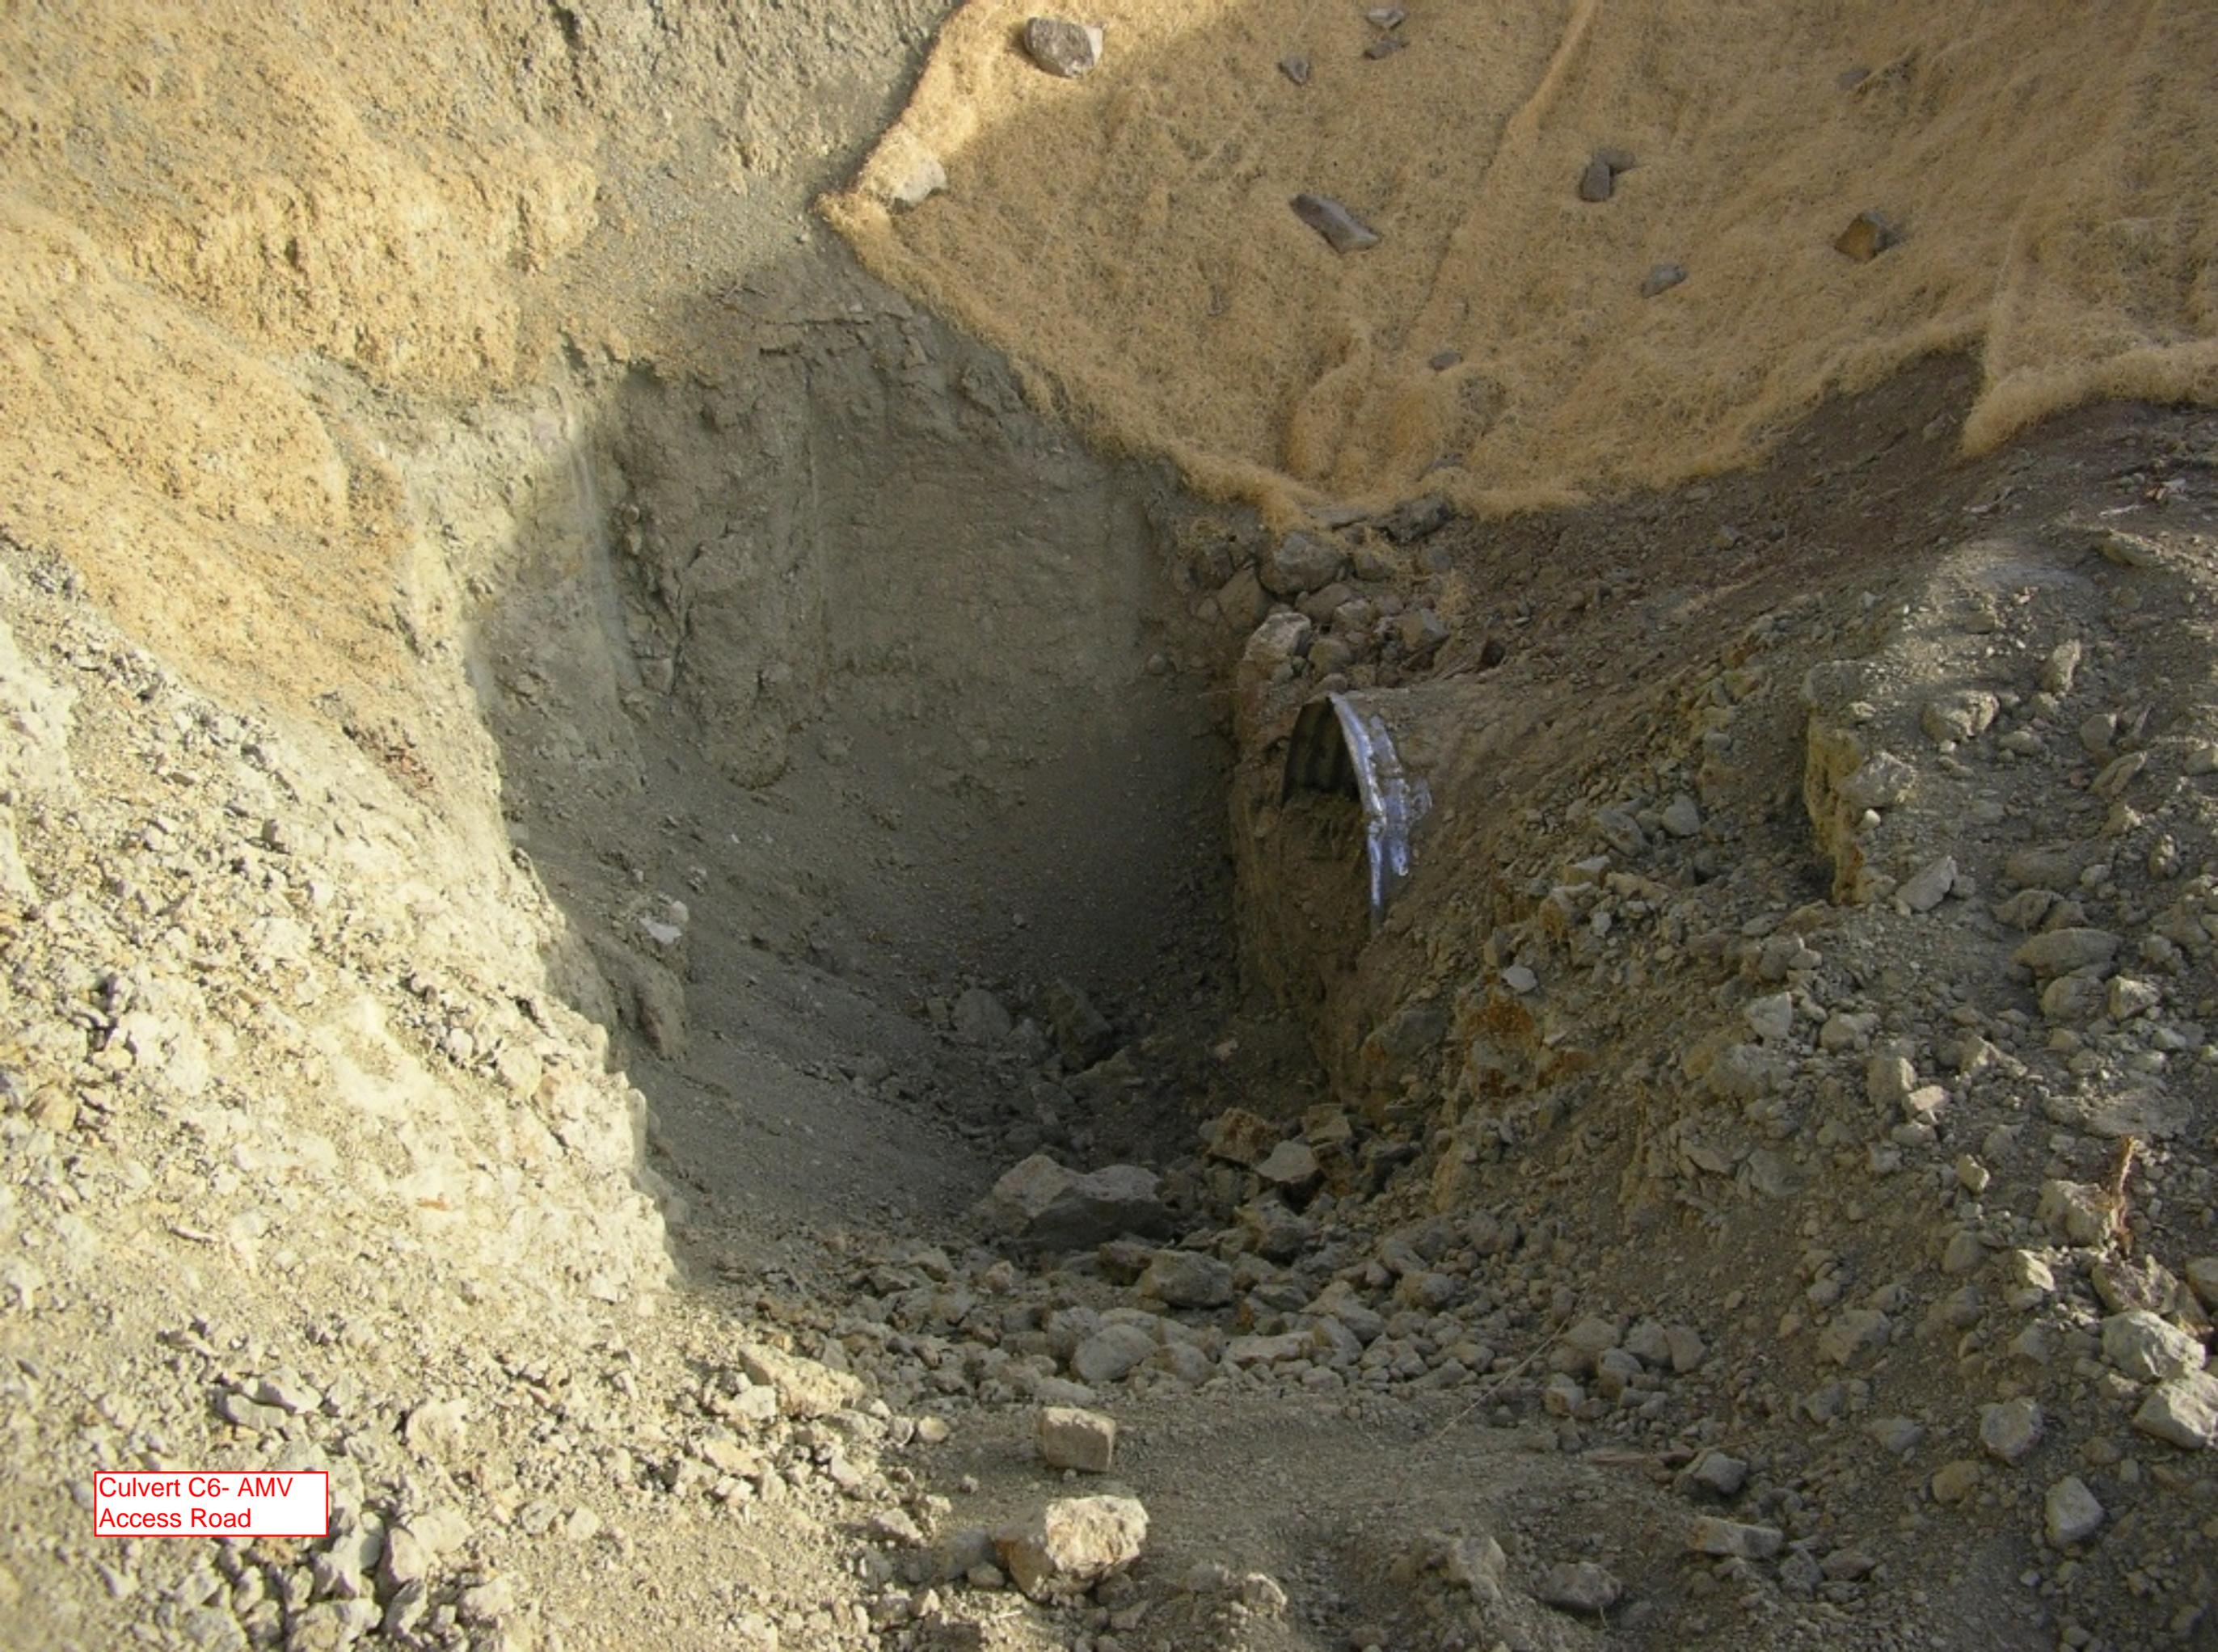
Culvert C6- AMV
Access Road

A large depression at the end of the reclaimed AMV road remains to funnel water to C-6. This depression will pool water before it flows into the culvert (see attached image).
