Inspection Report

Permit Number:	C0070039
Inspection Type:	PARTIAL
Inspection Date:	Thursday, November 29, 2012
Start Date/Time:	11/29/2012 7:00:00 AM
End Date/Time:	11/29/2012 12:30:00 PM
Last Inspection:	Thursday, November 15, 2012

Permitee: **CANYON FUEL COMPANY**
 Operator: **CANYON FUEL COMPANY**
 Site: **DUGOUT CANYON MINE**
 Address: **PO BOX 1029, WELLINGTON UT 84542**
 County: **CARBON**
 Permit Type: **PERMANENT COAL PROGRAM**
 Permit Status: **ACTIVE**

On November 29th, 2012, Division of Oil, Gas and Mining (the Division) staff conducted a field inspection of recently conducted reclamation work on gob gas vent holes and associated access roads at the Dugout Canyon Mine.

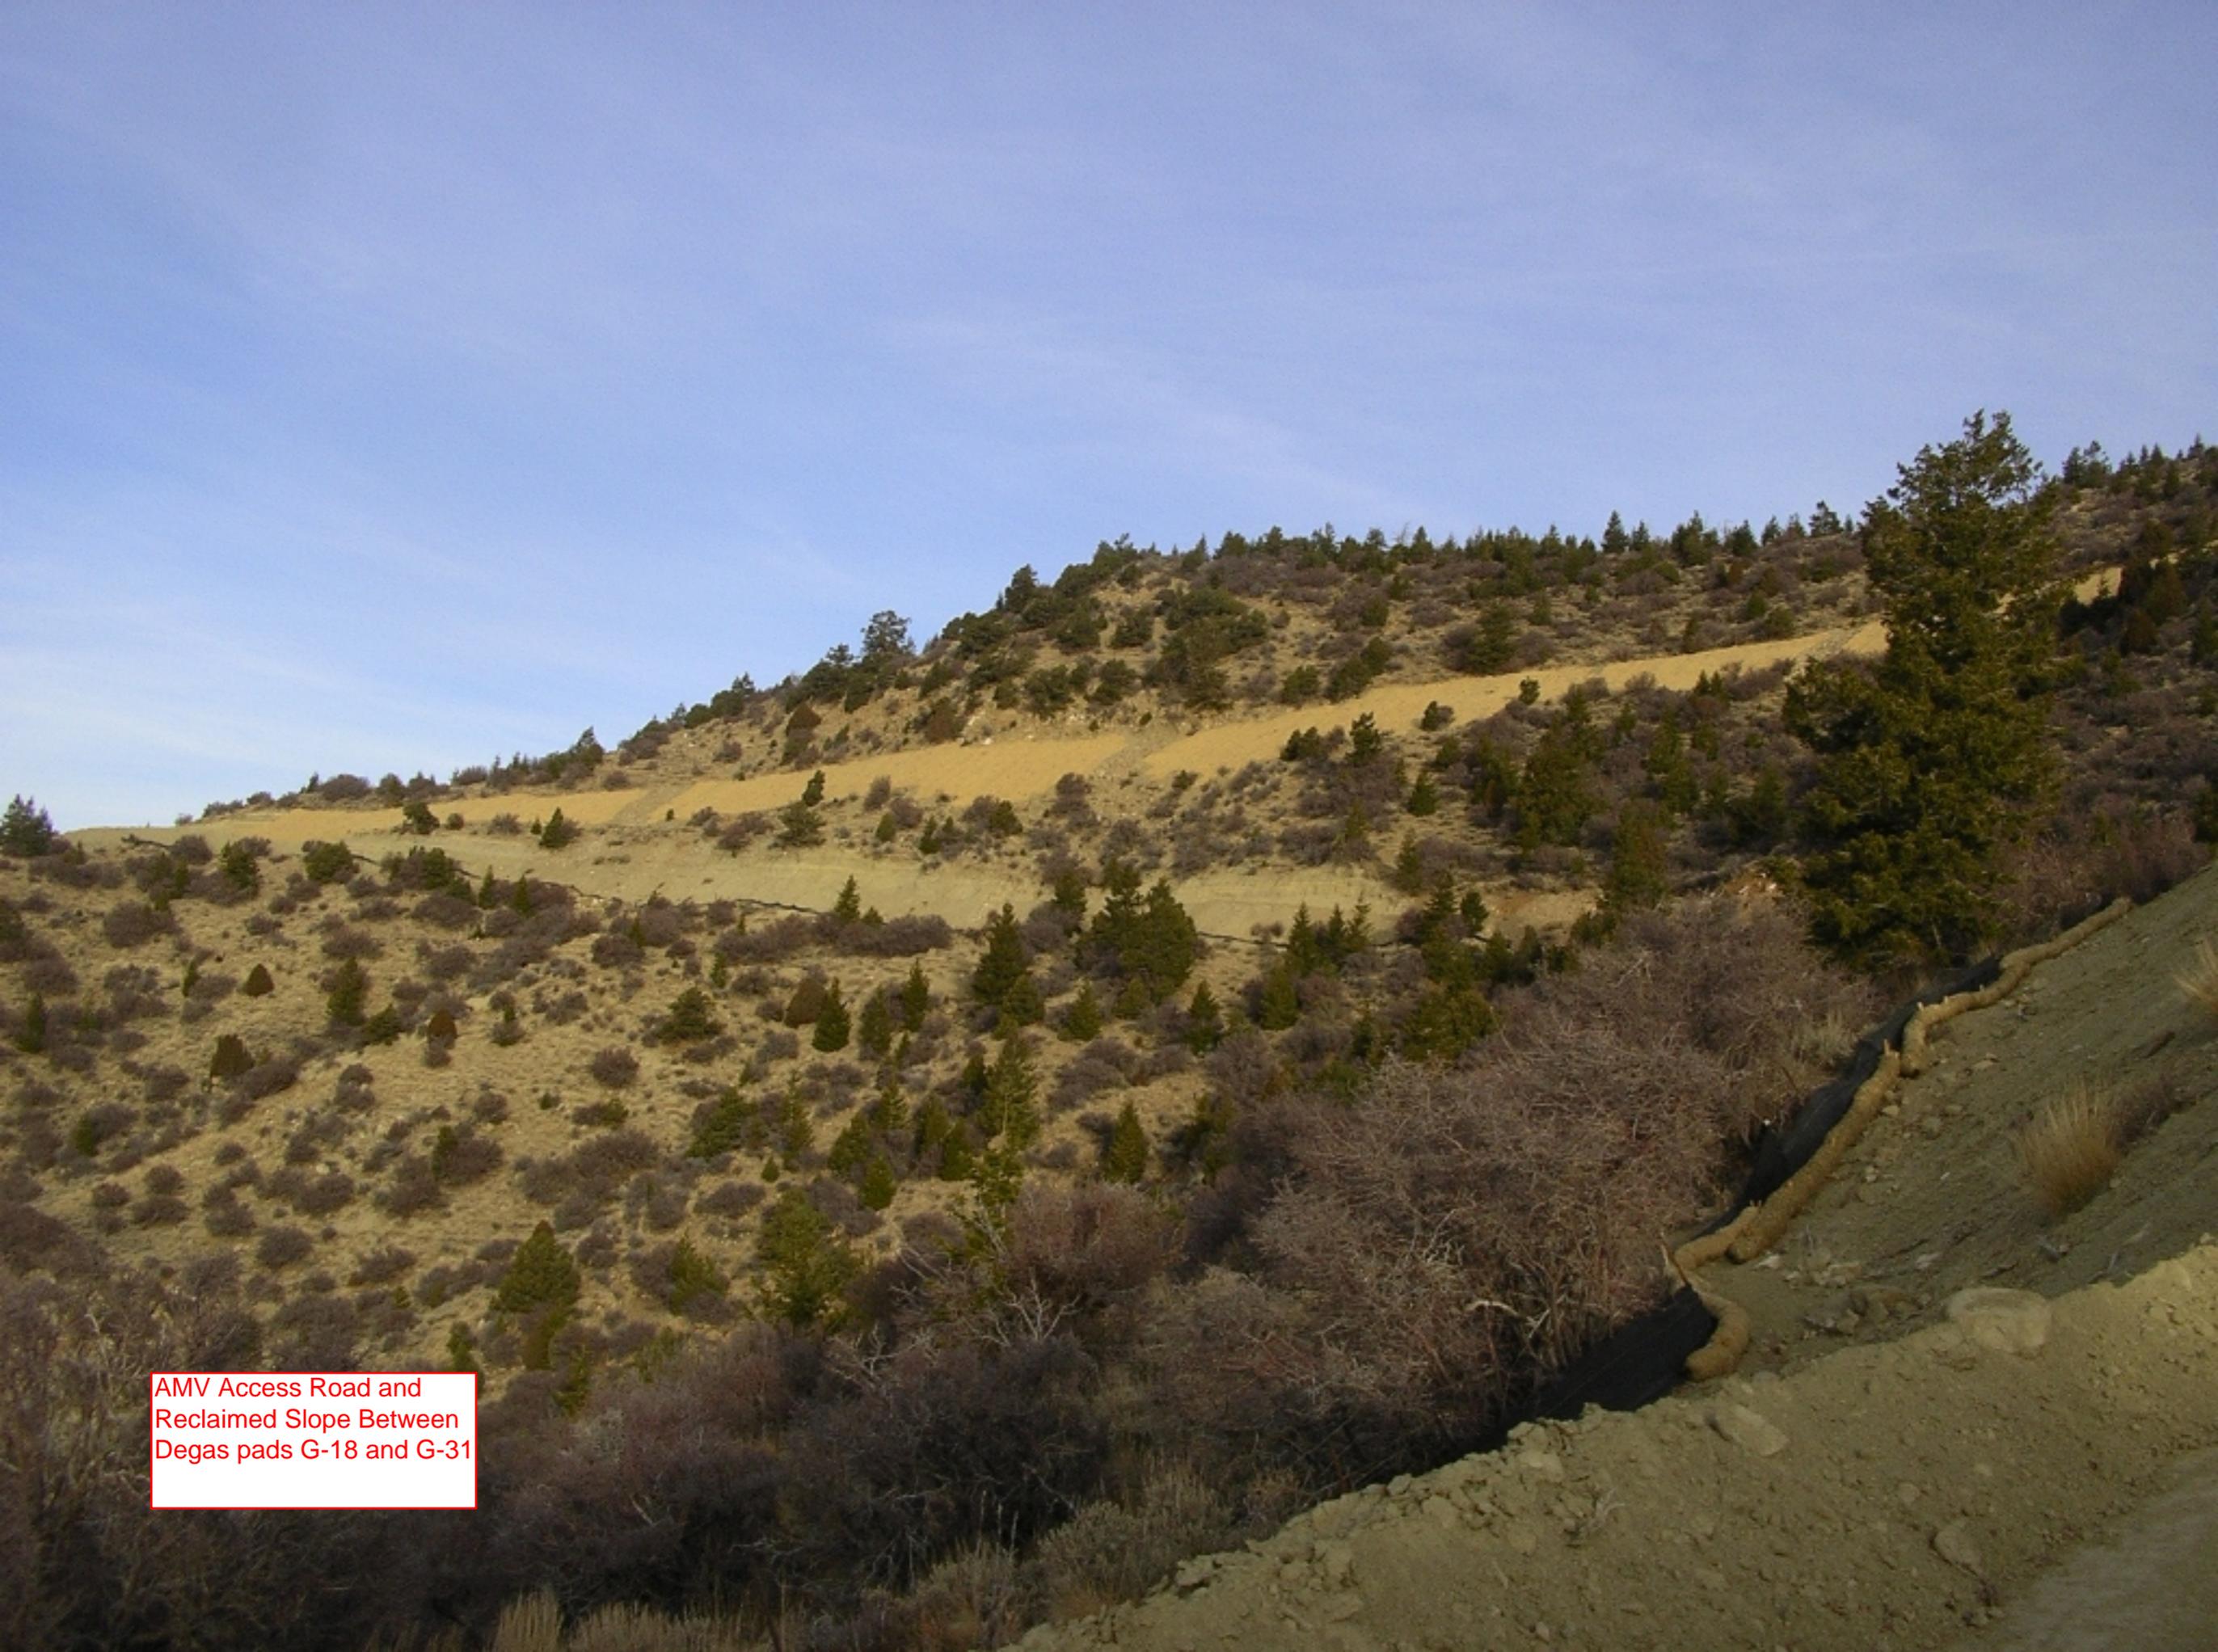
AMV Access Road and
Reclaimed Slope Between
Degas pads G-18 and G-31

AMV access road between DG 31 and DG-18, 1300 ft. (0.24 miles), has been reclaimed to approximate original contour. An elevation change of 70 ft. v./100 ft h. (70% or 1.5v:1h) is illustrated for cross section 5+00. An elevation change of 50 ft vertical /100 ft horizontal (50% or 2v:1h) is illustrated for cross section 7+00. The slope length narrows to 30 ft. at each end of the reclaimed roadway. The reclaimed surface was not pocked, but was left smooth. The reclaimed road was hand seeded and covered with an excelsior blanket. The excelsior blanket was held down with stakes and rocks. One small 3 ft. section near G 18 had blown off from the surface. Other sections near G 18 were seen to be anchored to shrubs and so elevated will likely catch wind. Three drainages were constructed approximately 300 ft apart along the 1300 ft. length (see images) An as-built for the drainages and surface treatments on the reclaimed AMV road will be provided to the Division.

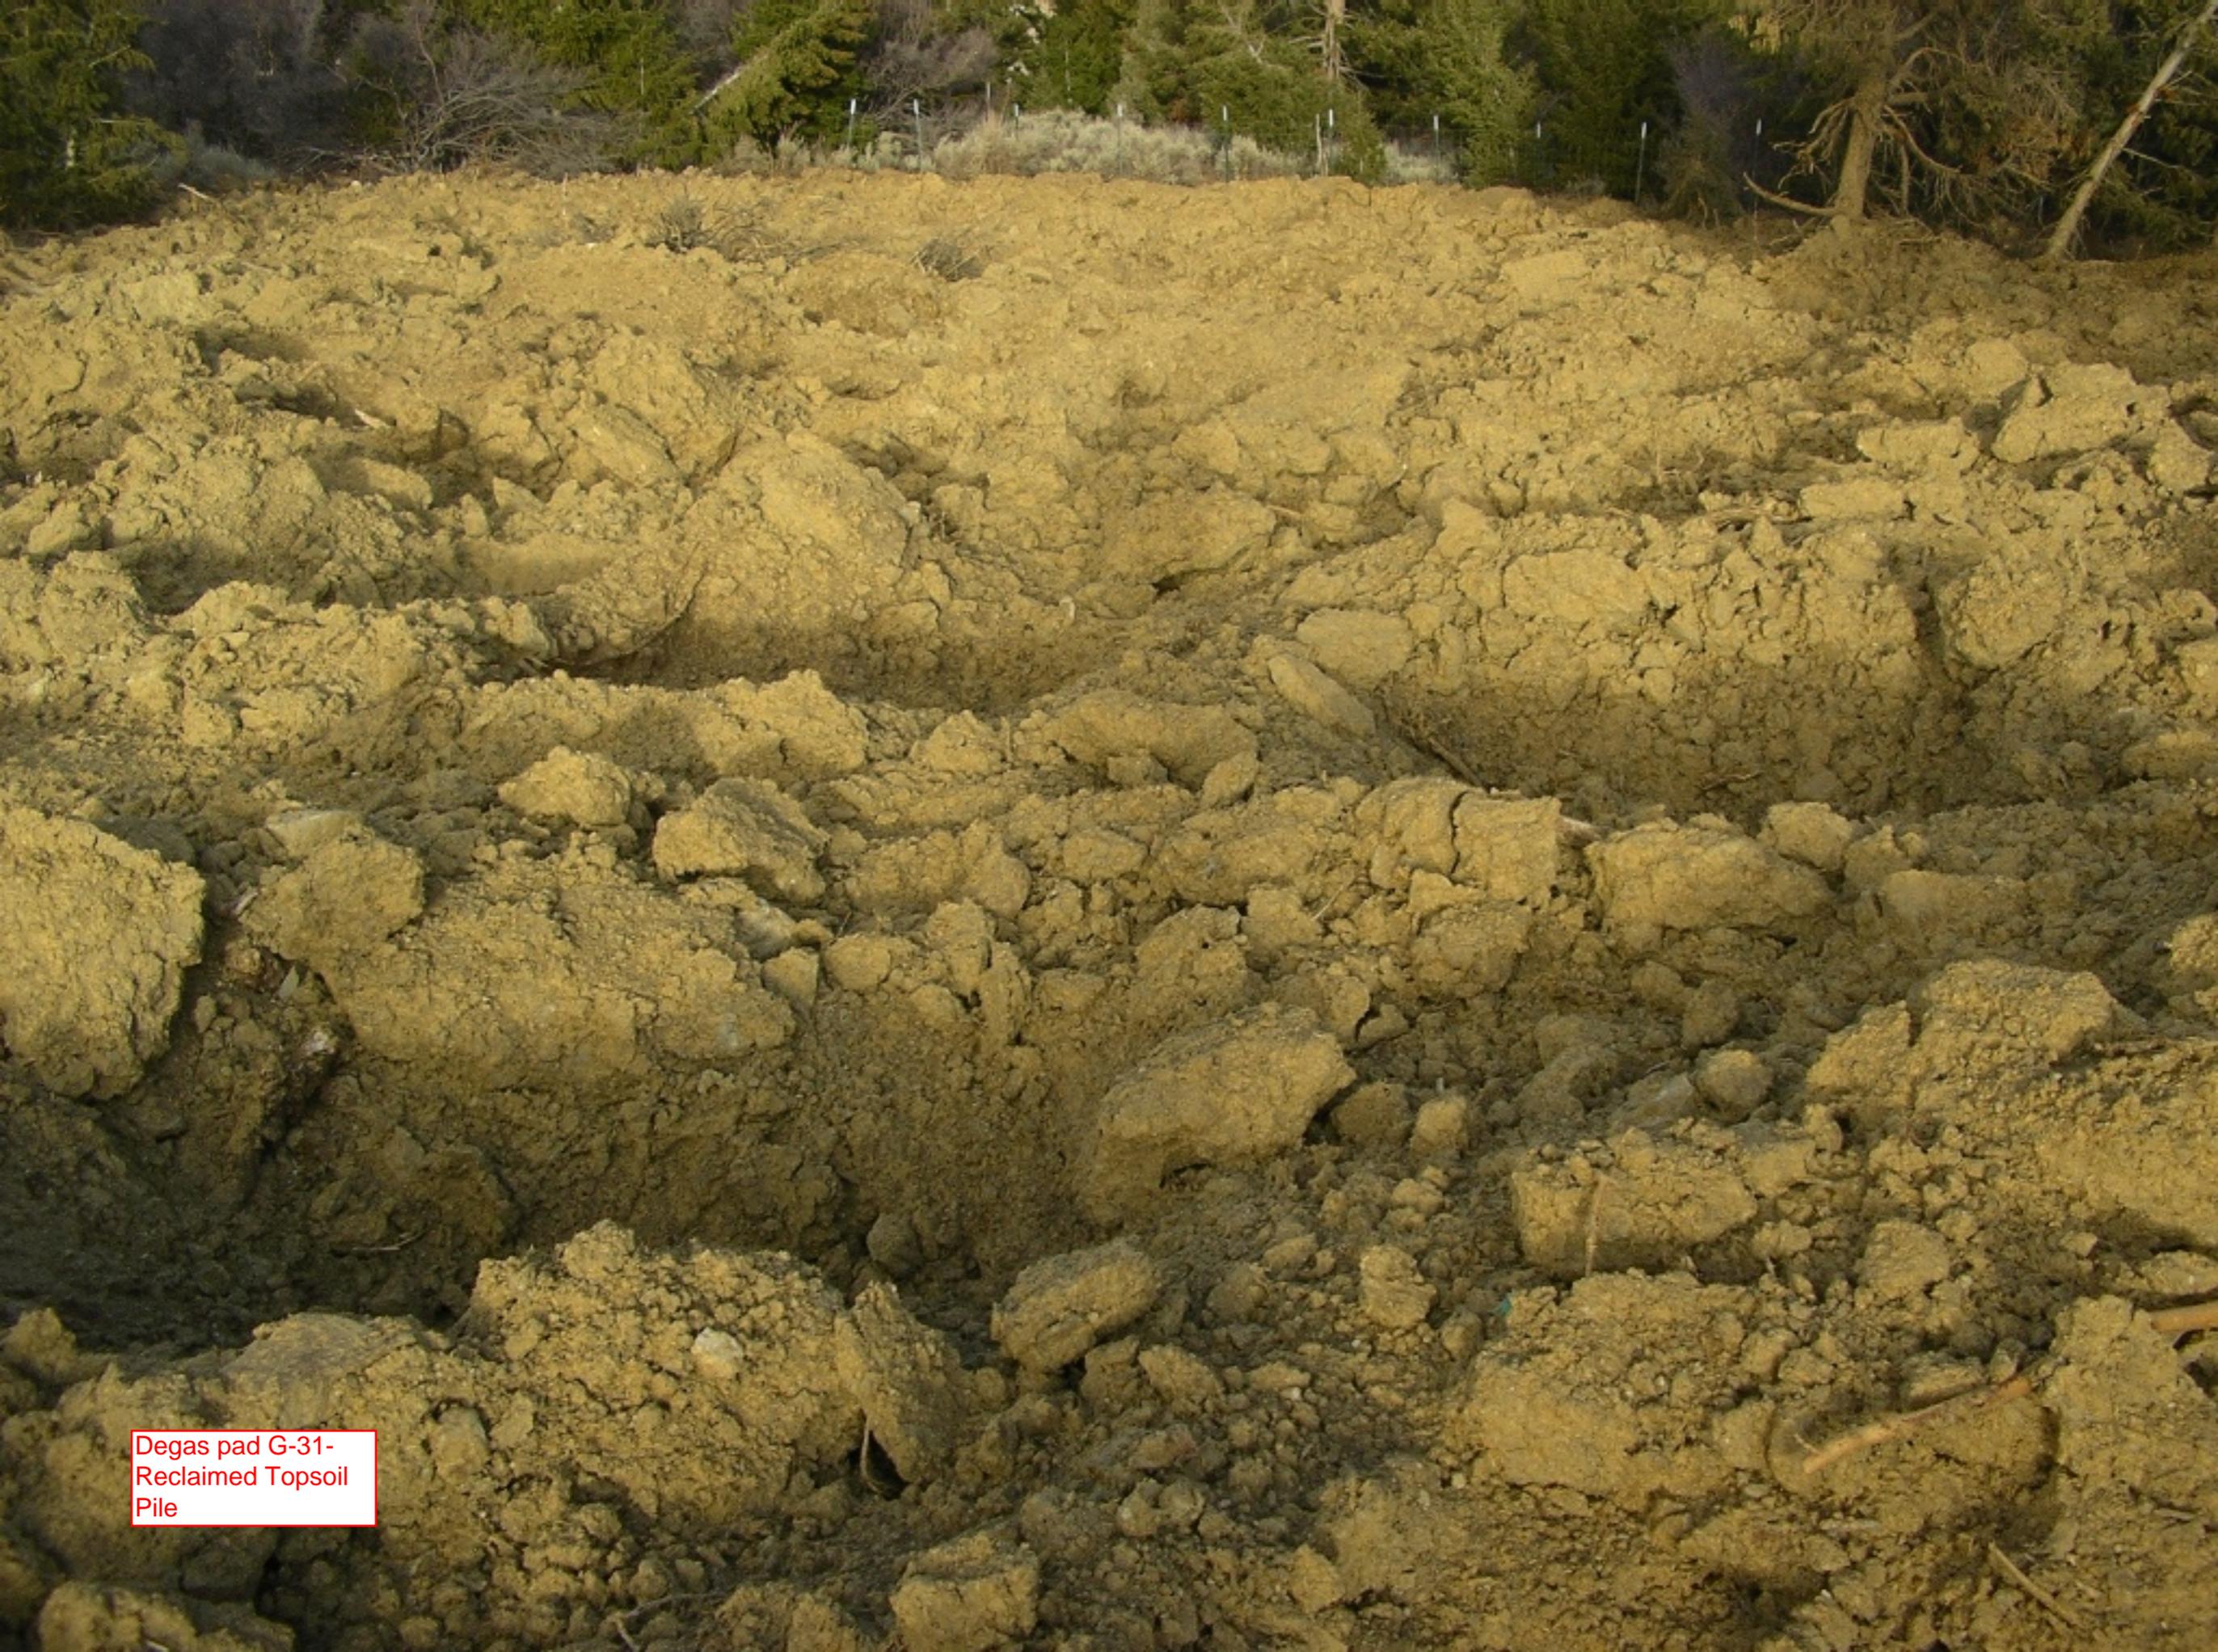
Degas pad G-31-
Reclaimed Topsoil
Pile

DG 31. Topsoil piles T-8 and T-9, containing 4,624 cu yds were replaced over 1.75 acres of site G-31. Replacement depth calculates to 19 inches, but was not replaced over the topsoil stockpile area. Estimated replacement depth in Table 2-3 is 15 inches over the site.

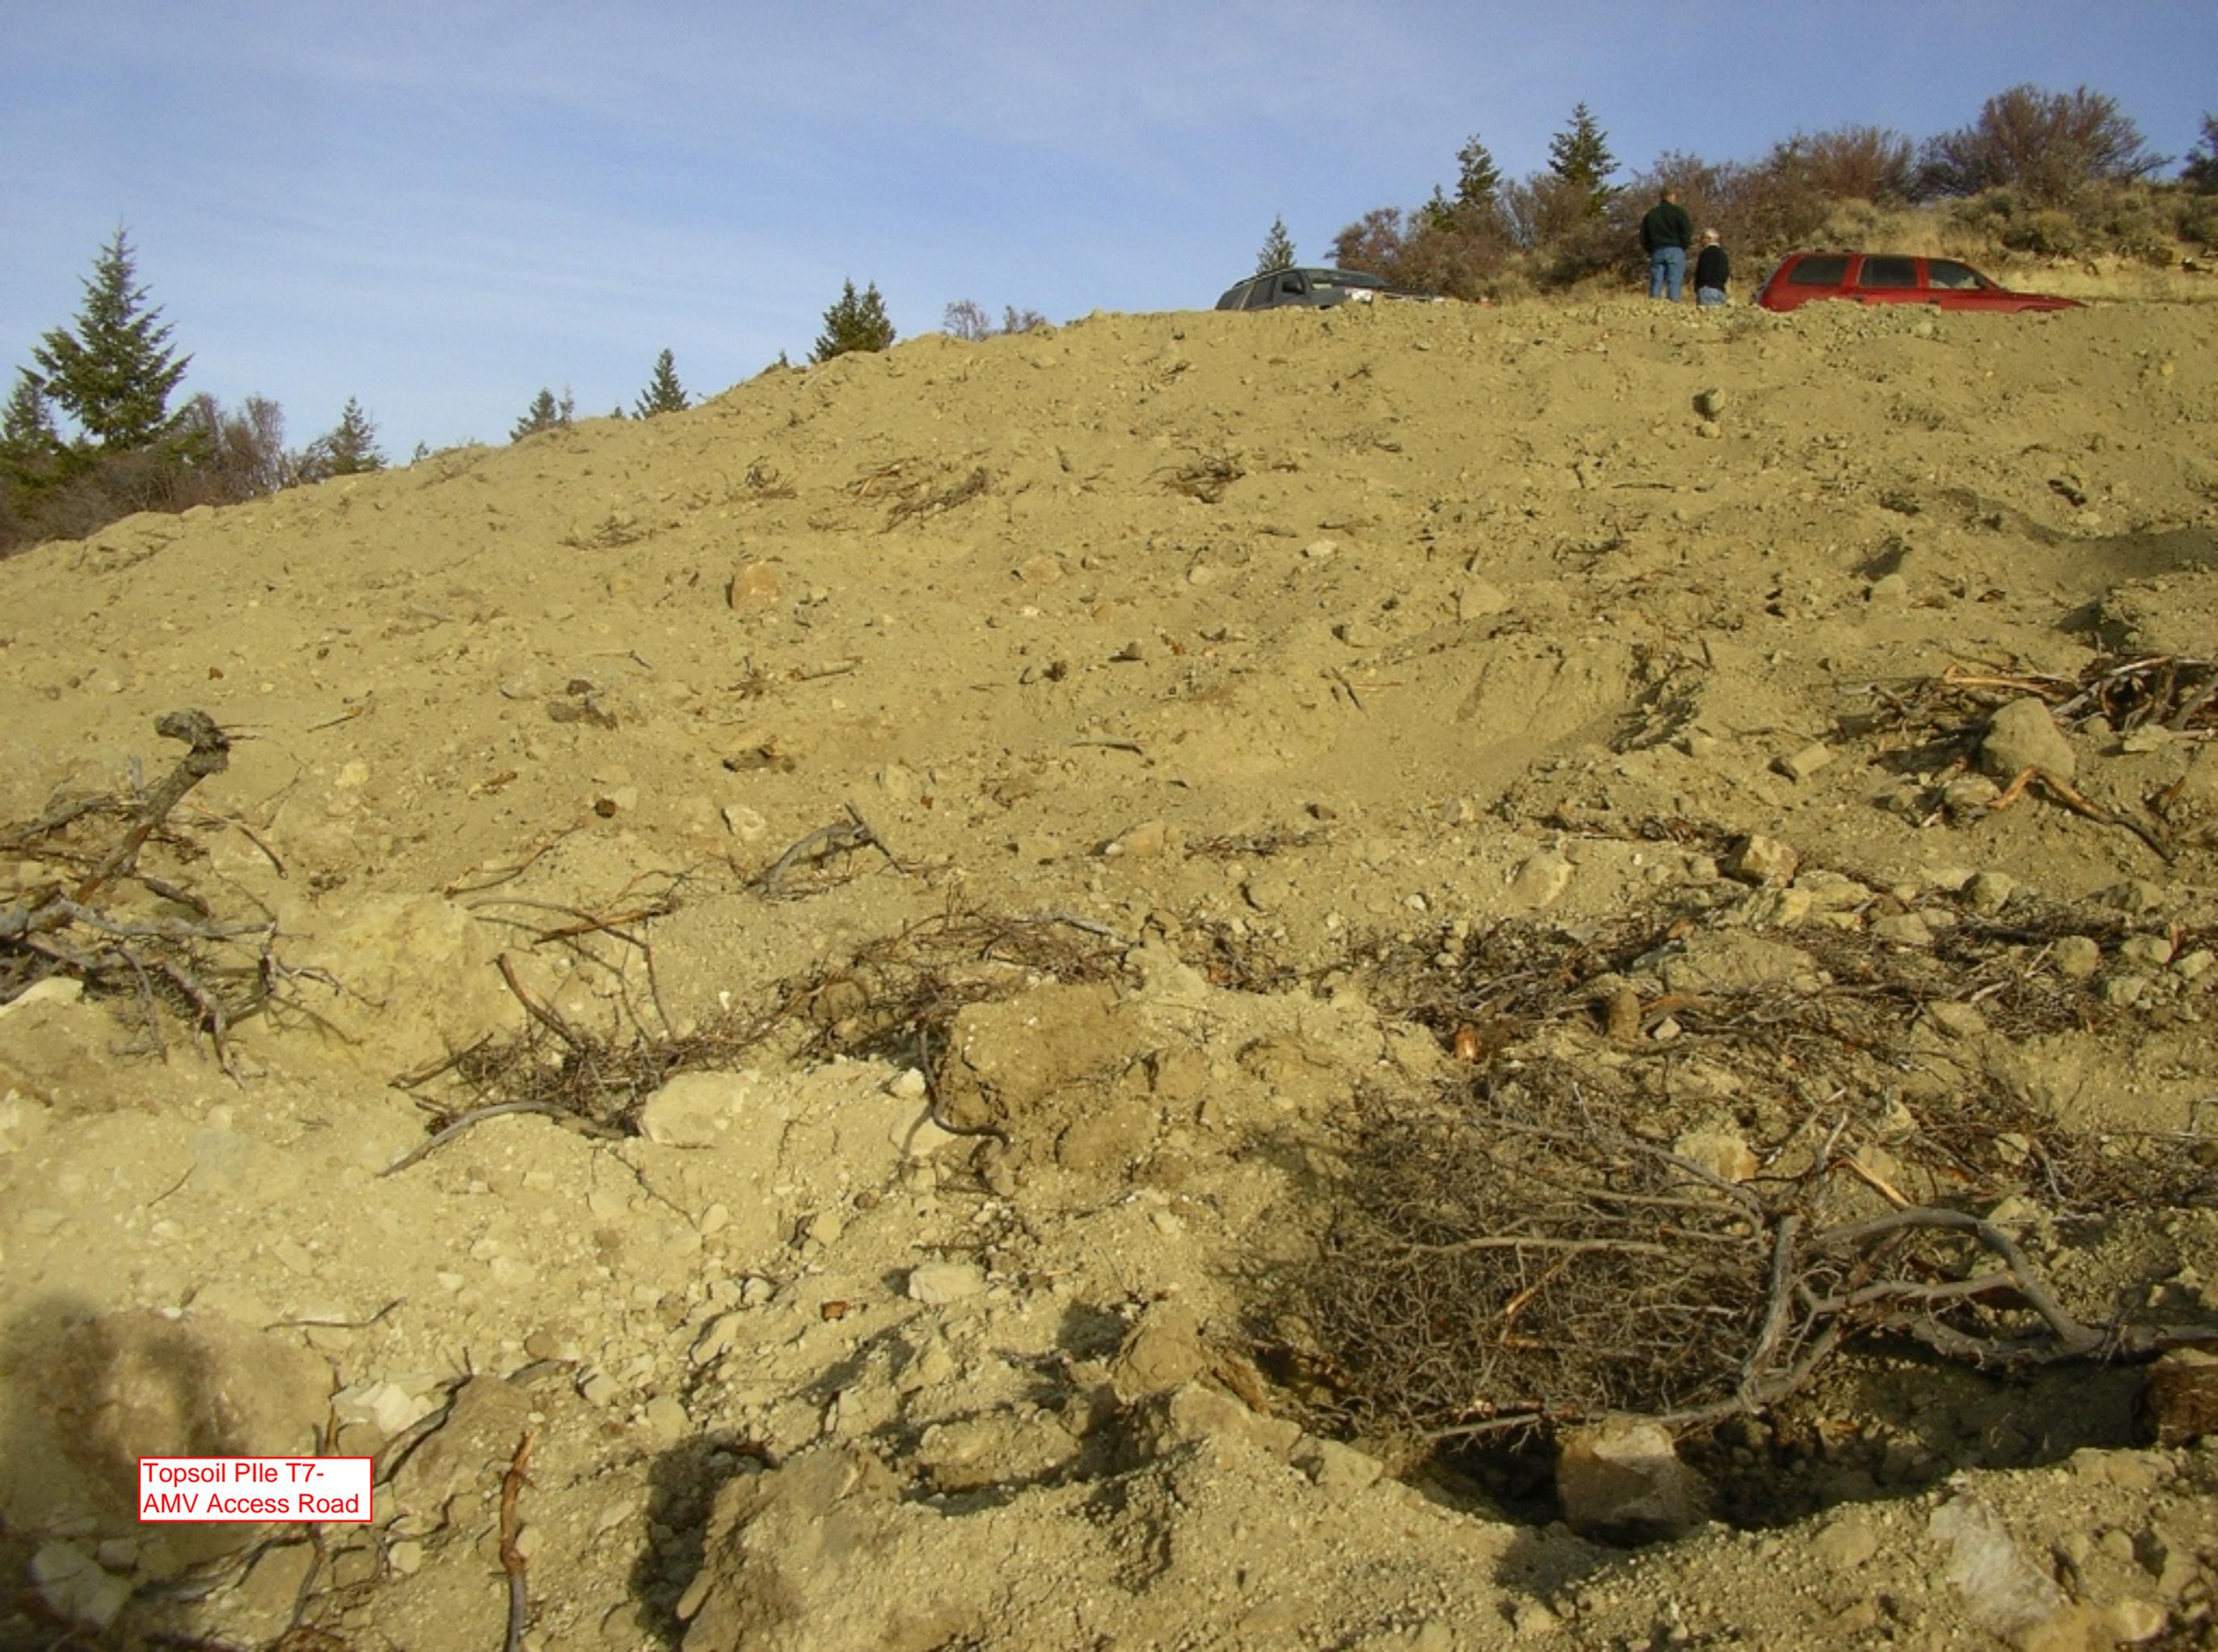
Topsoil Pile T7-
AMV Access Road

AMV road from G 31 to G 18. Topsoil pile STP-7 containing 4,305 cu yd (yardage specified in Attachment 2-2) was replaced on the 1300 ft. length of AMV road reclaimed in 2012. The area of replacement was calculated to be 110,000 sq ft from Plate 1, Attachment 5-4. This calculates to a one foot replacement depth in agreement with Table 2-3.

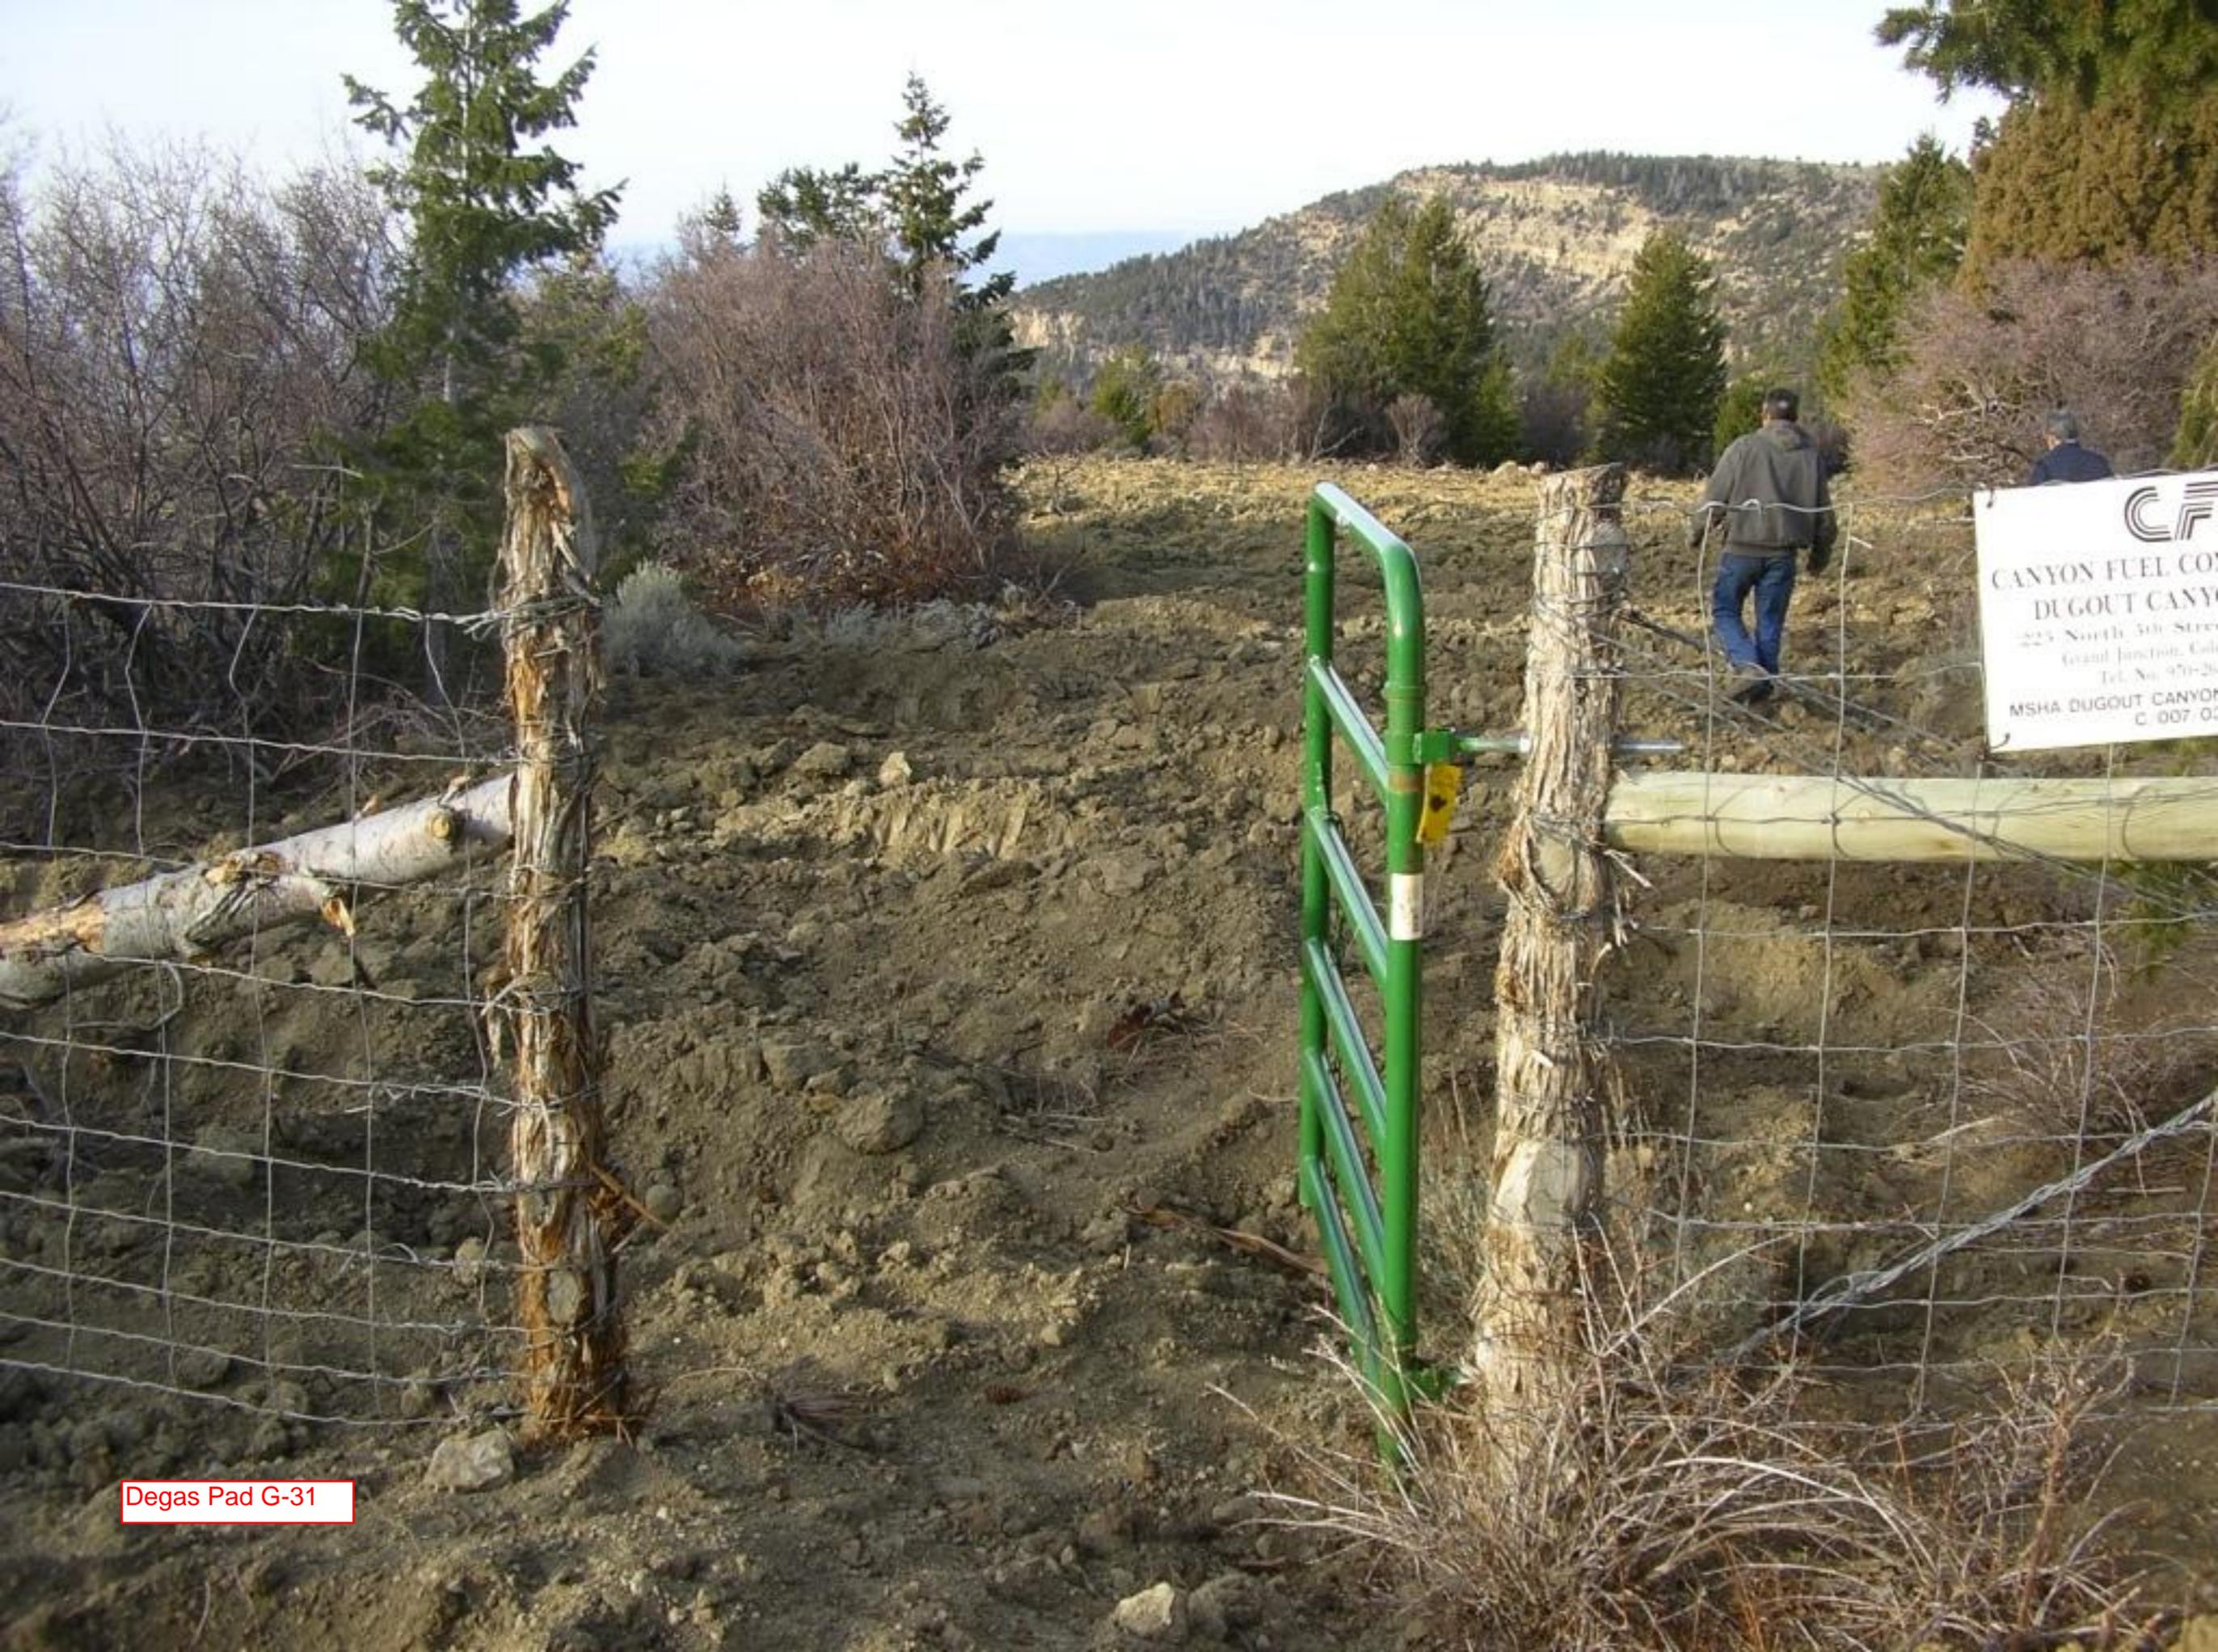
Degas Pad G-31

DG-31, 1.75 acres, fenced. Site 31 graded and is relatively level. The site and associated topsoil stockpiles were surface roughened, hand seeded and hydromulched. The center of the site was not hydrosprayed (mulched) as it was retained for hydrotruck access and was reclaimed after mulching. Mulch coverage looks thin at the center of the site and is heavier at the outer edges of the site. The spur road access off of the AMV road was surface roughened, hand seeded, but not mulched.

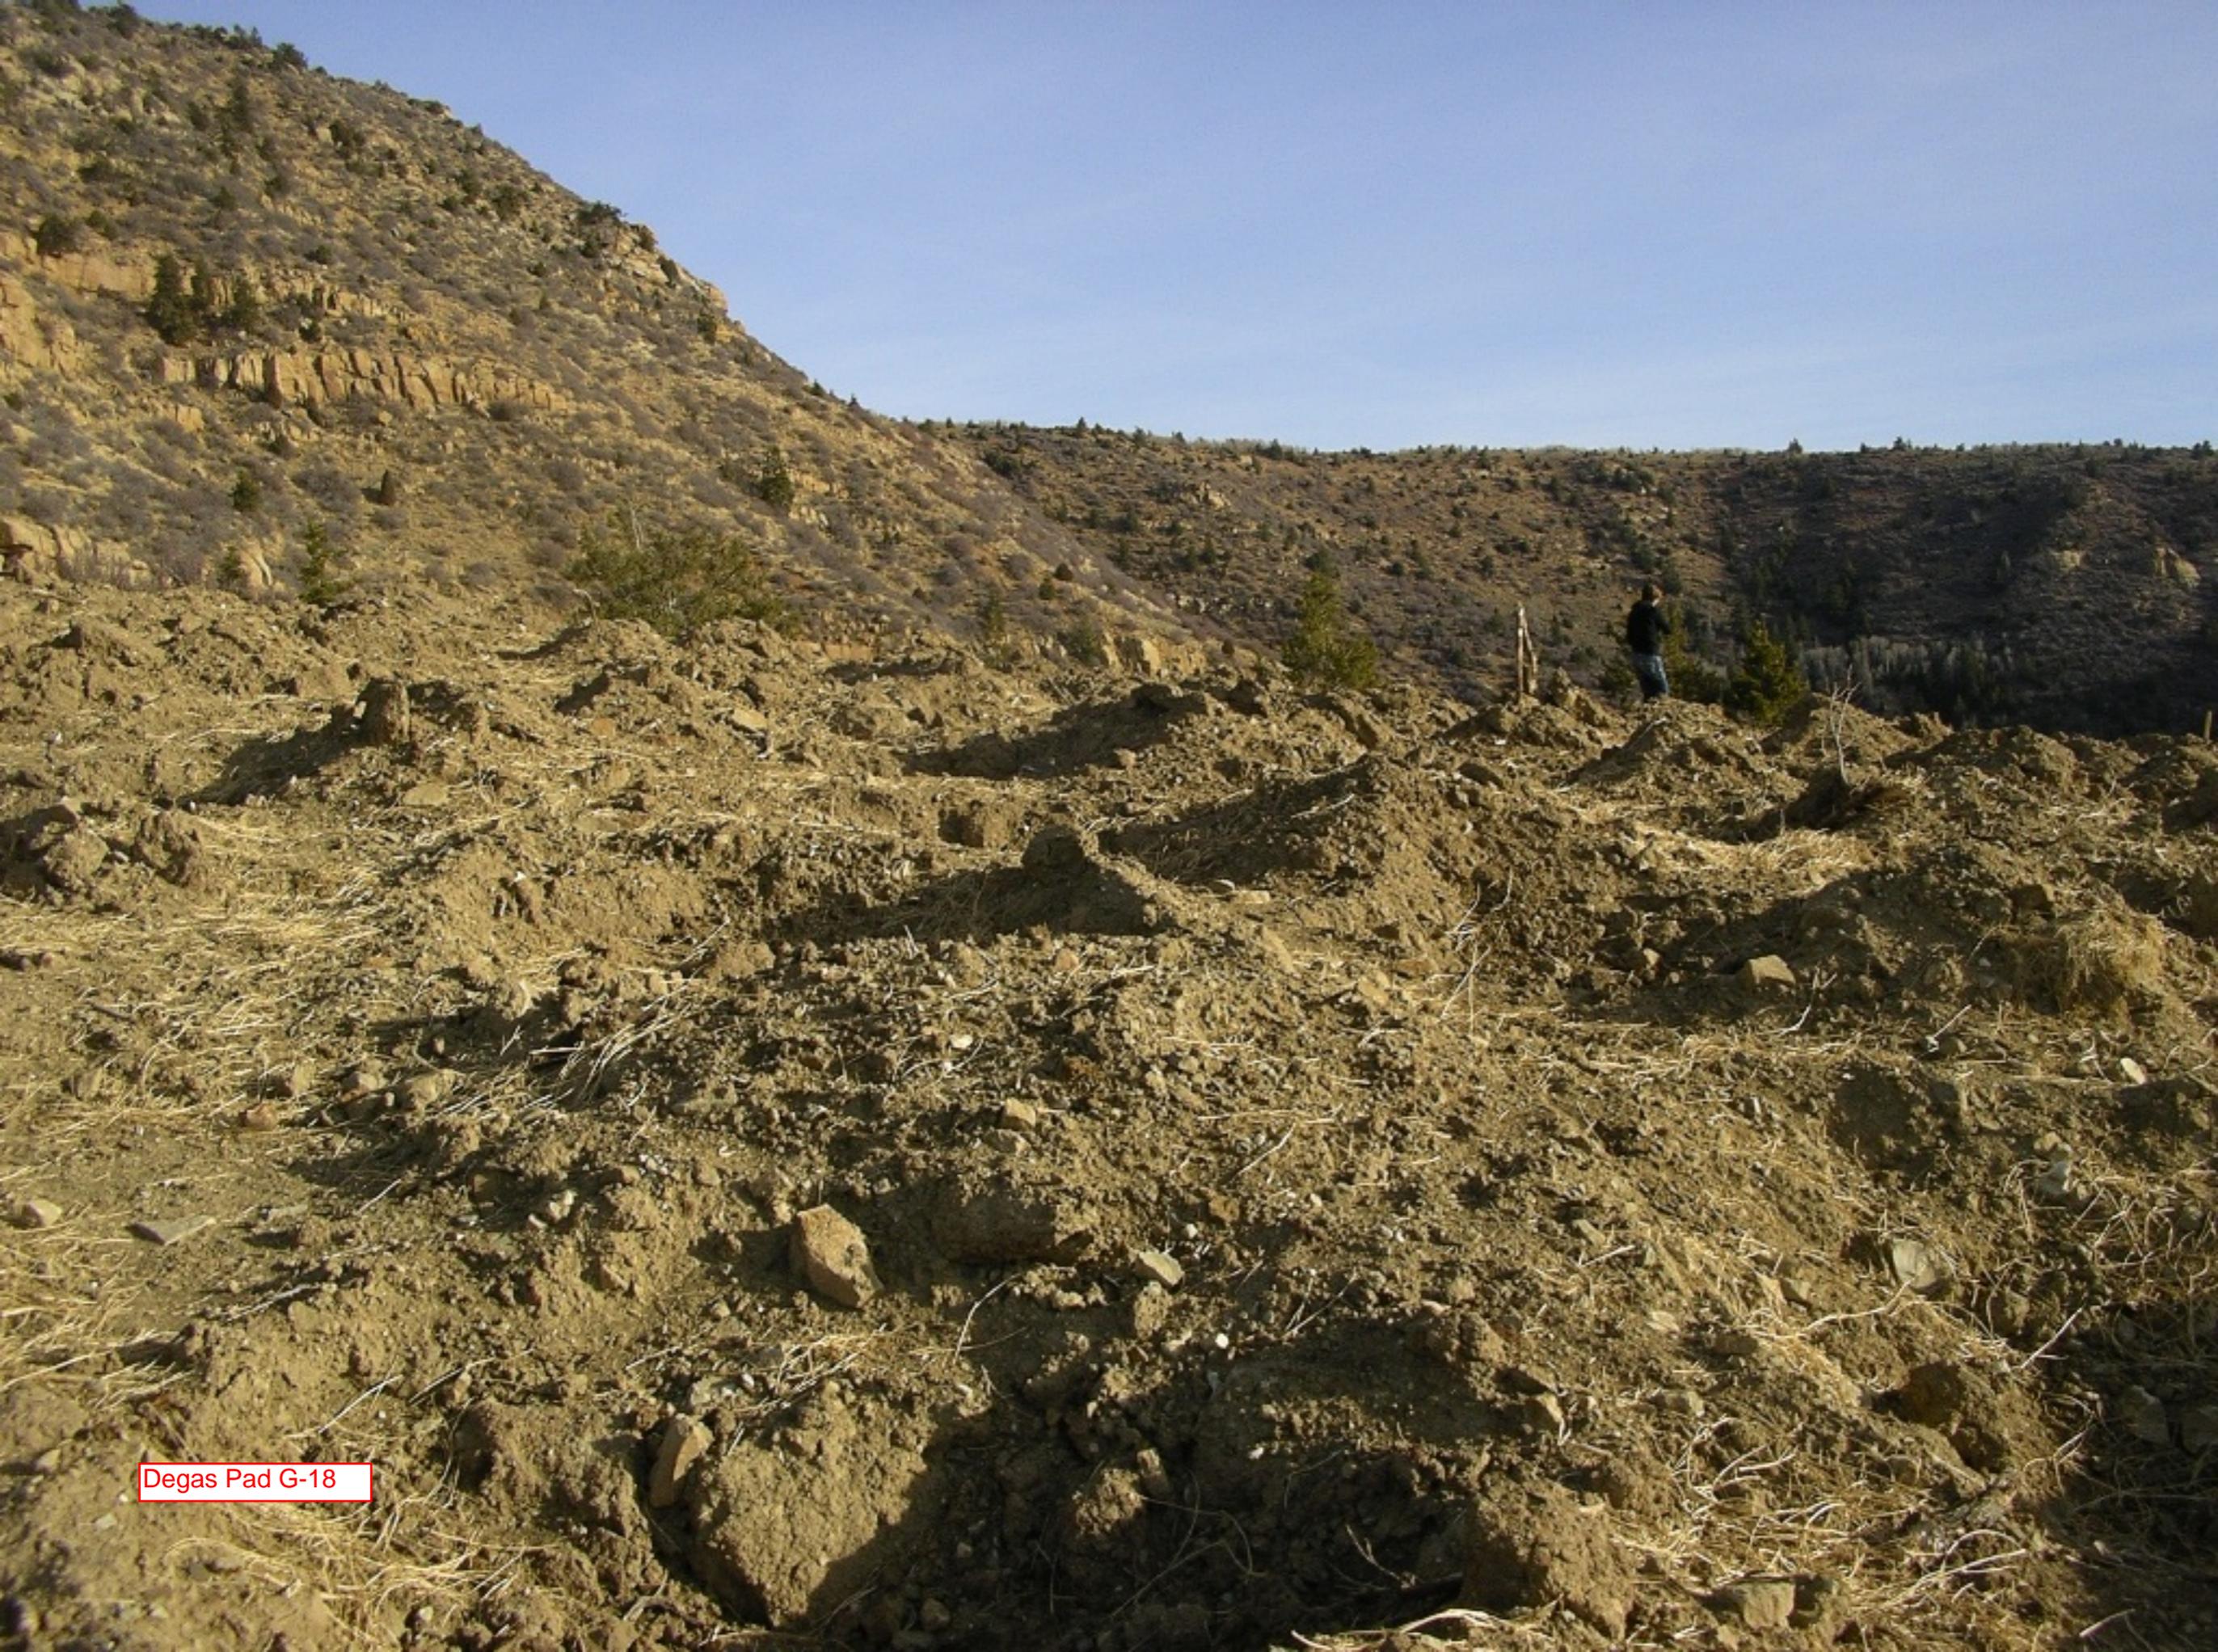
Degas Pad G-18

DG-18. This site had been graded in 2011. The 2,195 cu yd topsoil pile T-10 replacement over the 1.4 acre site was completed in 2012. Topsoil replacement depth calculates to approximately one foot. Placement markers were used to achieve a foot replacement .

DG-18, 2.3 acres, fenced. The site was pocked, hand seeded and surface mulched with certified, weed free alfalfa hay. Fifty, 50 lb bales were scattered over the 2.3 acre area. (See correspondence folder for hay certification.) The application rate (1/2 T/ac) was randomly scattered and appeared to provide between 5 and 20% cover (see image).
