Inspection Report

Permit Number:	C0070039
Inspection Type:	PARTIAL
Inspection Date:	Tuesday, August 20, 2013
Start Date/Time:	8/20/2013 7:00:00 AM
End Date/Time:	8/20/2013 3:30:00 PM
Last Inspection:	Tuesday, August 06, 2013

Site: **DUGOUT CANYON MINE**

On August 20th, 2013, Division of Oil, Gas and Mining staff (the Division) conducted a field inspection of the gob gas vent hole sites (the sites) at the Dugout Canyon Mine. The purpose of the field inspection was to document the condition of the sites and associated access roads and to inspect recently initiated/completed reclamation work. Overall, the condition of the degas sites (both reclaimed and un-reclaimed) was very good. No evidence of off-site impacts was observed during the field inspection. Some minor maintenance work is required on the skid road to degas pad G-19 and on the AMV Road's water bar (See discussion below).

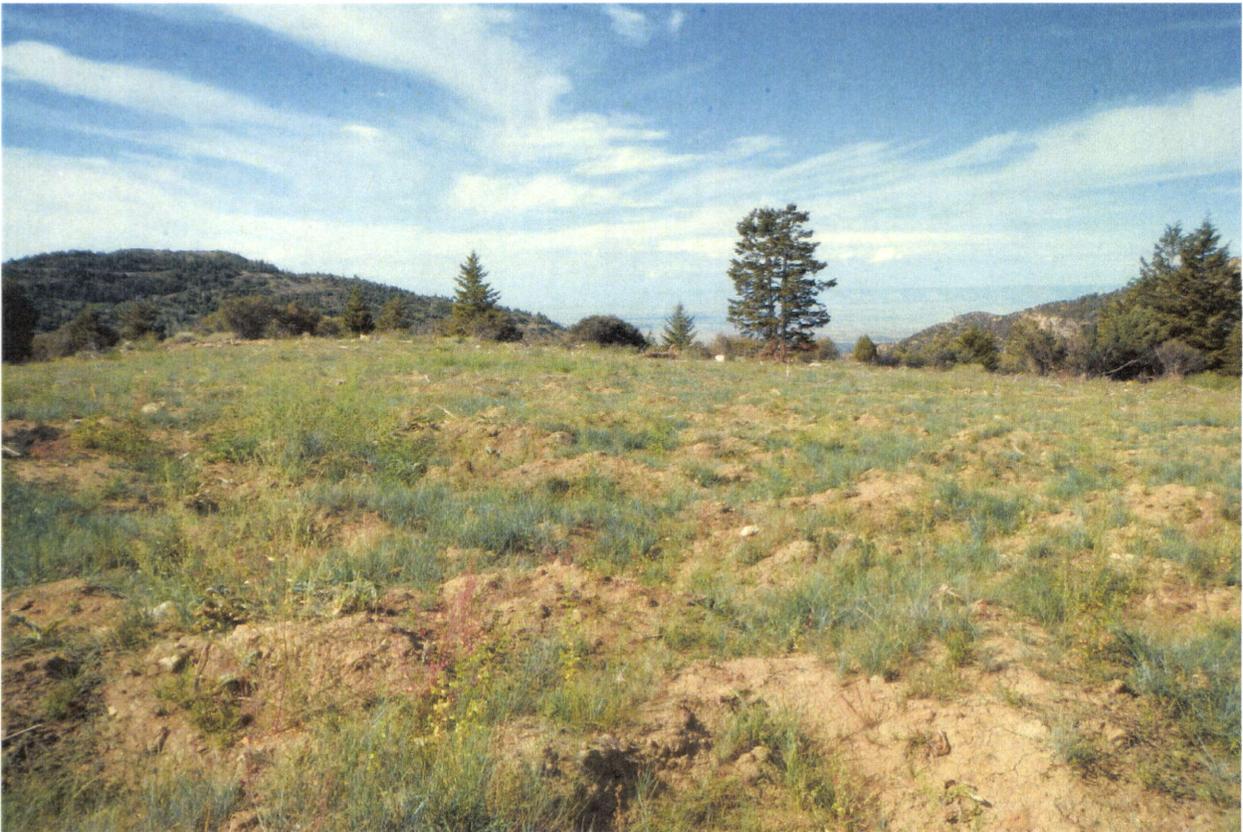
East View: AMV Road and Reclaimed Section between Sites G-18 and G-31

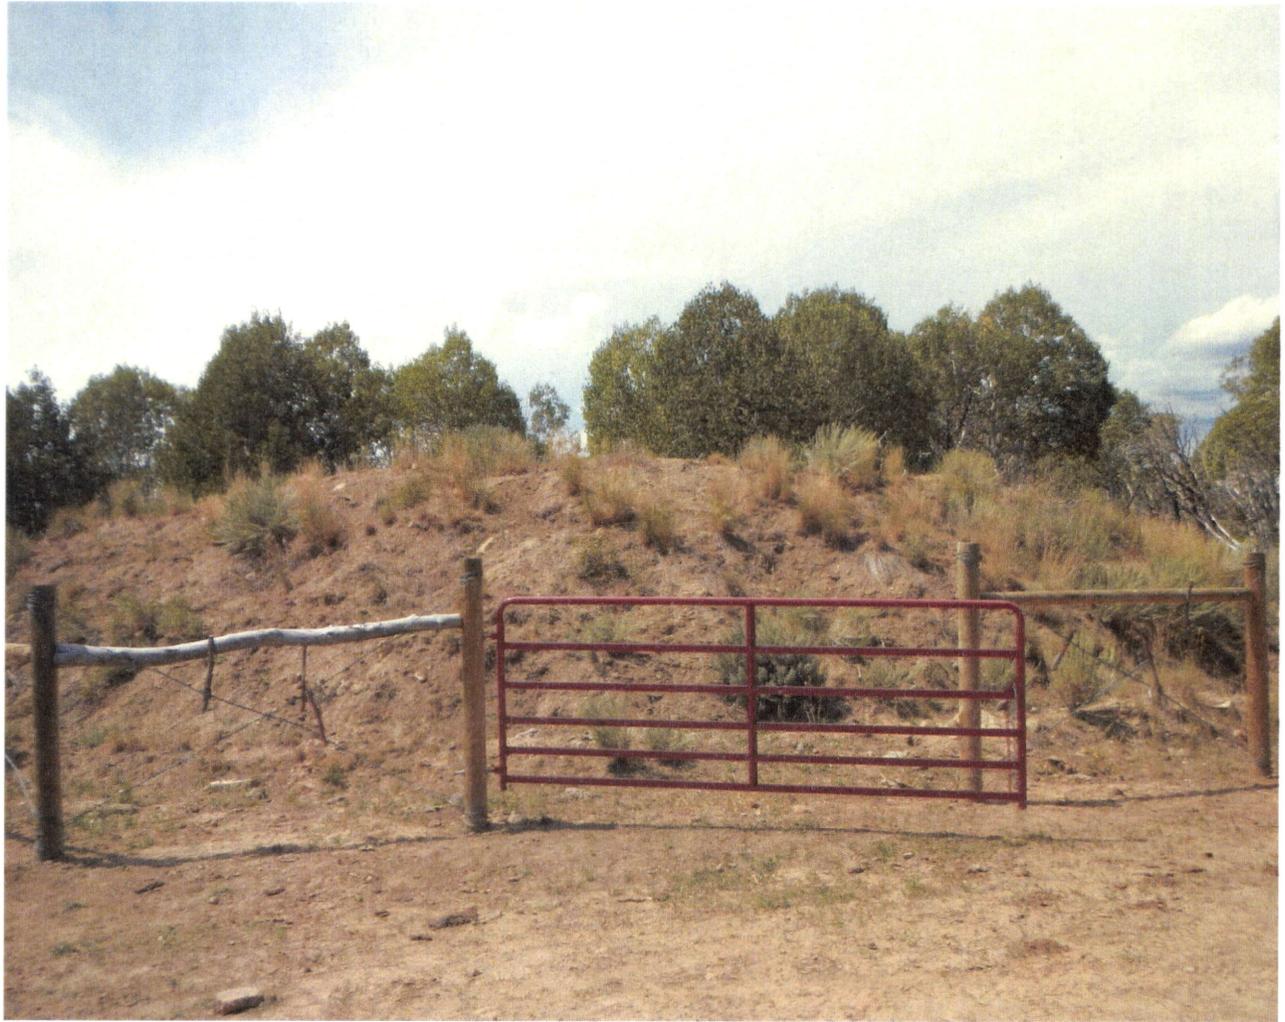
Site G-17

G-17: The site is being utilized as a top soil storage area. Top soil from Site G-22 and its access road are stored here. Once site G-22 is reclaimed, this area should be reclaimed as soon as possible.
