RE: 2015 Annual Report for Dugout Canyon Mine

Annual Report

Permit Number	ACT/007/039	Report Date	04/08/15
Mine Name	Dugout Canyon Mine		
Company Name	Canyon Fuel Company, LLC		
Impoundment Identification	Impoundment Name	Refuse Pile Sedimentation Pond	
	Impoundment Number	None	
	UPDES Permit Number	UT0025593	
	MSHA ID Number	Impoundment -None (Refuse Pile 1211-UT-09-01890-01)

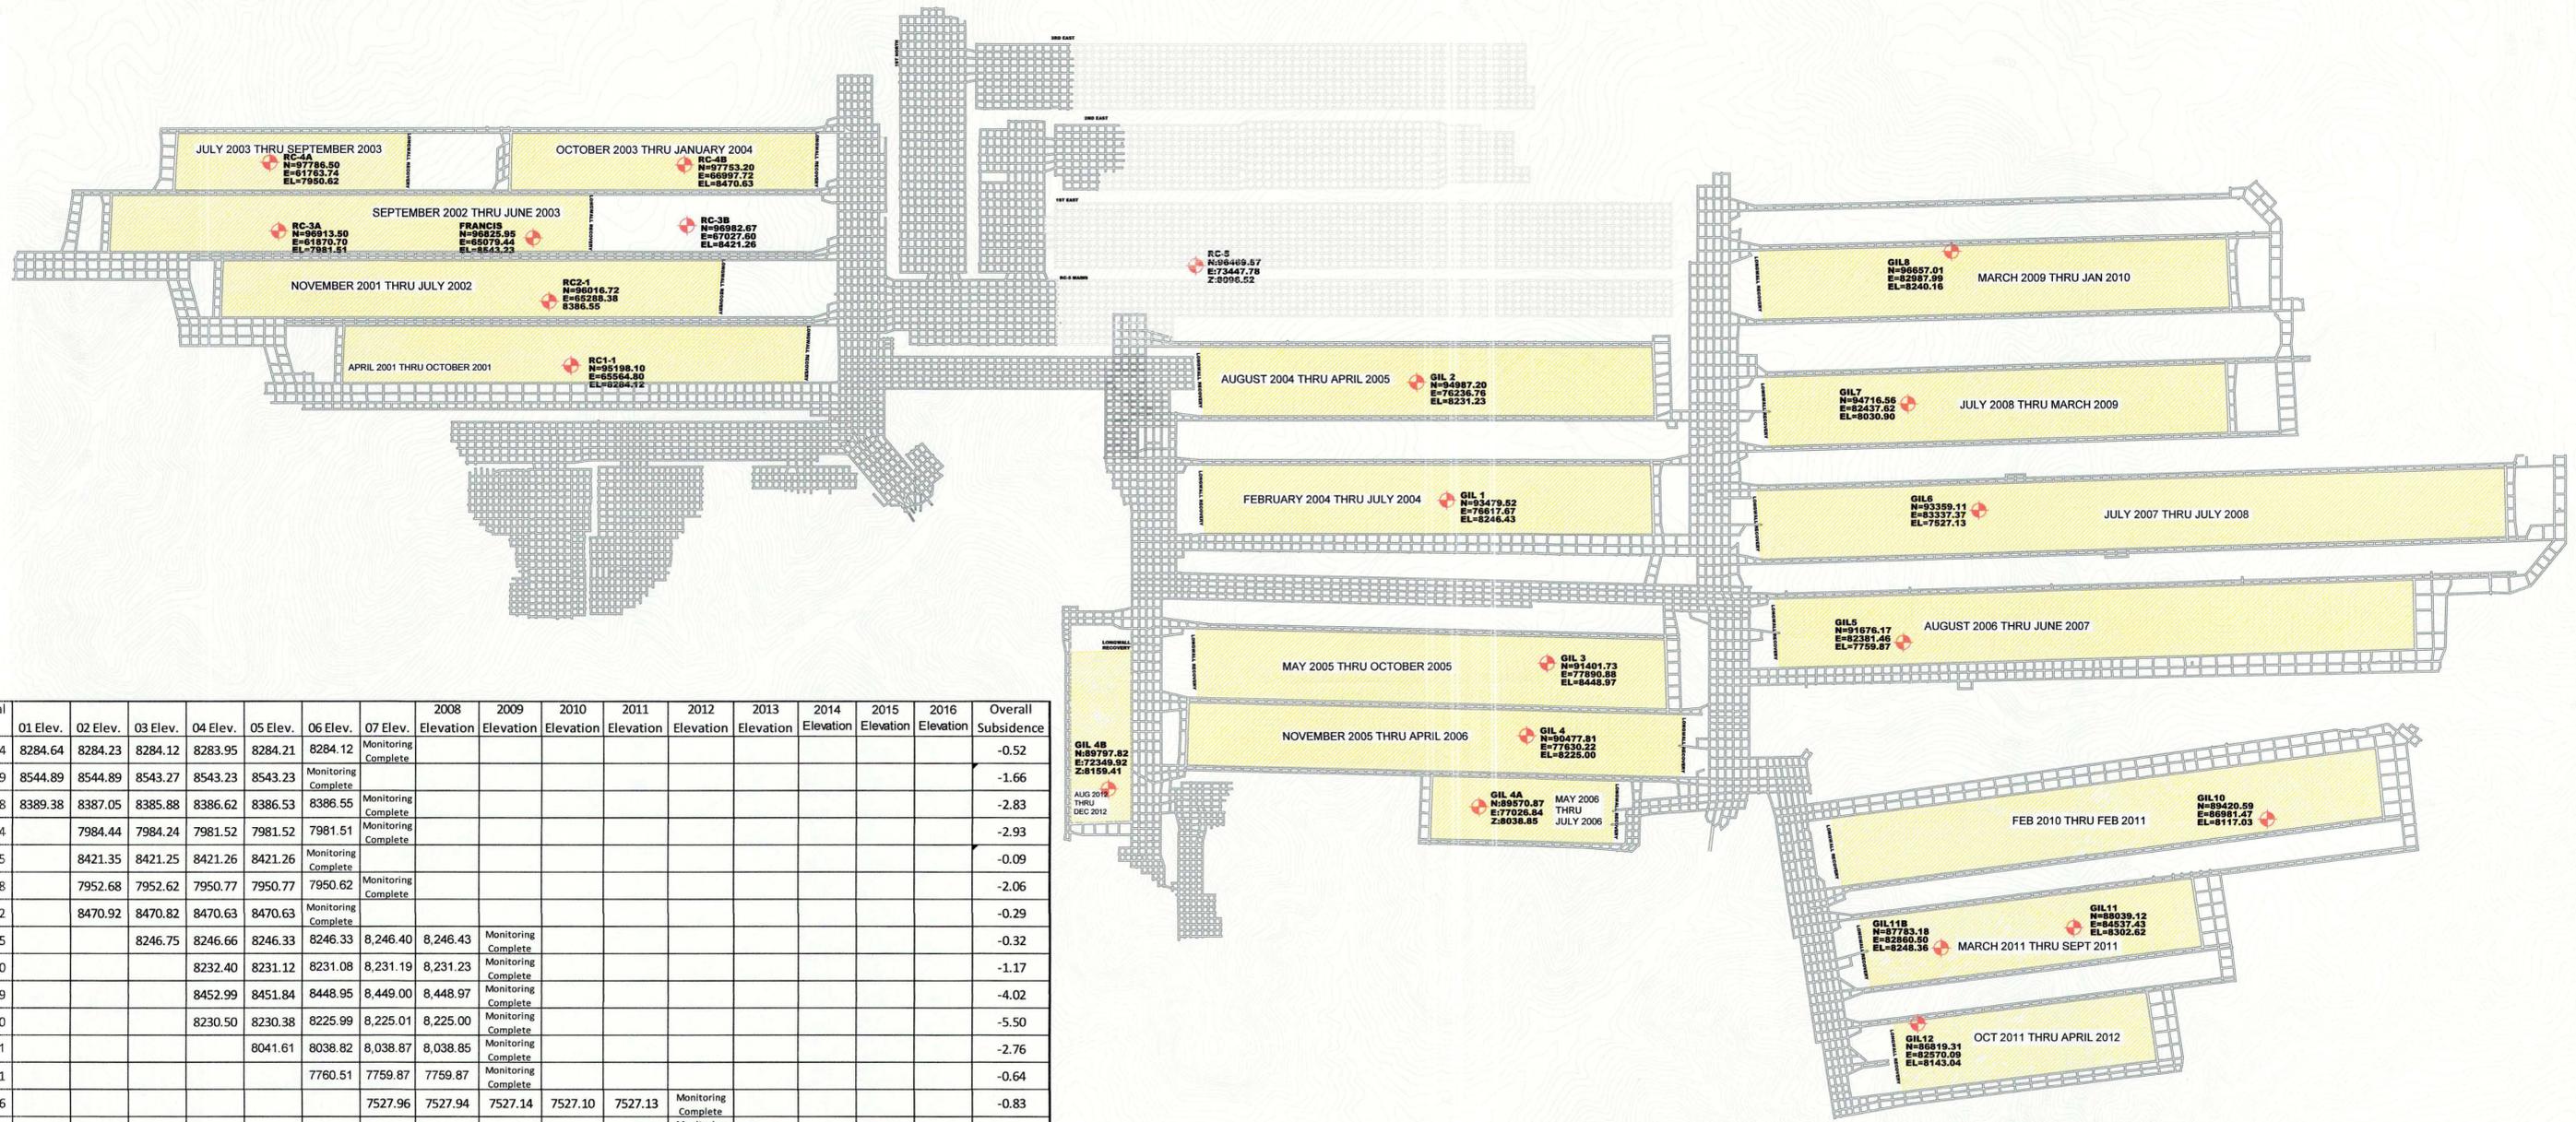
Dugout Canyon Mine – Visual Checks for Subsidence – 2015

Dugout Canyon Mine, M&RP, Chapter 5, Section 525 “Visual checks for subsidence will be made during all surface activities, especially during water monitoring activities. These visual surveys will be used to detect surface irregularities and surface cracks.”
