Inspection Report

Permit Number:	C0070039
Inspection Type:	PARTIAL
Inspection Date:	Wednesday, October 12, 2016
Start Date/Time:	10/12/2016 7:30:00 AM
End Date/Time:	10/12/2016 4:00:00 PM
Last Inspection:	Tuesday, September 13, 2016

Permitee: **CANYON FUEL COMPANY**
 Operator: **CANYON FUEL COMPANY**
 Site: **DUGOUT CANYON MINE**
 Address: **PO BOX 1029, WELLINGTON UT 84542**
 County: **CARBON**
 Permit Type: **PERMANENT COAL PROGRAM**
 Permit Status: **ACTIVE**

Dugout Canyon Mine
Degas Facilities Inspection
10/12/2016

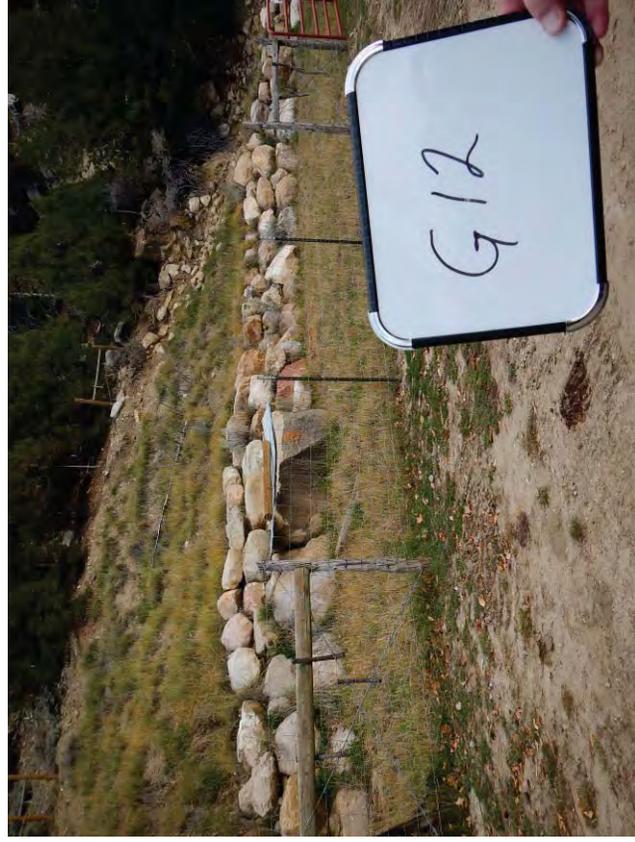
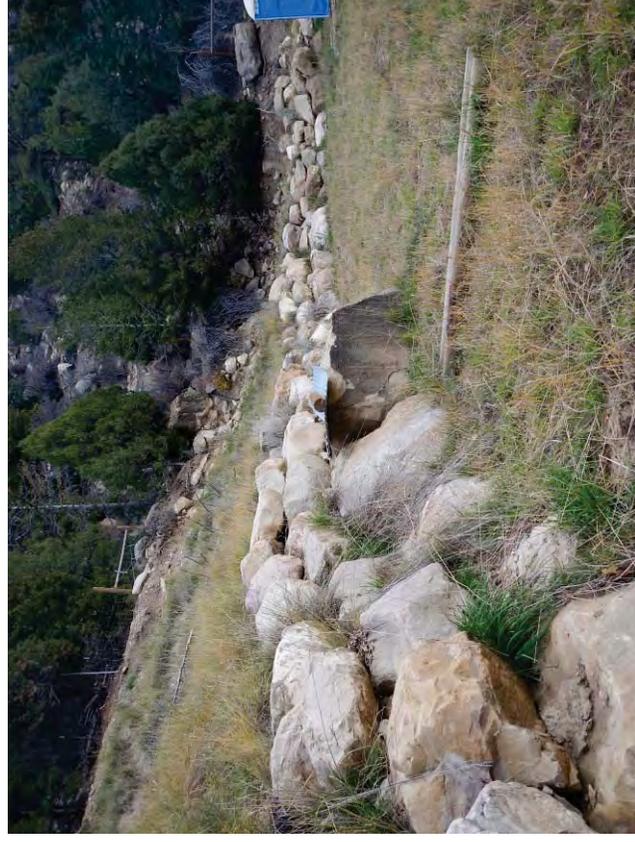
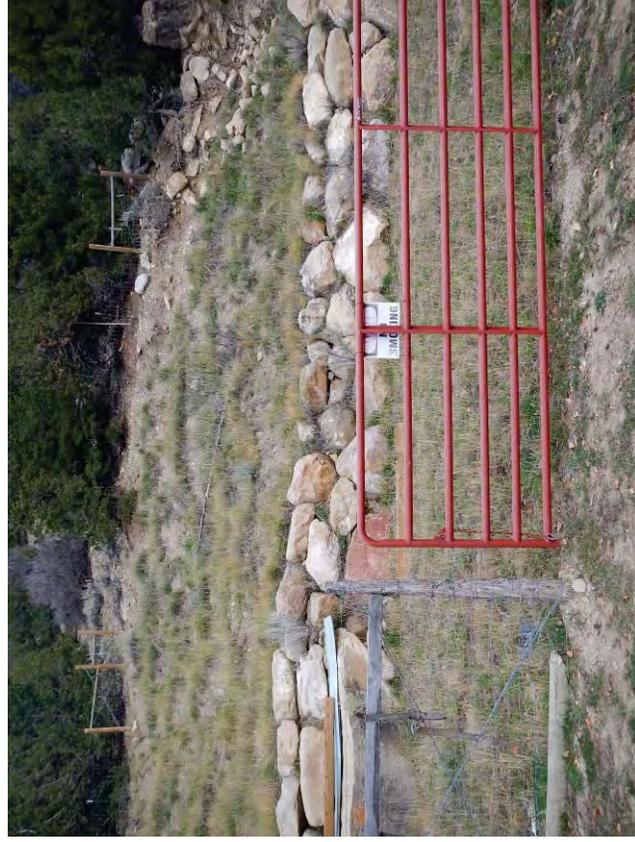
Site G-12

G-12: The site was reclaimed in 2011. A rip rap retaining wall was constructed on a portion of the highwall area. A rip rap diversion channel has been installed divert runoff around the pad area. No evidence of off-site impacts was noted during the field inspection. The site received Phase II bond release in 2014. A rockwall terrace was constructed as part of the final reclamation.

G-12: The site is fenced, well vegetated and stable.

a.Rock Wall Terrace- They need to submit an as-built drawing that shows the rockwall terrace.

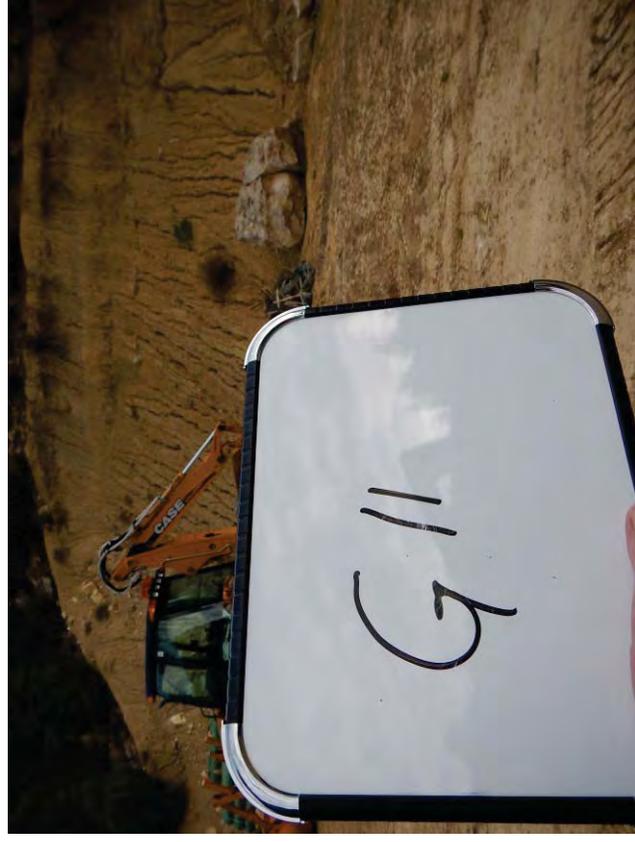
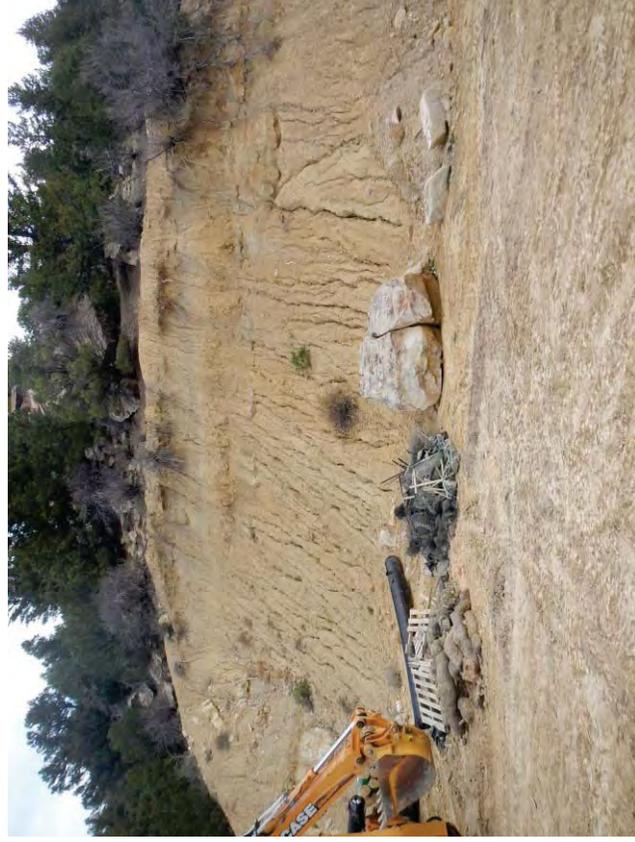
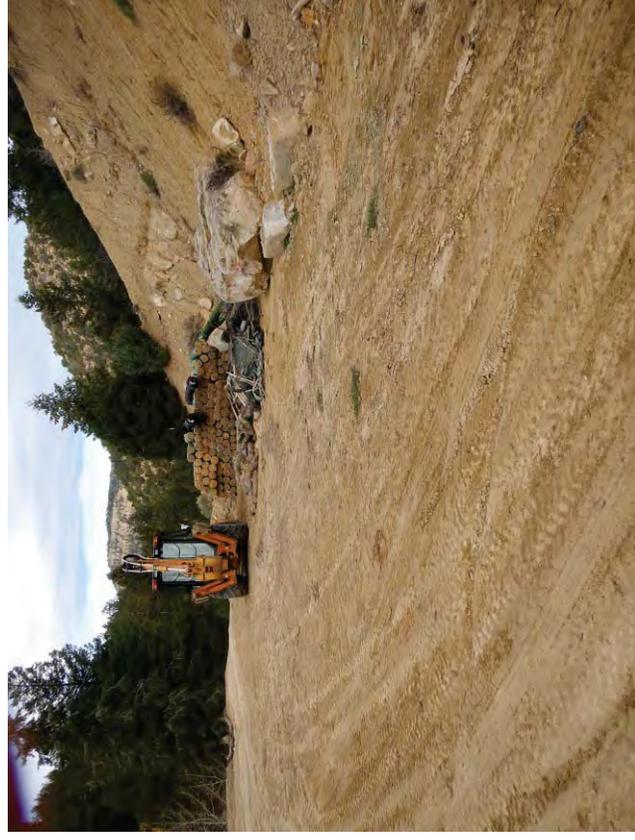
Site G-11

G-11: The site remains un-reclaimed. The site is being utilized as a staging area for the final reclamation work to be conducted on the AMV access road. The site was stable. No evidence of off-site impacts or additional suspended solids leaving the disturbed area was noted during the inspection. The landowner would like to keep a wide spot in the road.

G-11: This site is currently used as a staging area for reclamation activities on portions of the access road and has not been reclaimed or fenced. Interim seeding upslope from the pad would be beneficial to minimize the minor erosion on the slope. There was a back-hoe, some new and some old waddles and some debris located on the pad at the time of the inspection. The debris should be removed before winter sets in.

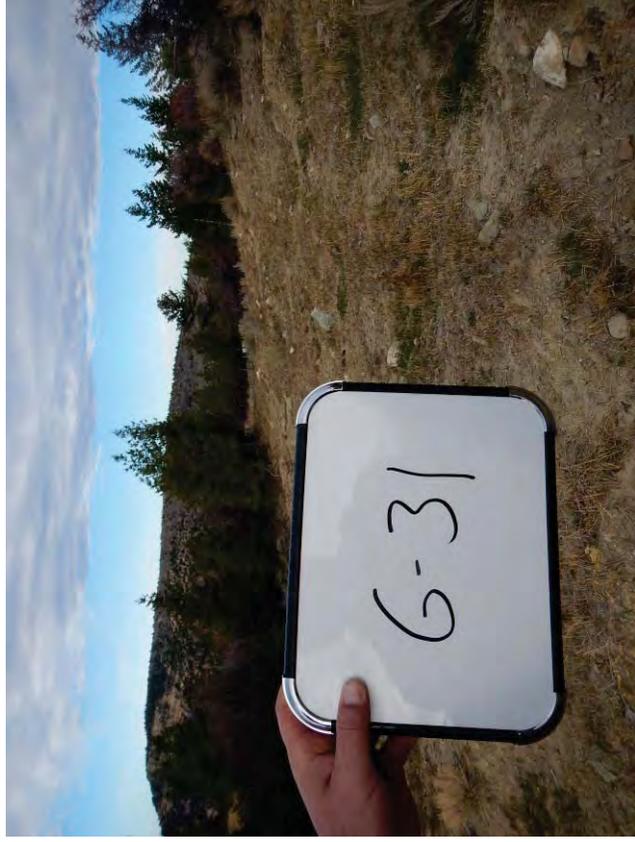
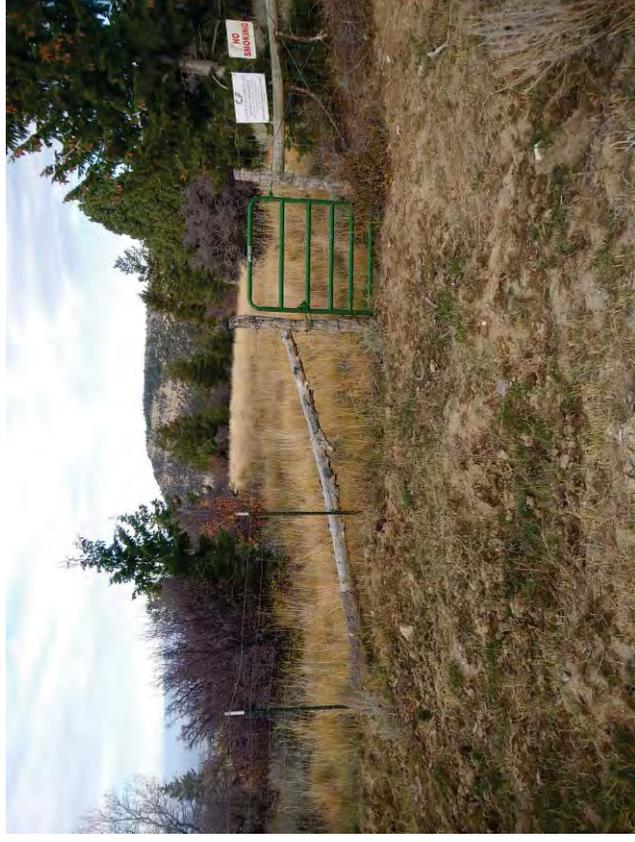
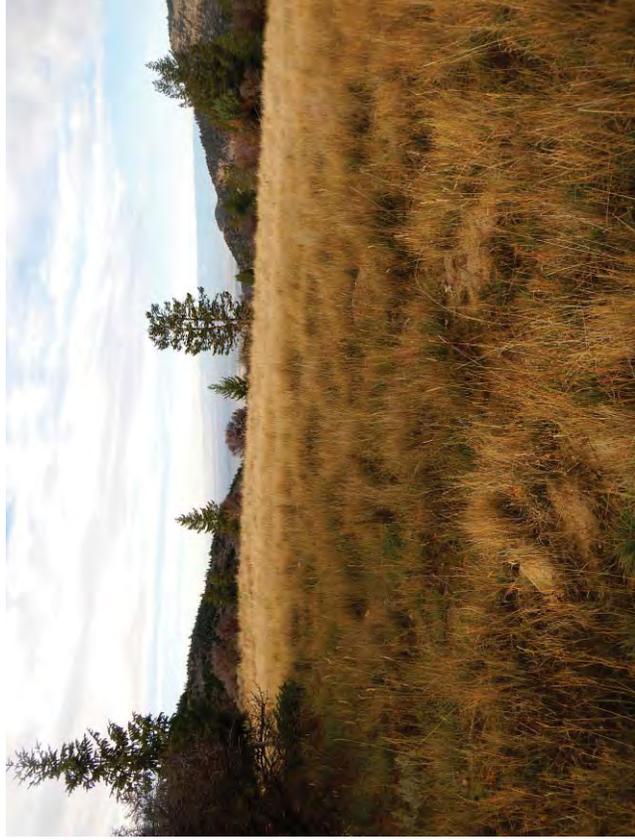
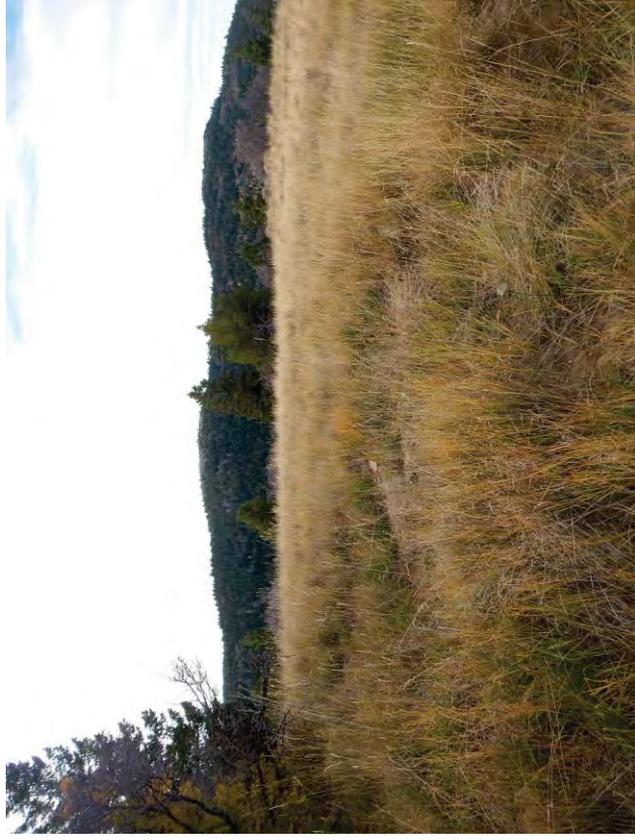
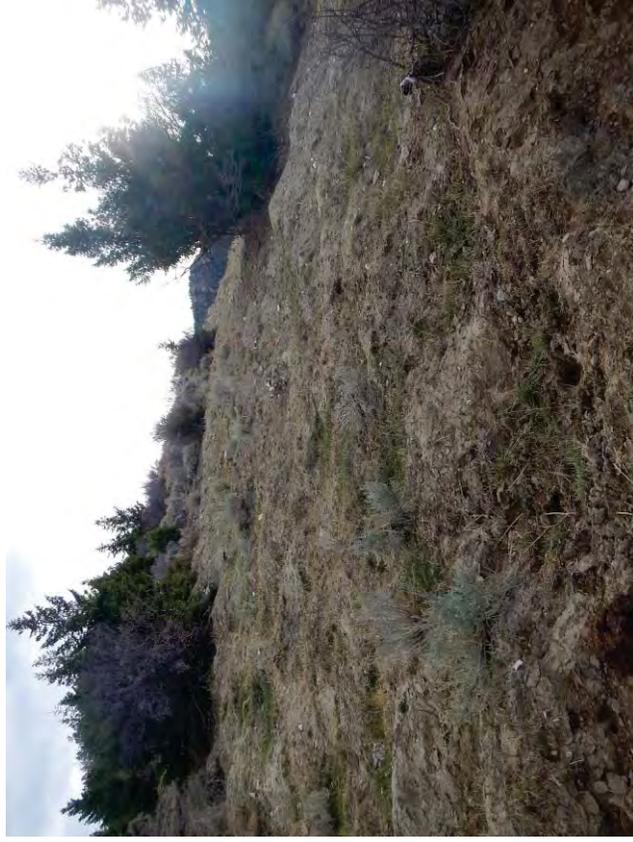
Site G-31

G-31: Reclamation work for this degas pad was completed in June of 2013. The small access/spur road to the pad site shows signs of cattle grazing impacts. The vegetation on this access road has been impacted by grazing activity. The degas pad itself was found to be in excellent condition. The pad was well vegetated and did not show evidence of instability and/or erosion. The pad received Phase I bond release in 2014.

G-31: This well site is located approximately 250' beyond the reclaimed access road. It is fenced and well vegetated. The reclaimed portion of the access road is not fenced and has been grazed fairly heavily. Alternative measures may need to be employed to ensure the standards for success and the postmining land-use can be achieved.

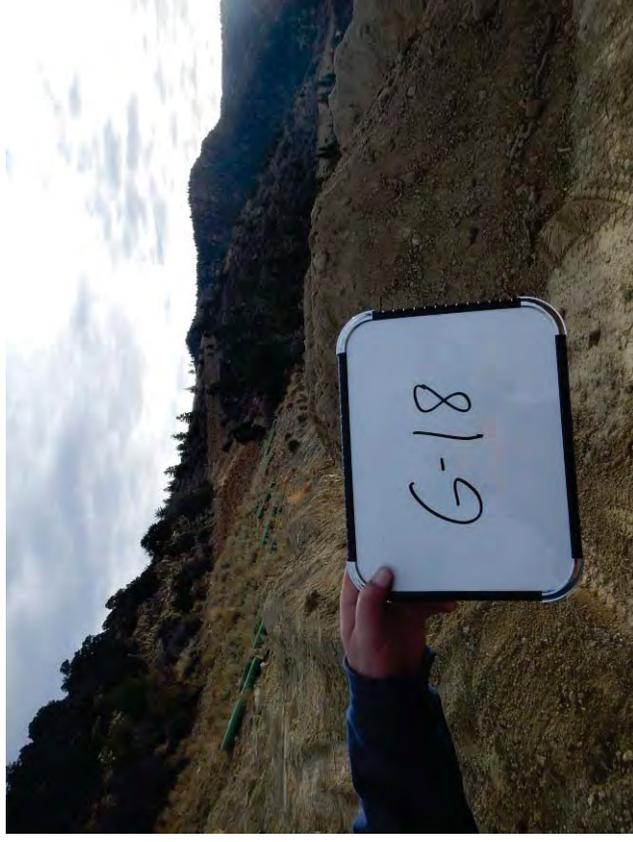
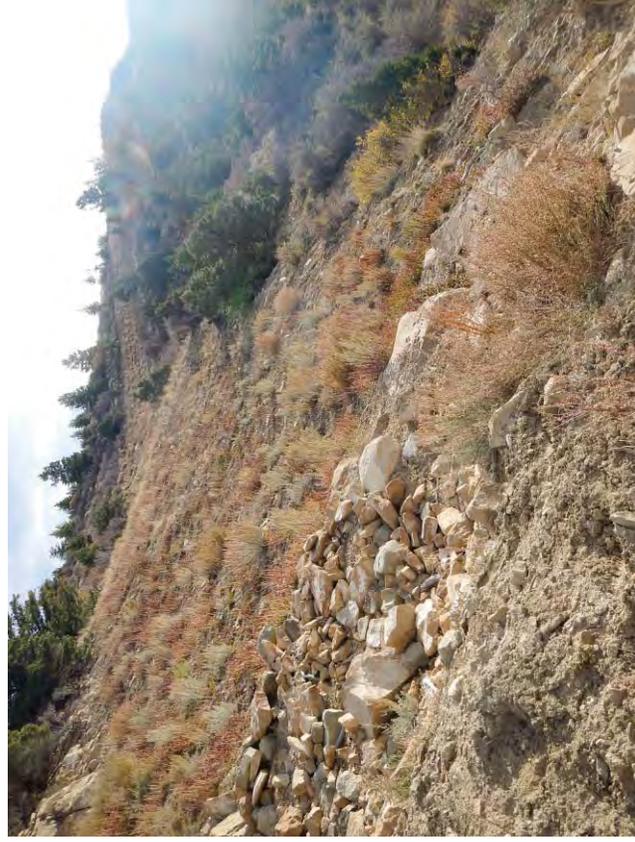
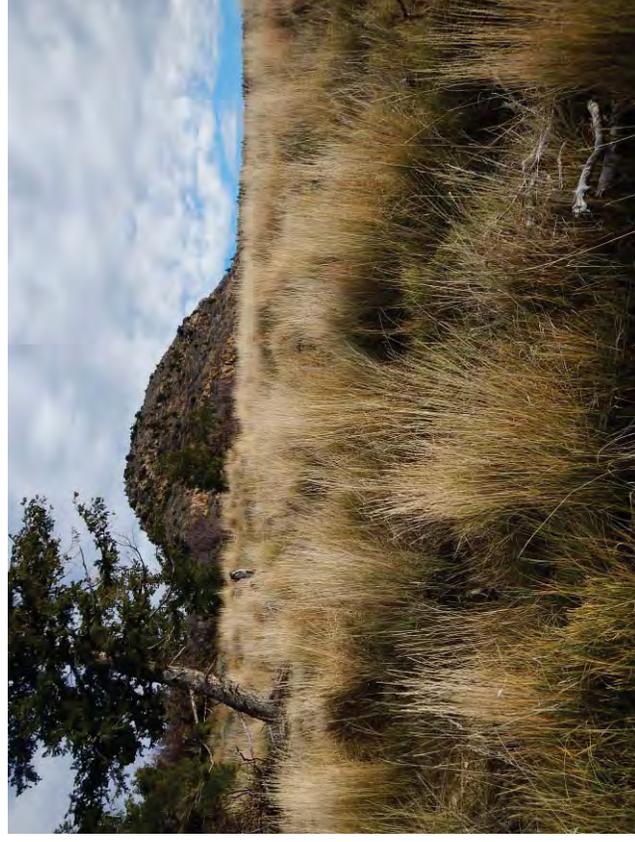
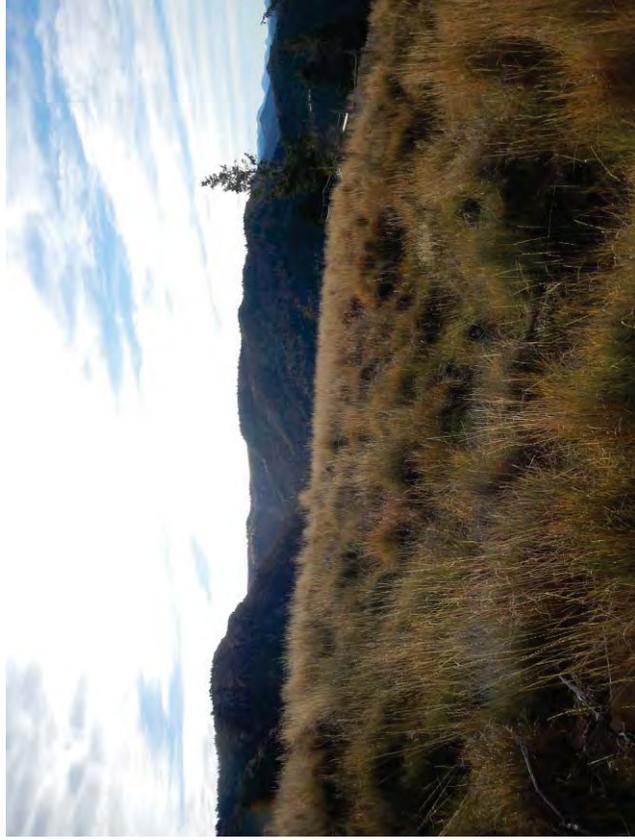
Site G-18

G-18: The site was graded and topsoil was partially replaced in 2011 followed by full reclamation including hand seeding and mulching during the 2012 construction season. The access road leading to G-18 was reclaimed in 2012 and is in good repair. The excelsior matting is stable on the reclaimed slope. There were no rills or gullies noted. The degas pad was noted to be in excellent condition and well vegetated. . No evidence of erosion and/or instability was noted. The site received Phase II bond release in 2014.

G18: This site is located approximately 200 yards East of the corresponding access road. It is fenced, well vegetated and stable. The reclaimed portion of the access road is not fenced and is dominated mainly by shrubs. Grazing appears to be minimal as there is not much evidence of grass species on the reclaimed road but the vegetation is well established. Alternative measures may need to be employed to ensure the standards for success and the postmining land-use can be achieved. Reclamation of the main road is ongoing.

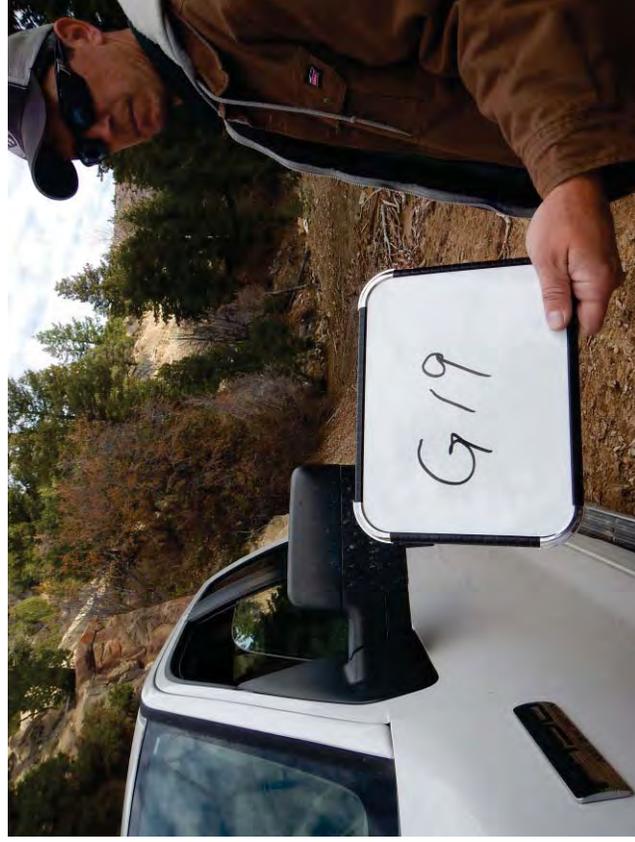
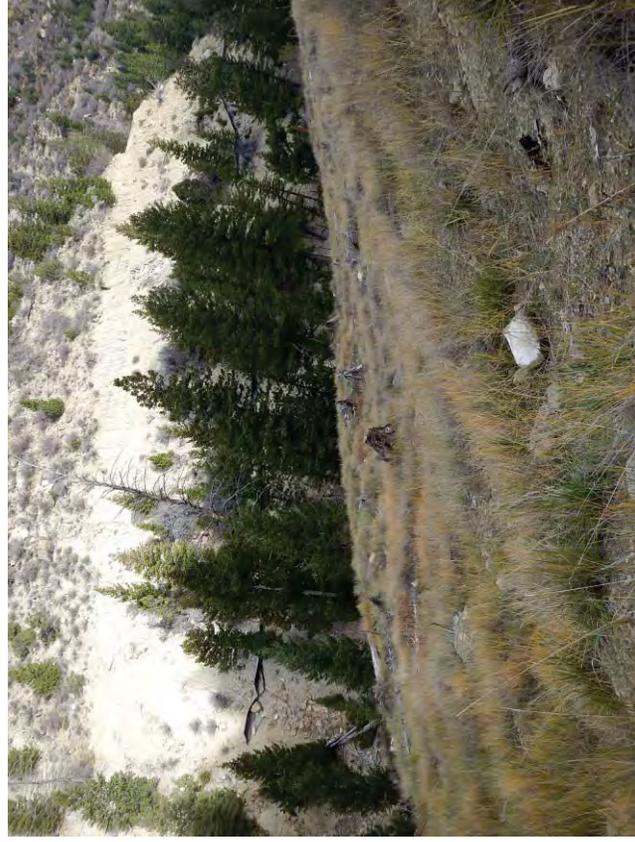
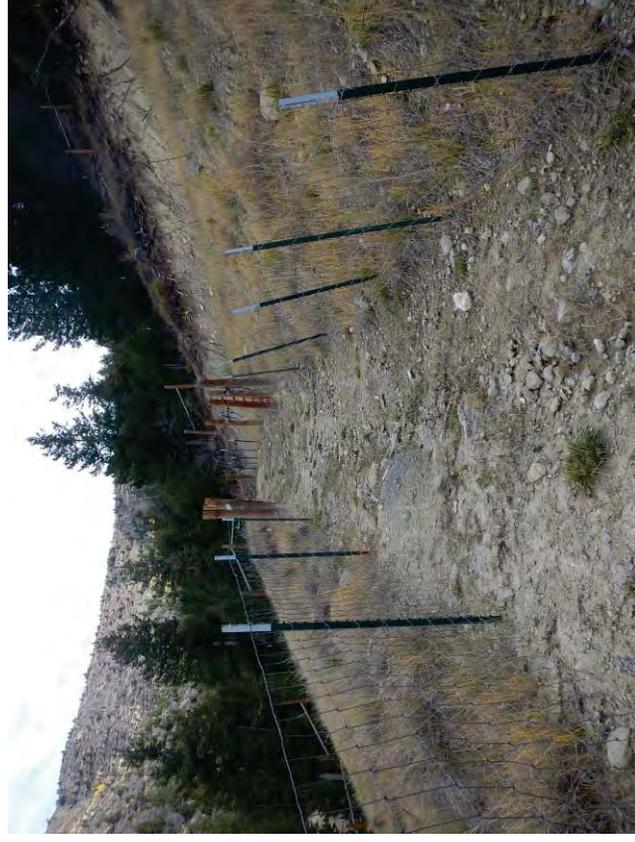
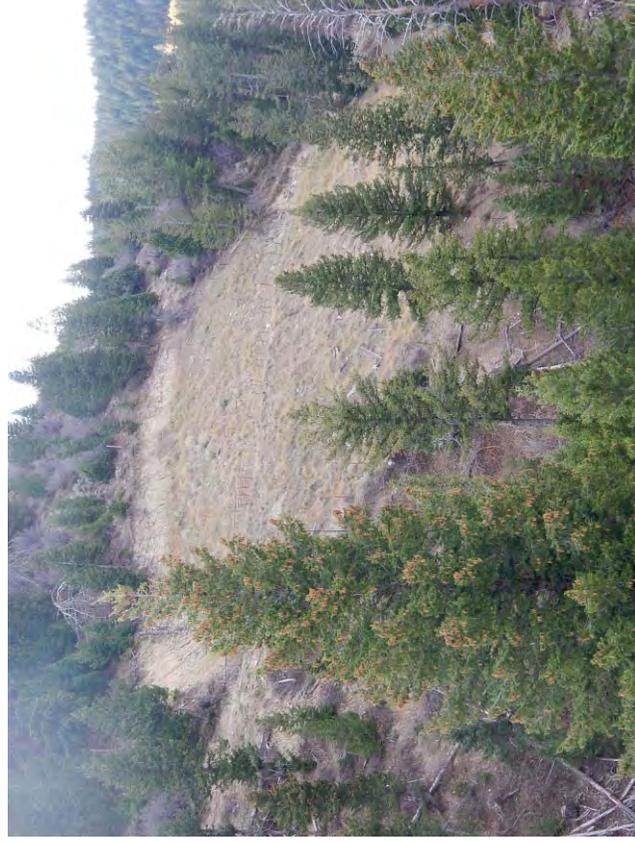
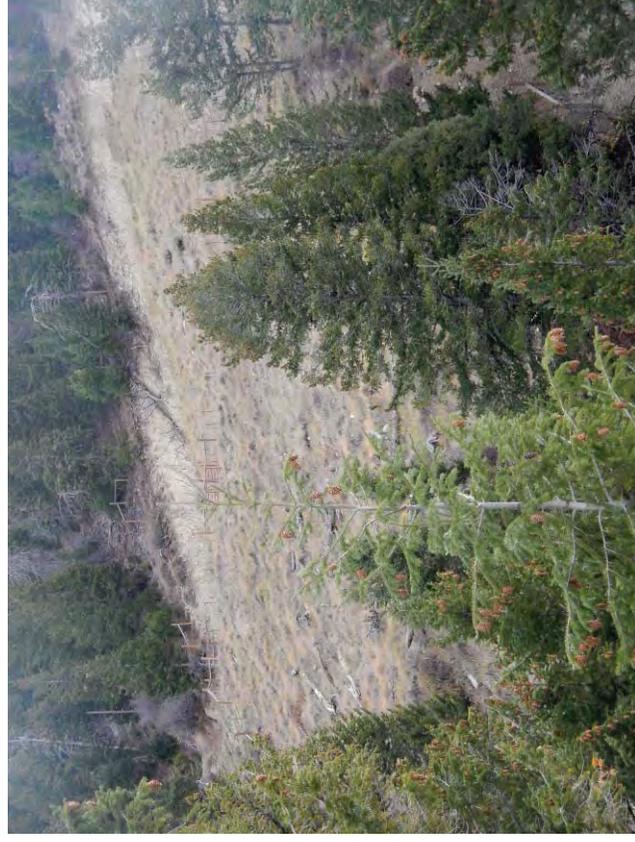
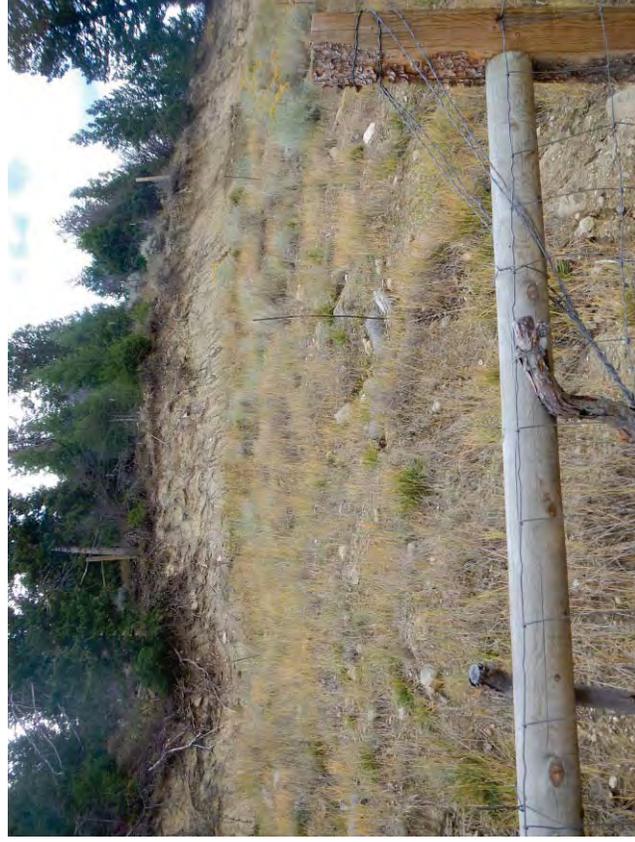
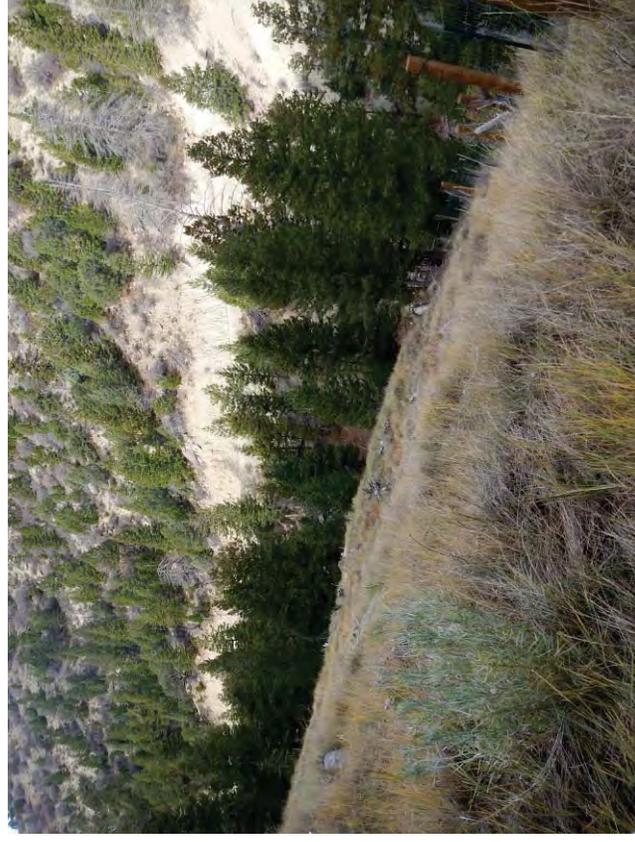
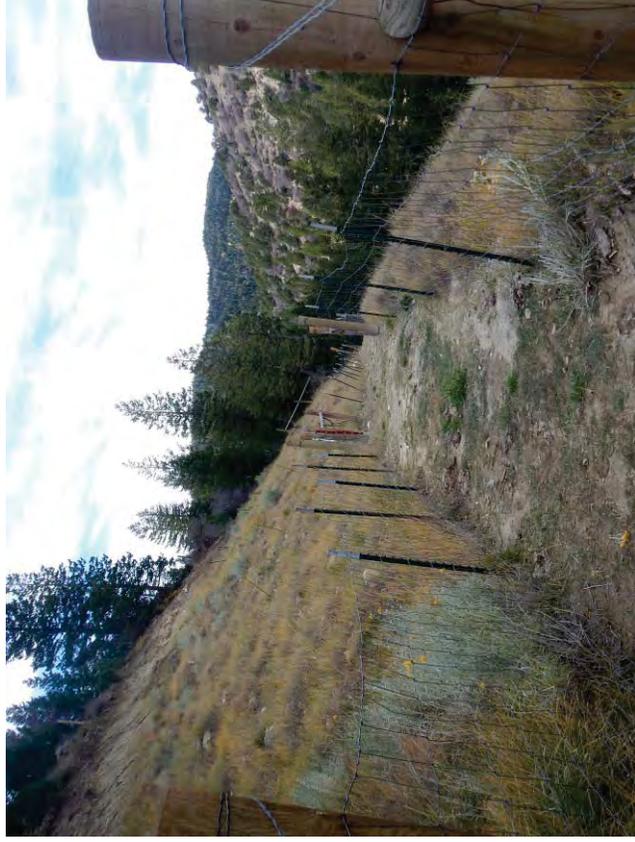
Site G-19

G-19: The site was reclaimed during the 2010 construction season and received Phase I bond release in 2014. The degas pad was noted to be stable (i.e. no evidence of erosion or instability were noted during the field inspection). The pre-existing skid road was observed during the inspection. Evidence of minor erosion on the skid road was observed during this inspection. The three water bars located on the G-19 access road require maintenance. The accumulated sediment within the water bars must be removed and new excelsior logs/sediment controls installed.

G-19: This is a fairly steep site bisected by an existing road. It is located approximately 250' from the main road. The reclaimed areas on either side of the access road are well vegetated and the rills that had formed in 2014 have been diminished with the establishment of additional vegetation and sediment controls.

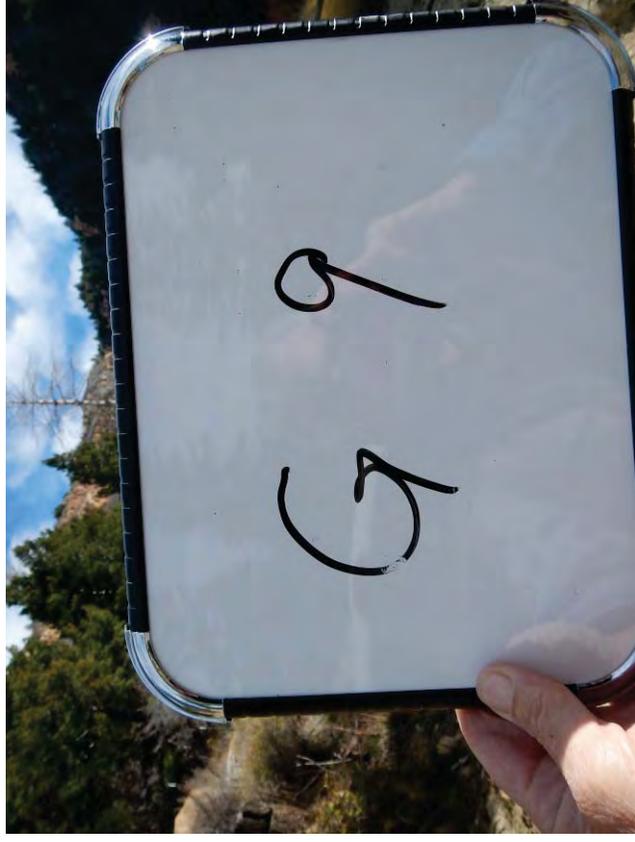
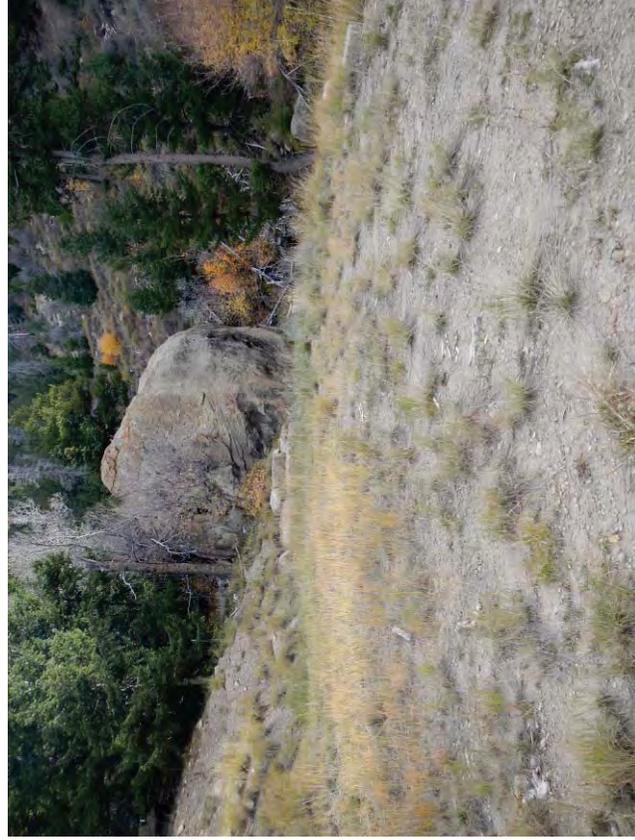
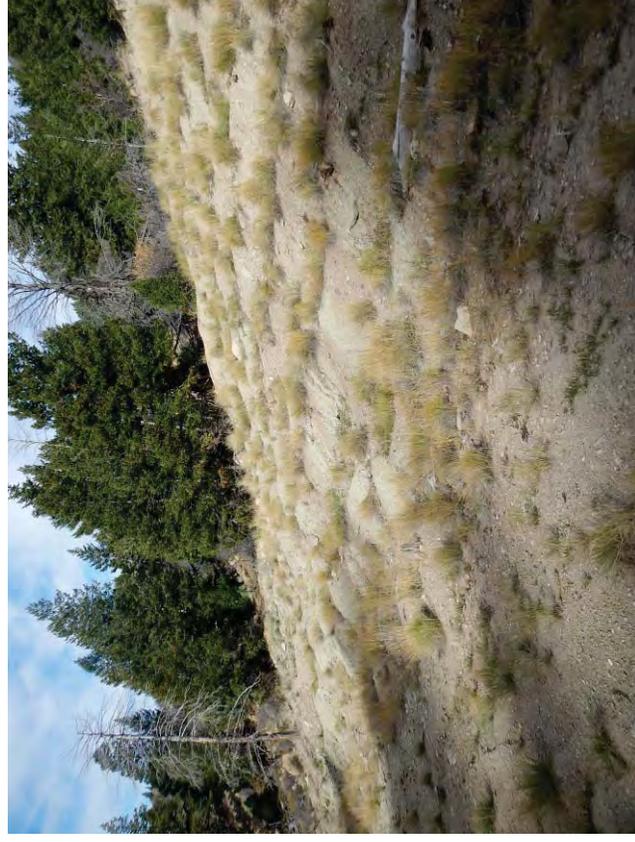
Site G-9

G-9: The site was reclaimed in 2012 and received Phase I bond release in 2014. No evidence of off-site impacts or erosion was noted during the time of the inspection. The site was observed to be in stable condition (i.e. no significant evidence of

erosion). Bill King indicated that the site had experienced issues with thistle. The site had been sprayed to knock the thistle infestation back. As a result, the vegetation has been impacted to a degree. Bill King indicated that husbandry seeding will occur in the spring of 2017 if vegetation has not emerged following the snowmelt.

G-9: This site is located at the end of an access road (See Pace Canyon Road System map Att). The site is stable, well vegetated and fenced.

4)Weed control: Thistle has been sprayed at several of the sites. The rosettes from the first year of growth for both the thistle and mullen should also be sprayed. If not they will appear the following year as a full grown plant.

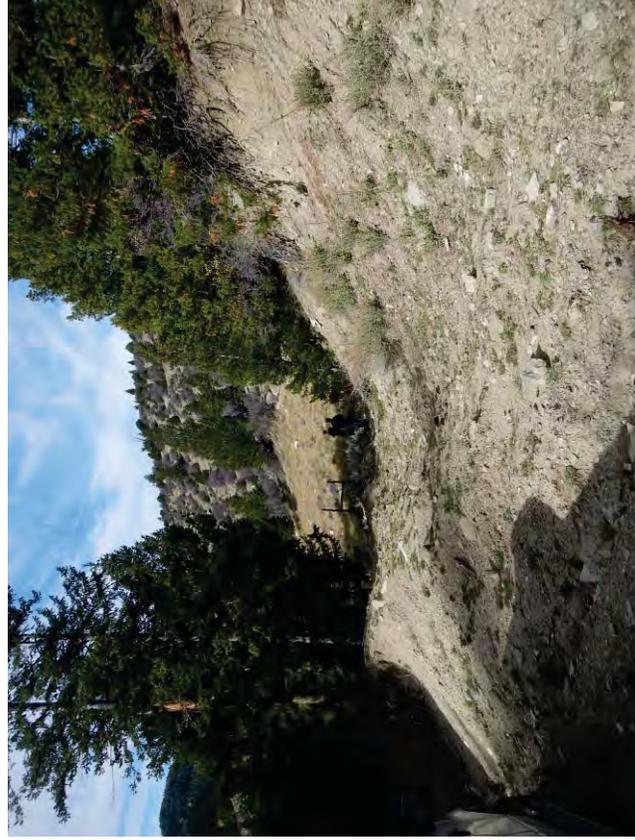
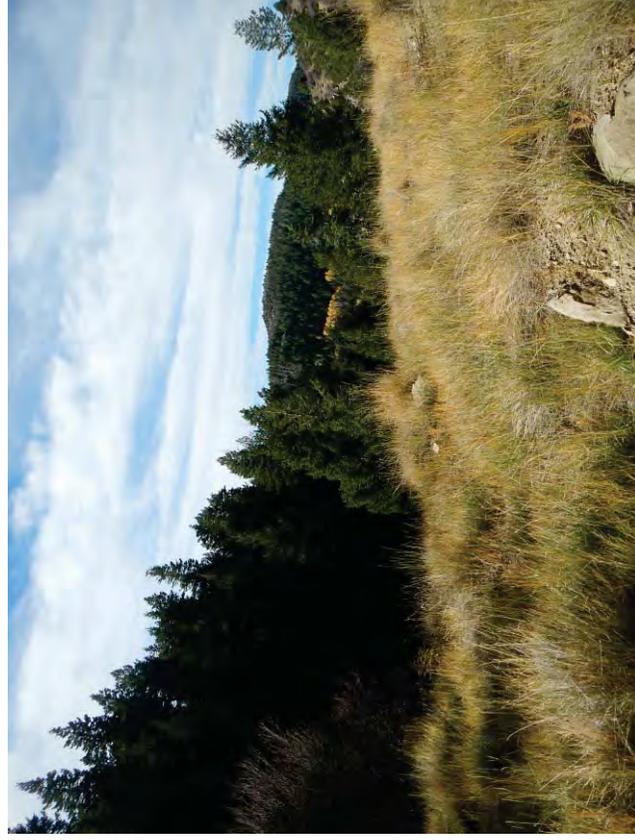
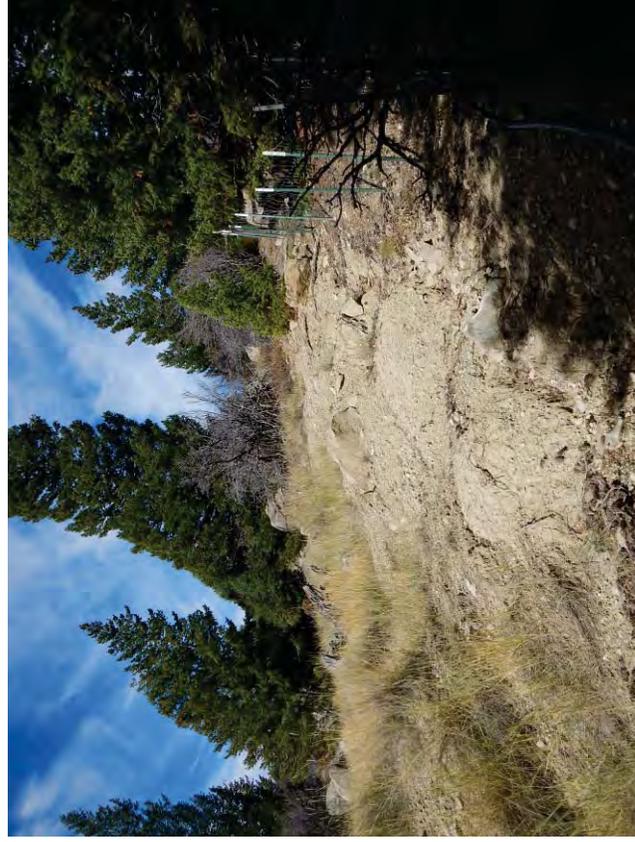
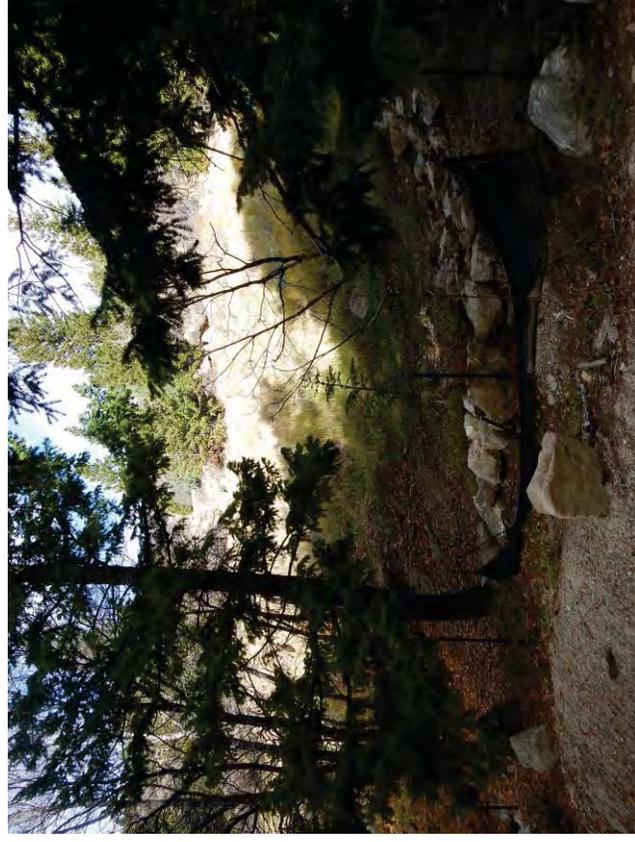
Site G-10

G-10: The site was reclaimed during the 2012 construction season and received Phase II bond release in 2014. No evidence of off-site impacts/erosion was noted during the time of the inspection. The site utilizes a culvert to route flow from the pad/access road area. Upon review of the approved MRP, it appears that the sizing for the culvert was designed with a 10-year, 6-hour event. A permanent diversion must be sized to safely pass the peak runoff from a 100-year, 6-hour event (See State of Utah R645-301-742.323. The Permittee must provide design calculations that the culvert at degas pad G-10 has been adequately sized to meet that design standard. The calculations must be submitted for review and incorporation into the approved MRP.

G-10: This site is fenced, stable and well vegetated (mostly grasses and forbs with some shrubs). It is located up-slope just off of the main road. The drill pad has been reclaimed to approximate original contour (AOC). This created a fairly steep slope that has been armored with 10-24" rip-rap and silt fence along the Southeast

a.Culvert- In MRP in Volume III (I believe its Attachment 7-1, Hydrologic Calculations)on page 376/611, it appears that the culvert was designed with a 10-year, 6-hour event. As this is assumed to be a permanent diversion, the Permittee needs to provide revised hydrologic calculations which demonstrate that the culvert can safely pass a 100-year, 6-hour rainfall event per R645-301-742.323.

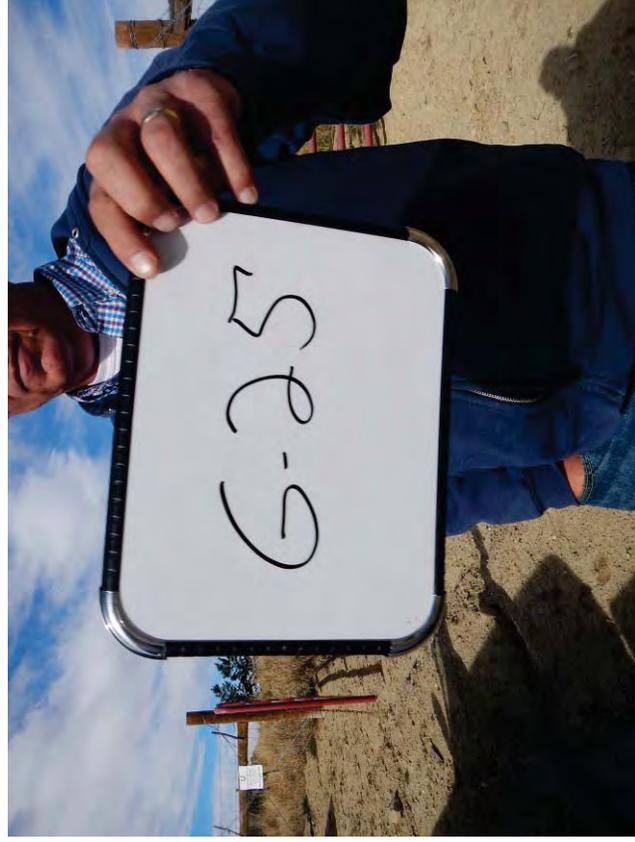
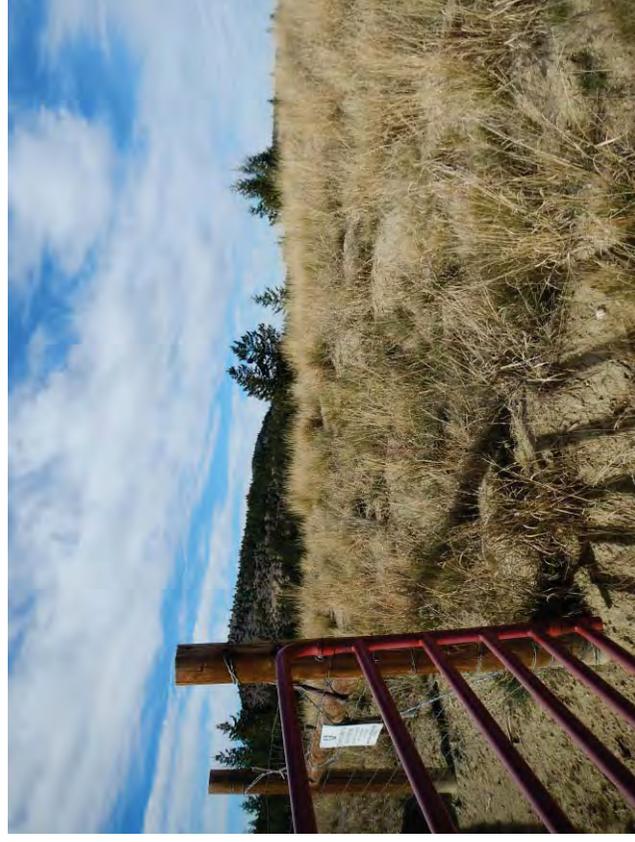
G-25: Site G-25 was reclaimed in June of 2013 and received Phase I bond release in 2014. The approximate original contour has been re-established and the site has been pocked. No evidence of off-site impacts was noted during the inspection.

G-25: This site is fenced, stable and well vegetated (mostly grasses and f orbs, some shrubs).

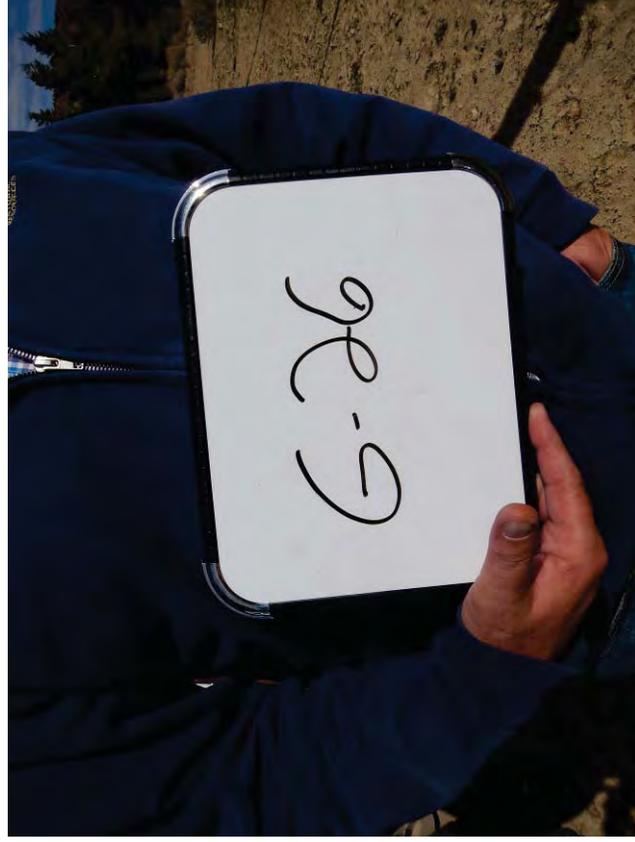
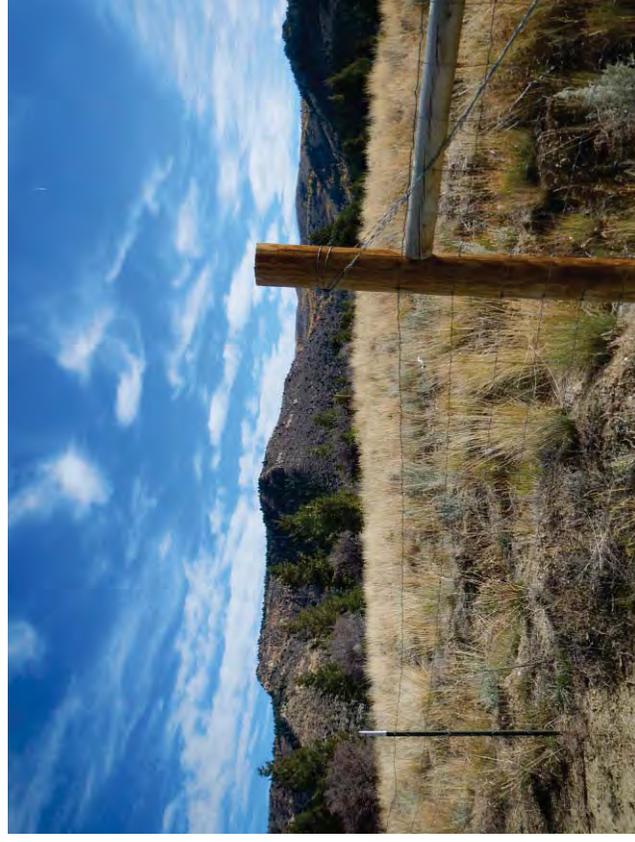
Site G-26

Site G-26: The site has been returned to original contour and pocked. Final reclamation of the site was completed in June of 2013 and received Phase I bond release in 2014. No sign of off-site impacts/erosion were observed during the time of the inspection.

G-26: This site is fenced, stable and well vegetated. The site is located just off of the main road. The vegetation at this site included a noticeable amount of sagebrush

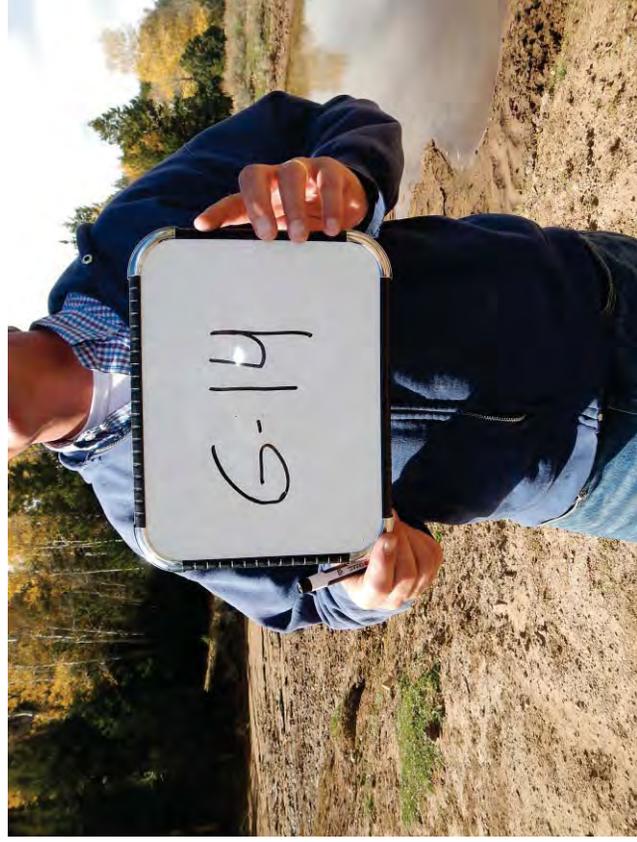
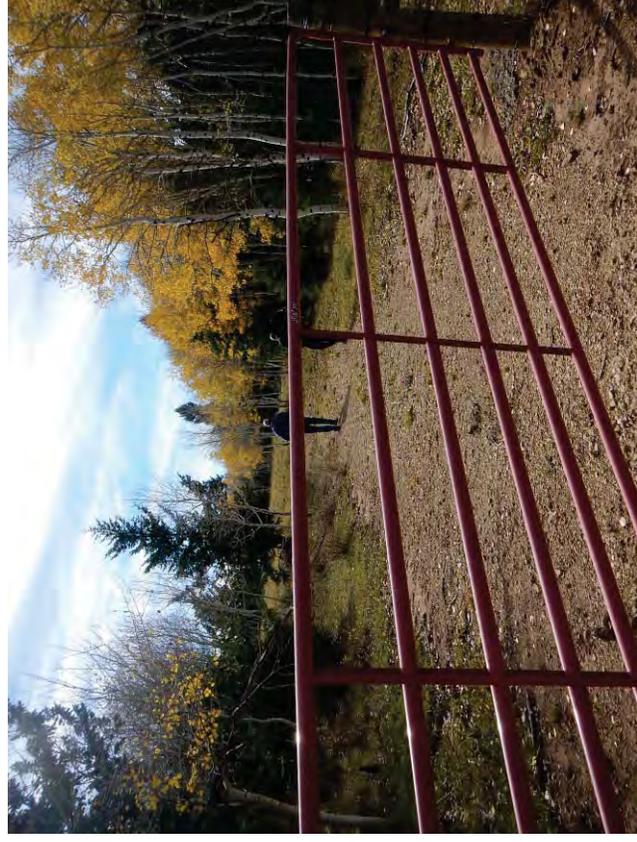
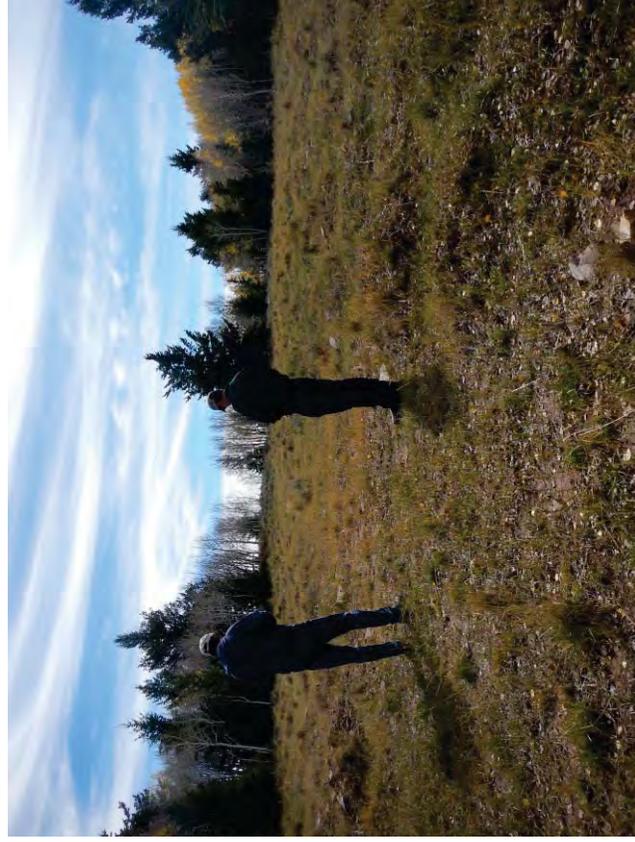
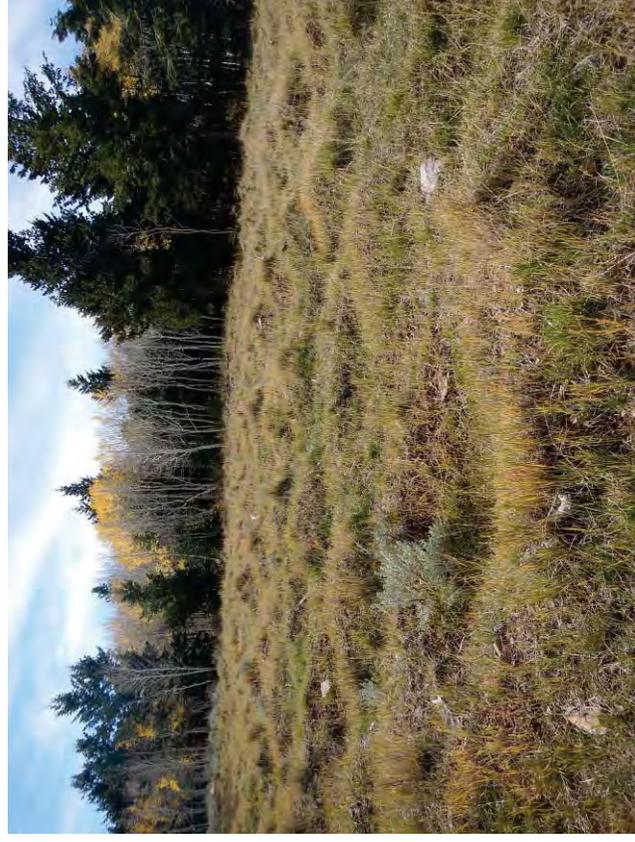
Site G-14

G-14: The site was reclaimed in June of 2010. Phase II bond release was approved for the site in 2014. The site was stable. No evidence of off-site impacts or erosion were noted during the inspection.

G-14: This site is located about 100 yards off the existing road. The site is fenced, stable and well vegetated. The pad is fairly level and was pocked during reclamation to promote the conservation of precipitation.
