Inspection Report

Permit Number:	C0070039
Inspection Type:	PARTIAL
Inspection Date:	Wednesday, October 12, 2016
Start Date/Time:	10/12/2016 7:30:00 AM
End Date/Time:	10/12/2016 4:00:00 PM
Last Inspection:	Tuesday, September 13, 2016

Permitee: **CANYON FUEL COMPANY**
 Operator: **CANYON FUEL COMPANY**
 Site: **DUGOUT CANYON MINE**
 Address: **PO BOX 1029, WELLINGTON UT 84542**
 County: **CARBON**
 Permit Type: **PERMANENT COAL PROGRAM**
 Permit Status: **ACTIVE**

Dugout Canyon Mine
Degas Facilities Inspection
10/12/2016

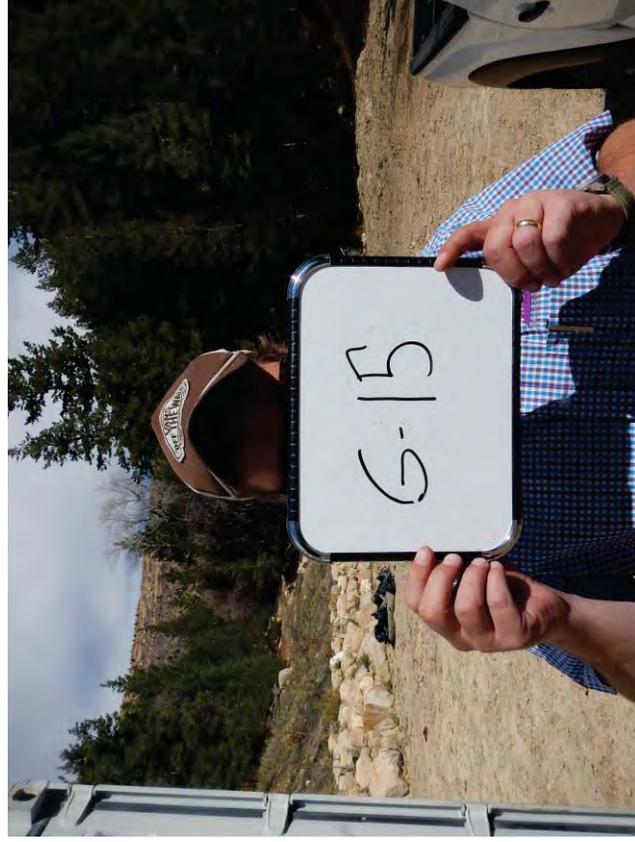
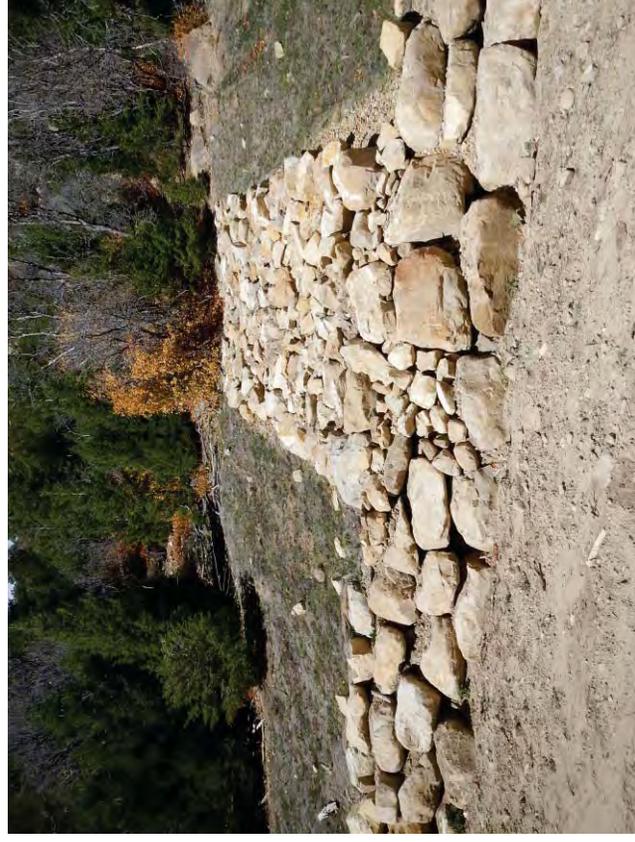
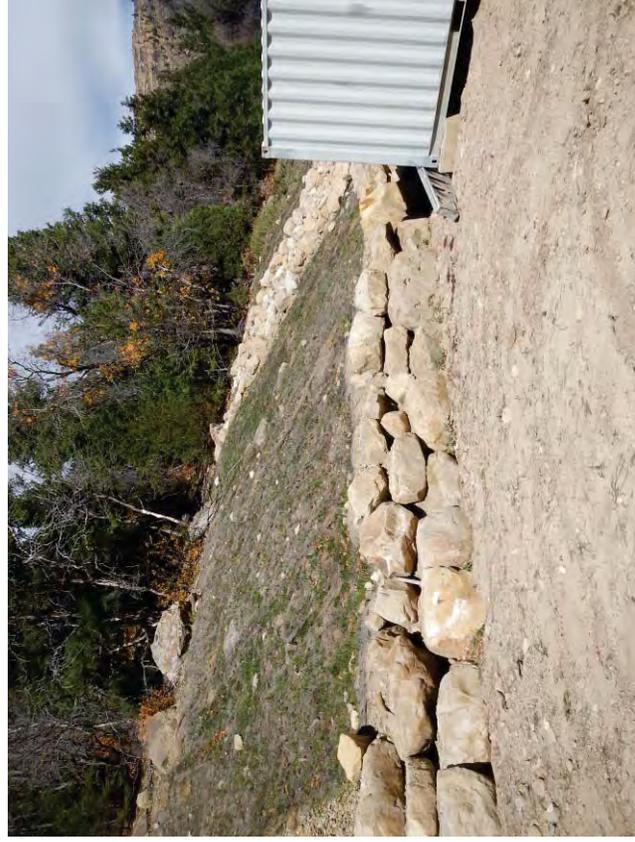
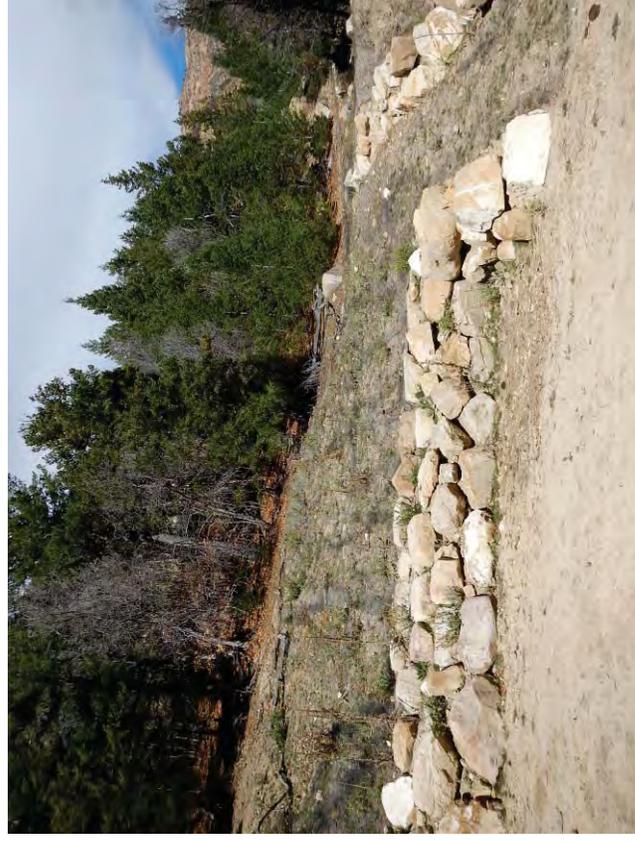
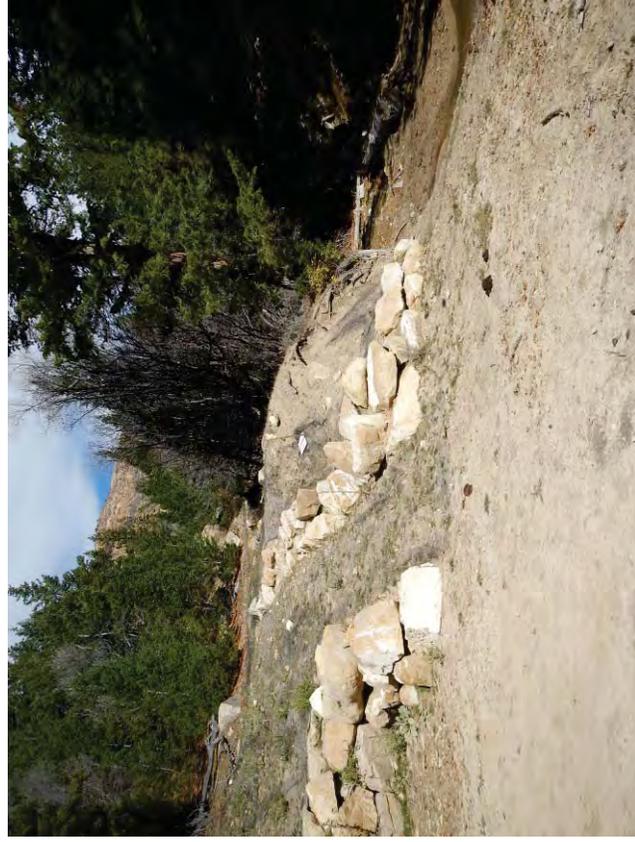
Site G-15

G-15: Final reclamation of the site was achieved in June of 2015. Bond release has not been sought by the Permittee for this degas site. The pad was constructed, but the gob gas vent hole was never drilled. The pad is located directly adjacent to the pre-existing main access road. No evidence of instability or off-site impacts was noted during the inspection. A rock-wall terrace and two rock-lined diversion channels have been constructed at the site. The Permittee must provide revised as-built drawings as well as supporting hydrologic calculations that the rock-lined channels have been designed to safely pass a 100-year, 6-hour event as required per R645-301-742.323.

G-15: This site was reclaimed in 2015. It is fenced and stable. The vegetation is just starting to show through the netting and appears to be doing well at this stage of reclamation.

a.Rock Wall Terrace- They need to submit an as-built drawing that shows the rockwall terrace.

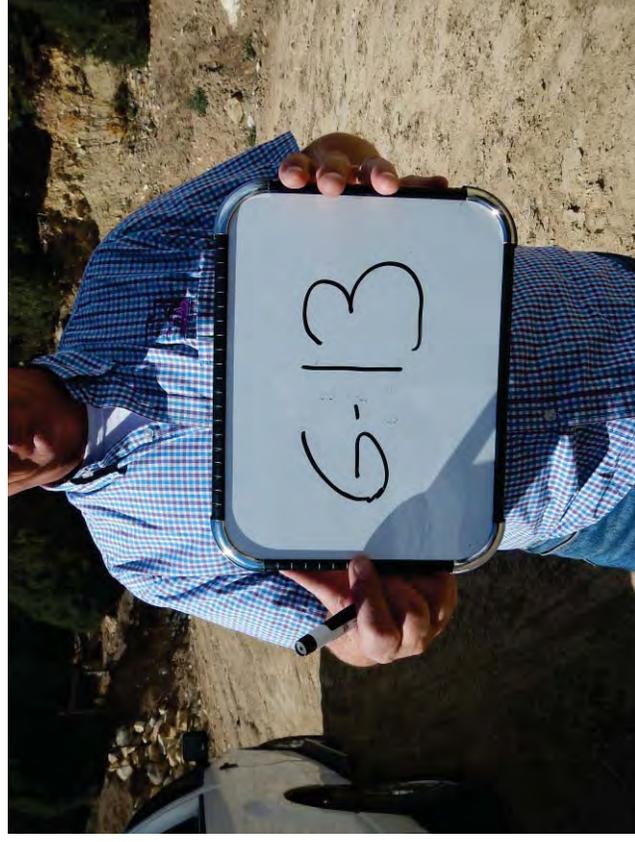
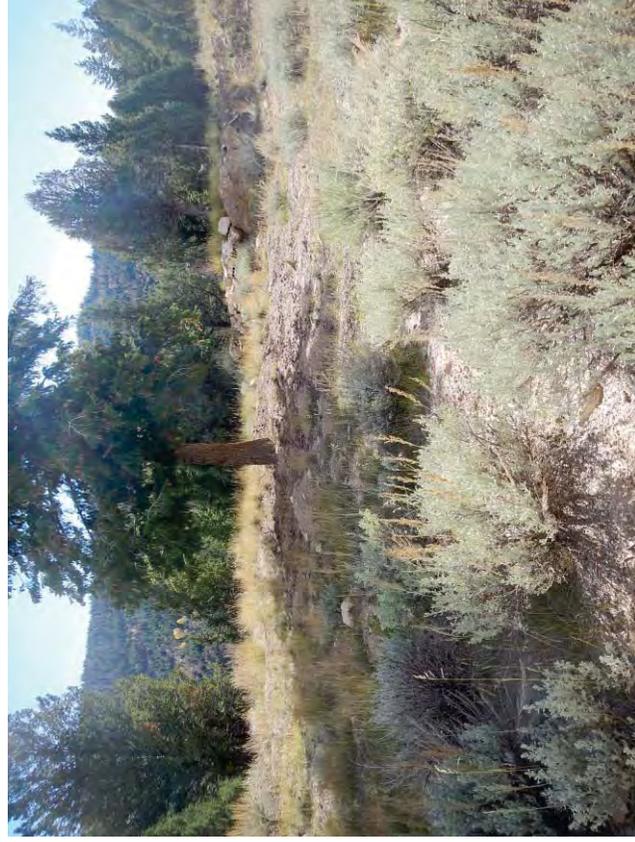
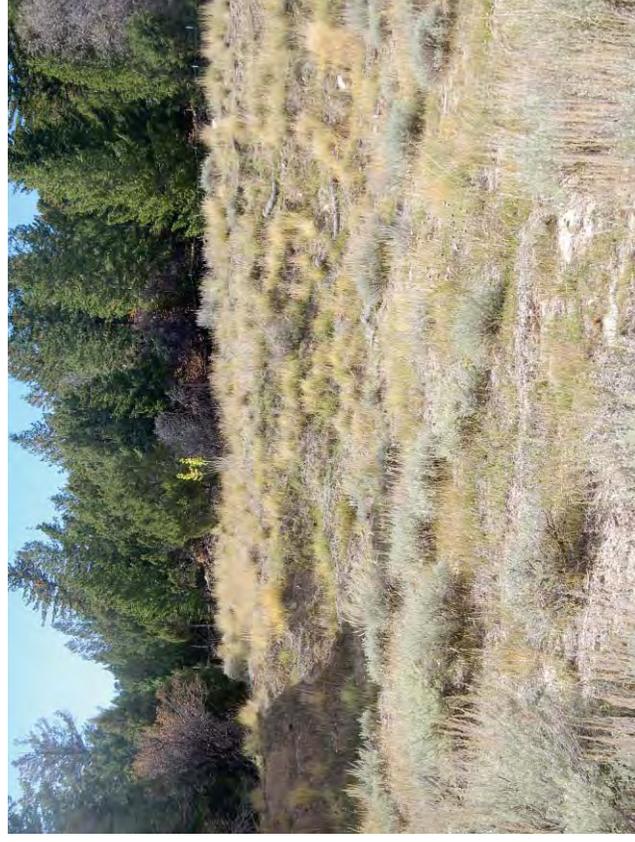
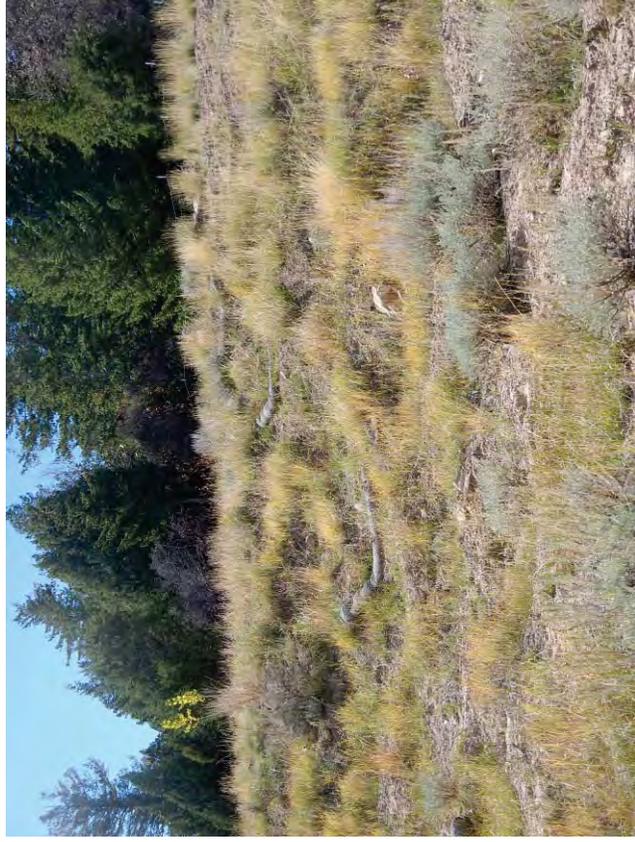
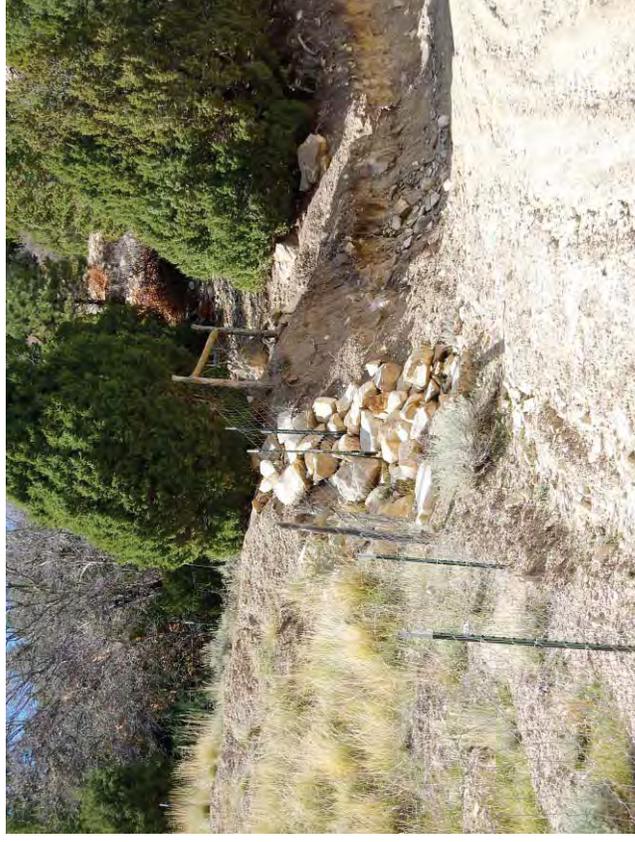
Site G-13

G-13: The site was reclaimed in 2009 and received Phase II bond release in 2014. No evidence of off- site impacts was observed during the field inspection.

G-13: This site is fenced, stable and well vegetated. The sagebrush is also well established as it was reclaimed in 2009.

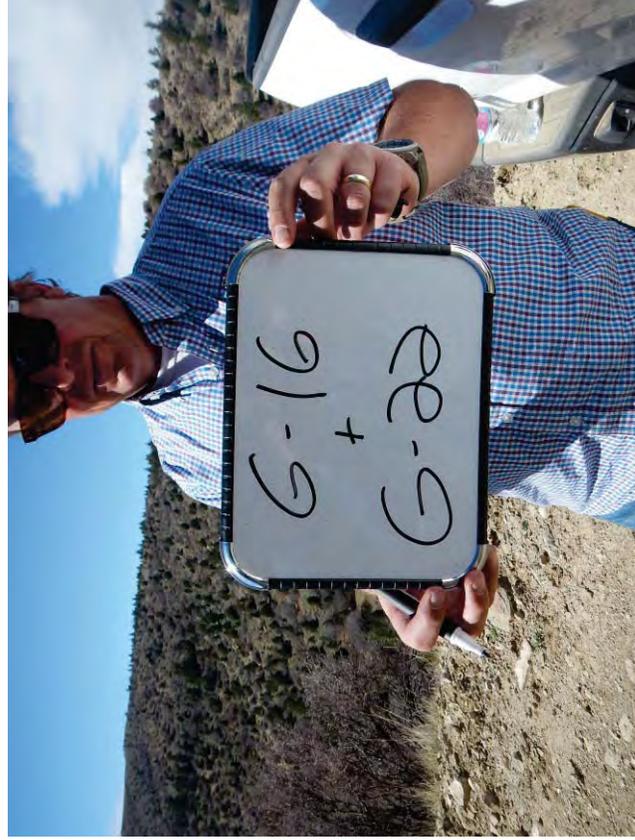
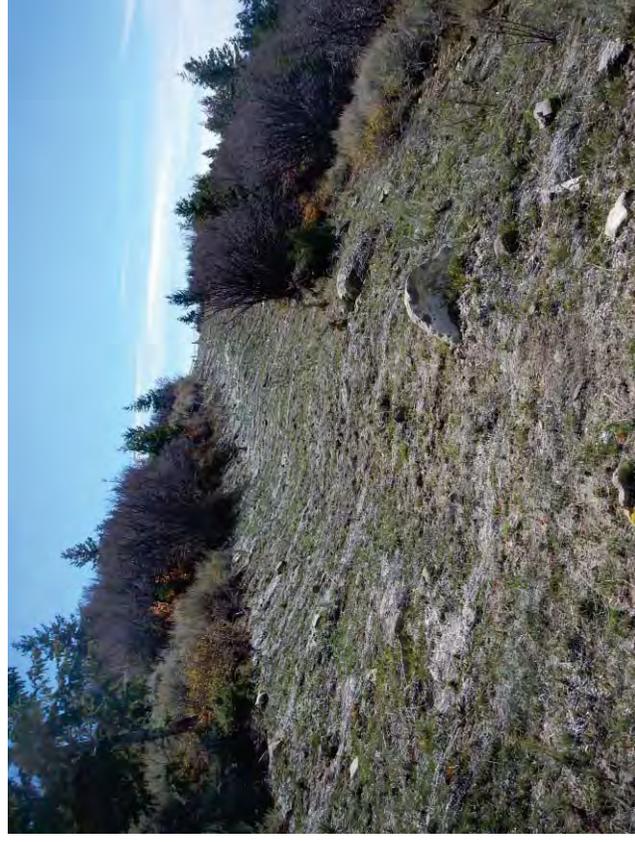
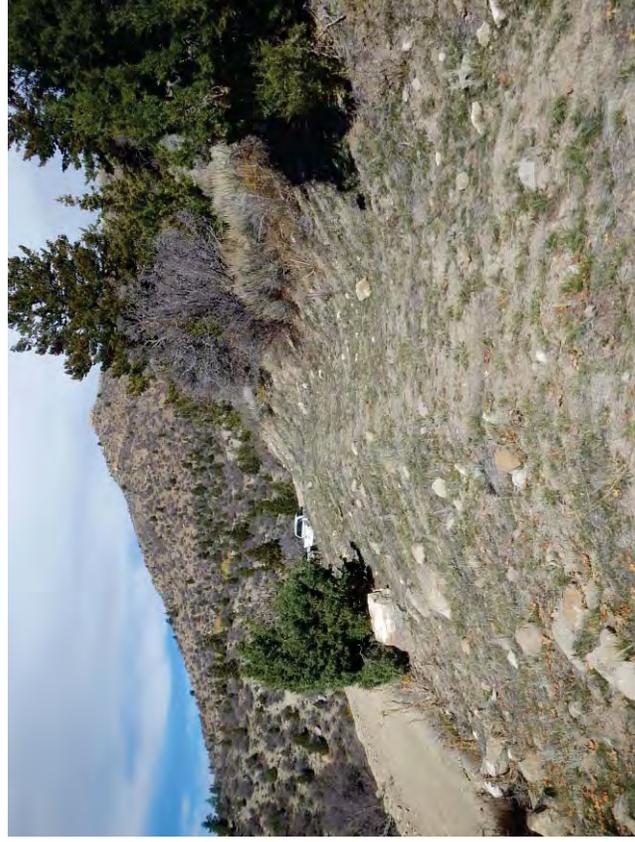
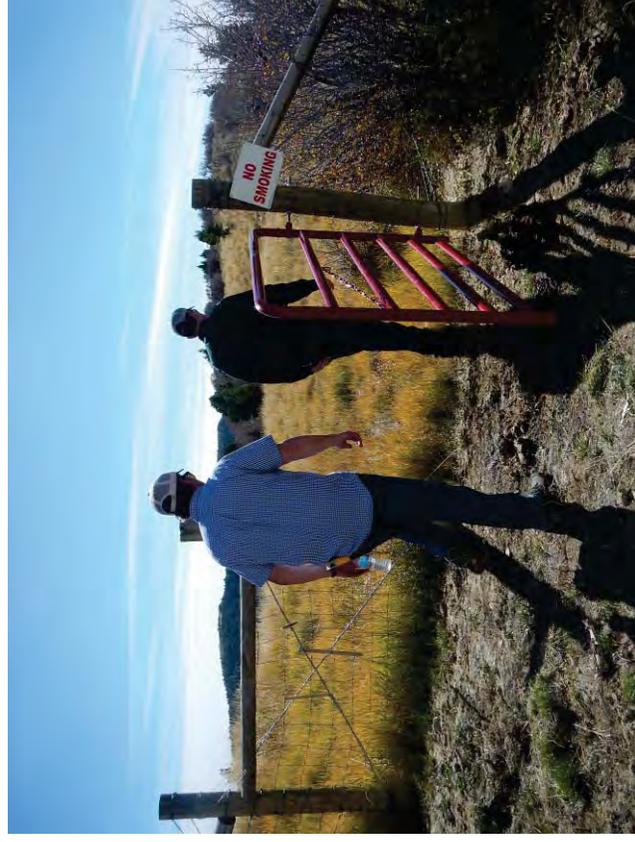
Site G-16

G-16: The degas pad was reclaimed in June of 2013. The access road to the pad was reclaimed in 2014. Phase I bond release was approved in 2014. The access spur road to G-16 was observed to be stable with no signs of erosion or off-site impacts. The degas pad was found to be in similar condition (i.e. stable, no off-site impacts observed). The access road between G-16 and degas pad G-22 has been reclaimed and found to be in stable condition (i.e. no off-site impacts and/or erosion were noted during the field visit). The access road between G-16 and G-22 was reclaimed in 2013.

G-16: This site is fenced, stable and well vegetated. This site is located on a knoll of predominately conifer and juniper interspersed with pockets of sagebrush and serviceberry. The reclaimed site is mainly a grass/forb vegetative community.

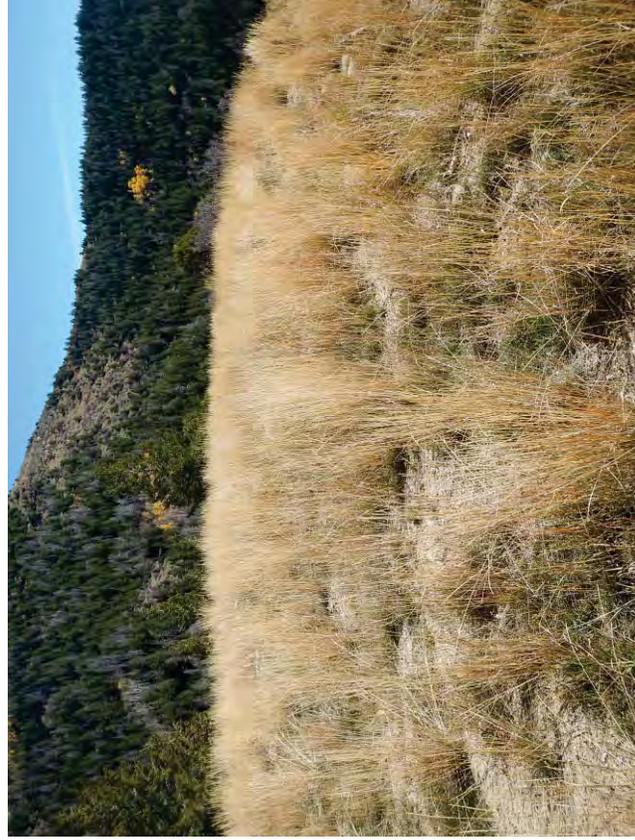
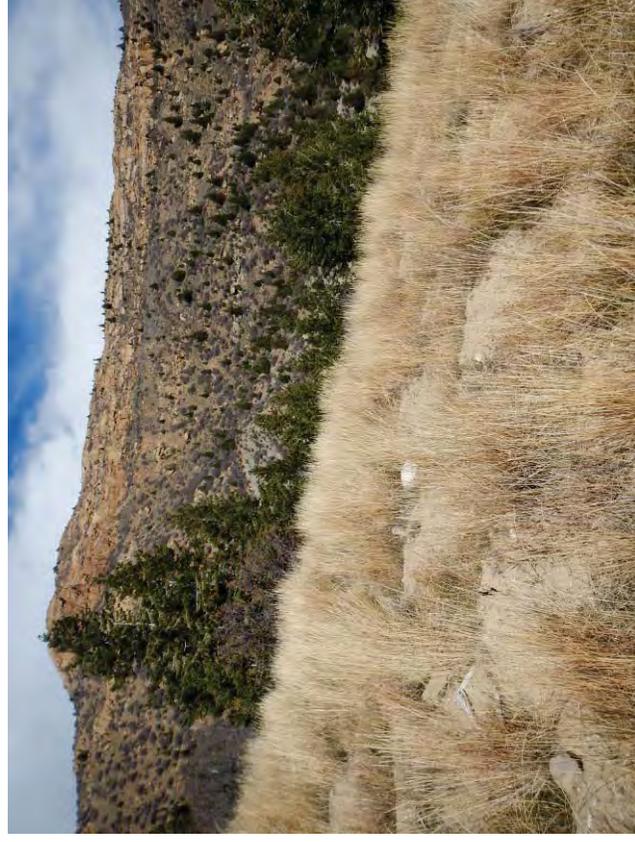
Site G-22

G-22: The site has been fully reclaimed and received Phase I bond release in 2014. The degas pad was found to be in excellent condition. No signs of erosion or off-site impacts were noted during the field inspection.

G-22: This site is fenced, stable and well vegetated. This site is also located on a knoll of predominately conifer and juniper interspersed with pockets of sagebrush and serviceberry. The reclaimed site is mainly a grass/forb vegetative community. The access road to these two sites (16 & 22) has been reclaimed and is fairly heavily grazed by comparison to the fenced pads.

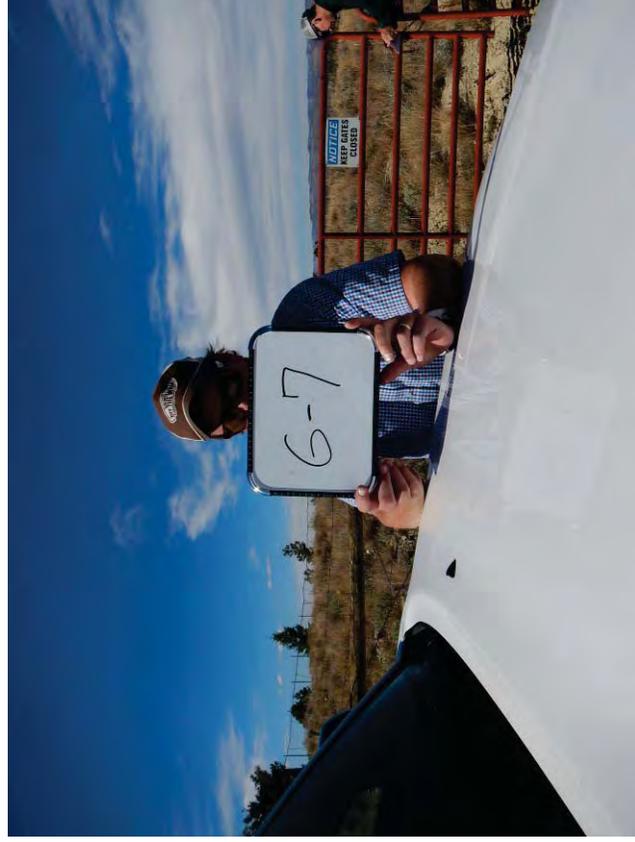
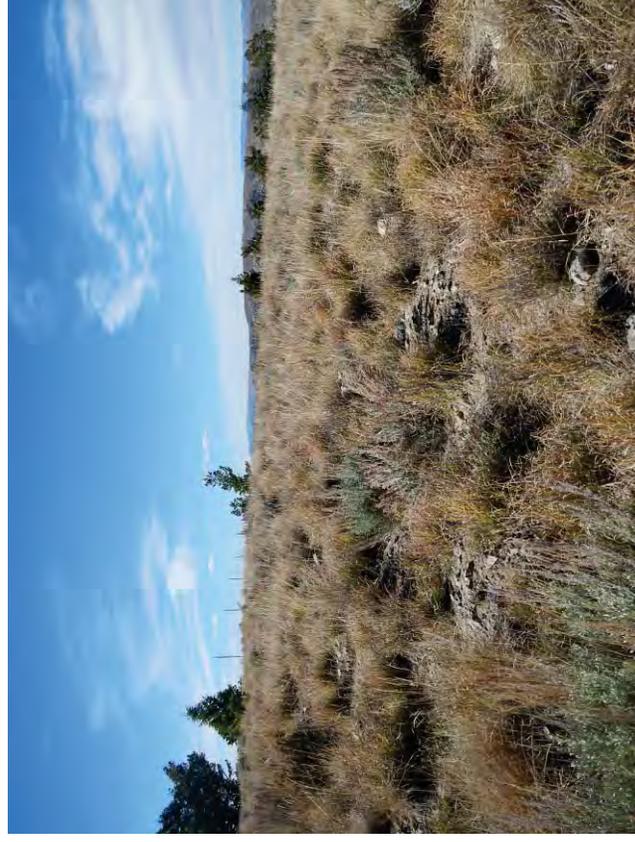
Site G-7

G-7: The site was reclaimed in 2009 and received Phase II bond release in 2014. No evidence of off-site impacts was observed during the field inspection. The site is well vegetated.

G-7: This site is fenced, stable and well vegetated. This site is predominately grass/sagebrush. The outlying vegetative community is mixed conifer sagebrush with some grasses and forbs in the understory.

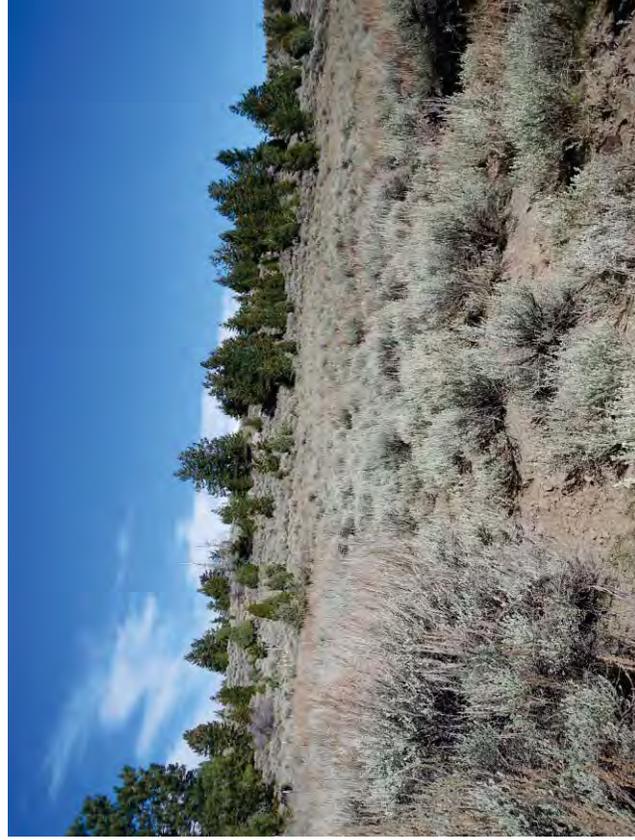
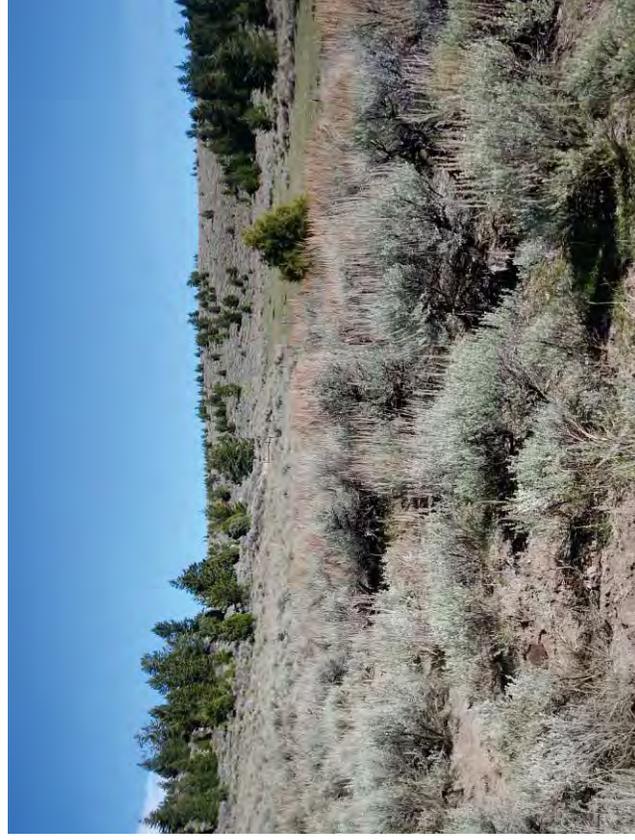
Site G-2

G-2: The site was reclaimed in June of 2009. No evidence of off-site impacts was observed during the field inspection. Musk thistle had been an issue at this site in years past. However; during the field inspection no evidence of musk thistle was observed. The site was noted to be in stable condition with no evidence of erosion or off-site impacts.

G-2: This site is fenced, stable and well vegetated. This site is also predominately grass/sagebrush. The outlying vegetative community is mixed conifer sagebrush with some grasses and forbs in the understory.

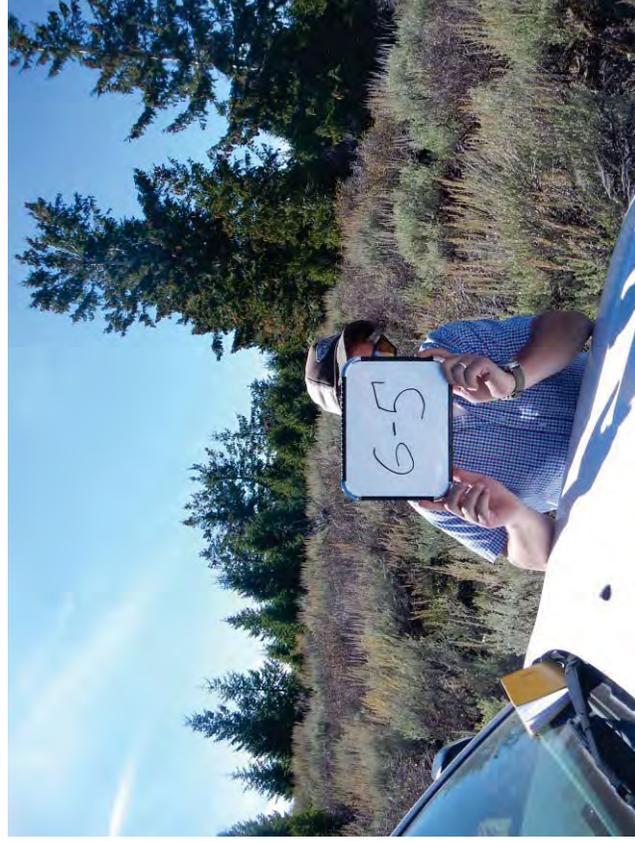
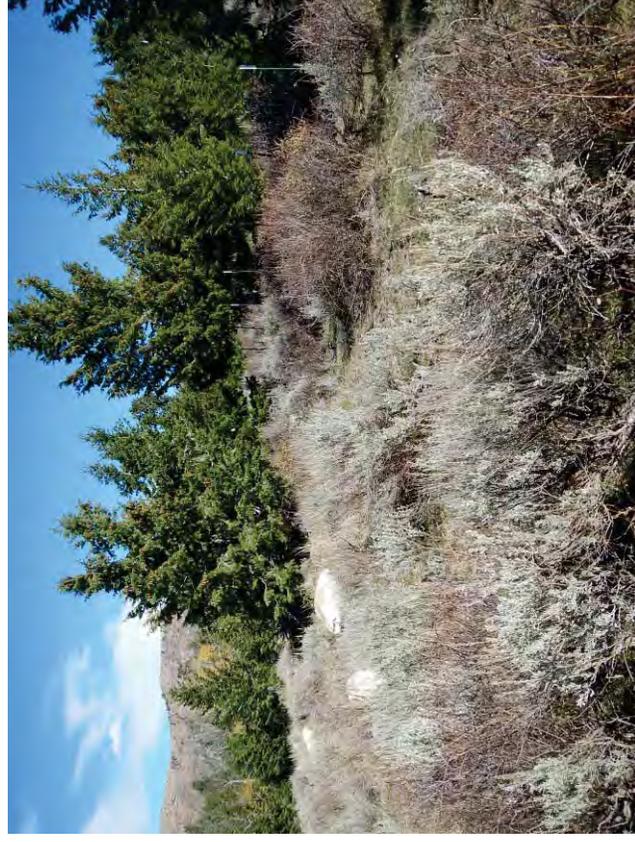
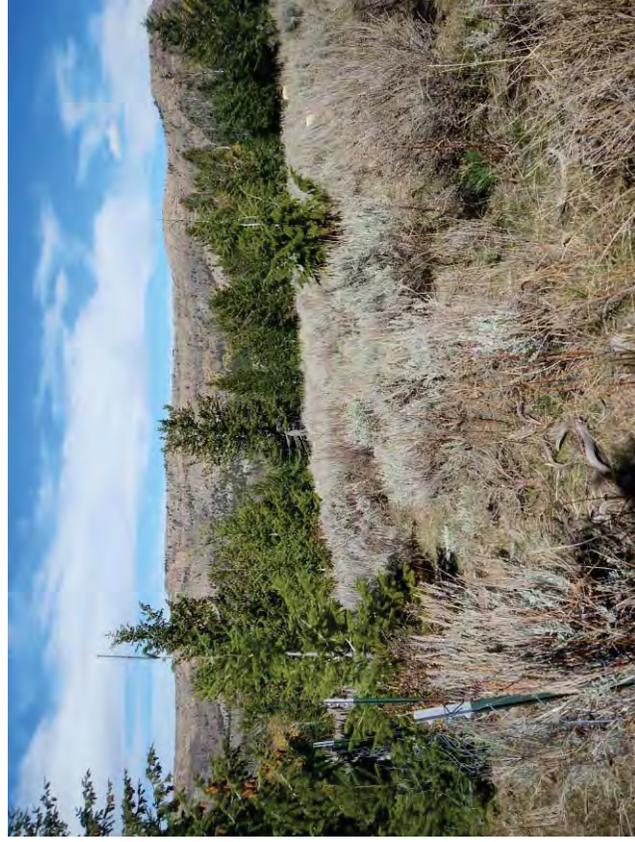
Site G-5

G-5: The site was reclaimed in June of 2009. Phase II bond release was approved in 2014. No evidence of off-site impacts or instability was observed during the field inspection.

G-5: This site is fenced, stable and well vegetated. This site is predominately a mature sagebrush snowberry vegetative community with some grass/forb understory perhaps due to some grazing. The shrubs are approximate 4' tall. The outlying vegetative community is conifer with a grass/forb understory.

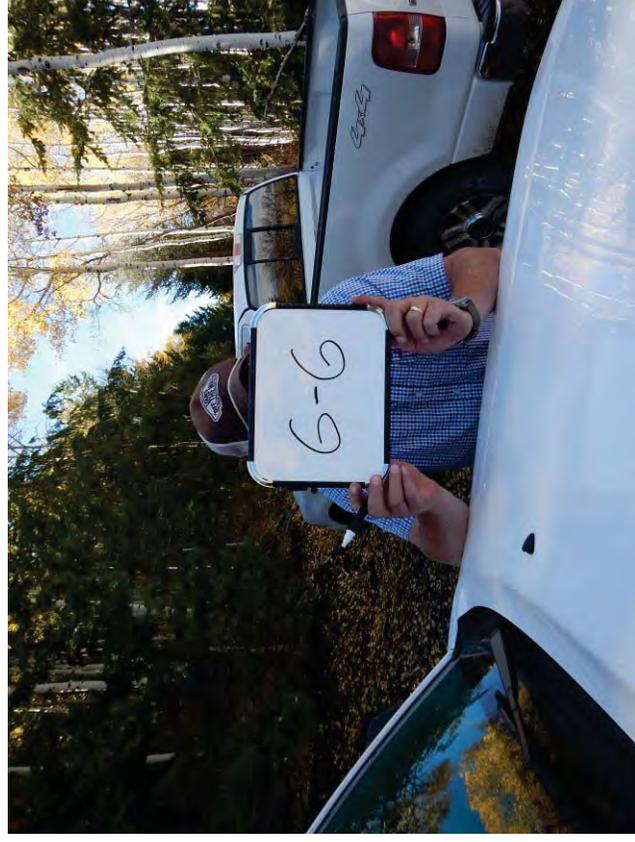
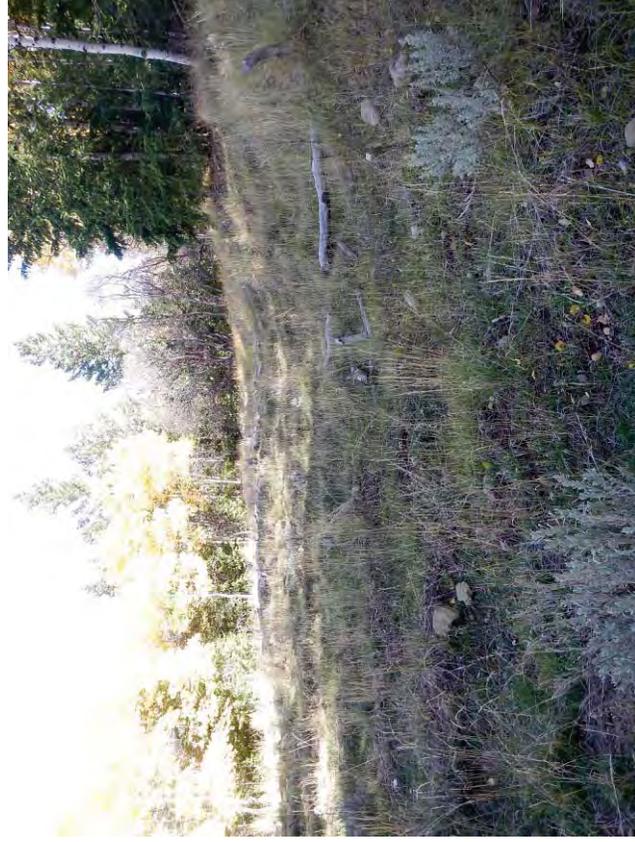
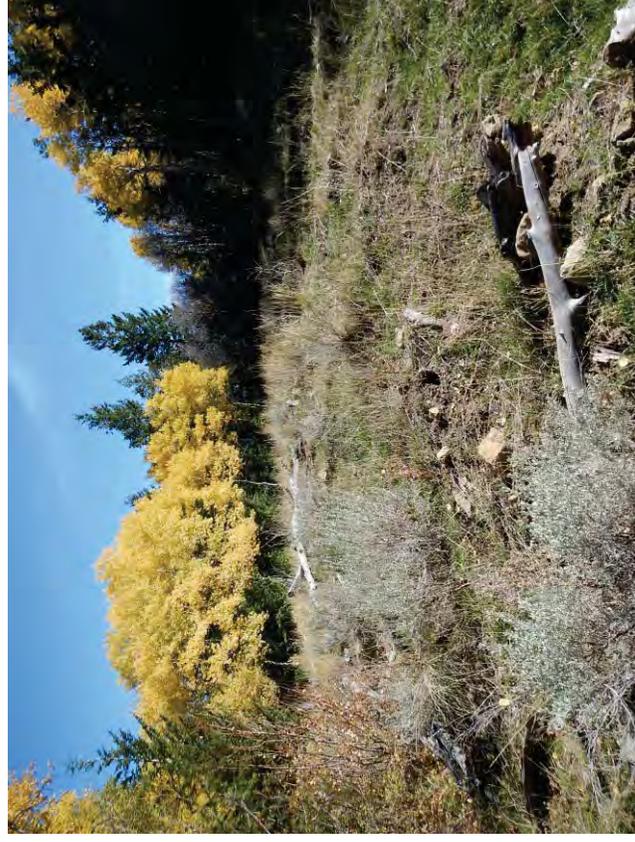
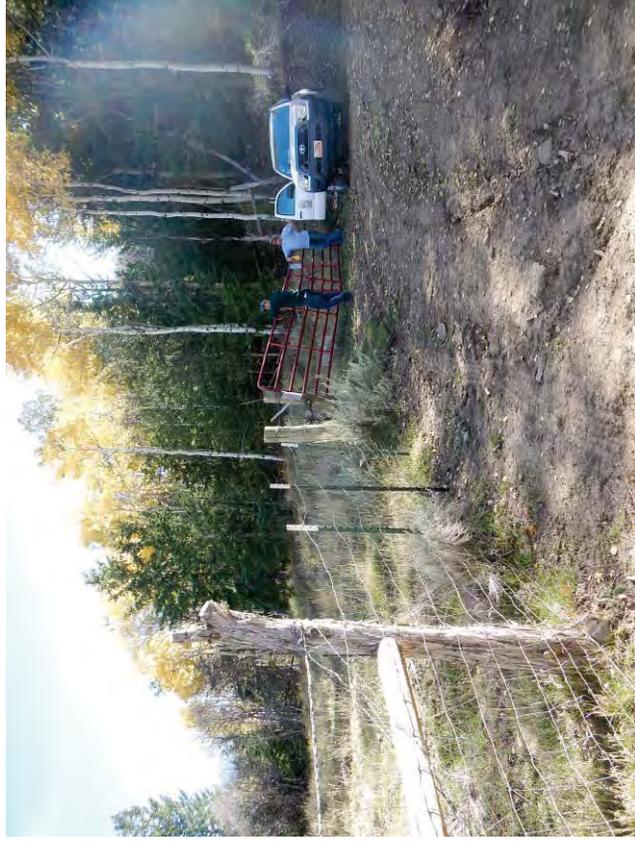
Site G-6

G-6: The site was reclaimed in June of 2007. Phase II bond release was granted in 2014. No evidence of off-site impacts was observed during the field inspection. Vegetation shows improvement from the previous year.

G-6: This site is fenced, stable and well vegetated. It is currently a sagebrush grass vegetative community with some evidence of forbs. Volunteer trees (conifer & aspen) and shrubs (snowberry & service berry) may add to the species composition during the remaining portion of the liability period. The outlying vegetative community is

mixed conifer aspen with a grass/forb understory.
