Division of Oil, Gas and Mining

Inspection Report

Permit Number:	C0070039
Inspection Type:	PARTIAL
Inspection Date:	Wednesday, November 01, 2017
Start Date/Time:	11/1/2017 7:30:00 AM
End Date/Time:	11/1/2017 2:00:00 PM
Last Inspection:	Monday, October 16, 2017

Permitee: **CANYON FUEL COMPANY**
 Operator: **CANYON FUEL COMPANY**
 Site: **DUGOUT CANYON MINE**
 Address: **PO BOX 1029, WELLINGTON UT 84542**
 County: **CARBON**
 Permit Type: **PERMANENT COAL PROGRAM**
 Permit Status: **ACTIVE**

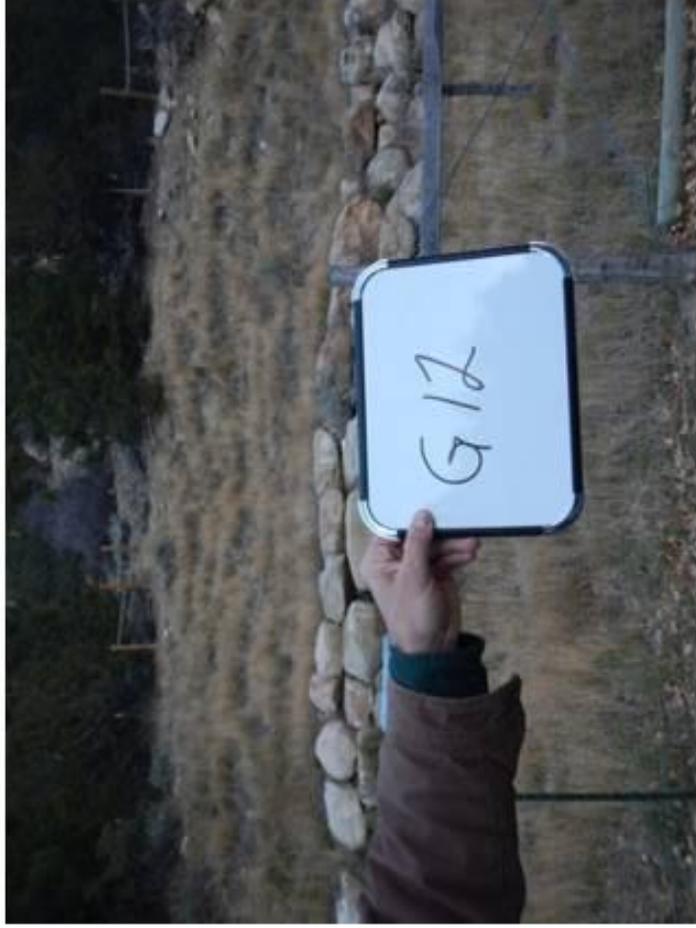
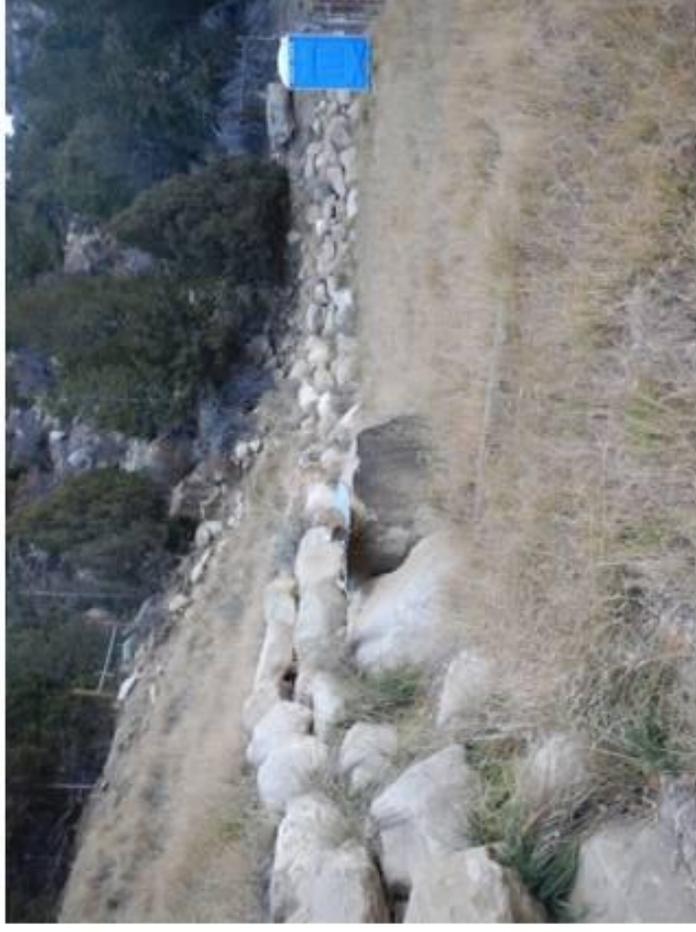
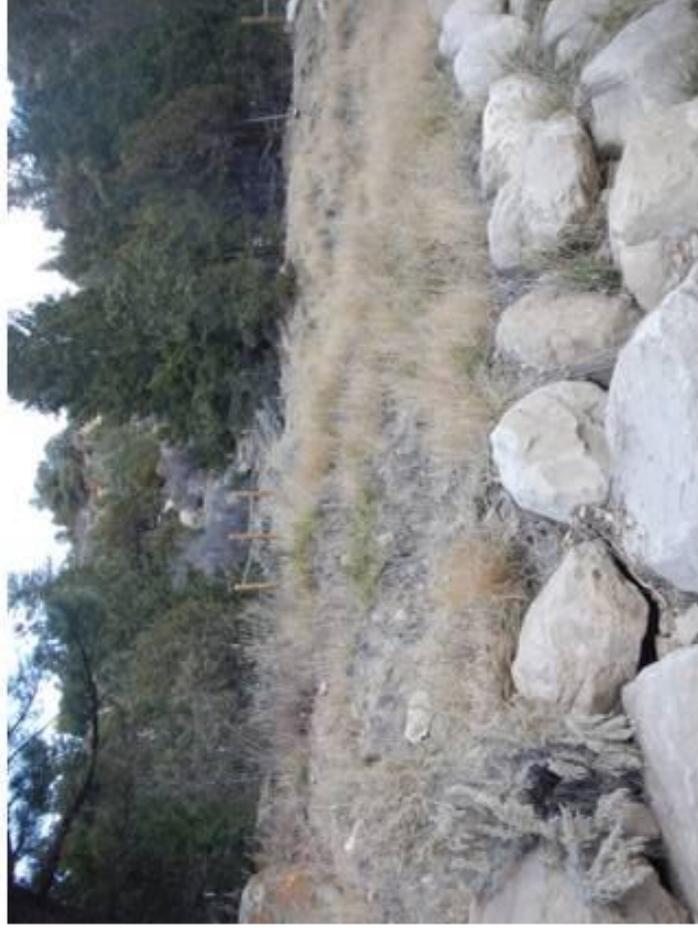
Site G-12

G-12: The site was reclaimed in 2011. A rip rap retaining wall was constructed on a portion of the highwall area. A rip rap diversion channel has been installed divert runoff around the pad area. No evidence of off-site impacts was noted during the field inspection. The site received Phase II bond release in 2014. A rockwall terrace was constructed as part of the final reclamation.

G-12: The site is fenced, well vegetated and stable.

a.Rock Wall Terrace- Permittee needs to submit an as-built drawing showing the rock wall terrace. This drawing is expected to be submitted by June 30, 2018.

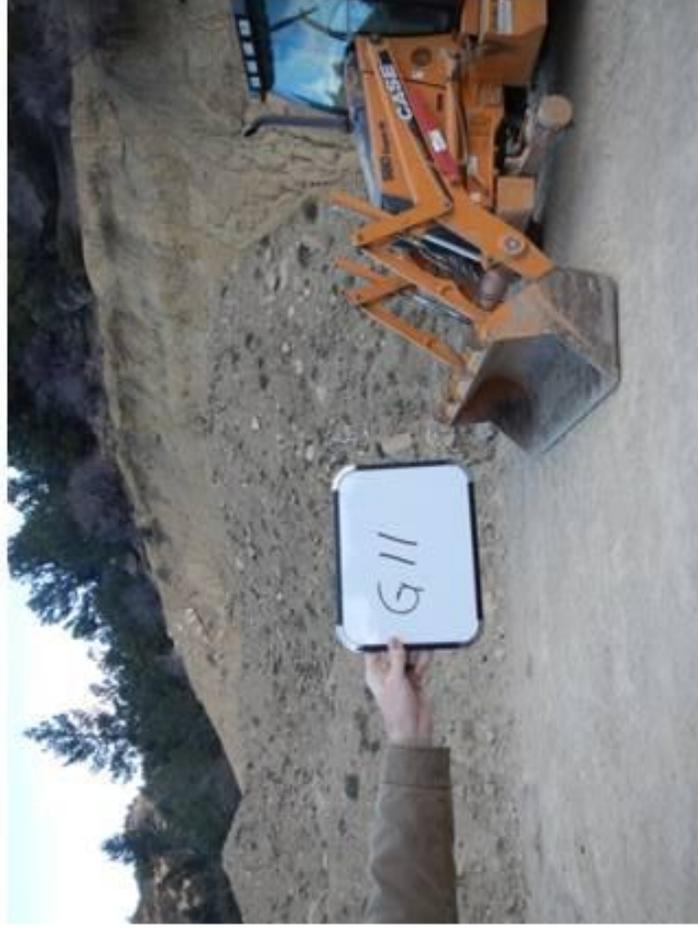
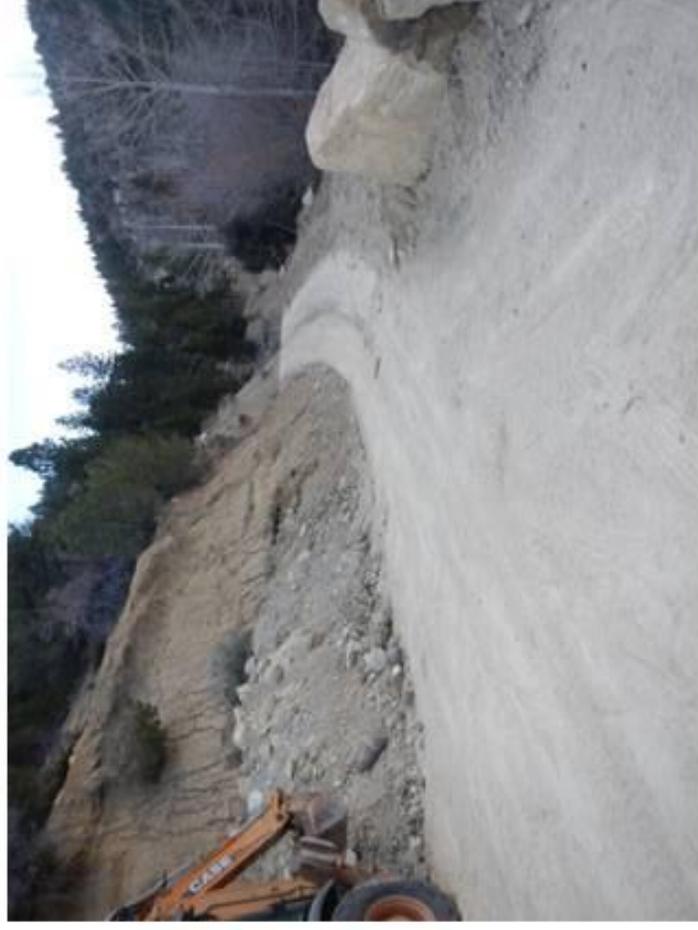
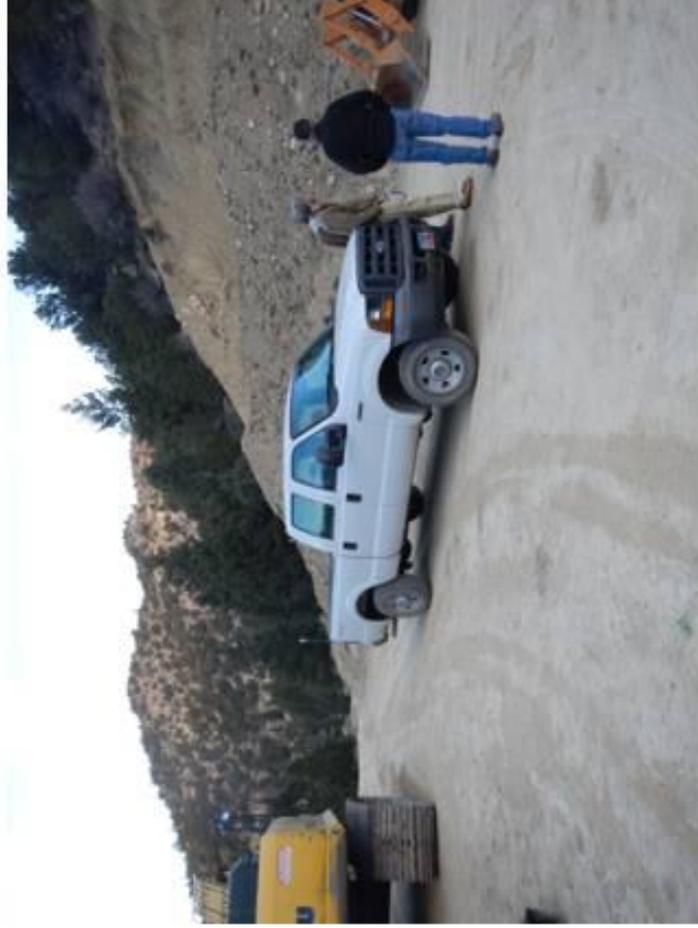
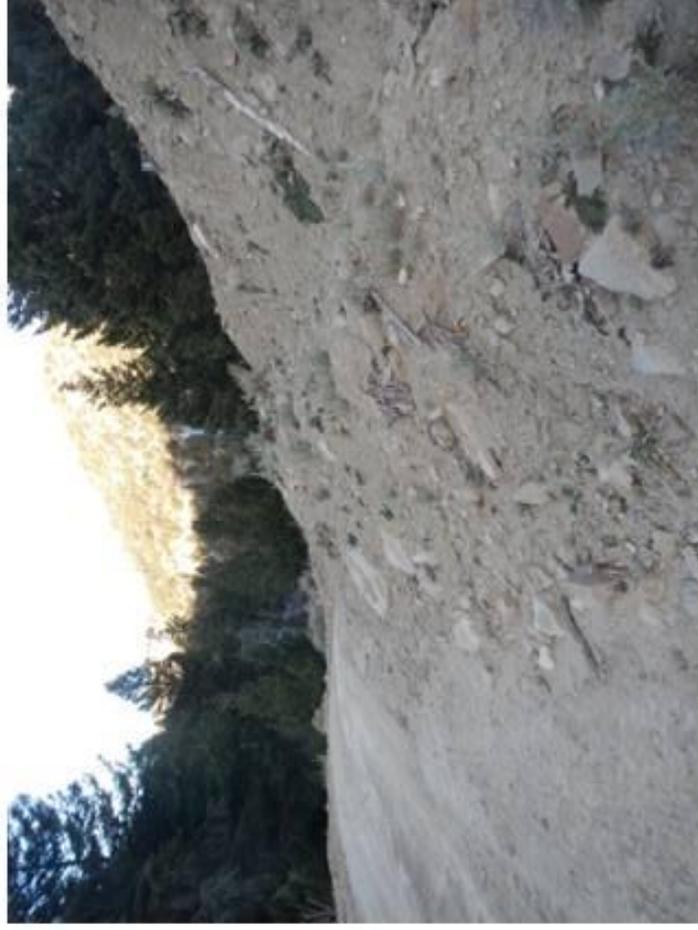
Site G-11

G-11: The site remains un-reclaimed. The site is being utilized as a staging area for the final reclamation work to be conducted on the AMV access road. The site was stable. No evidence of off-site impacts or additional suspended solids leaving the disturbed area was noted during the inspection. The landowner would like to keep a wide spot in the road.

G-11: This site is currently used as a staging area for reclamation activities on portions of the access road and has not been reclaimed or fenced. Interim seeding upslope from the pad would be beneficial to minimize the minor erosion on the slope. There was a back-hoe, some new and some old waddles and some debris located on the pad at the time of the inspection. The debris should be removed before winter sets in.

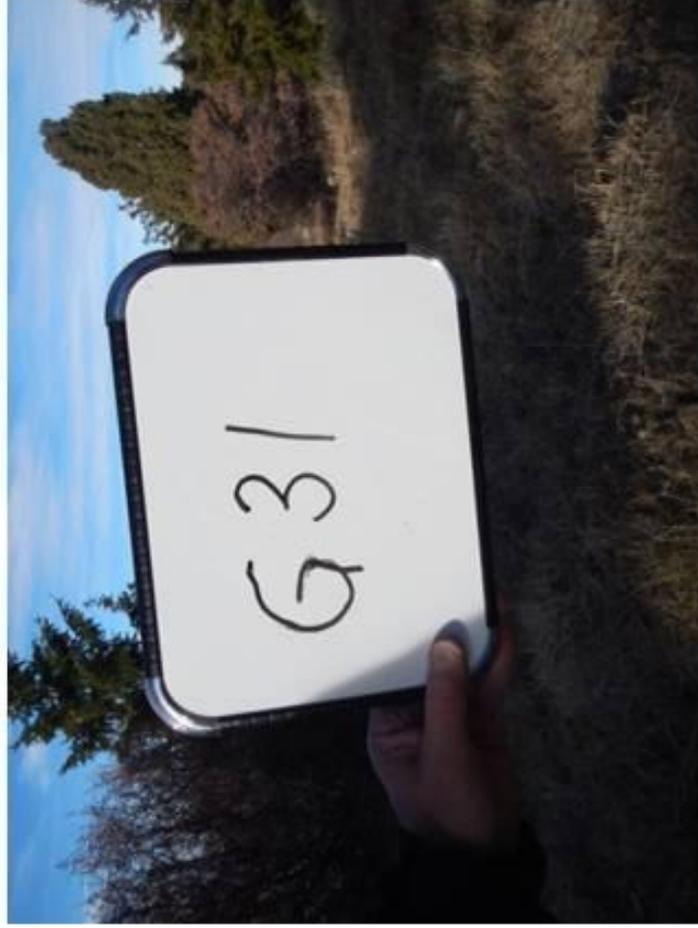
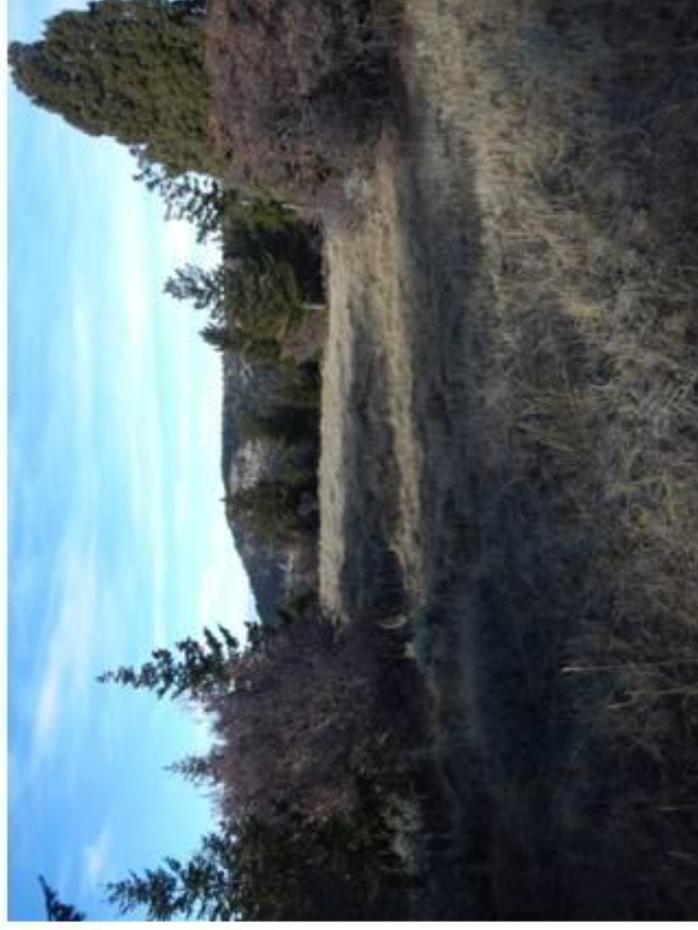
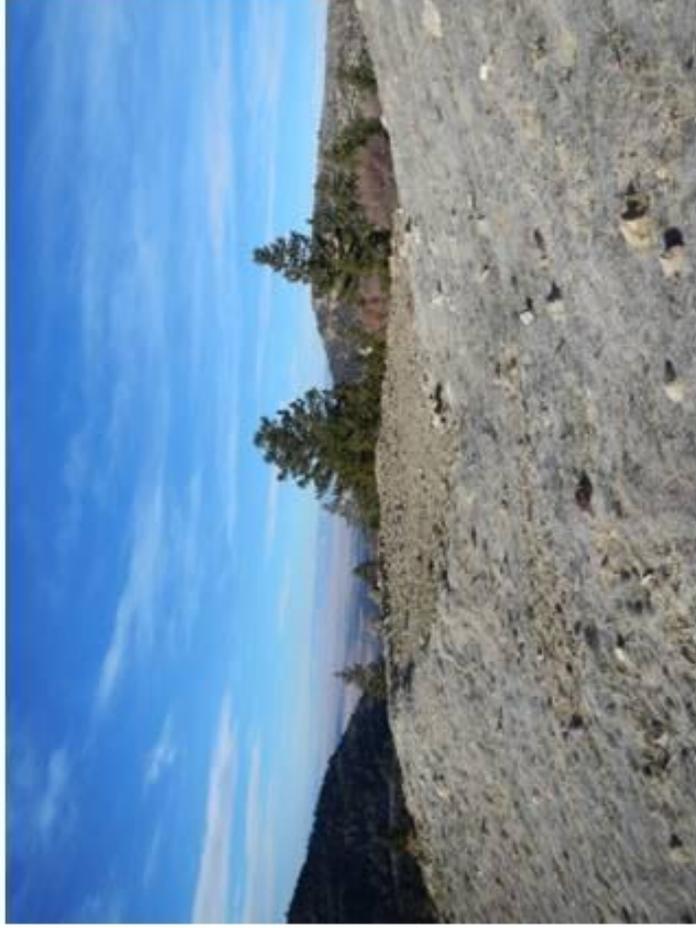
Site G-31

G-31: Reclamation work for this degas pad was completed in June of 2013. The small access/spur road to the pad site shows signs of cattle grazing impacts. The vegetation on this access road has been impacted by grazing activity. The degas pad itself was found to be in excellent condition. The pad was well vegetated and did not show evidence of instability and/or erosion. The pad received Phase I bond release in 2014.

G-31: This well site is located approximately 250' beyond the reclaimed access road. It is fenced and well vegetated. The reclaimed portion of the access road is not fenced and has been grazed fairly heavily. Alternative measures may need to be employed to ensure the standards for success and the postmining land-use can be achieved.

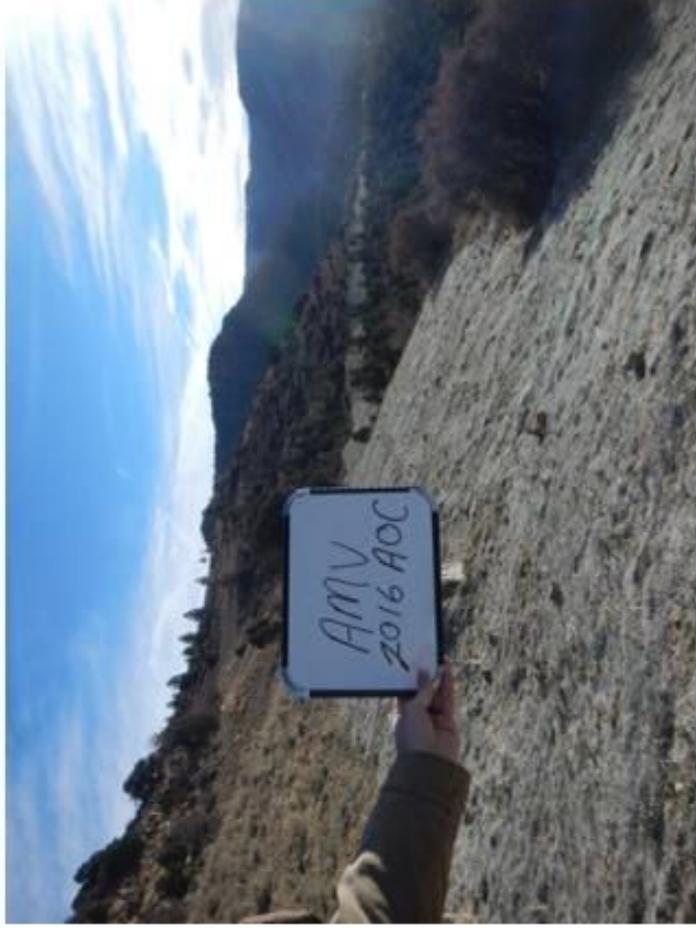
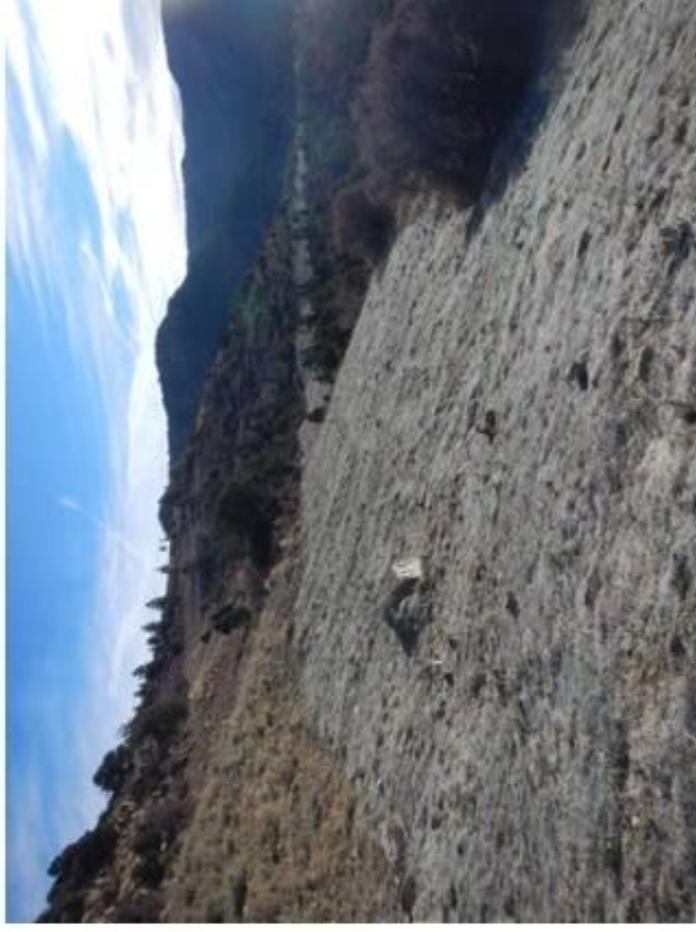
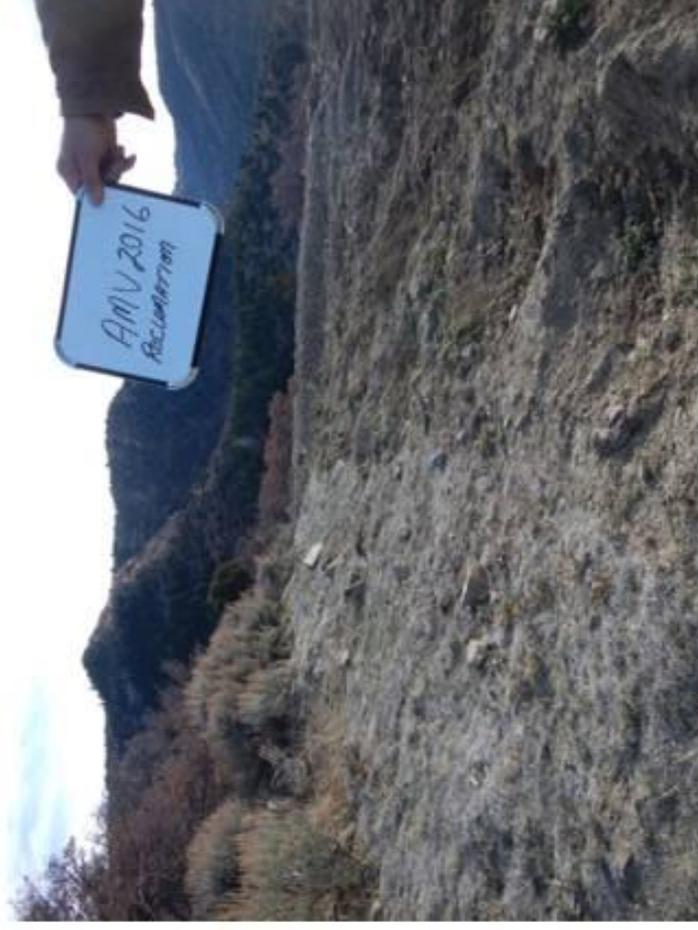
AMV 2016 AOC

AMV Road: The entire length of the AMV road was walked during the inspection. No evidence of off-site impacts was noted during the inspection. Sediment control measures (excelsior logs and/or silt fence) were observed along the AMV outslope. The sediment control measures along the entire length of the road were functioning

as designed and in good shape. Additionally, the water bars located throughout the length of the AMV road were observed to be clear of debris, stable and functioning as designed. The inlets and outlets to all of the water bars were observed to be clear of accumulated sediment and debris as a result of the recent rainfall events.

Reclamation work on the AMV has commenced. Heavy equipment has been mobilized to the site. Work was not being conducted during the time of the inspection. According to Bill King and David Spillman (Dugout Mine representatives) the reclamation of the road will be conducted in four phases (approximately 1,200' each). The Permittee has completed the first two phases (From G-18 to Topsoil pile STP-6) thus far. The road cut/prism in this section will be removed entirely during the reclamation work. Discussion between the land owner and the Permittee has taken place and it has been agreed to fully reclaim to the AOC the AMV road. A small horse trail was made in the area, separate from the AMV road, to provide the land owner access to the area.

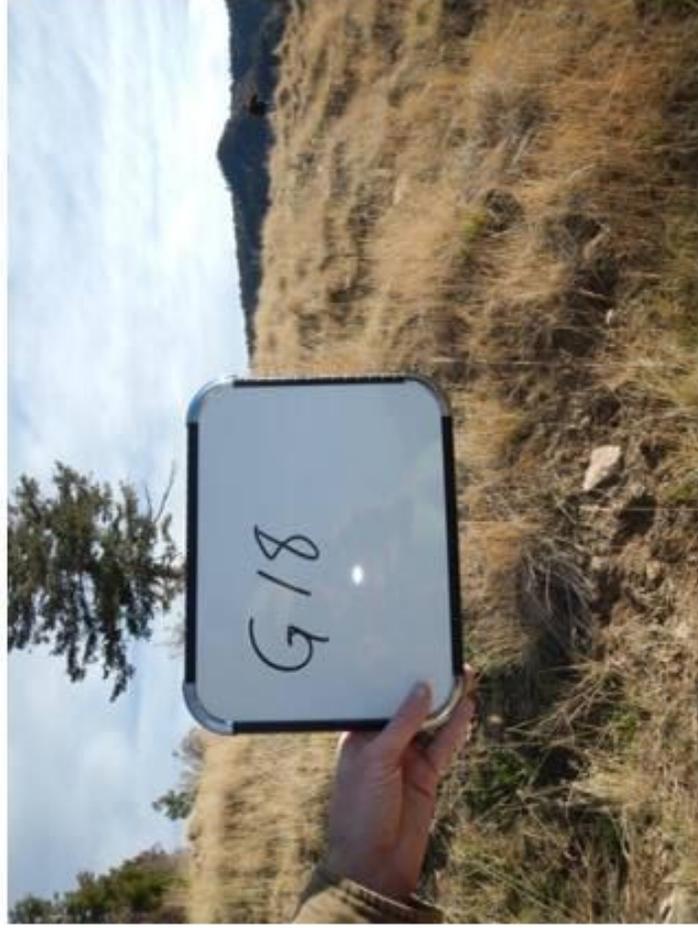
Site G-18

G-18: The site was graded and topsoil was partially replaced in 2011 followed by full reclamation including hand seeding and mulching during the 2012 construction season. The access road leading to G-18 was reclaimed in 2012 and is in good repair. The excelsior matting is stable on the reclaimed slope. There were no rills or gullies noted. The degas pad was noted to be in excellent condition and well vegetated. . No evidence of erosion and/or instability was noted. The site received Phase II bond release in 2014.

G18: This site is located approximately 200 yards East of the corresponding access road. It is fenced, well vegetated and stable. The reclaimed portion of the access road is not fenced and is dominated mainly by shrubs. Grazing appears to be minimal as there is not much evidence of grass species on the reclaimed road but the vegetation is well established. Alternative measures may need to be employed to ensure the standards for success and the postmining land-use can be achieved. Reclamation of the main road is ongoing.

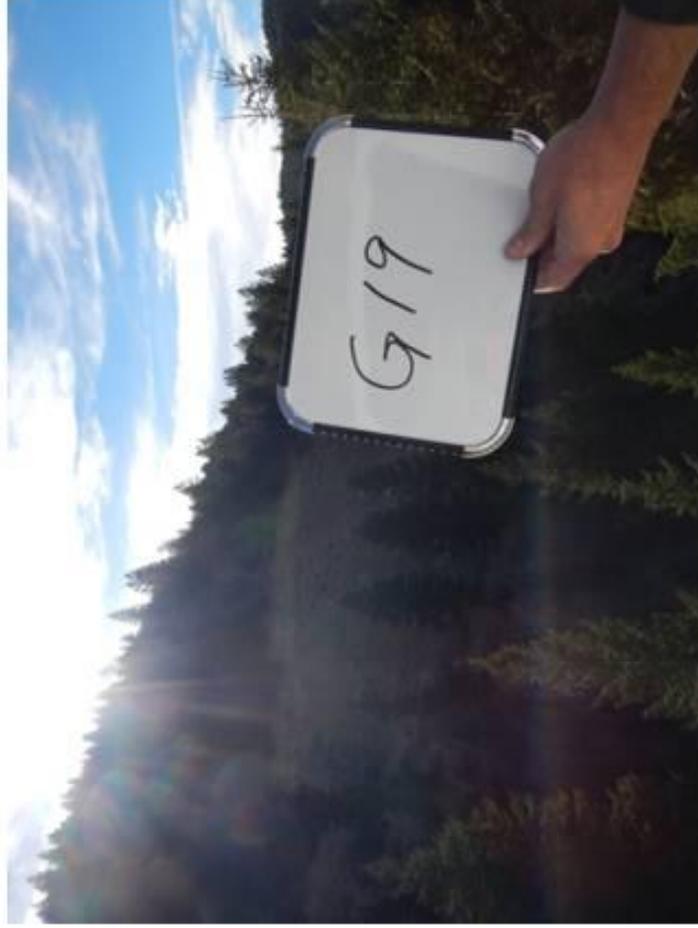
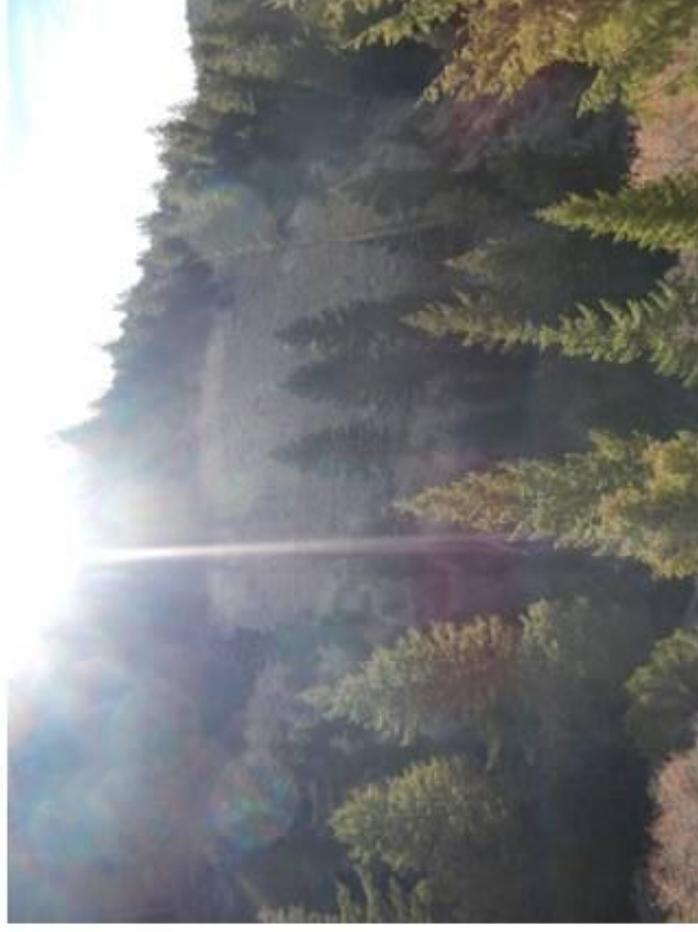
Site G-19

G-19: The site was reclaimed during the 2010 construction season and received Phase I bond release in 2014. The degas pad was noted to be stable (i.e. no evidence of erosion or instability were noted during the field inspection). The pre-existing skid road was observed during the inspection. Evidence of minor erosion on the skid road was observed during this inspection. The three water bars located on the G-19 access road require maintenance. The accumulated sediment within the water bars must be removed and new excelsior logs/sediment controls installed.

G-19: This is a fairly steep site bisected by an existing road. It is located approximately 250' from the main road. The reclaimed areas on either side of the access road are well vegetated and the rills that had formed in 2014 have been diminished with the establishment of additional vegetation and sediment controls.

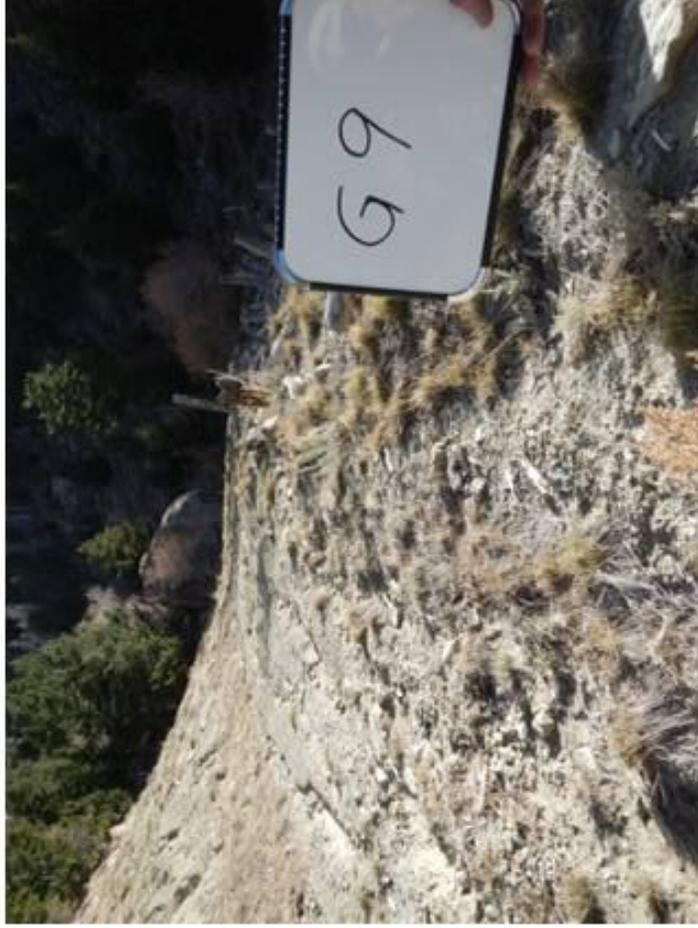
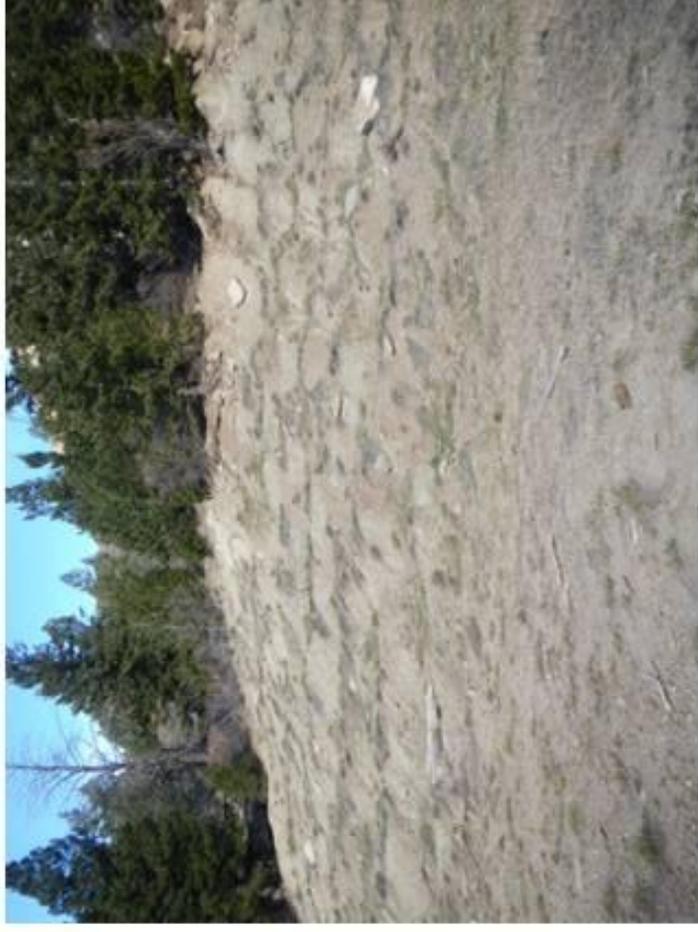
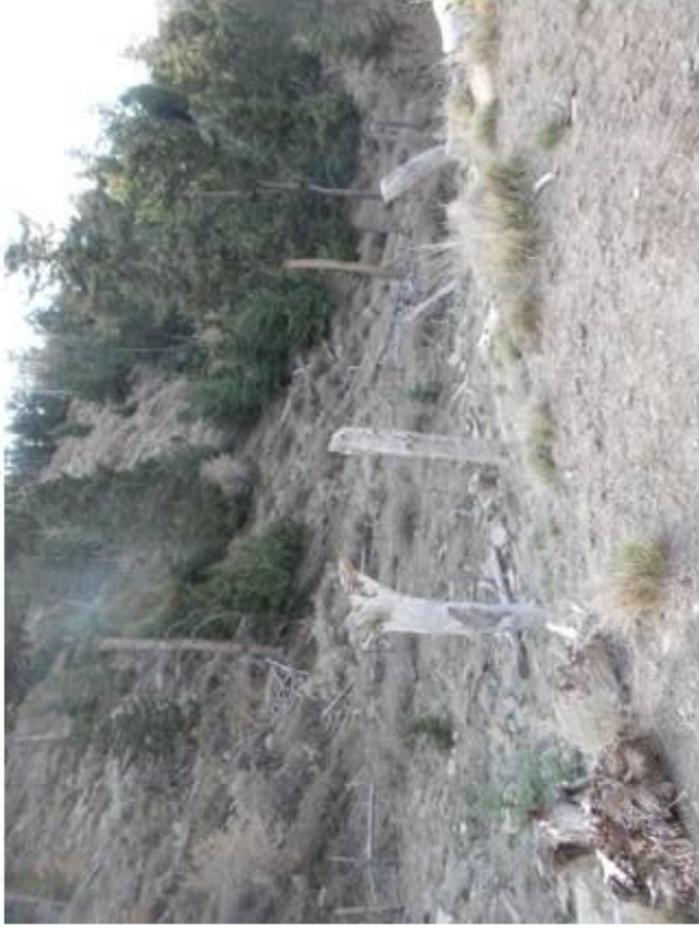
Site G-9

G-9: The site was reclaimed in 2012 and received Phase I bond release in 2014. No evidence of off-site impacts or erosion was noted during the time of the inspection. The site was observed to be in stable condition (i.e. no significant evidence of

erosion). Bill King indicated that the site had experienced issues with thistle. The site had been sprayed to knock the thistle infestation back. As a result, the vegetation has been impacted to a degree. Bill King indicated that husbandry seeding will occur in the spring of 2017 if vegetation has not emerged following the snowmelt.

G-9: This site is located at the end of an access road (See Pace Canyon Road System map Att). The site is stable, well vegetated and fenced.

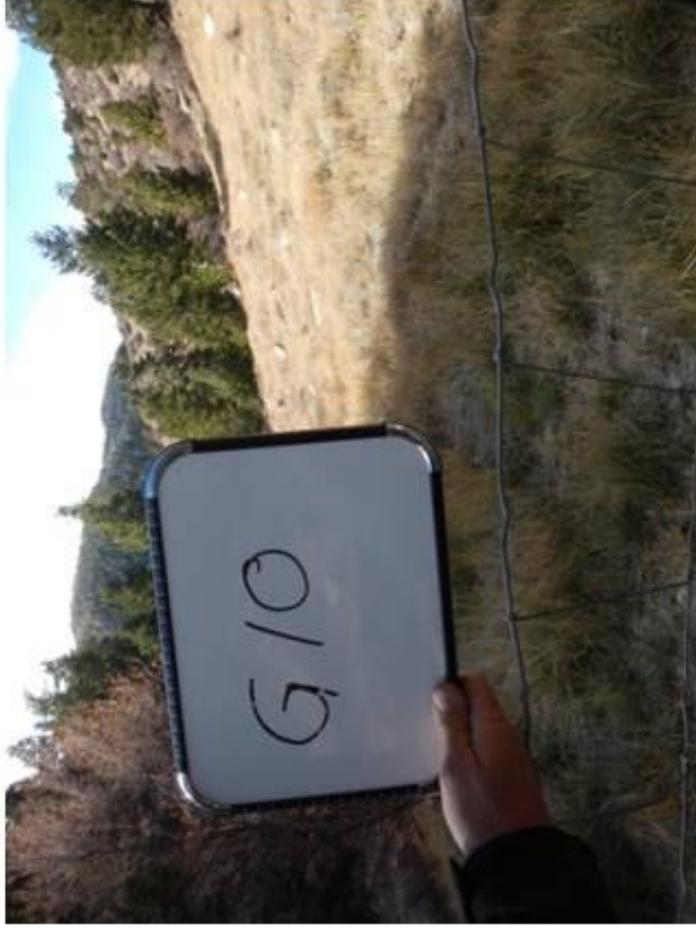
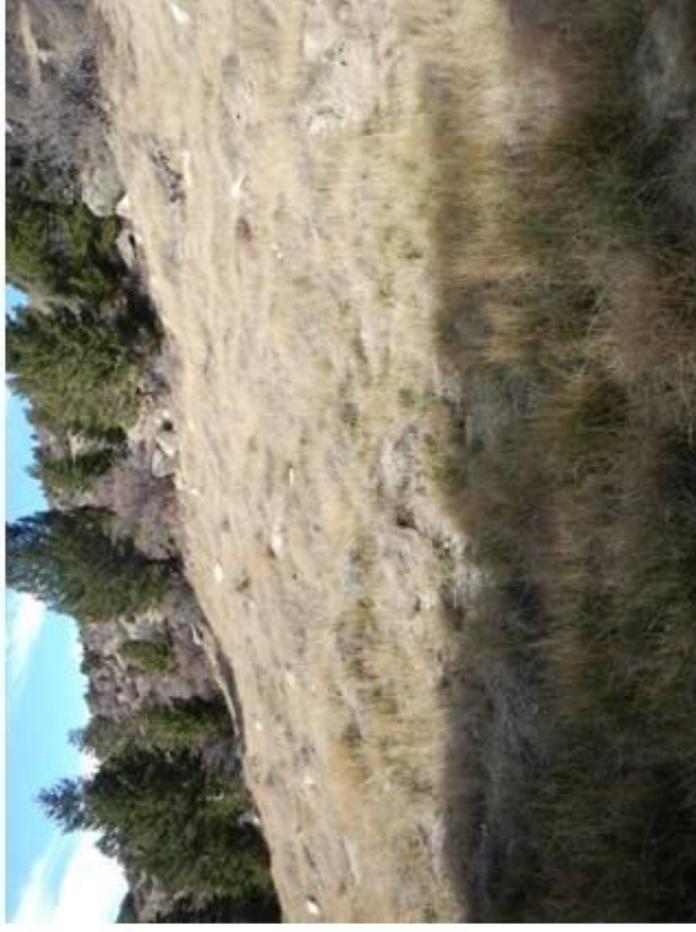
Site G-10

G-10: The site was reclaimed during the 2012 construction season and received Phase II bond release in 2014. No evidence of off-site impacts/erosion was noted during the time of the inspection. The site utilizes a culvert to route flow from the pad/access road area. Upon review of the approved MRP, it appears that the sizing for the culvert was designed with a 10-year, 6-hour event. A permanent diversion must be sized to safely pass the peak runoff from a 100-year, 6-hour event (See State of Utah R645-301-742.323. The Permittee must provide design calculations that the culvert at degas pad G-10 has been adequately sized to meet that design standard. The calculations must be submitted for review and incorporation into the approved MRP.

G-10: This site is fenced, stable and well vegetated (mostly grasses and forbs with some shrubs). It is located up-slope just off of the main road. The drill pad has been reclaimed to approximate original contour (AOC). This created a fairly steep slope that has been armored with 10-24" rip-rap and silt fence along the Southeast

a.Culvert- In MRP in Volume III, Attachment 7-1, Hydrology Calculations on pgs. 375-388/611, it appears that the culvert was designed for a 10-year, 6-hour event. As this is assumed to be a permanent diversion, the Permittee needs to provide revised hydrologic calculations which demonstrate that the culvert can safely pass a 100-year, 6-hour rainfall event per R645-301-742.323. This information is expected to be provided by June 30, 2018.

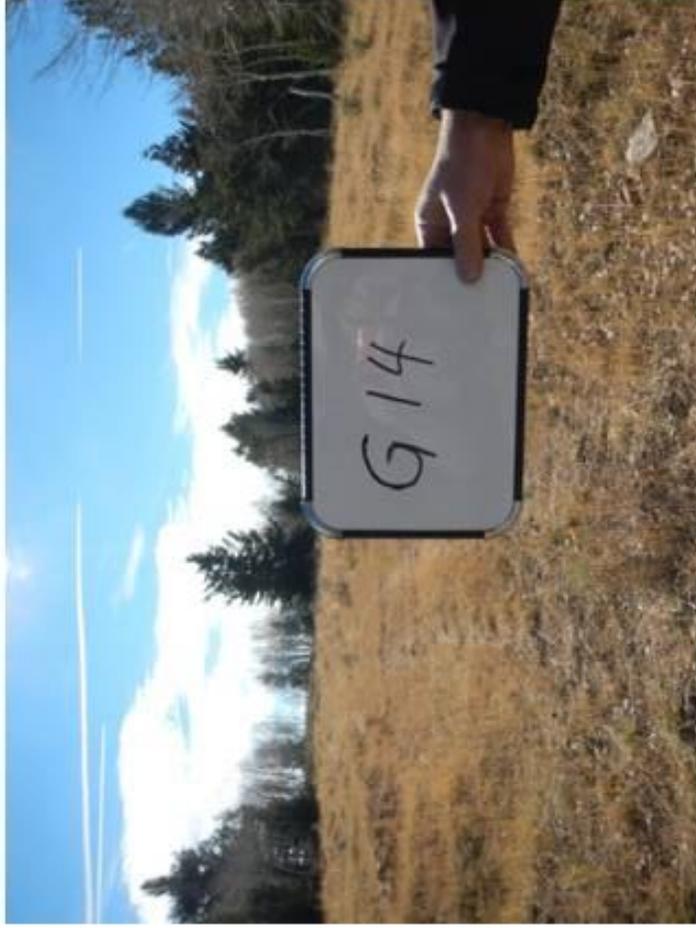
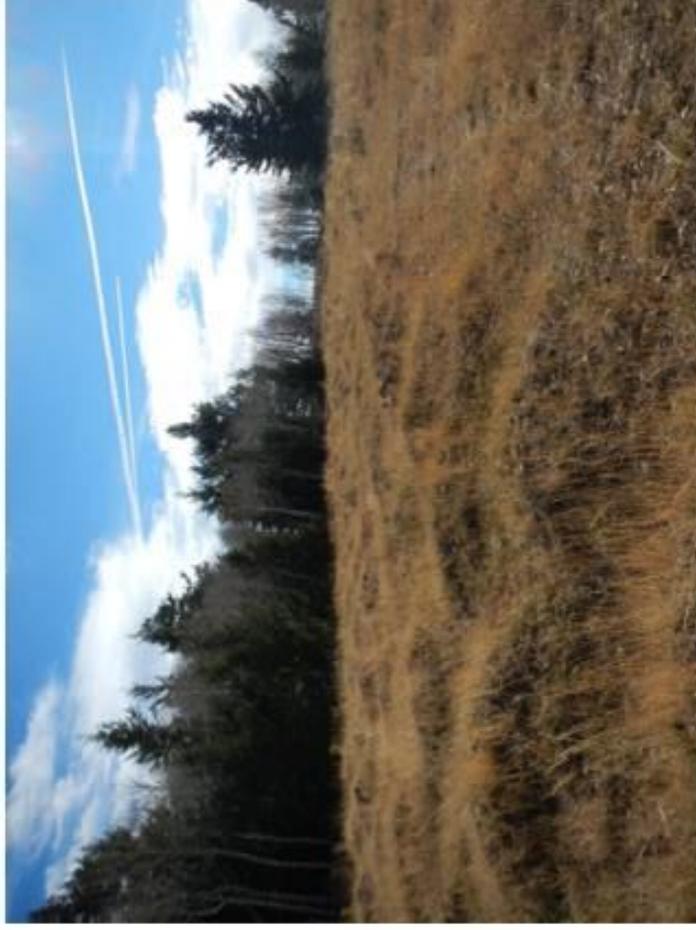
Site G-14

G-14: The site was reclaimed in June of 2010. Phase II bond release was approved for the site in 2014. The site was stable. No evidence of off-site impacts or erosion were noted during the inspection.

G-14: This site is located about 100 yards off the existing road. The site is fenced, stable and well vegetated. The pad is fairly level and was pocked during reclamation to promote the conservation of precipitation.

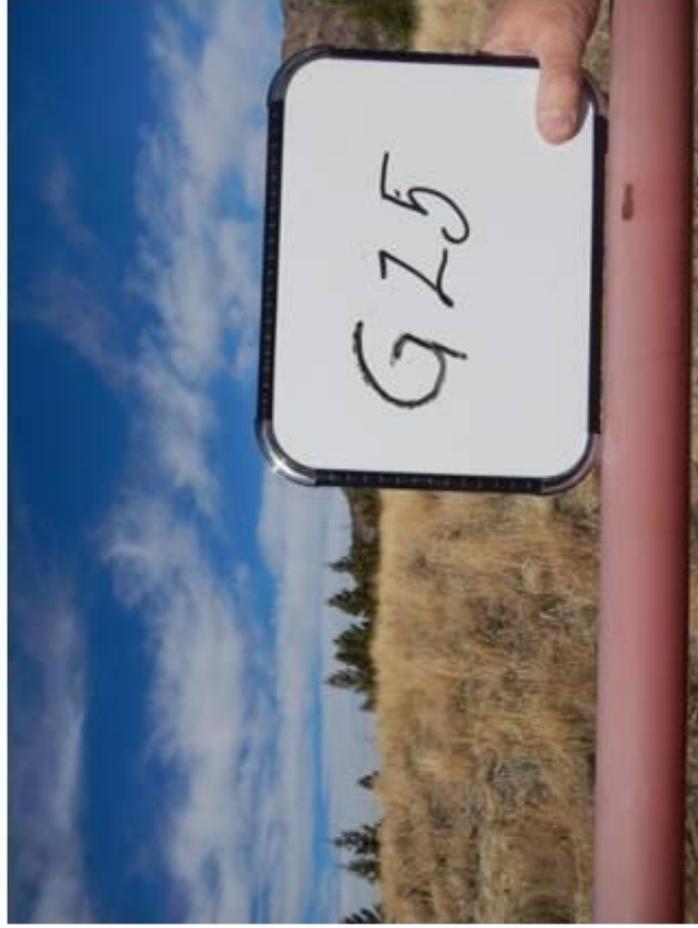
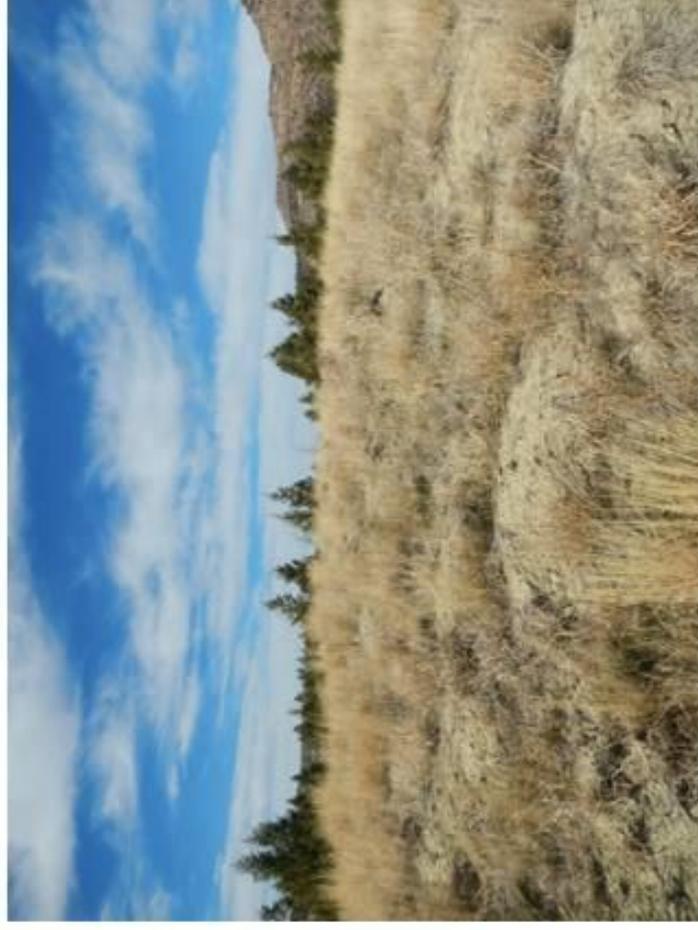
G-25: Site G-25 was reclaimed in June of 2013 and received Phase I bond release in 2014. The approximate original contour has been re-established and the site has been pocked. No evidence of off-site impacts was noted during the inspection.

G-25: This site is fenced, stable and well vegetated (mostly grasses and f orbs, some shrubs).

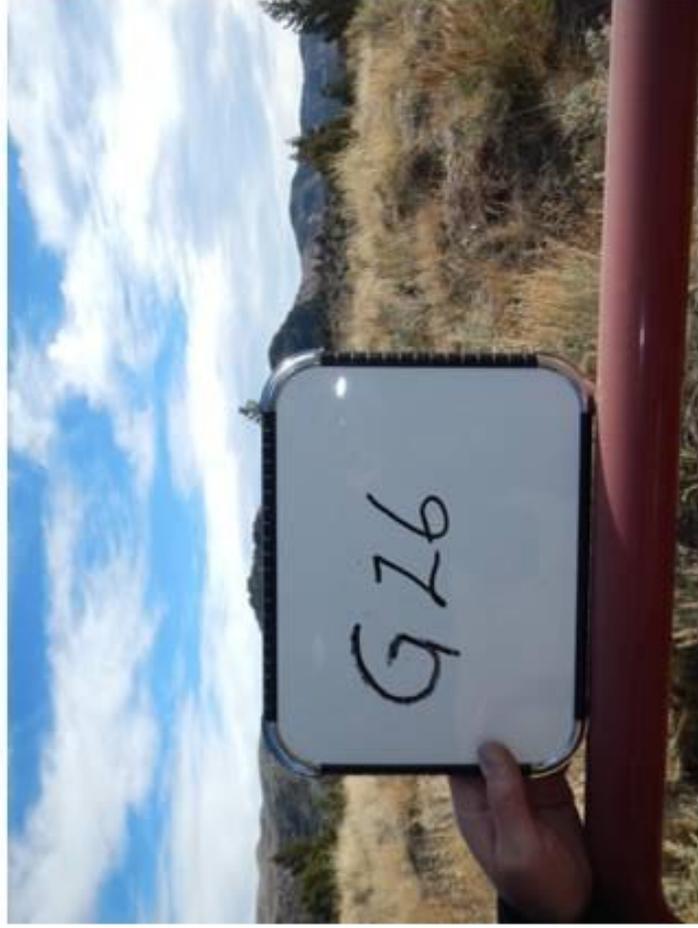
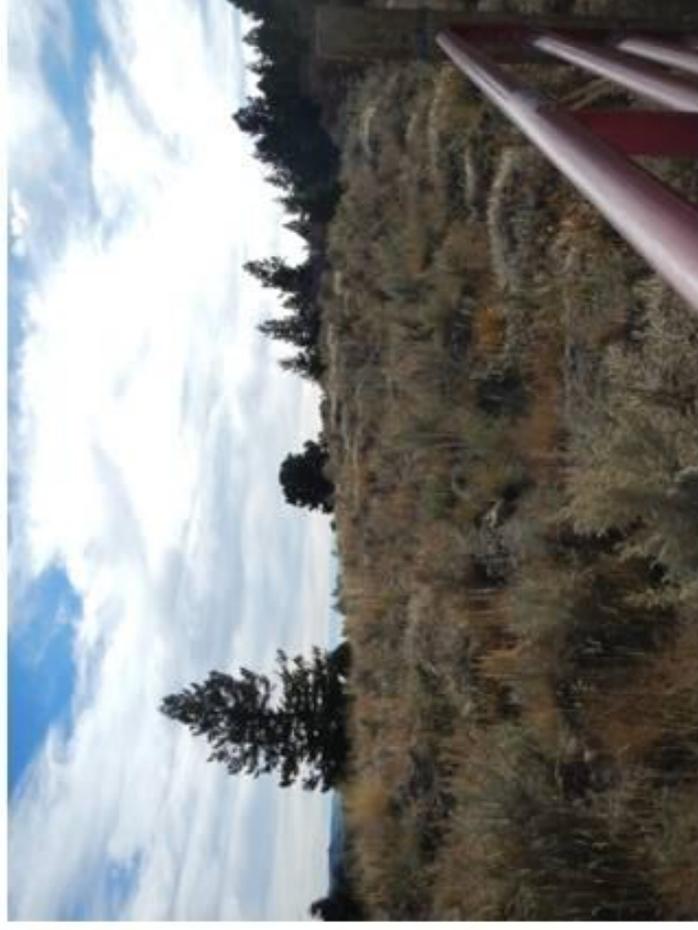
Site G-26

Site G-26: The site has been returned to original contour and pocked. Final reclamation of the site was completed in June of 2013 and received Phase I bond release in 2014. No sign of off-site impacts/erosion were observed during the time of the inspection.

G-26: This site is fenced, stable and well vegetated. The site is located just off of the main road. The vegetation at this site included a noticeable amount of sagebrush

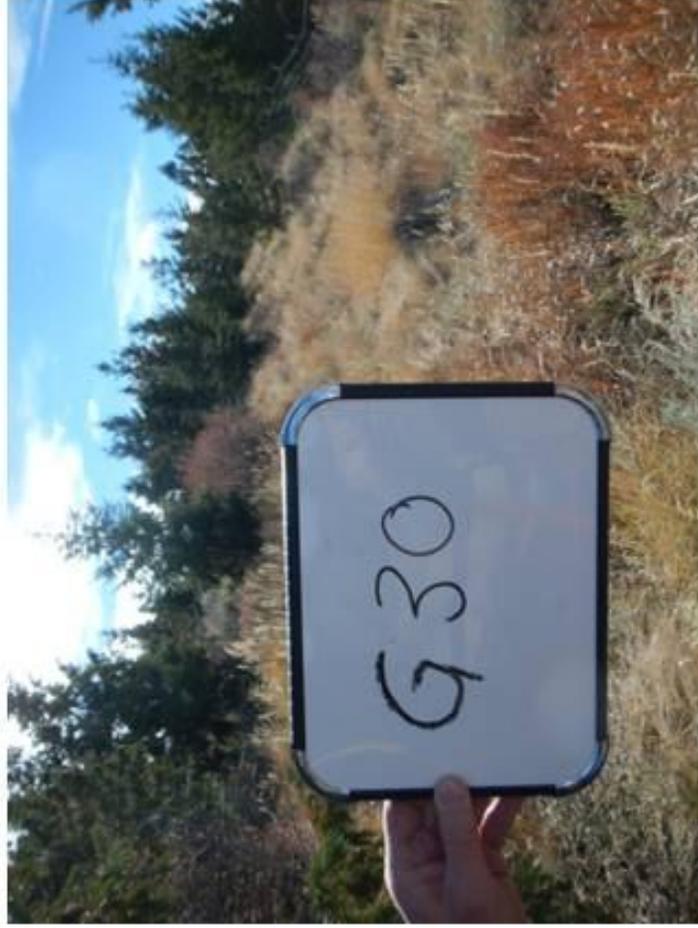
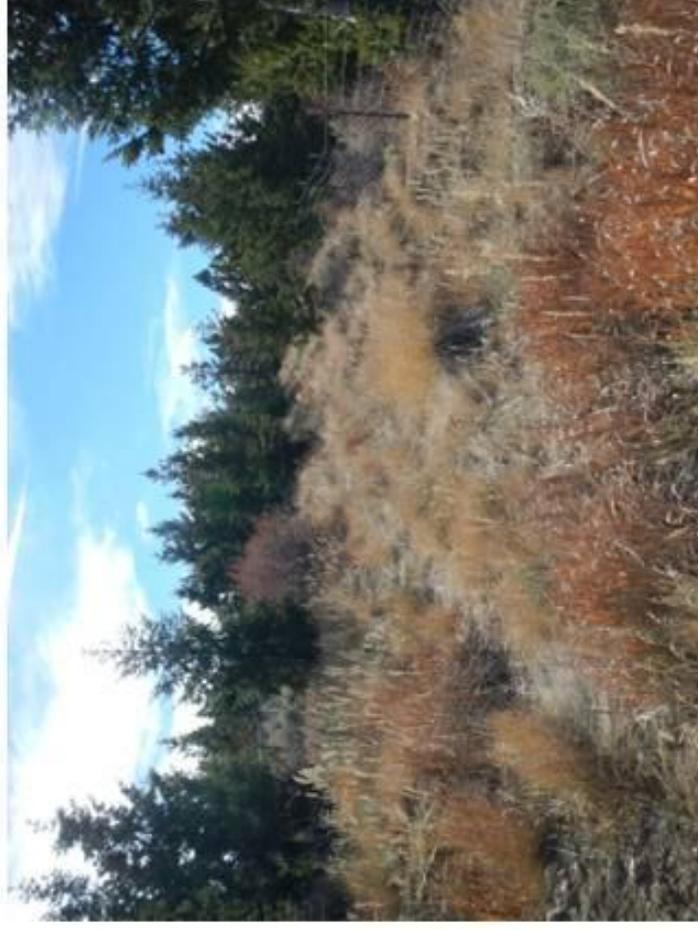
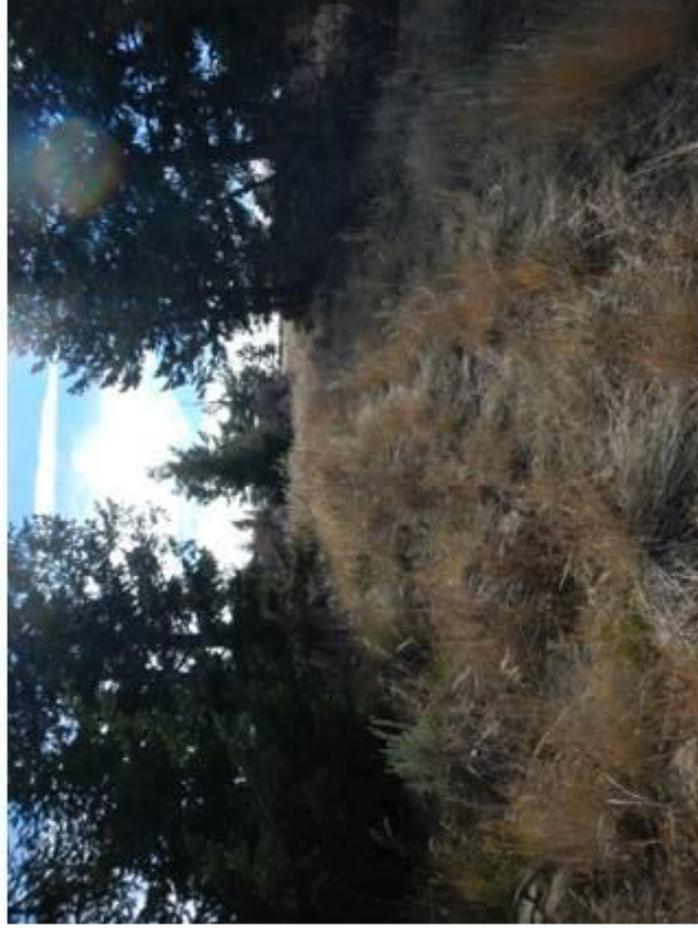
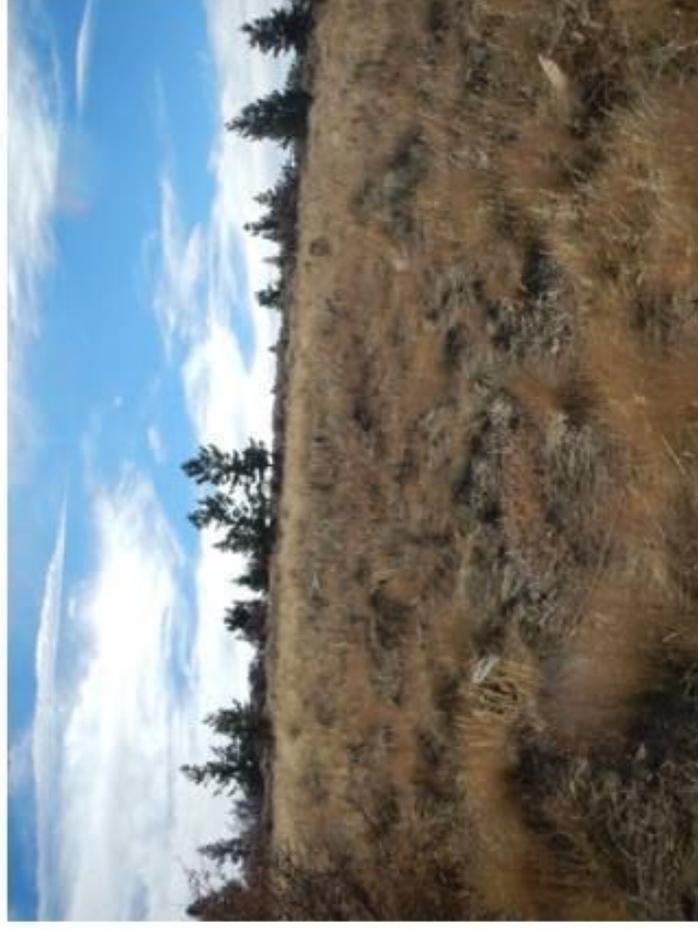
Site G-30

Site G-30: Final reclamation of the site was completed in June of 2013. Phase I bond release was approved in 2014. The area has been pocked and approximate original contour has been re-established. The site was stable. No signs of excessive erosion or sedimentation off the disturbed area were noted during the inspection.

G-30: This site is fenced, stable and well vegetated. The site is located approximately 100 yards south of the main road. The vegetation at this site also included a noticeable amount of sagebrush. The access road (although not required) appears to have been reclaimed and the vegetation is very well established perhaps due to a greater amount of precipitation at this elevation.
